<b>Summary of:</b>	<b>Aircraft Accident Report No: 3/2007</b>	140
	Report on the accident to Piper PA-23-250 Aztec, N444DA 1 nm north of South Caicos Airport, Turks and Caicos Islands, Caribbean on 26 December 2005

<b>Aircraft Type and Registration:</b>	Airbus A320-232, G-MIDW	
<b>No &amp; Type of Engines:</b>	2 International Aero Engines V2527-A5 turbofan engines	
<b>Year of Manufacture:</b>	2000	
<b>Date &amp; Time (UTC):</b>	8 October 2006 at 0340 hrs	
<b>Location:</b>	En-route Kos to Glasgow International Airport	
<b>Type of Flight:</b>	Commercial Air Transport	
<b>Persons on Board:</b>	Crew - 6	Passengers - 156
<b>Injuries:</b>	Crew - None	Passengers - None
<b>Nature of Damage:</b>	None	
<b>Commander's Licence:</b>	Airline Transport Pilot's Licence	
<b>Commander's Age:</b>	47 years	
<b>Commander's Flying Experience:</b>	10, 600 hours (hours on type - unknown) Last 90 days - 260 hours Last 28 days - 70 hours	
<b>Information Source:</b>	Aircraft Accident Report Form submitted by the airline's flight safety department and additional inquiries by the AAIB

<b>Aircraft Type and Registration:</b>	Airbus A340-642, G-VSHY
<b>No &amp; Type of Engines:</b>	4 Rolls-Royce Trent 556-61 tu

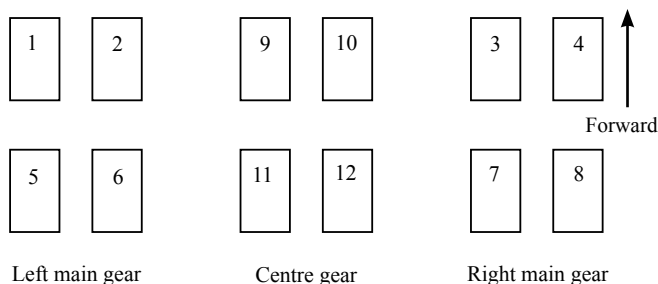
The main and centre landing gear wheels are numbered as follows:

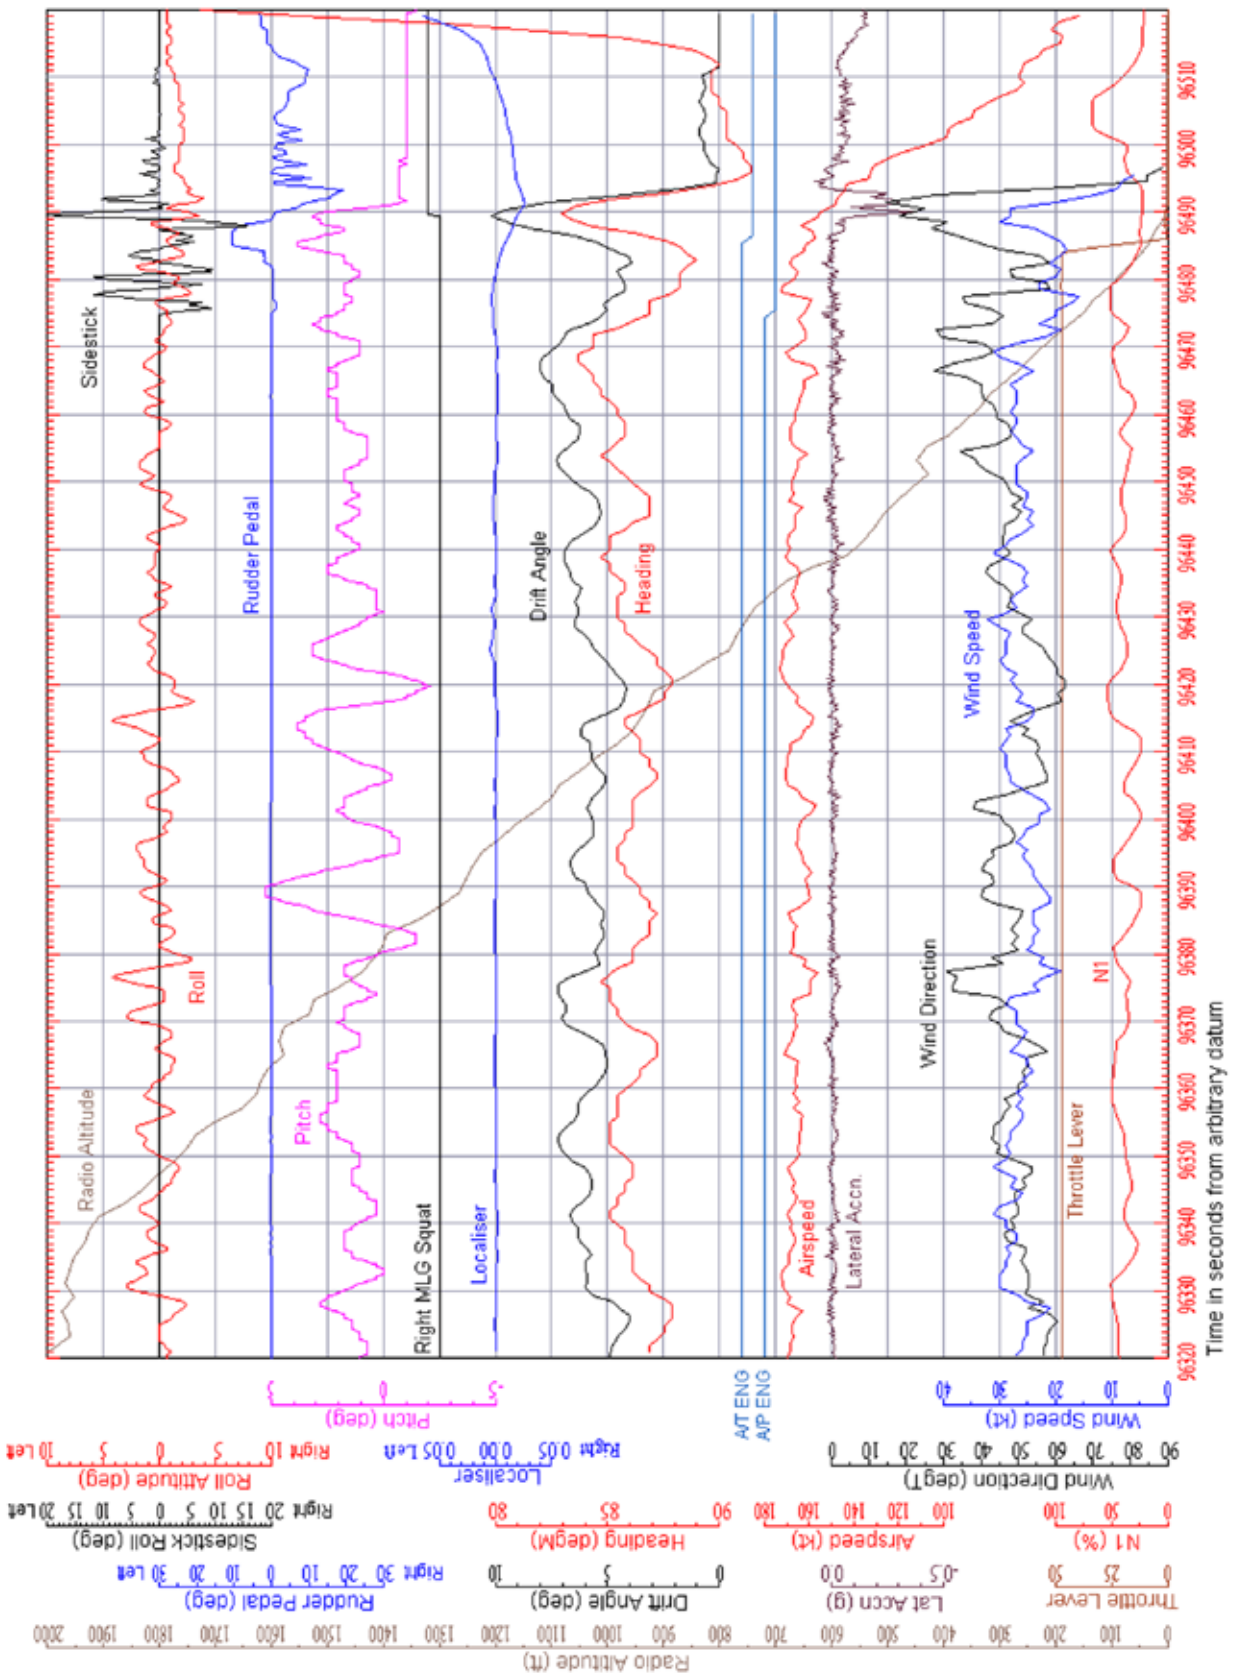
Figure 5

The two solid-state flight recorders (DFDR and QAR) were removed from the aircraft and replayed, and both had retained data covering the events leading up to and during the landing. Pertinent parameters recorded during the approach and landing are shown in Figures 5 and 6.

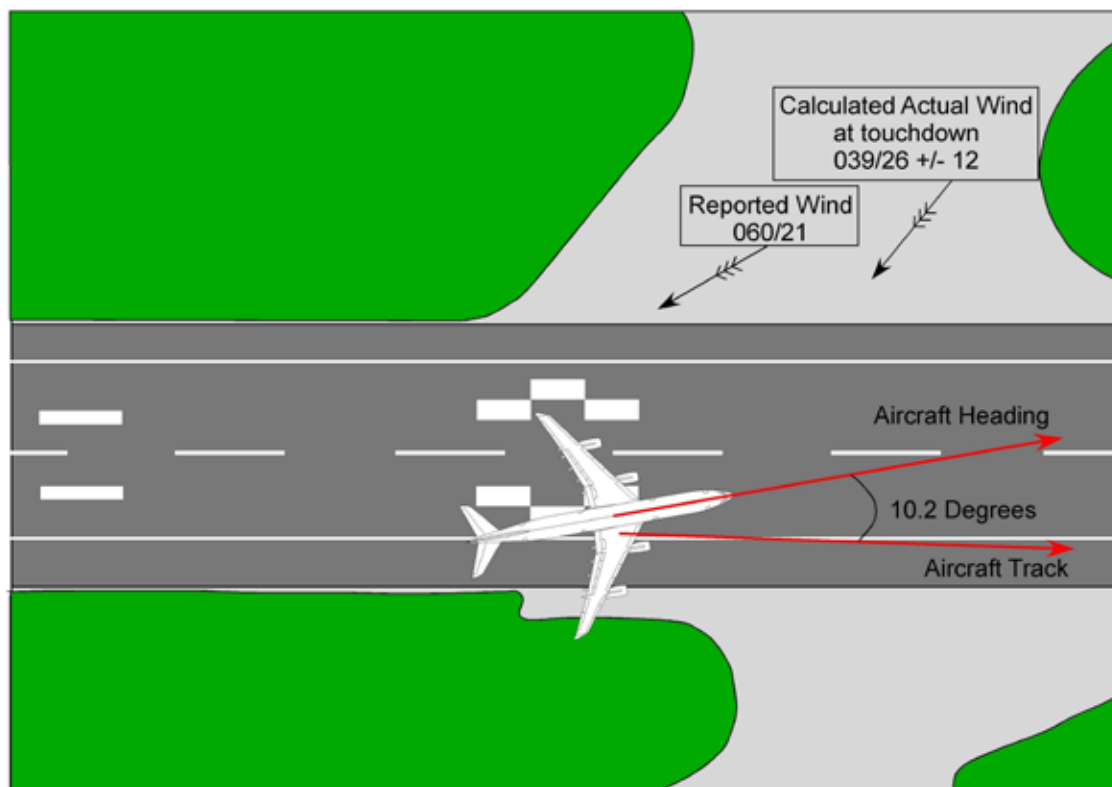
**Figure 7**

The aircraft landed at a speed of 156 kt, to the right of the centreline on a heading of 083°M and with a drift angle of 10.2°, Figure 7.

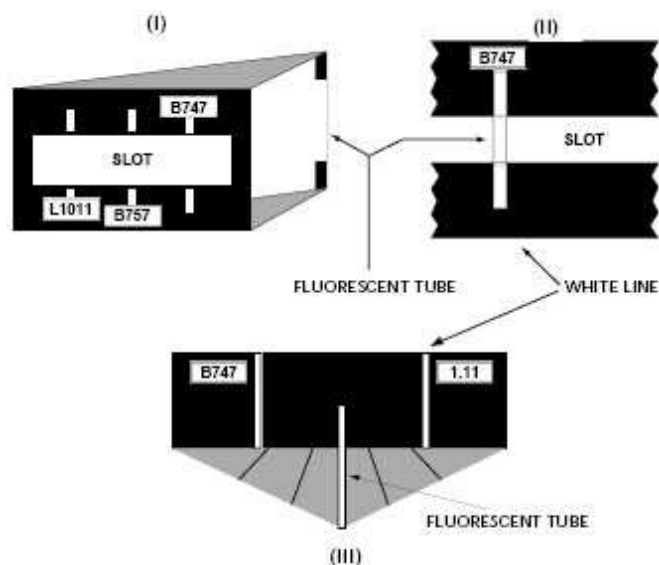
**Figure 2**

PAPA (typical)

On Stand 19, the PAPA, Figure 2, was installed approximately 13 m to the right of the stand centreline but designed for use from the left pilot position. Consequently, it was necessary for the commander to look across the cockpit in order to view it as shown in Figure 3.

The system is calibrated to provide correct stopping guidance to the pilot occupying the left seat of an aircraft tracking the stand centreline. Being a parallax system, it cannot provide meaningful stopping guidance to anyone in another location, such as the pilot occupying the right seat or staff on the ground.

The PAPA for Stand 19 was serviceable and would have provided correct stopping guidance to the commander of the aircraft whilst tracking the stand centreline. The commander reported after the incident that, because of its location, it was not apparent that this PAPA referred to Stand 19.

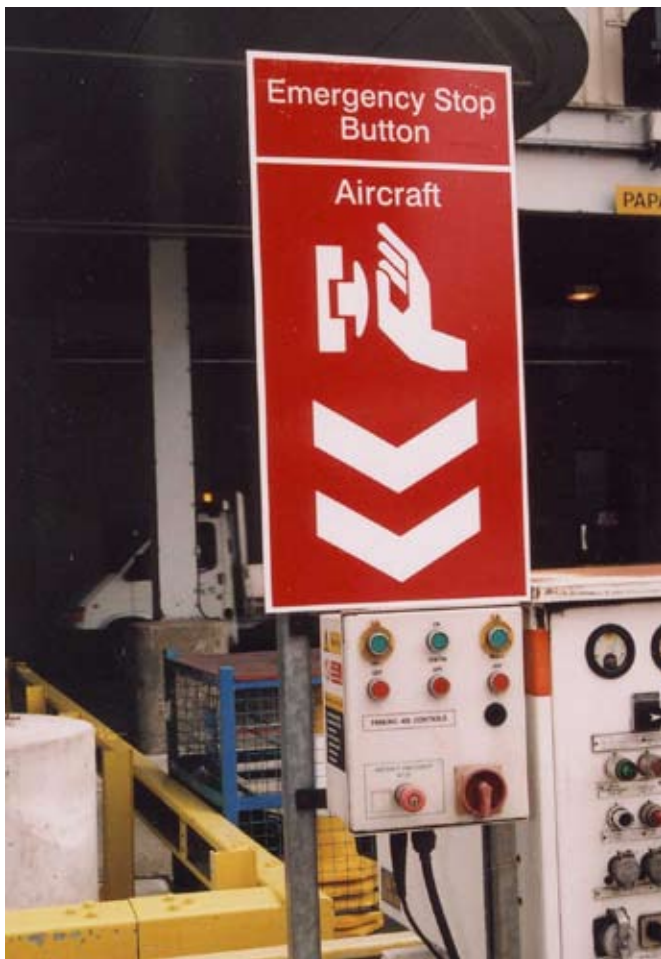
**Figure 4**

Stand guidance control box (ground)

The emergency STOP sign could be activated by pressing a button on the stand guidance control box, located at the head of the stand (nearest the terminal building) to the left of the stand centreline, Figure 4. It could also be operated by a button on an identical control box mounted above the steering controls in the cab of the airbridge, on the left side of the airbridge head (nearest the aircraft), Figure 5. The Traffic Officer was not aware of this, believing that it was located beside the door to the airbridge steps, on the other side of the airbridge head and, consequently, out of reach.

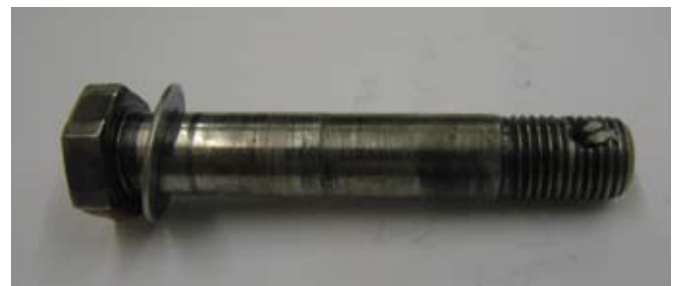
**Figure 3**

A bolt from the mid door attachment was recovered from the stand, which exhibited a degree of damage to the threads and which contained the remains of a cotter pin, Figure 3. With the exception of some minor bending and scoring of the shank, the bolt had not

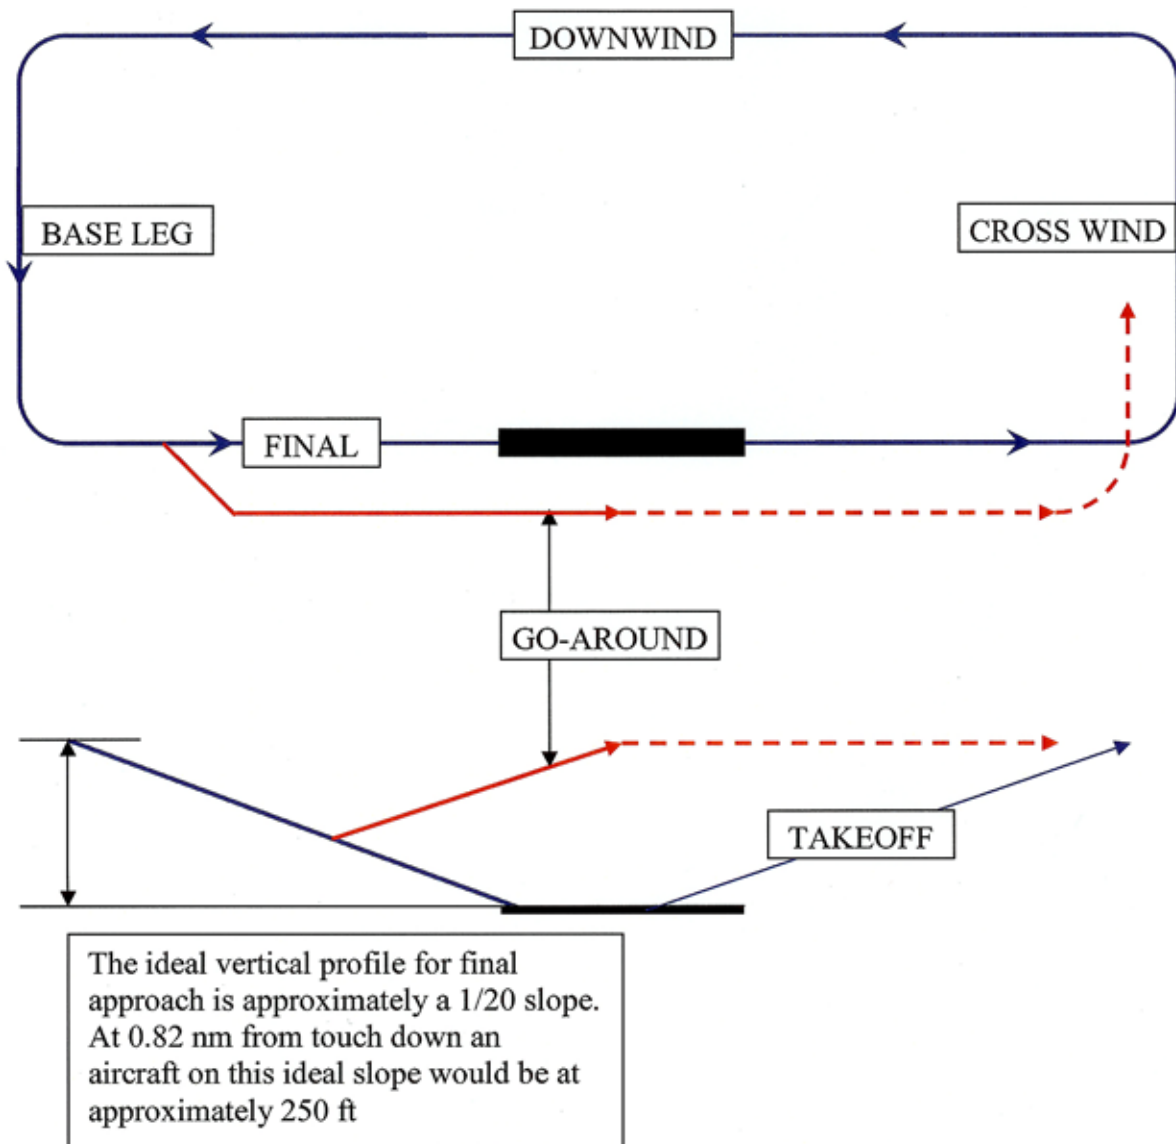
Figure 4

A diagram of a typical circuit is shown in Figure 4.

Typical circuit pattern

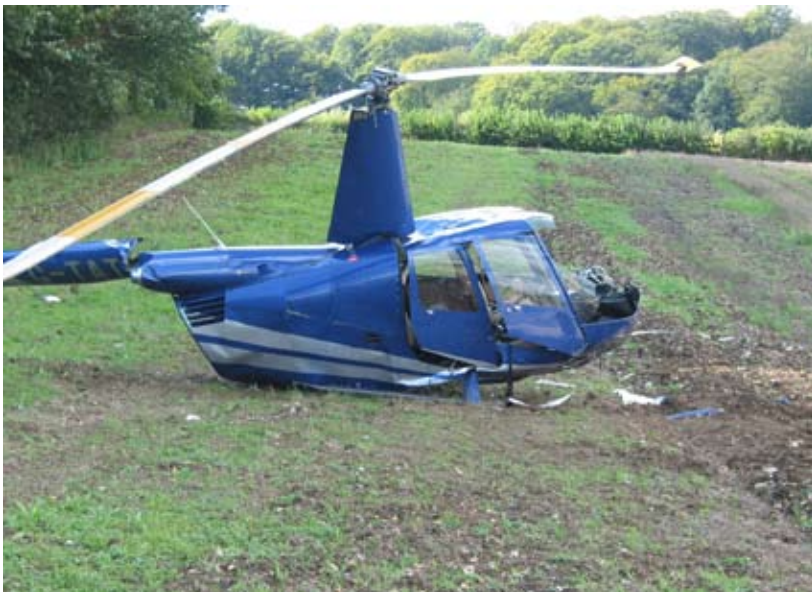
**Figure 1**

G-TATY, 16 September 2005

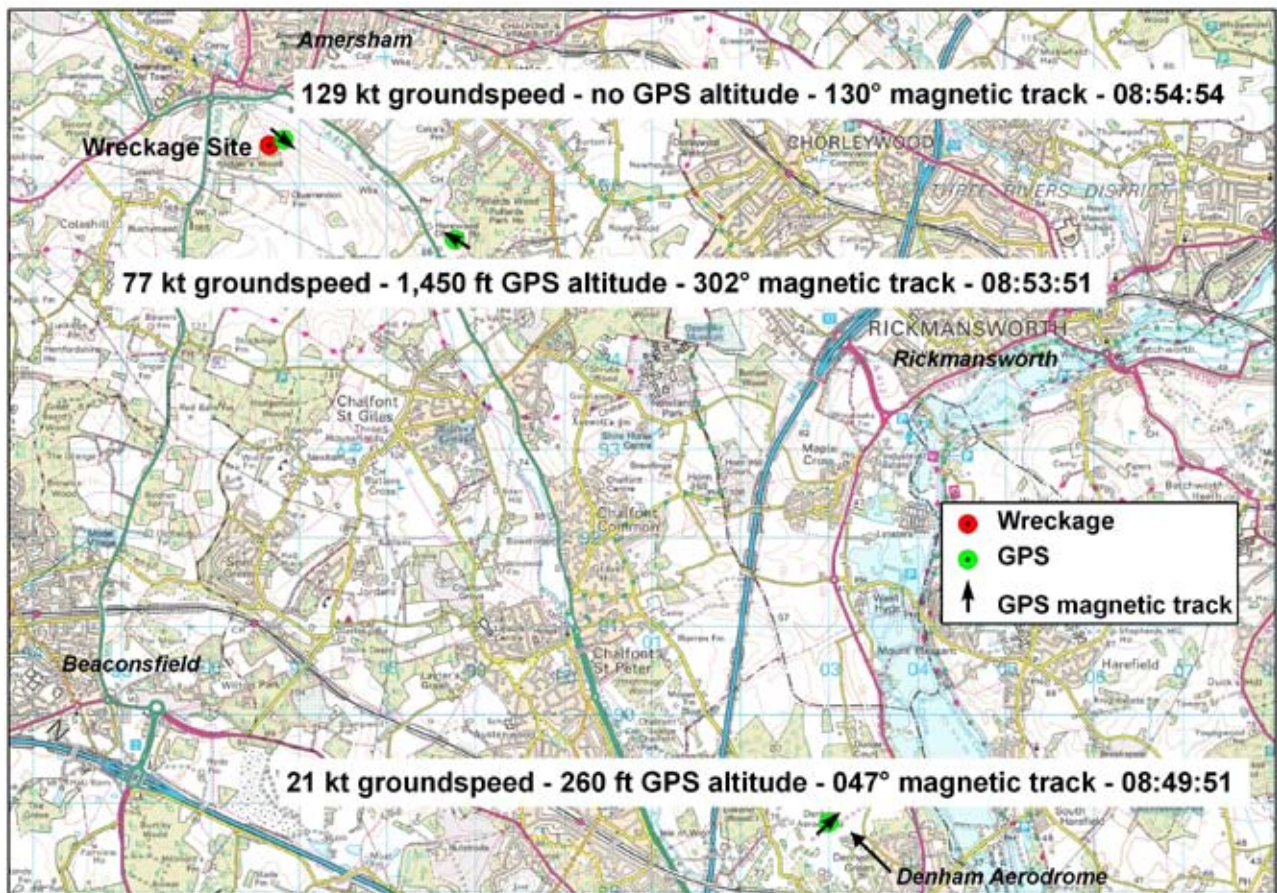
Figure 2

Recorded information was retrieved from G-TATY’s GPS equipment. The GPS memory was set to record waypoints, and their associated information, every four minutes. However, there was a gap of only one minute and three seconds between the last two points. This could have happened as a result of power being removed and then restored to the GPS at some time after the penultimate waypoint was recorded.

The recorded GPS waypoints are shown in Figure 2.

G-TATY recorded waypoints

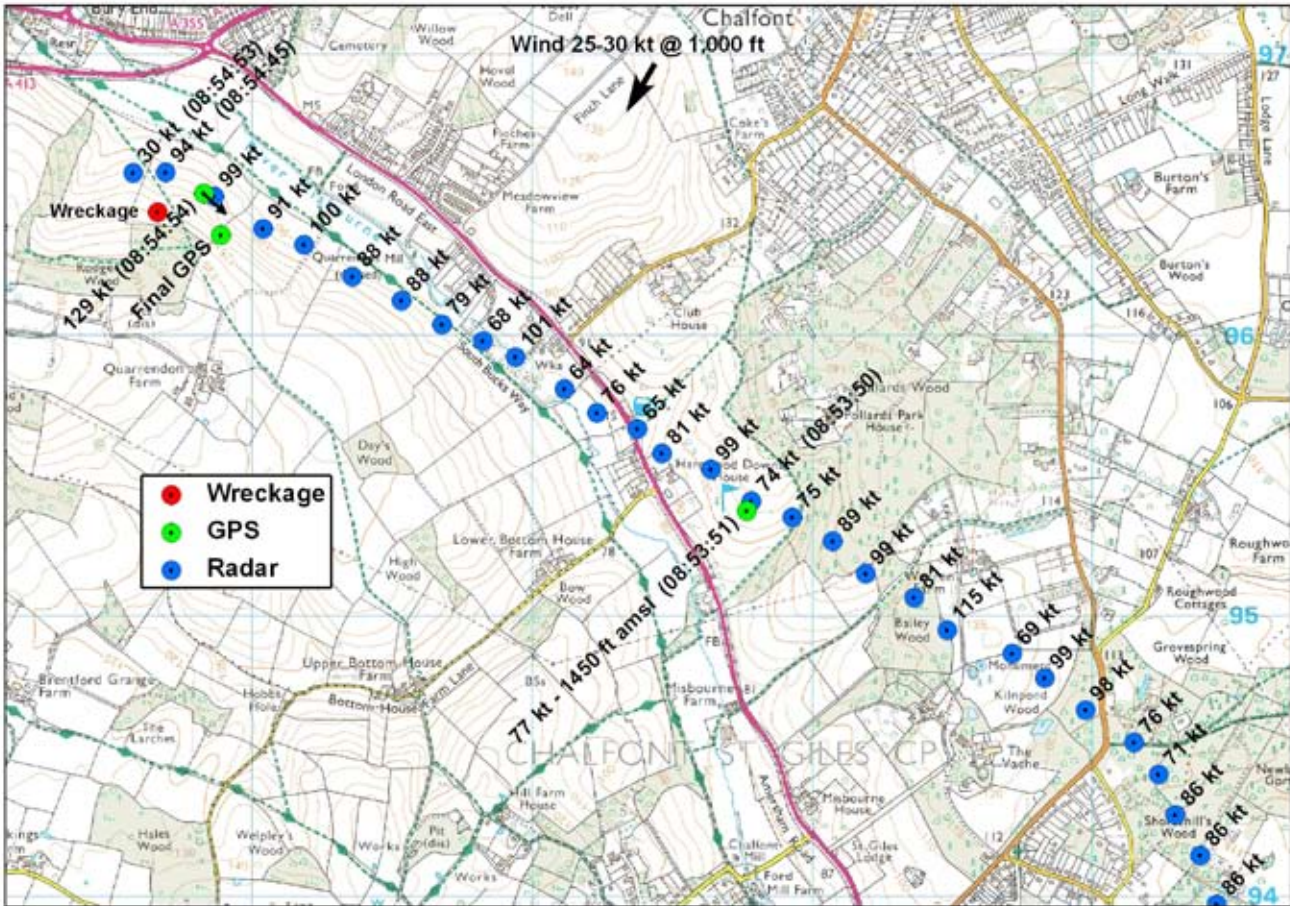
Figure 3  
G-TATY radar recordings

However, the helicopter’s GPS groundspeed of 129 kt at 0854:54 hrs was considered unreliable because it was not consistent with any of the witness statements, nor was it reflected in the recorded radar data, which is shown in Figure 3.

The GPS and recorded radar information indicated that G-TATY descended from an altitude of 1,450 ft amsl to about 620 ft amsl in the space of 1 minute 2 seconds; an **average** rate of descent of approximately 800 fpm. This was about half the rate of descent expected during a stable autorotation. There was no specific evidence that the helicopter descended throughout that period or that it descended at a uniform rate. Conversely, there was no evidence of G-TATY having descended at a rate that indicated that it had entered autorotation. The average ground speed during that time was 86 kt and, given the wind conditions, G-TATY’s airspeed averaged 88 kt. This is reflected in the speeds annotated on the plot of radar recordings in Figure 3 for the same period, which indicate fluctuations about about the mean ground
