Rail Accident Investigation Branch

Rail Accident Report

Report on the runaway manually propelled trolley between Larkhall and Barncluith Tunnel 2 November 2005

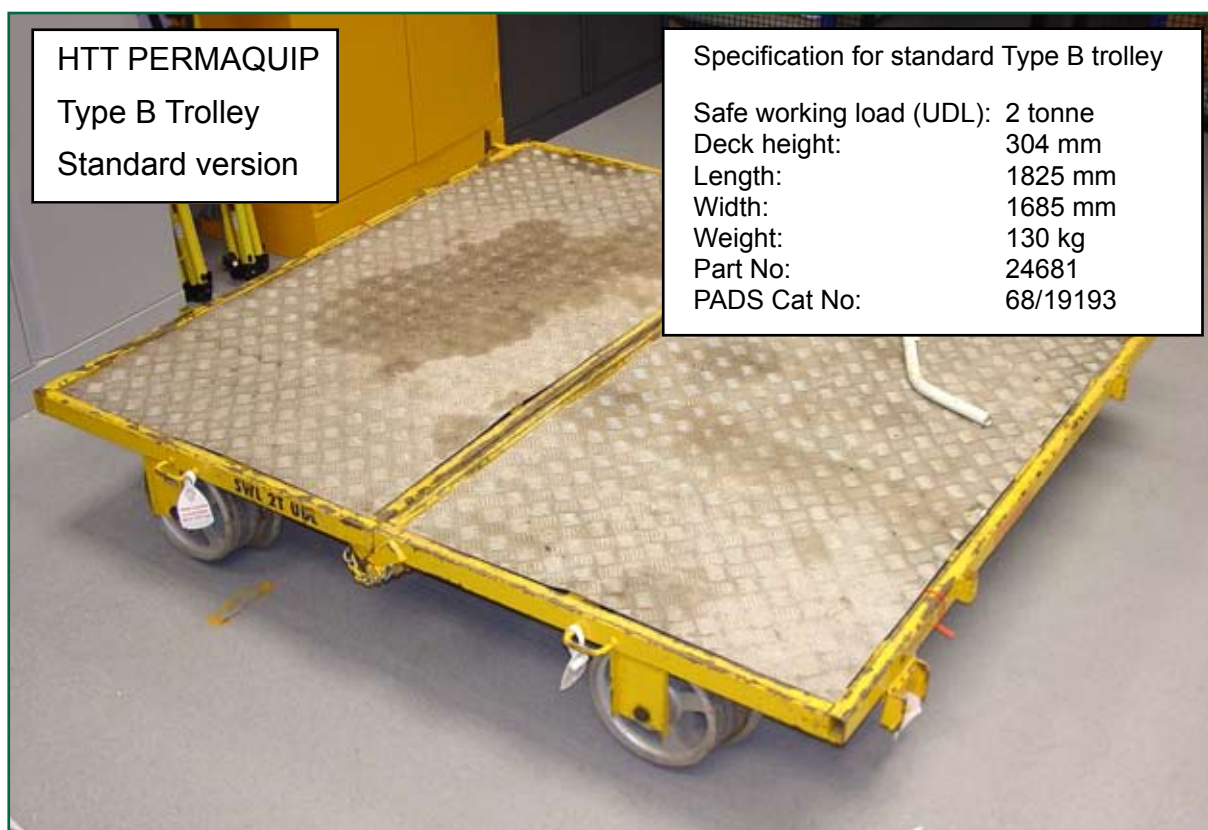
- 30 The incident trolley (see Figure 5) was a Type B portable trolley serial number RT10574, manufactured by Harsco. It is also known as a *standard* design trolley. It was commonly referred to as a '*bogie*' by the local work force.

Figure 5: HTT Type B trolley

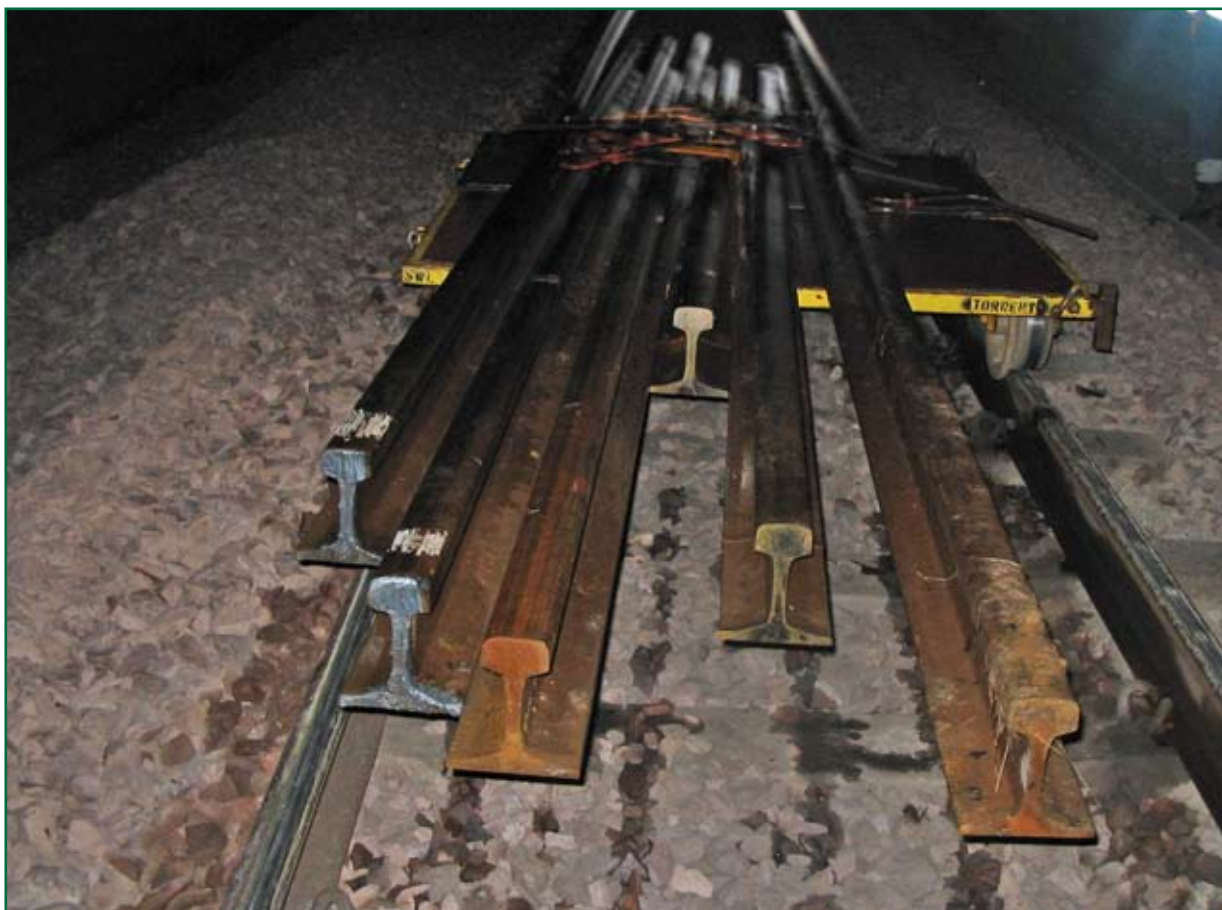
Figure 12: Image taken by the RIO from within Barncluith tunnel

- 100 It was observed that one side of the trolley was ‘dipped’ due to the securing pin between the two halves having become loose and detached. It cannot be established when the two halves became separated, although it may have been caused by the impact when the trolley ran through the points at Haughhead Junction.

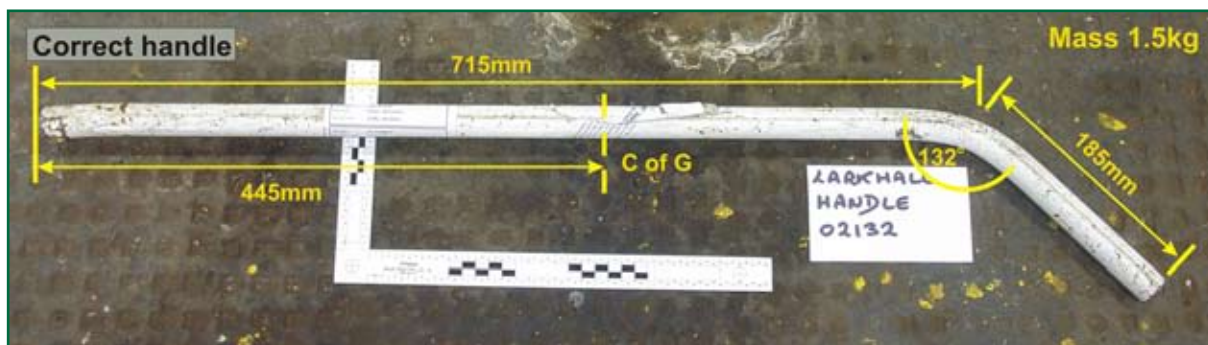
Figure 16: Type B trolley - correct brake handle

175 The handle found at Haughhead Junction (see paragraph 111) was identified as that used on the incident trolley. However it was not supplied for use with a Type B Permaquip trolley (Figure 10), but for use with a *Link* trolley also known as a Type A (Figure 12).

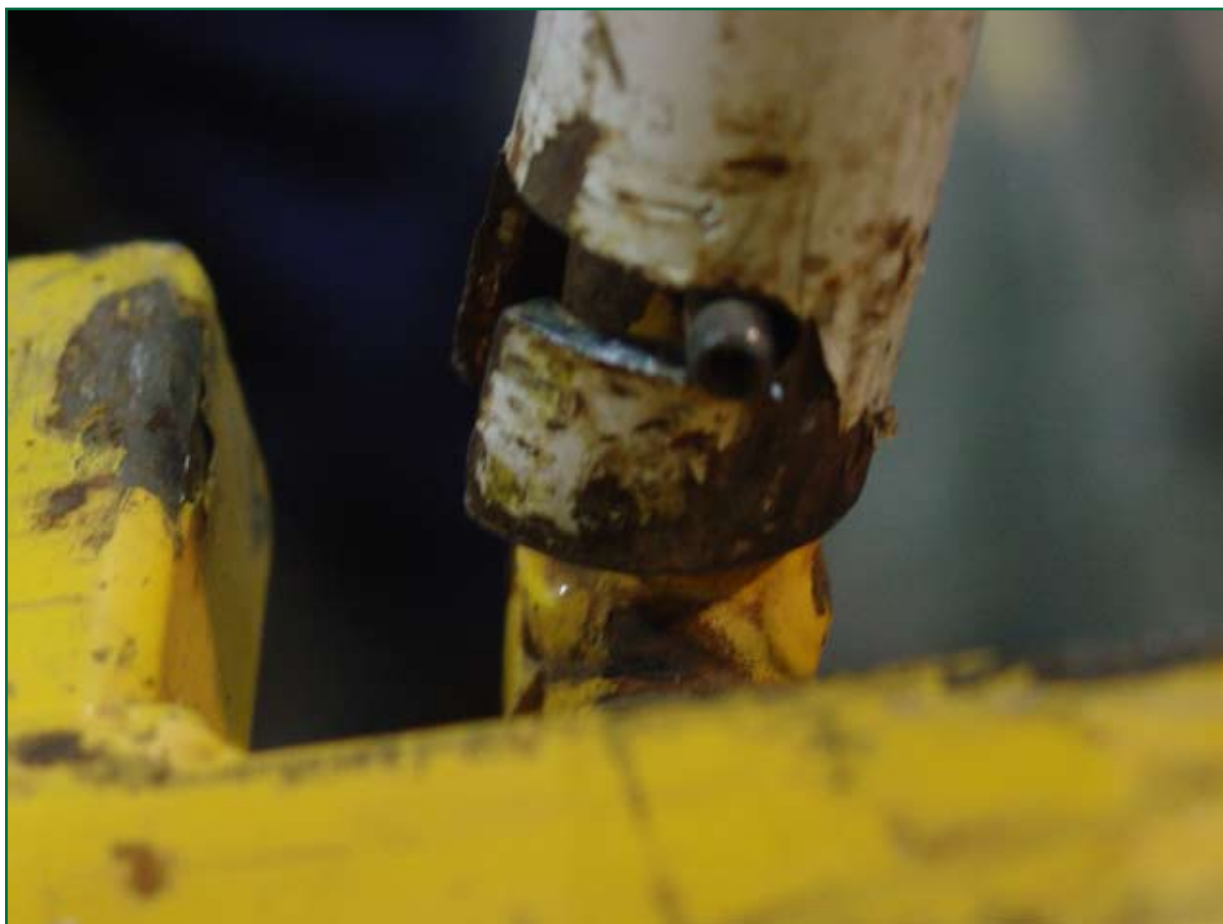
Figure 17: Handle and locating lug connected for Type B trolley

176 Torrent's records of their AP38 tests show that they had supplied the correct handle when the trolley was initially hired to Carillion. The investigation could not establish why an incorrect handle had been used with the incident trolley.

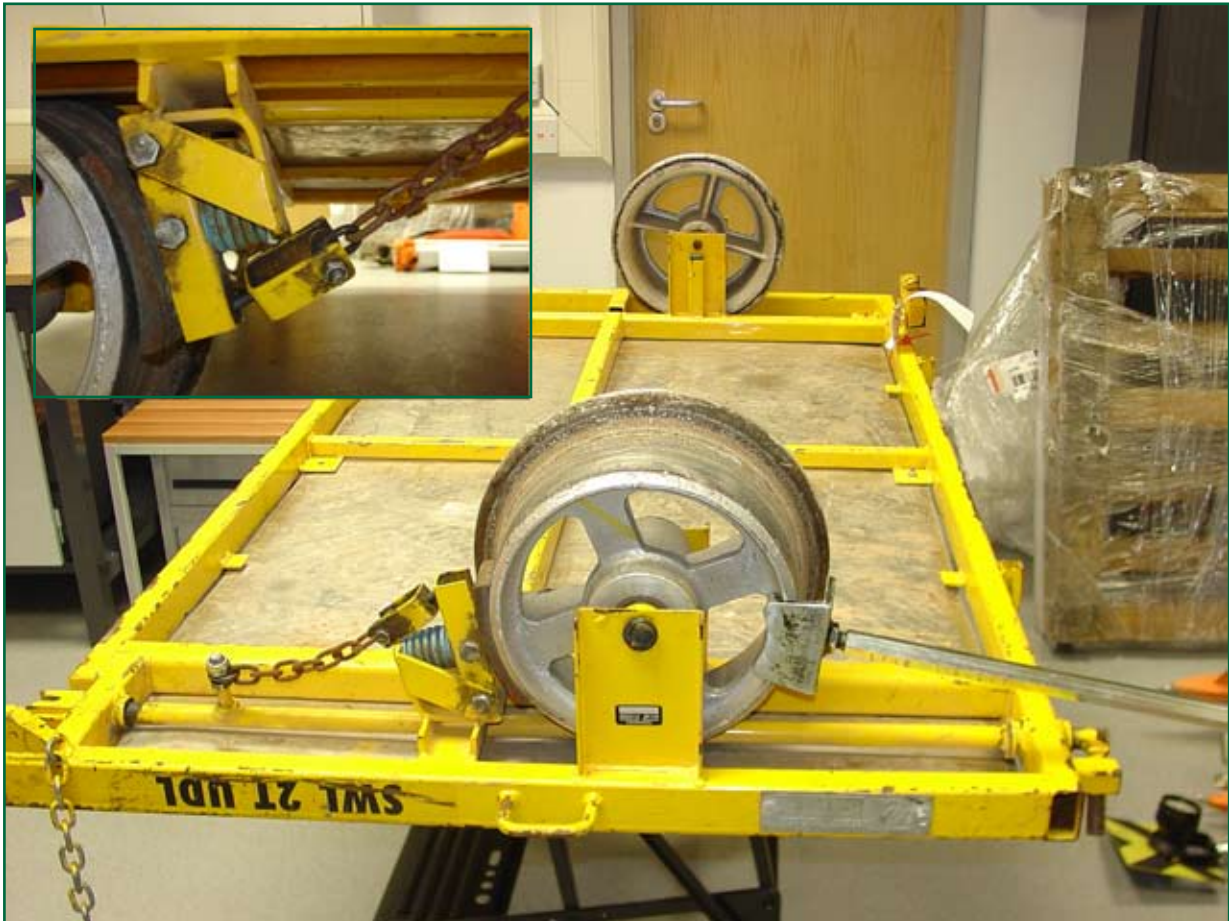
Figure 23: Image showing trolley, brake block and associated linkage (reference trolley)
