# Rail Accident Report

## **Derailment of a freight train at Marks Tey, Essex 12 June 2008**

This report is published by the Rail Accident Investigation Branch, Department for Transport.

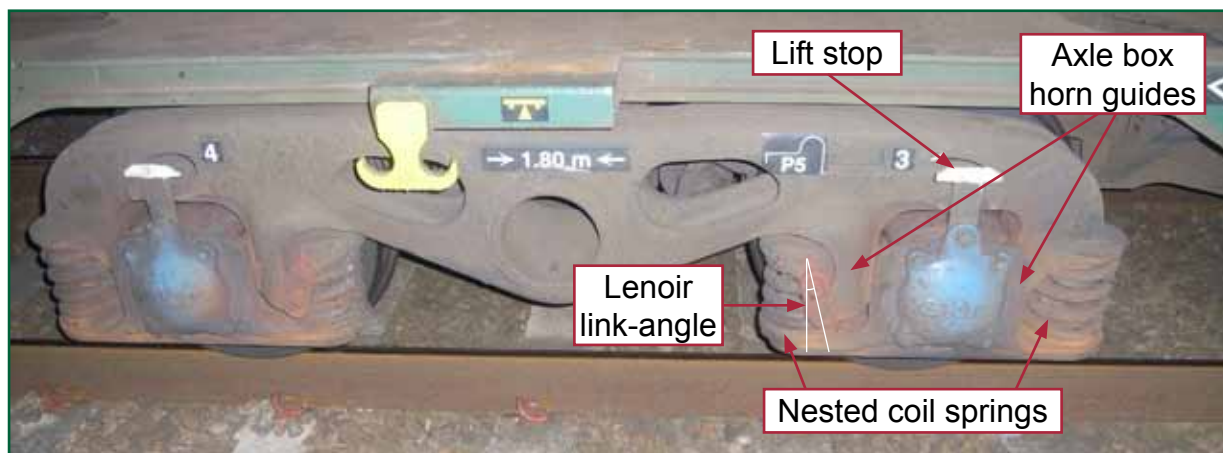
Figure 6: Y25 type bogies

- 83 The rear bogie leading wheelset showed contact marks indicating that the left-hand wheel had also ridden high on the wheel flange. The trailing wheelset of the rear bogie had contact marks on the tip of its left-hand wheel flange; this wheel also had a fresh mark on its tread that was indicative of it having dropped onto a rail head (figure 14). There was a possible contact mark on the right-hand wheel of this wheelset, and evidence of contact on the underside of the lift stop on the right-hand wheel of the trailing wheelset (figure 6), indicating that the bogie frame may have applied a lifting force to this wheel.
