AAIB
Air Accidents Investigation Branch

AAIB Bulletin

7/2016

Published 14 July 2016

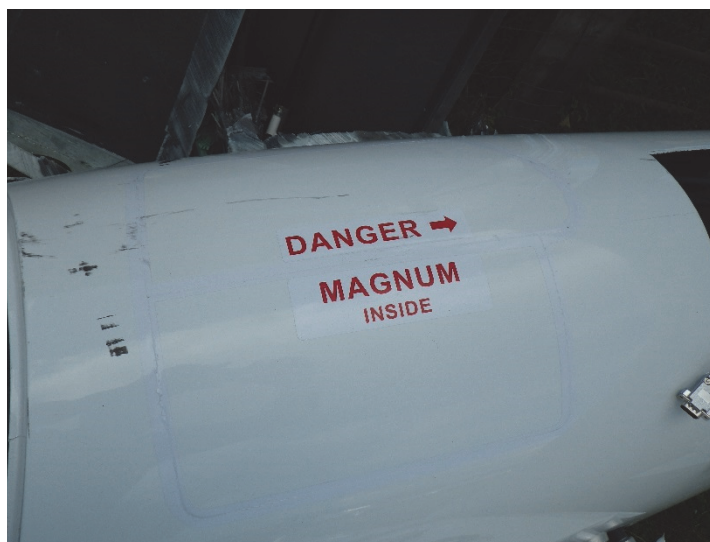
G-CIYA was equipped with the Magnum 300 SSP Ballistic Parachute Recovery System (BPRS). The rocket and parachute were located in a compartment behind the pilot and above the wing spars. The operating handle was located on the right side of the cockpit and had a safety pin to prevent inadvertent operation. A warning placard stating '*Ballistic Parachute Deployment Handle Emergency Use Only*' was attached to the inside of the cockpit adjacent to the operating handle. A second red warning sign stating '*DANGER MAGNUM INSIDE*' was affixed to the BPRS compartment access panel (see Figure 1).

Figure 1
BPRS warning sign

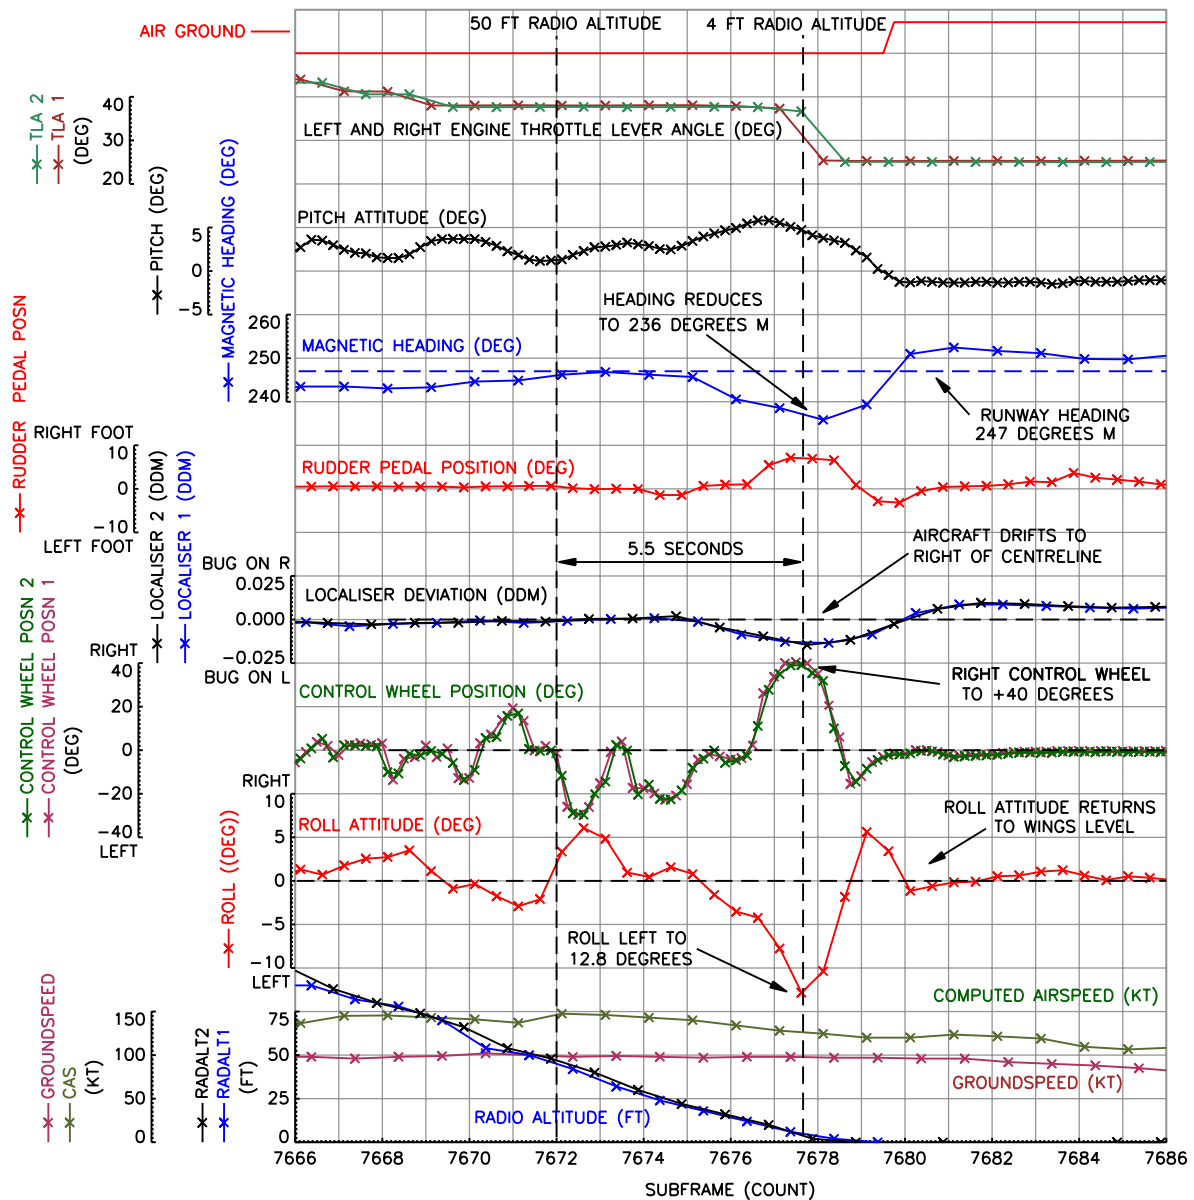
maximum of (-)12.8° to the left, with a nose-up pitch attitude of approximately 5°. At the same time, the CAS reduced to 126 kt and the groundspeed to 97 kt. Full control wheel (40°) was applied to the right to counter the roll to the left, together with 7° of right rudder pedal².

Figure 3
G-CGWV FDM data

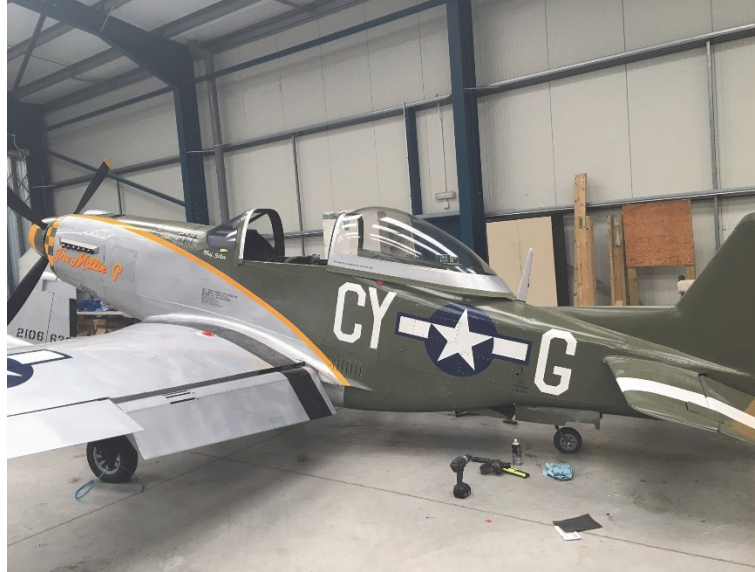
Figure 1

The Titan T-51 Mustang is a three-quarter scale replica of the P-51 Mustang (Figure 1). It is a two-seat homebuilt aircraft of steel frame and aluminium skin construction, with a retractable main landing gear and tailwheel. The tailwheel is attached to an aluminium spring (Figure 2) which serves as a shock absorber. This spring is supported by a rod with two adjustable rose joints, called the 'link' (Figure 2).

Titan T-51 Mustang (G-TSIM)
