RAIB investigations involving freight trains – current areas of concern

Presentation to DB Schenker Rail (UK) 4th Risk Management Seminar on 5 November 2015

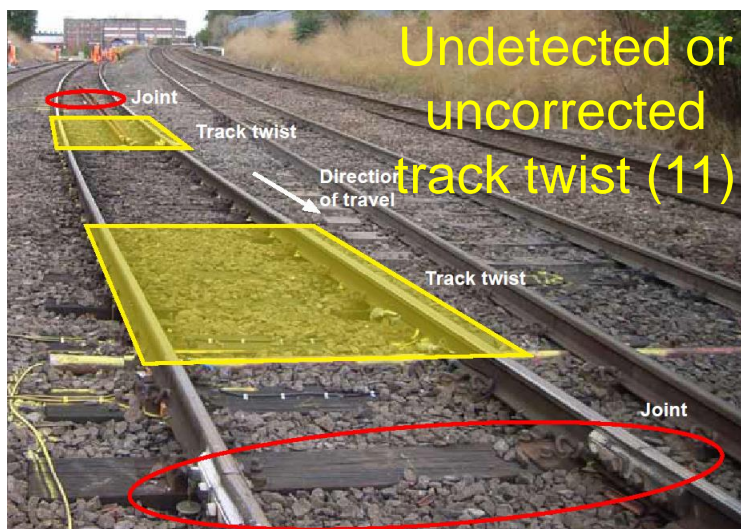
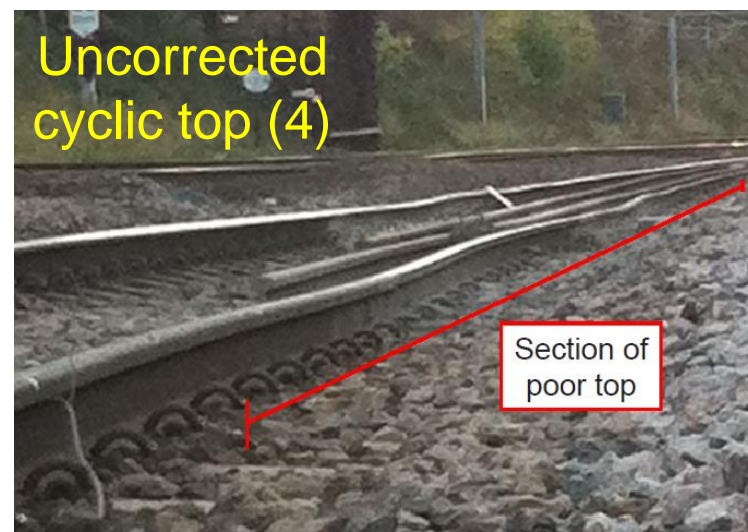
Track condition factors

- In cases where both track and vehicle factors have been identified, the majority of track issues were:

- All of these track geometry faults required maintenance action but standards did not require trains to stop running
- Recommendations being implemented by Network Rail for effective detection and management of track geometry

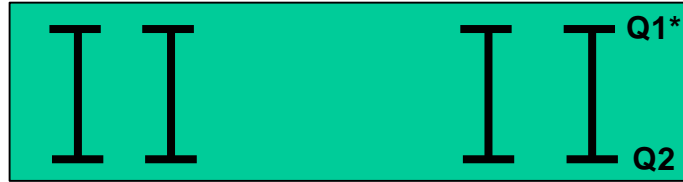
Effect of offset load on derailment risk

Calculations show how the derailment risk due to wheel load imbalance is increased when there is both a longitudinal and a lateral load offset

*at-risk wheel

Level track			
	Q1 (kN)	Q2 (kN)	Qave (kN)	DQ/Q
No load offset	50	50	50	0%
Longitudinal offset load	35	35	35	0%
Lateral offset load	35	65	50	30%
Lateral + Longitudinal load offset	20	50	35	43%

Twisted track			
	Q1 (kN)	Q2 (kN)	Qave (kN)	DQ/Q
No load offset	35	65	50	30%
Longitudinal offset load	20	50	35	43%
Lateral offset load	20	80	50	60%
Lateral + Longitudinal load offset	5	65	35	86%
