Maritime &
Coastguard
Agency

SS RICHARD MONTGOMERY Survey & Sub-Bottom Profiling Report 2014

Maritime and Coastguard Agency
September 2015

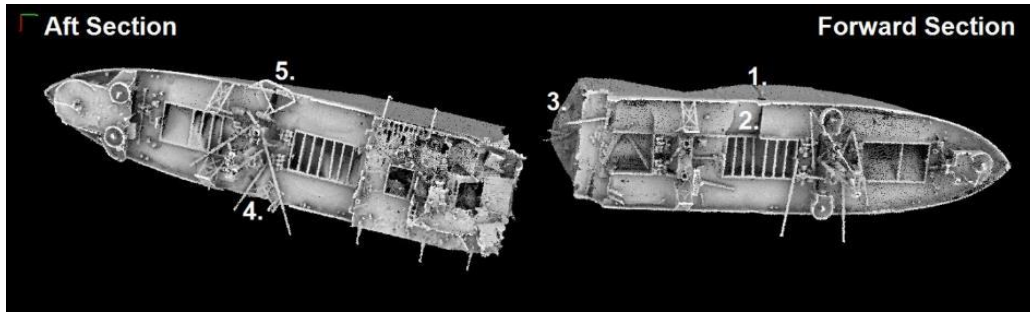
Figure 3. Overview of the wreck with locations of key areas

4.5.2 The locations of these five areas can be seen in the plan view of the wreck site shown below. On assessing the 2014 survey data, in only one of these five key locations was any change observed.

Key Location Number	Feature	Location	Change Observed in 2014
Area 1	Crack in Hull	Port Side, Forward Section (Near Hold 2)	NO
Area 2	Collapse of Cargo Hold Deck	Port Side, Forward Section (Near Hold 2)	YES
Area 3	Aperture	Aft End of Forward Section	NO
Area 4	Splitting of Hull	Starboard Side, Aft Section (Near Aft Mast House)	NO
Area 5	Split in Deck & Hull Plating	Port Side, Aft Section (Near Aft Mast House)	NO

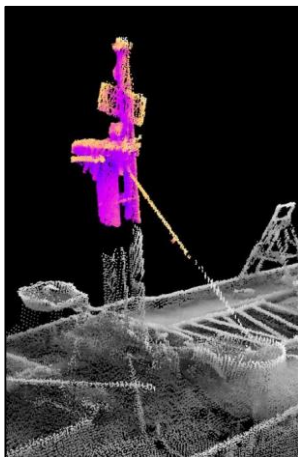
Fore-Mast and Mast Stay Cable

Fig. 15, 16 & 17. Combined laser (coloured) and sonar data (grey) acquired during the 2014 survey.

4.7.2 Dense coverage of the fore mast area was achieved in the 2014 dataset and none of the features in this area exhibited any evidence of deterioration since the last survey. The single mast stay cable remains attached and was well picked out in both datasets. The cargo handling booms, which were originally all attached to the foremast and mast house were all assessed in the data and, using a combination of point cloud imagery, surface difference analysis and cross-sections, no evidence of deterioration since the last survey was found.

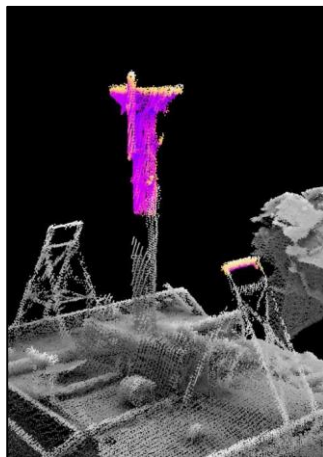
Main Mast and top of Port Life-Raft Rack

4.7.3 Dense coverage was also achieved in the area around the main mast and mast house. Various comparisons between the datasets showed no evidence of deterioration of the mast or mast house when compared to 2010 and 2013. The cargo handling booms lying across the deck showed no evidence of movement or deterioration since 2010.

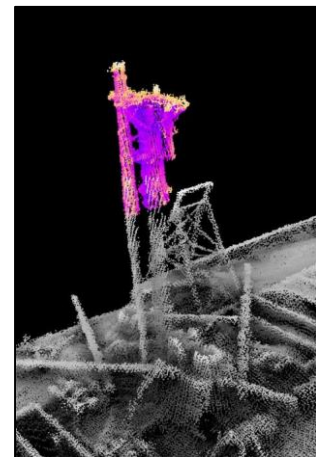
Mizzen Mast

4.7.5 Three of the mizzen mast cargo handling booms can be seen in the multibeam data lying across the deck. Of these, two showed no evidence of change or deterioration. One showed no evidence of change or deterioration since 2013 but comparisons to the 2010 dataset indicated that some subsidence had occurred.

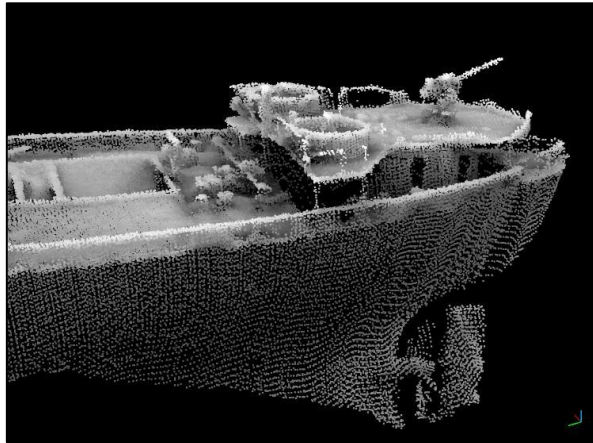
- The rudder and propeller were clearly visible in the 2014 survey data and no changes were noted.
- The mass of debris on the seabed adjacent to Hold 3 includes what are probably hatch cover supports from Hold 3, cargo handling booms and lifeboat davits from the boat deck. The presence of a vertical boiler has been mentioned in historical datasets but is not identifiable in the debris. Surface difference analysis in this region showed that some small scale changes had occurred but these are likely to be the result of sediment movement as the structures present did not reflect the same magnitude of movement.

Figure 20. Point cloud showing the stern gun tub, rudder and propeller

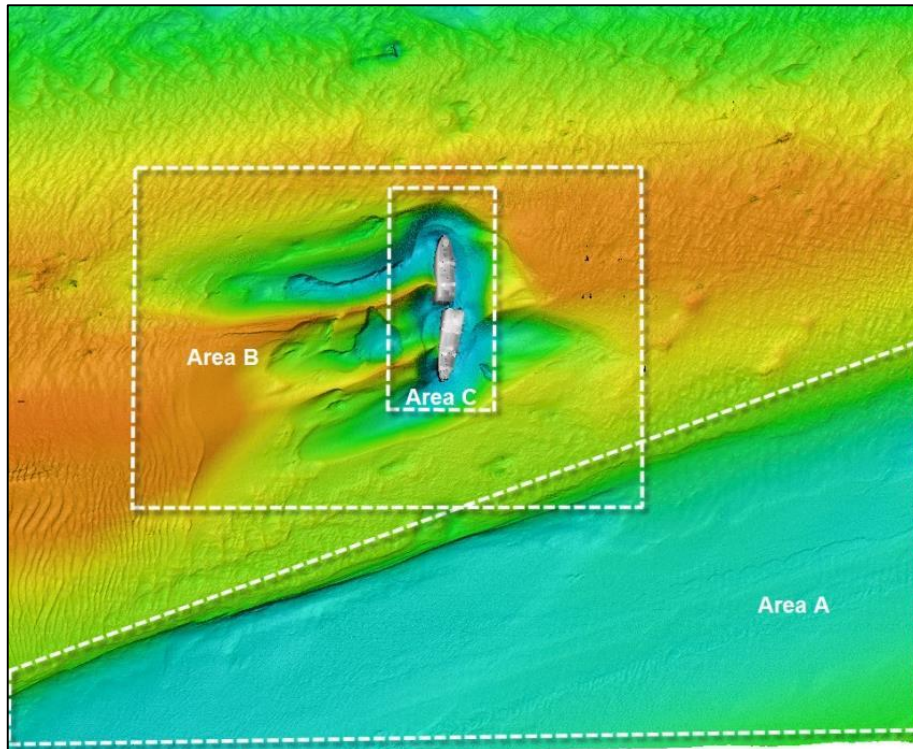
5.3 As in previous years, to assess the data the seabed around the wreck was split into three sections. Area A covers the area of the dredged Medway Approach Channel, area B focuses on the scour patterns which have formed to the east and west of wreck; and area C examines the sediment formations in the immediate vicinity of the wreck with the aim of identifying any changes which may affect the support of the two sections of the wreck.

Figure 24. The three areas of the seabed that will be examined in greater detail

5.4 The assessment of area A showed that there had been relatively little change in the seabed topography in this area. Within the channel there is evidence of small degrees of sediment accumulation and erosion. The areas of accumulation had typically received +0.3m of sediment with a local maximum of +0.52m. Areas which have undergone erosion since 2013 have generally lost -0.25m of material and these areas are in the eastern and western sections of the survey area. The area exhibiting the greatest change is the wall of the dredged channel. This is likely to have resulted from a small repositioning of the slope which manifests as a height change in the surface difference above. The change is consistently an increase in depth (up to -1.6m) which suggested that the top of the channel had moved northwards by up to 5m, most likely as a result of slumping of the material on its upper section.

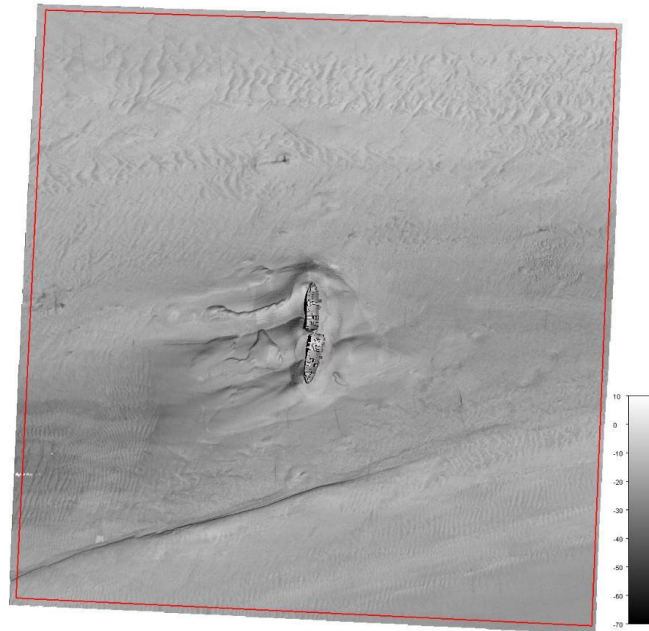
Figure 25. Backscatter results for the wreck site of the Richard Montgomery

different material to the surrounding seabed and, during the examination of this data an additional 12 objects were identified. These items have mostly been identified as chains and sinkers for current and previous marker buoys and most are along the line of the diamond shaped perimeter of the prohibited area. However, one much larger target appears to be an extensive area of debris in the far west of the survey area. Examination of the soundings in this area showed that the overall shape of the debris field was similar in profile to that of another target within the survey area which has previously been identified as probably the wreck of a Thames Barge. However, this new target is much larger measuring approximately 30m x 12m and may represent a third wreck within the survey area.

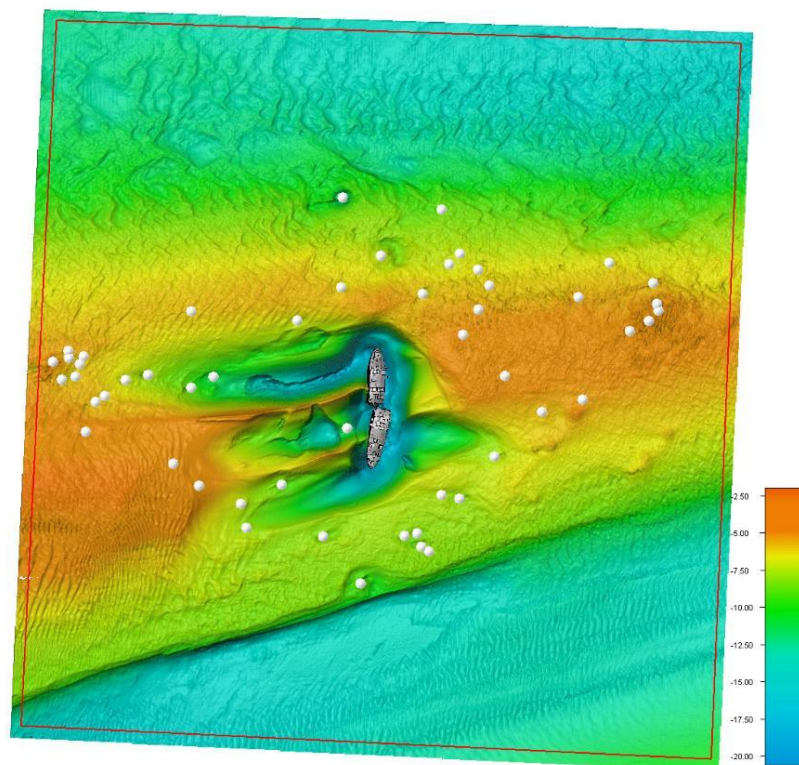
5.13.6 Another of the new features was located in close proximity to the aft section of the wreck. This is a small object measuring approximately 0.75m by 0.75m and with 0.25m exposed above the surrounding sediment. This object was identified by the presence of a small scour which has formed around its eastern side which suggested that it is more dense than the surrounding sediment. When comparing the 2013 and 2014 datasets this object can be located in both. It has not moved over the last year and may have been deposited relatively recently given that it could not be identified in data prior to 2013. Due to its small size there is insufficient data density to get a clear image. As the object lies only 30m from the hull of the aft section it is an object with potential importance. It is noted that during diving work carried out on the wreck in 2013, prior to the multibeam survey, two current meters were lost. At present, it is not possible to say whether this new target represents one of these lost current meters.

Figure 26. Locations of Seabed Targets
