Report No: 24000/13/15

Date: 04 September 2015

For: Department for Transport

Department for Transport Technical Assessment of Petroleum Tankers: Metallographic and Analytical Assessment of AT11-1475

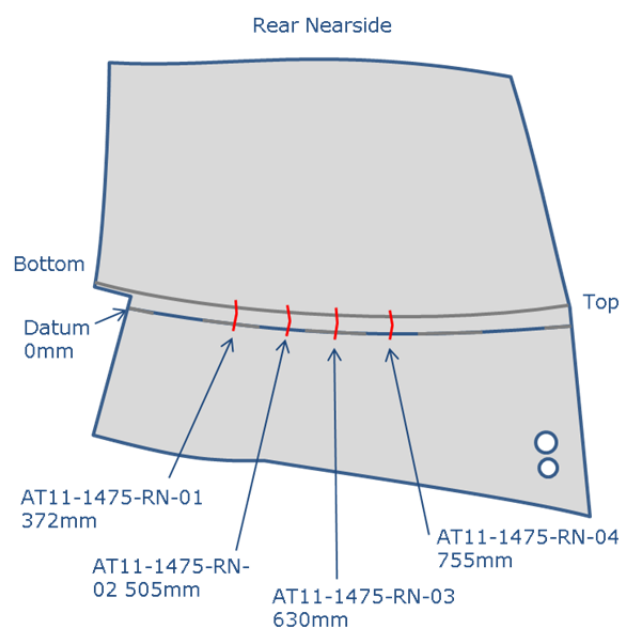
Figure 13 Diagram of the sampling plan for the rear nearside (undamaged) section of AT11-1475.

Four samples were machined from the undamaged, rear nearside section of AT11-1475. The locations of the samples are shown in Figure 13. The four

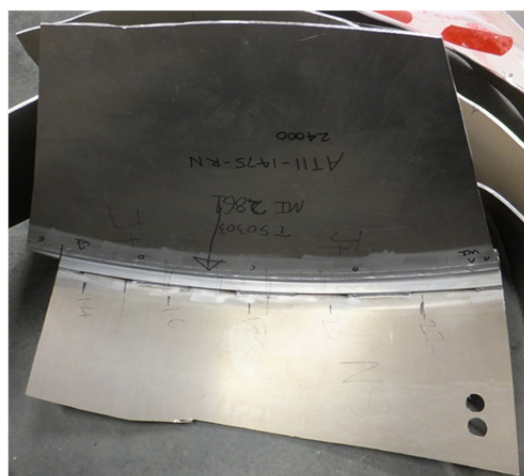
samples were spaced approximately 125mm apart. Samples RN-01 to RN- are shown in Figure 14. All of the primary circumferential welds from the rear nearside samples are shown in Figure 15. As with the rear offside, the penetration into the root of the weld is variable, with sample RN-03 exhibiting good penetration and fusion between the tanker shell and extrusion band, whilst samples RN-01, RN-02 and RN-04 show signs of lack of fusion at the root of the weld, resulting in surface-breaking defects that are up to 1.5mm deep.

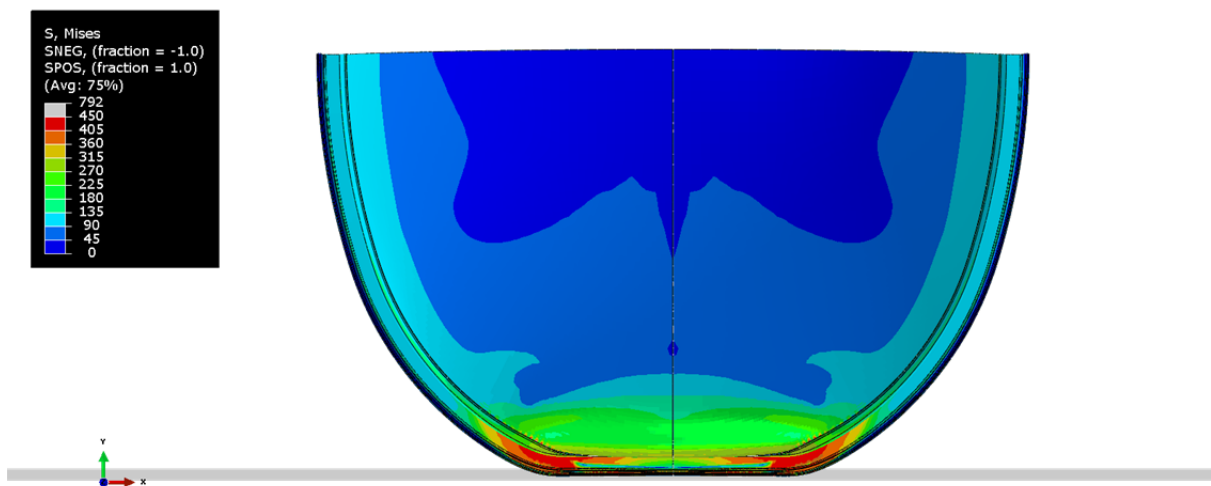
The deformation and Von Mises stress contour for the rear dish model is shown in Figure 25 at the solution increment when the flattened length was 760mm. The deformation of the rear dish model showed exceptional agreement with the samples taken from the rear, offside section of AT11-1475. In particular, the shape, curvature and dimensions of the crush zone agreed with the samples taken from the centre (sample RO-05, see Figure 26) as well as the ends of the crush zone (sample RO-03, see Figure 27). For this reason, the model was considered to be a reasonably accurate representation of the topple test.

Figure 25 Image of the rear dish (viewed from the back of the tanker) when the flattened length is approximately 760mm. The symmetric half of the quarter model has been added for visualisation purposes.

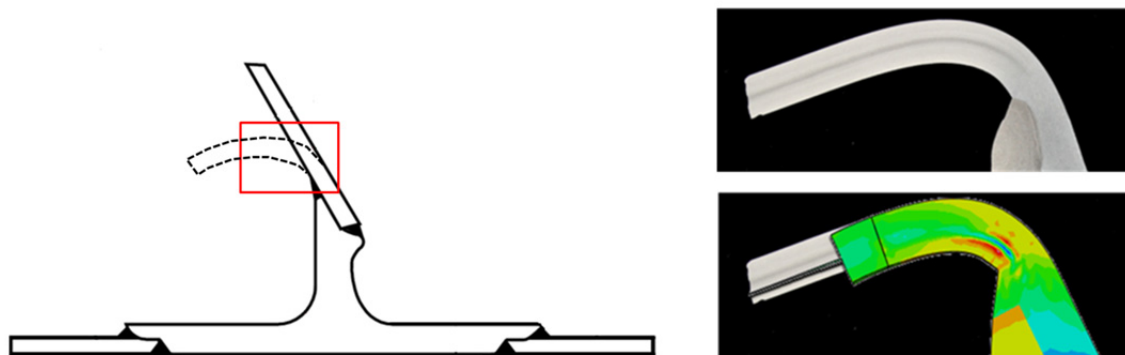
Figure 26 FEA results superimposed on the macro-section AT11-1475-RO-05 taken from the centre of the crush zone (equivalent to the symmetry plane in the FE model). Deformation not magnified, and equivalent plastic strain contour shown for reference.

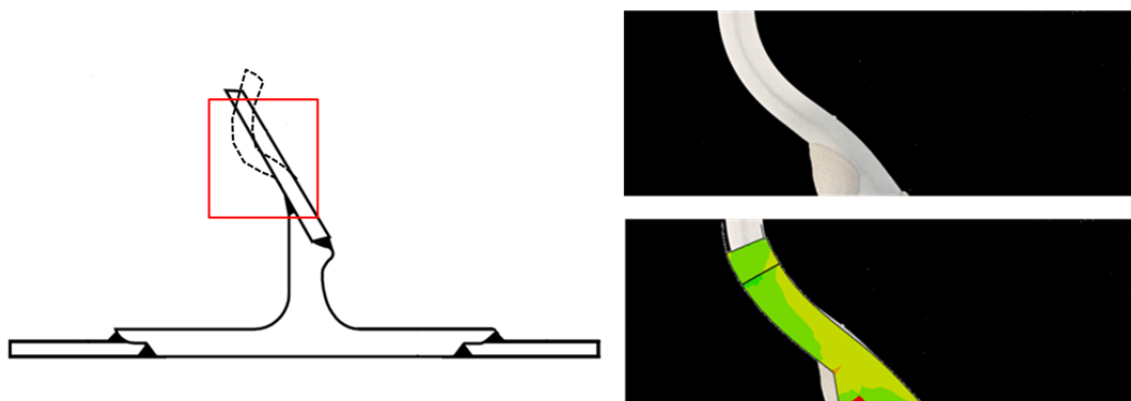
Figure 27 FEA results superimposed on the macro-section AT11-1475-RO-03 taken from the end of the crush zone approximately 400mm from the centre of the crush zone.

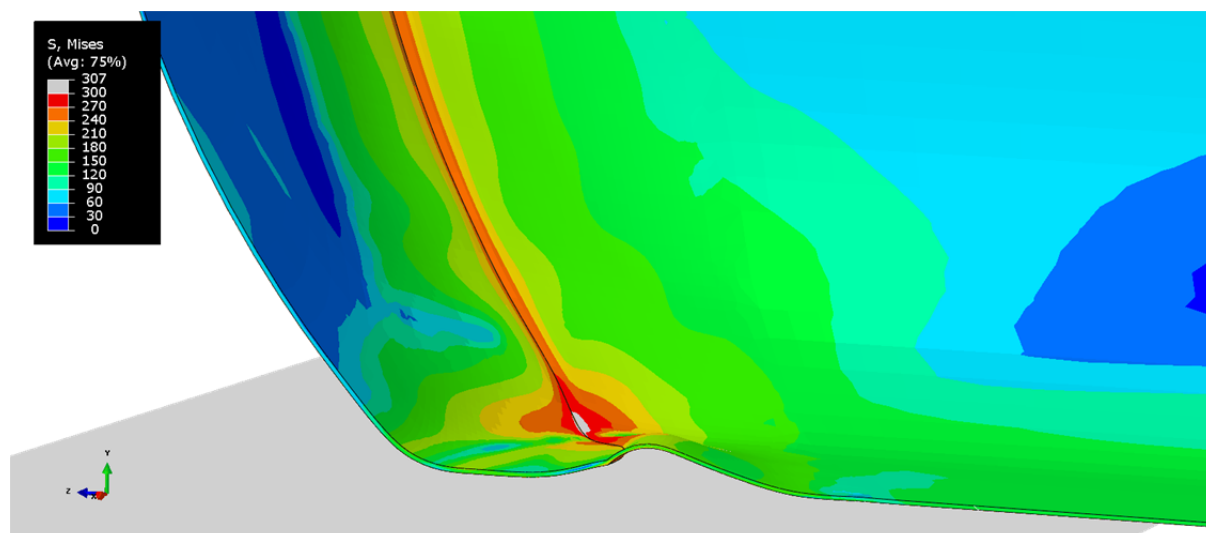
The deformation and Von Mises stress contour for the front dish model is shown in Figure 28 at the solution increment when the flattened length was approximately 580mm. As with the rear band model, the front dish model showed very good agreement with measurements taken from samples of the front, offside section of AT11-1475.

Figure 28 Image of the front dish viewed along the central symmetry plane (ie the plane cutting the tank from 3 o'clock to 9 o'clock when upright) showing the deformation at the centre of the crush zone (see the right frames of Figure 17 for similar bending deformation).
