## **Appendix K: Metallographic Examination of Samples from GRW Tanker J3564**

This appendix specifically addresses the examination of sections from J3564.

Sections from the cradle position of bands C, D and G of GRW tanker J3564 were removed and sent to TWI. These samples are located in positions where the fatigue stresses are likely to be relatively high and therefore the main objective of the examination of these samples was to identify whether there was any evidence of fatigue crack growth. Additionally, the circumferential length of these specimens means that they could be subjected to impact under a roll over event. Each of the three sections was sectioned at approximately 100mm intervals and macros were prepared of the cross-section. Table K2 describes the positions of each of the macros that are presented. This table can be cross-referenced with Table K1 for reference to the specific band from which the section was obtained.

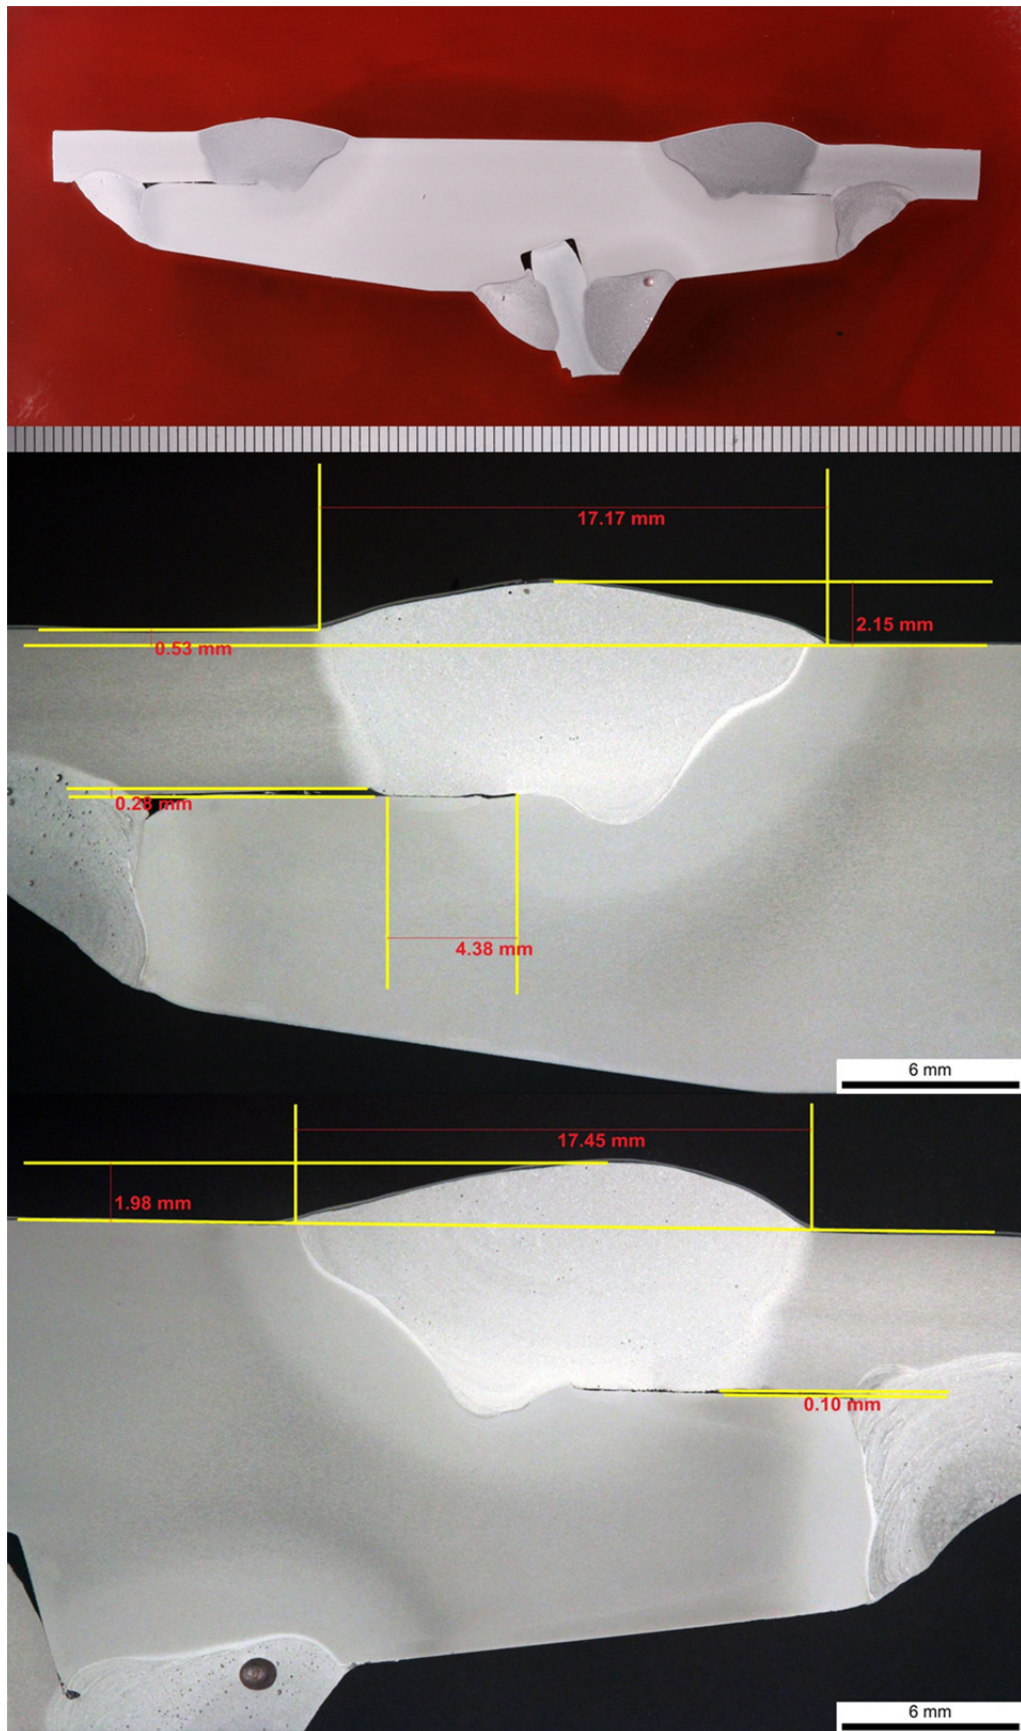
**Figure K4** J3564 sample W03-04, Slice 3.

These defects are present in slice 4, but either side of this macro (slice 3 and slice 5), only a gas pore is present where the crack-like defect appears in slice 4. Further sectioning of the macro-section was undertaken and the results are shown in Figure K6. In this figure, it can be seen that, up to a 10mm resolution of the length, both flaws are at least 40mm in length and no more than 50mm in length. Additionally, the further sectioning revealed that on the side containing the 1.62mm deep flaw, there was a deeper point along the length, with the maximum observed depth equal to 2.04mm.

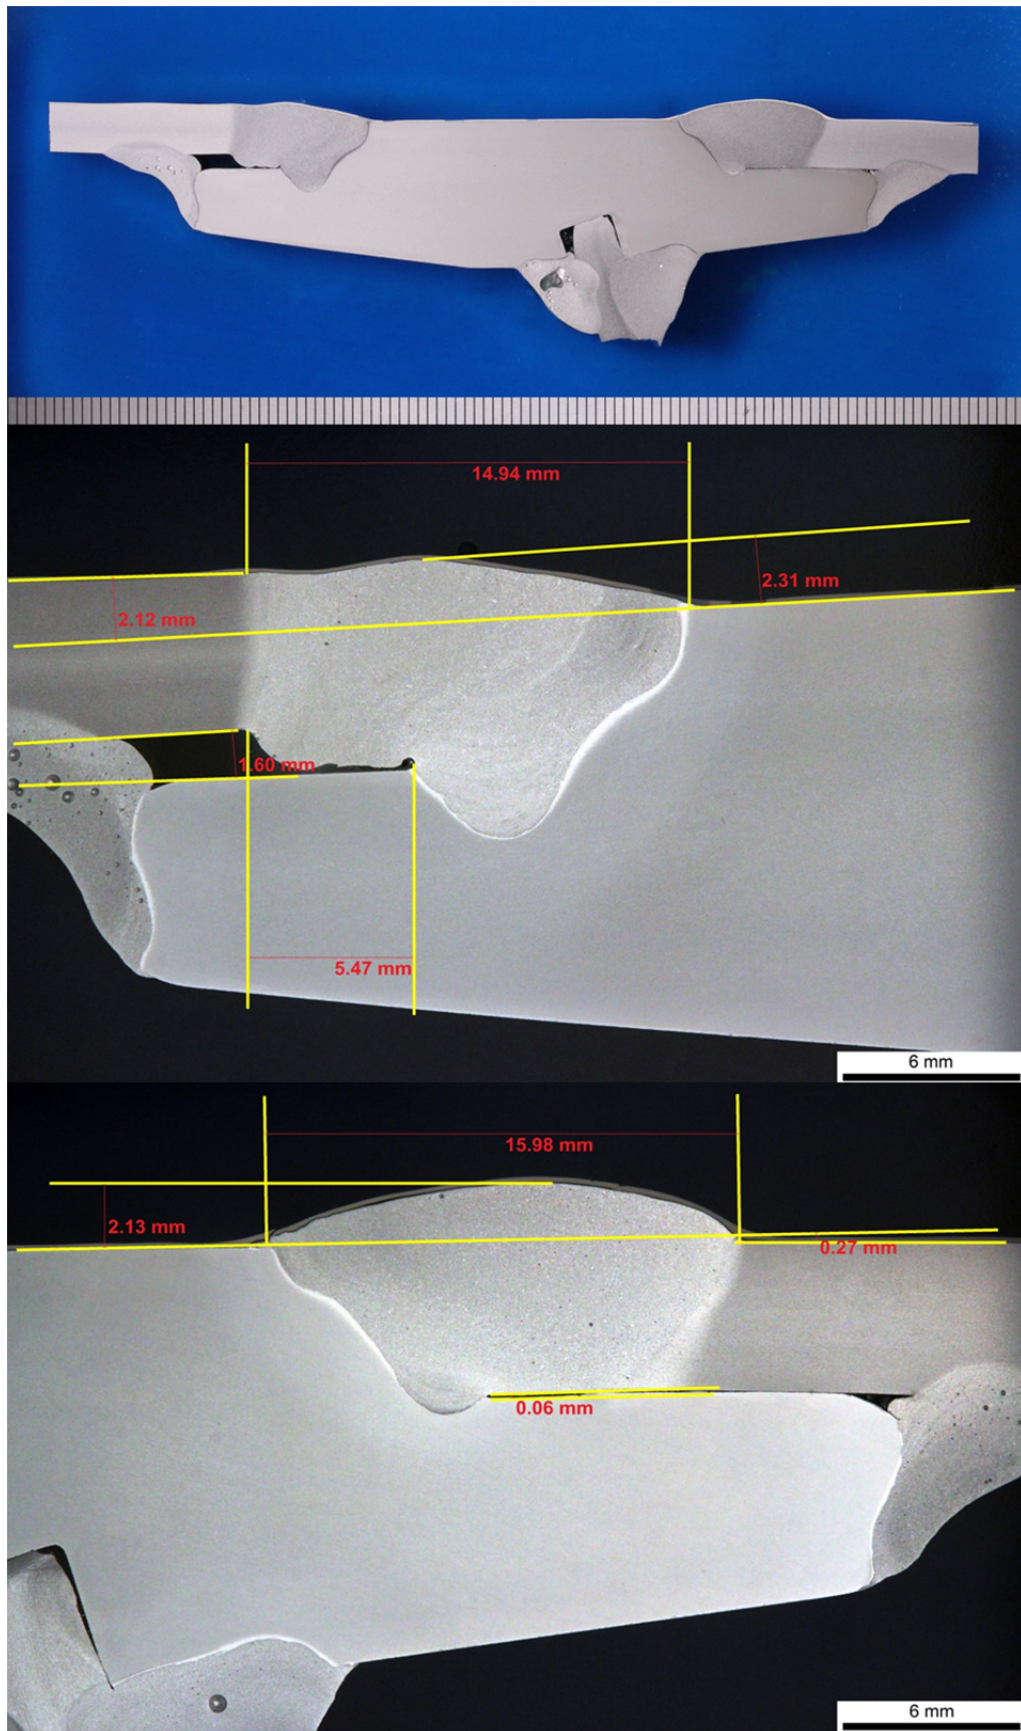
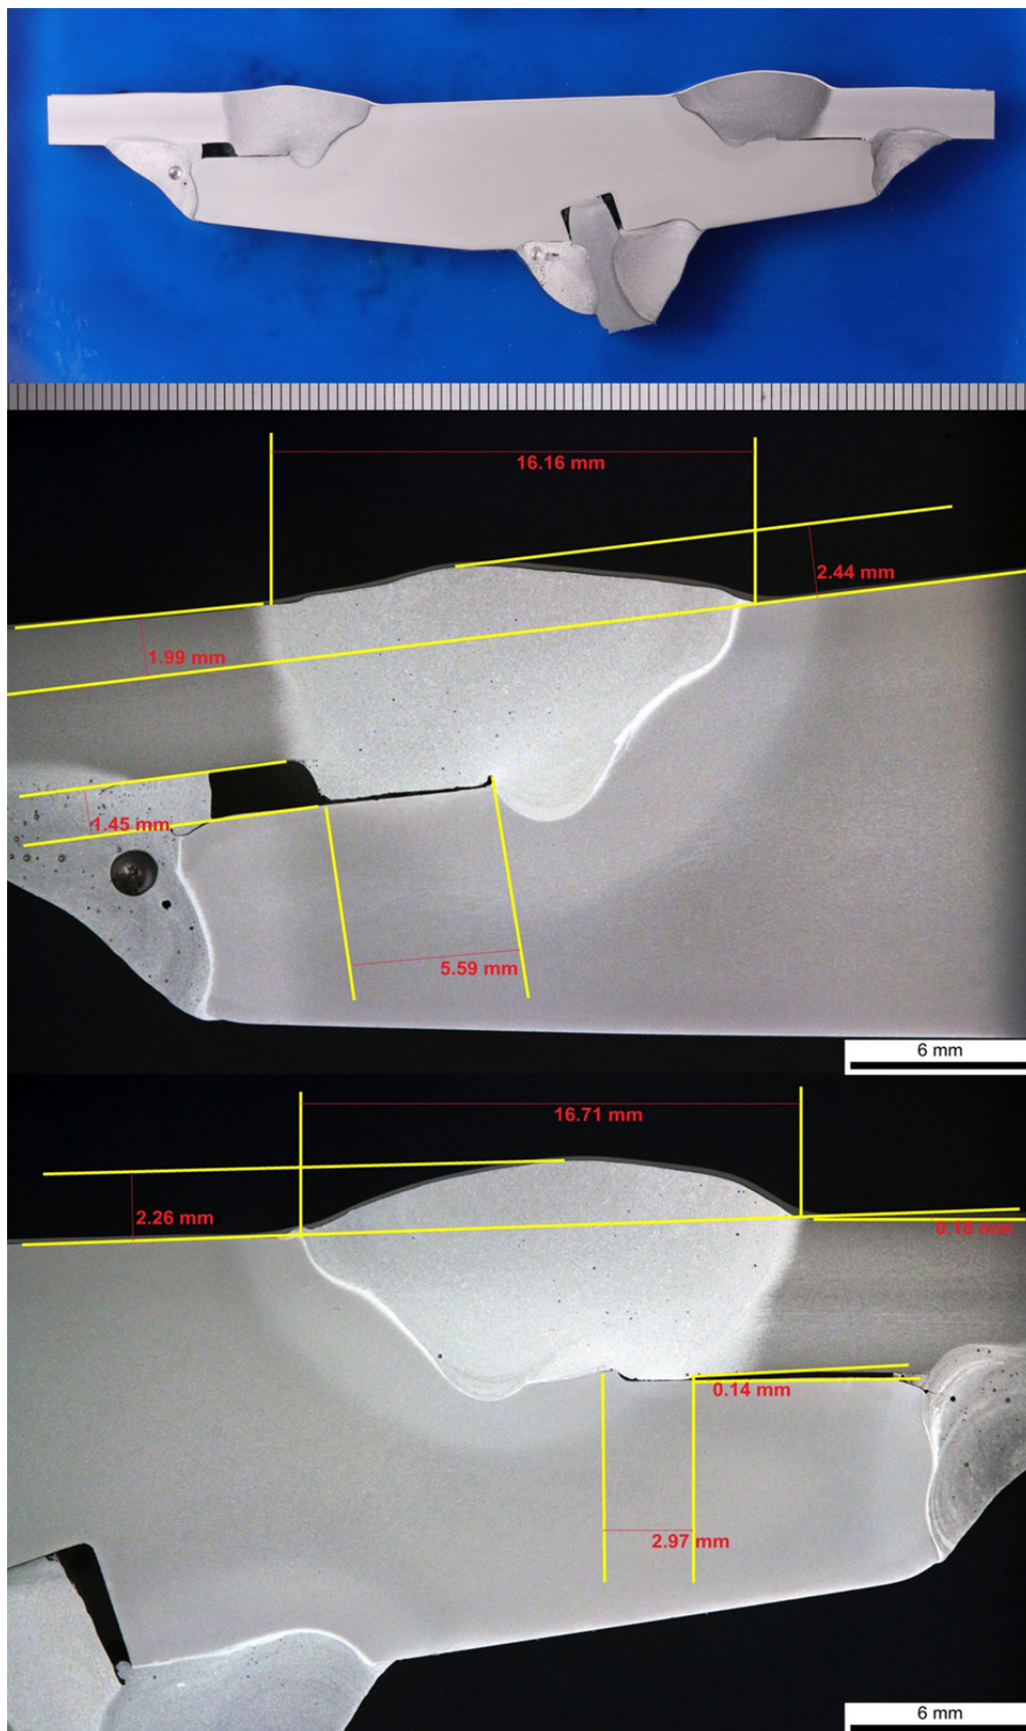
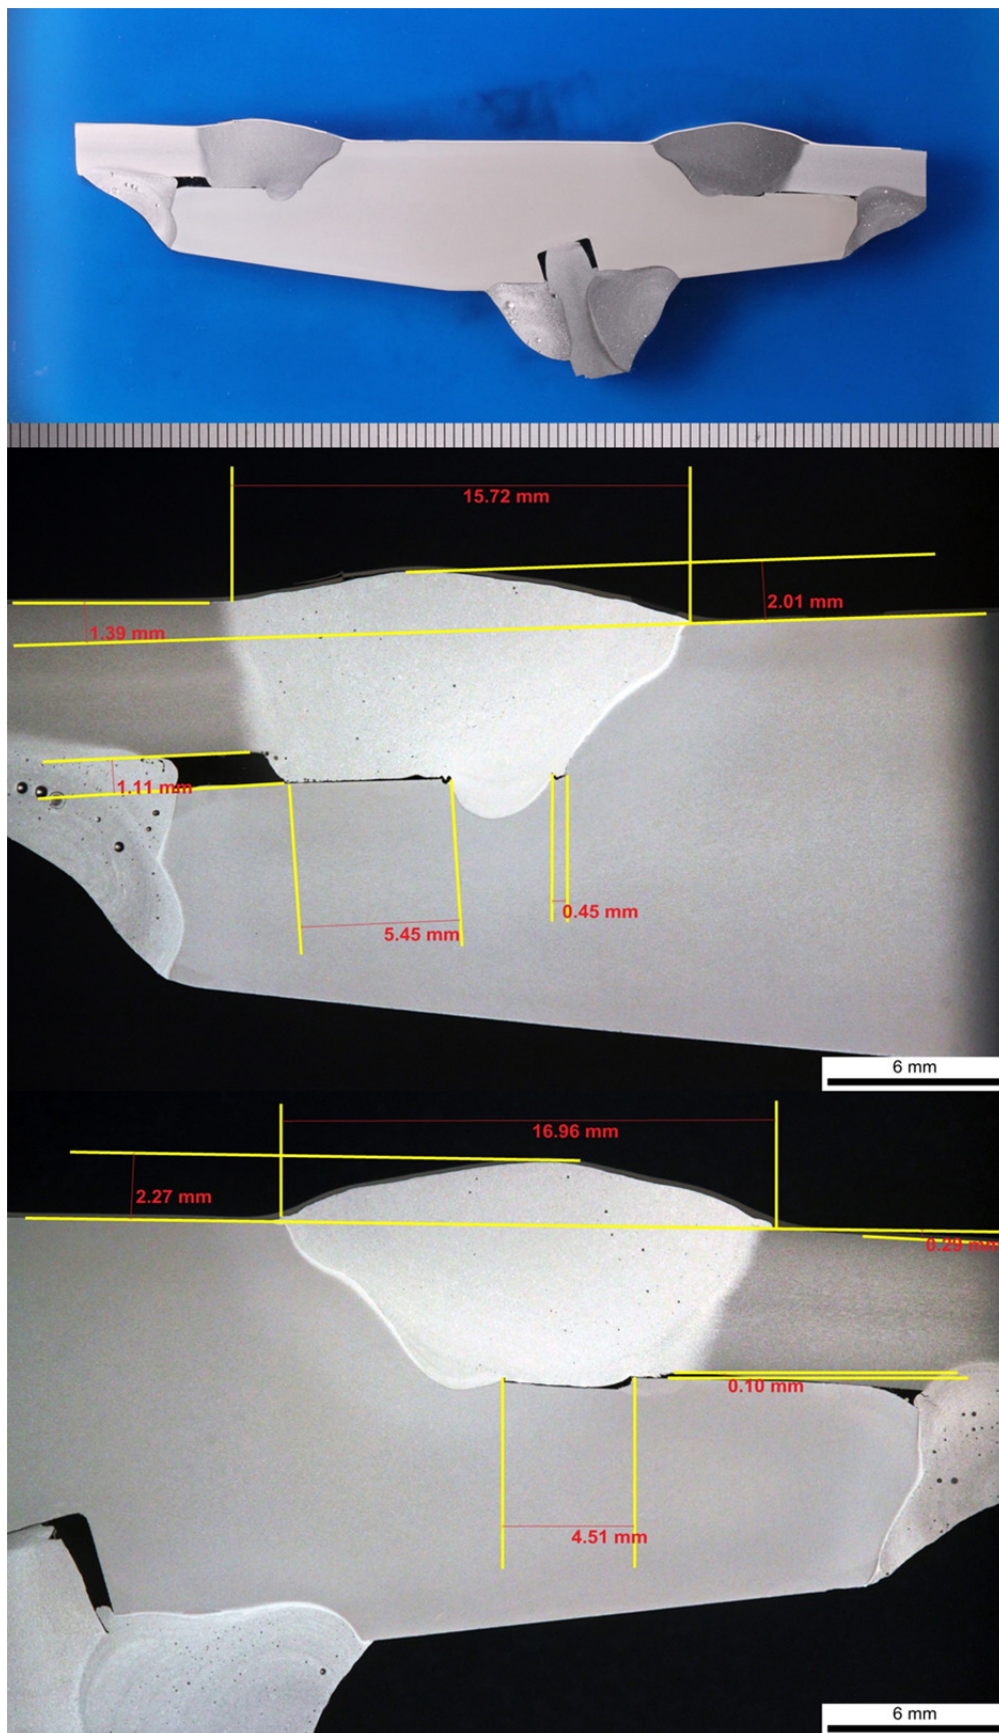
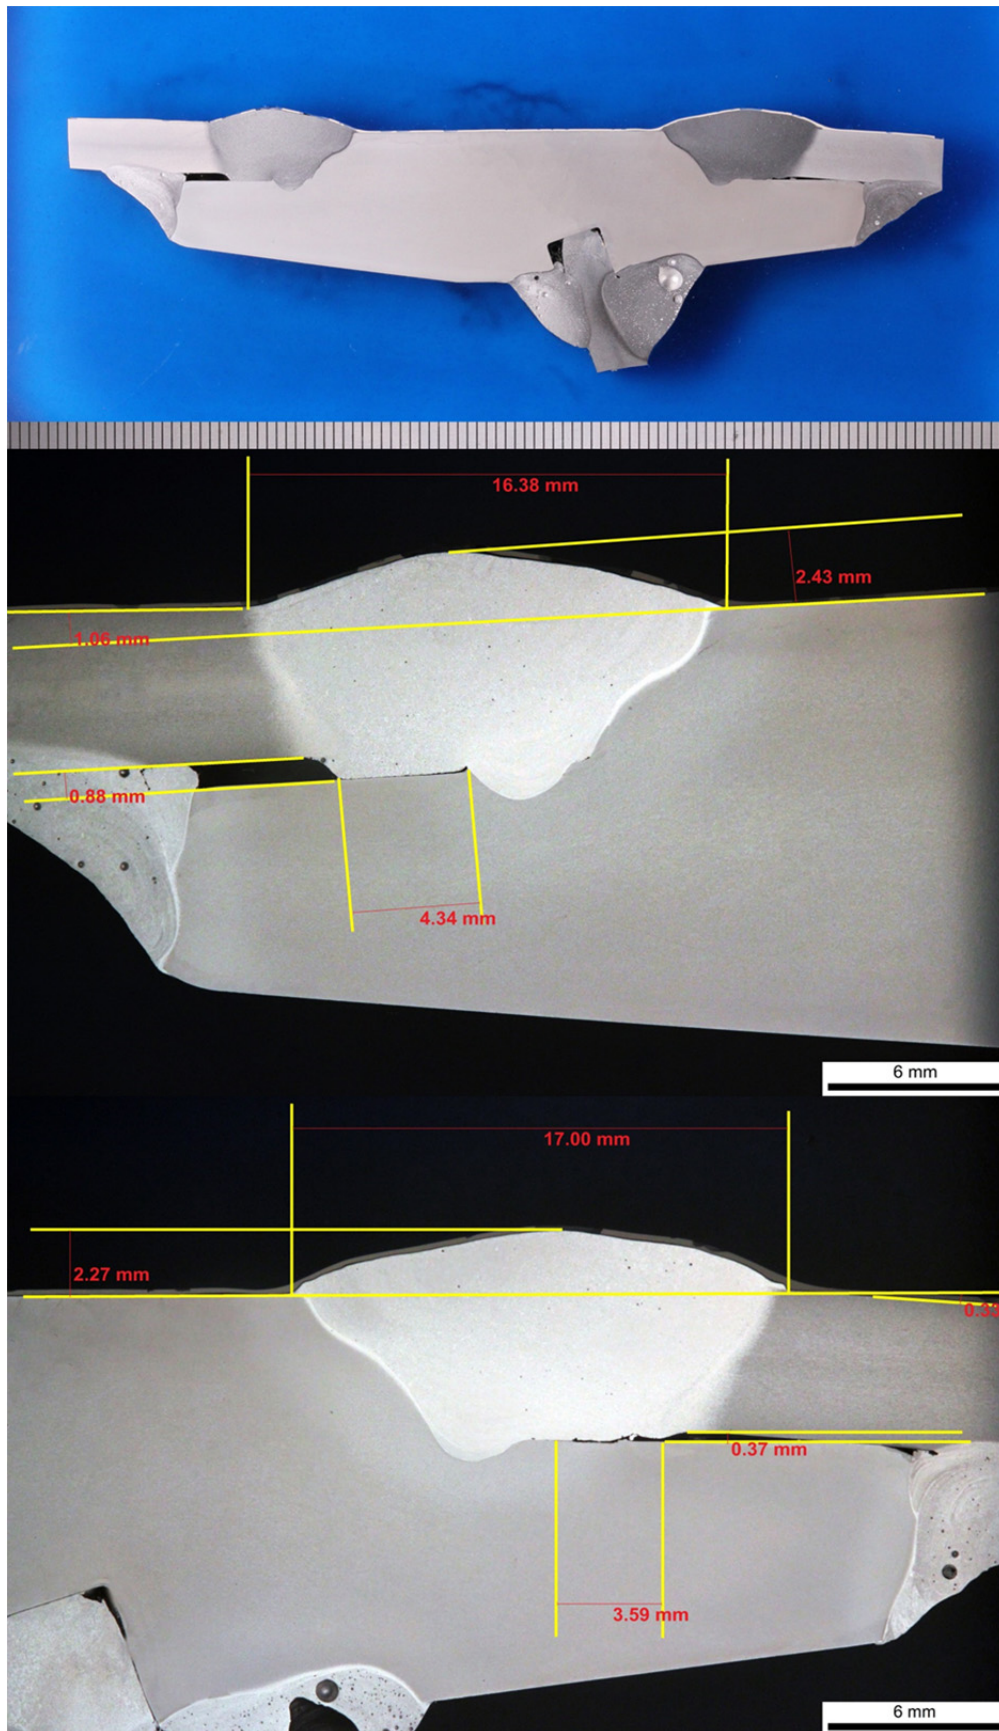
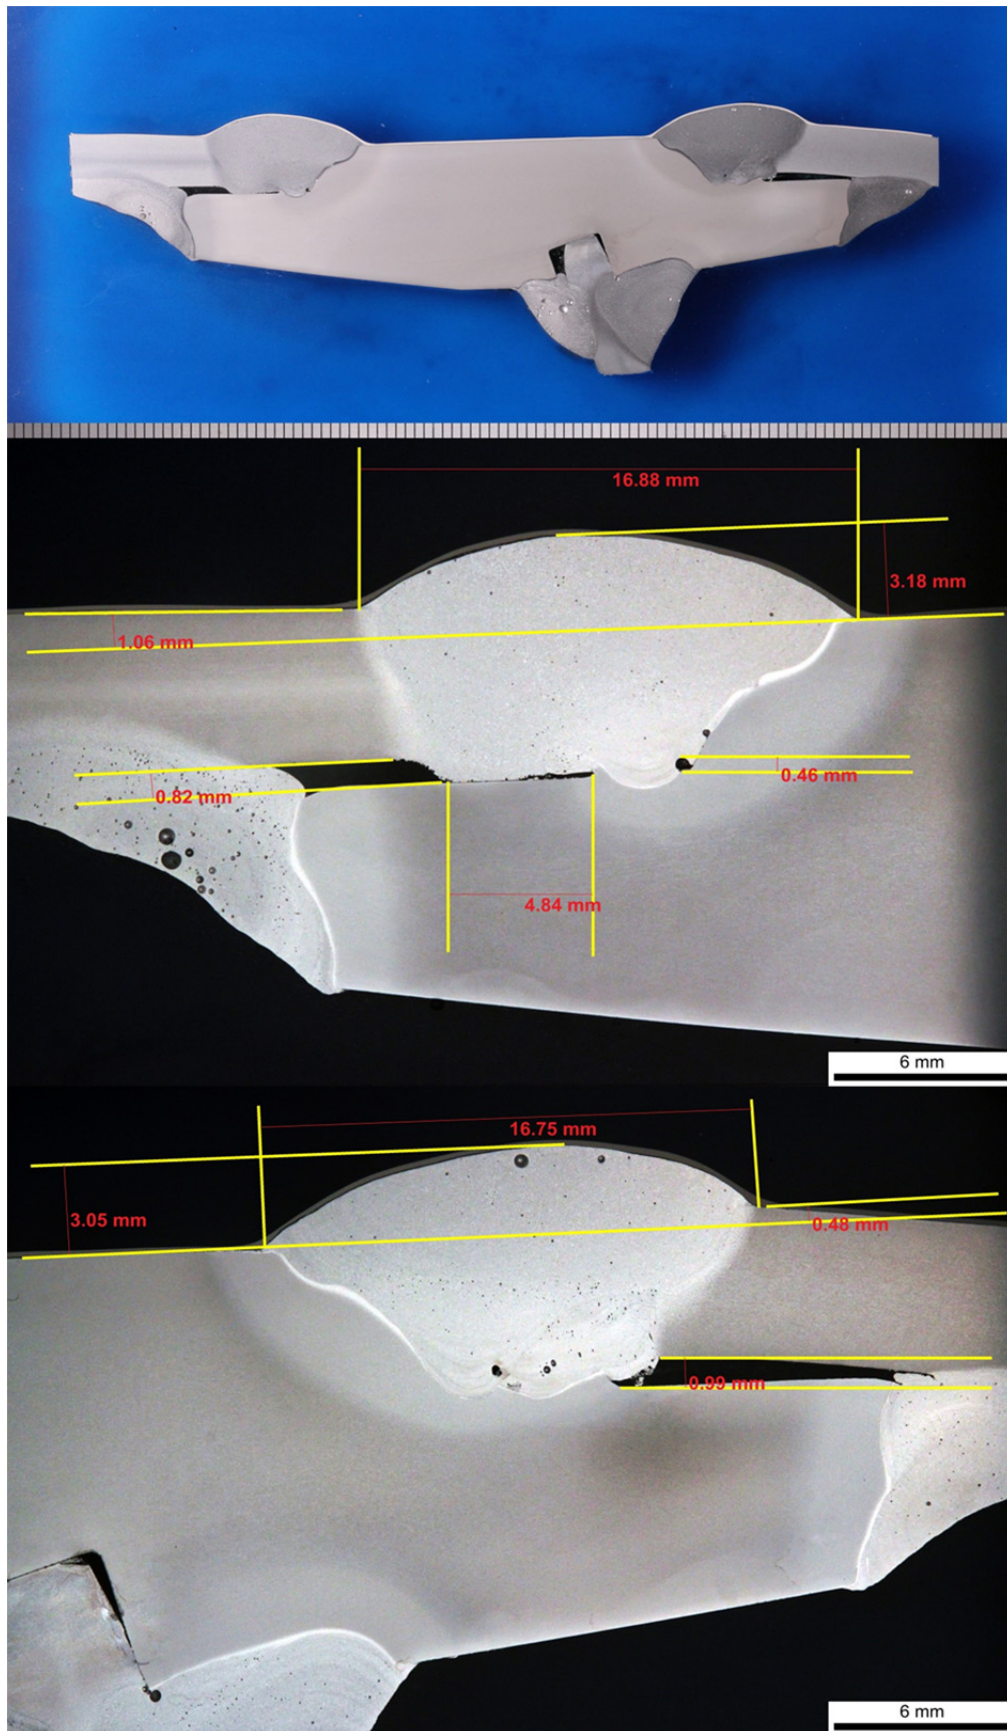
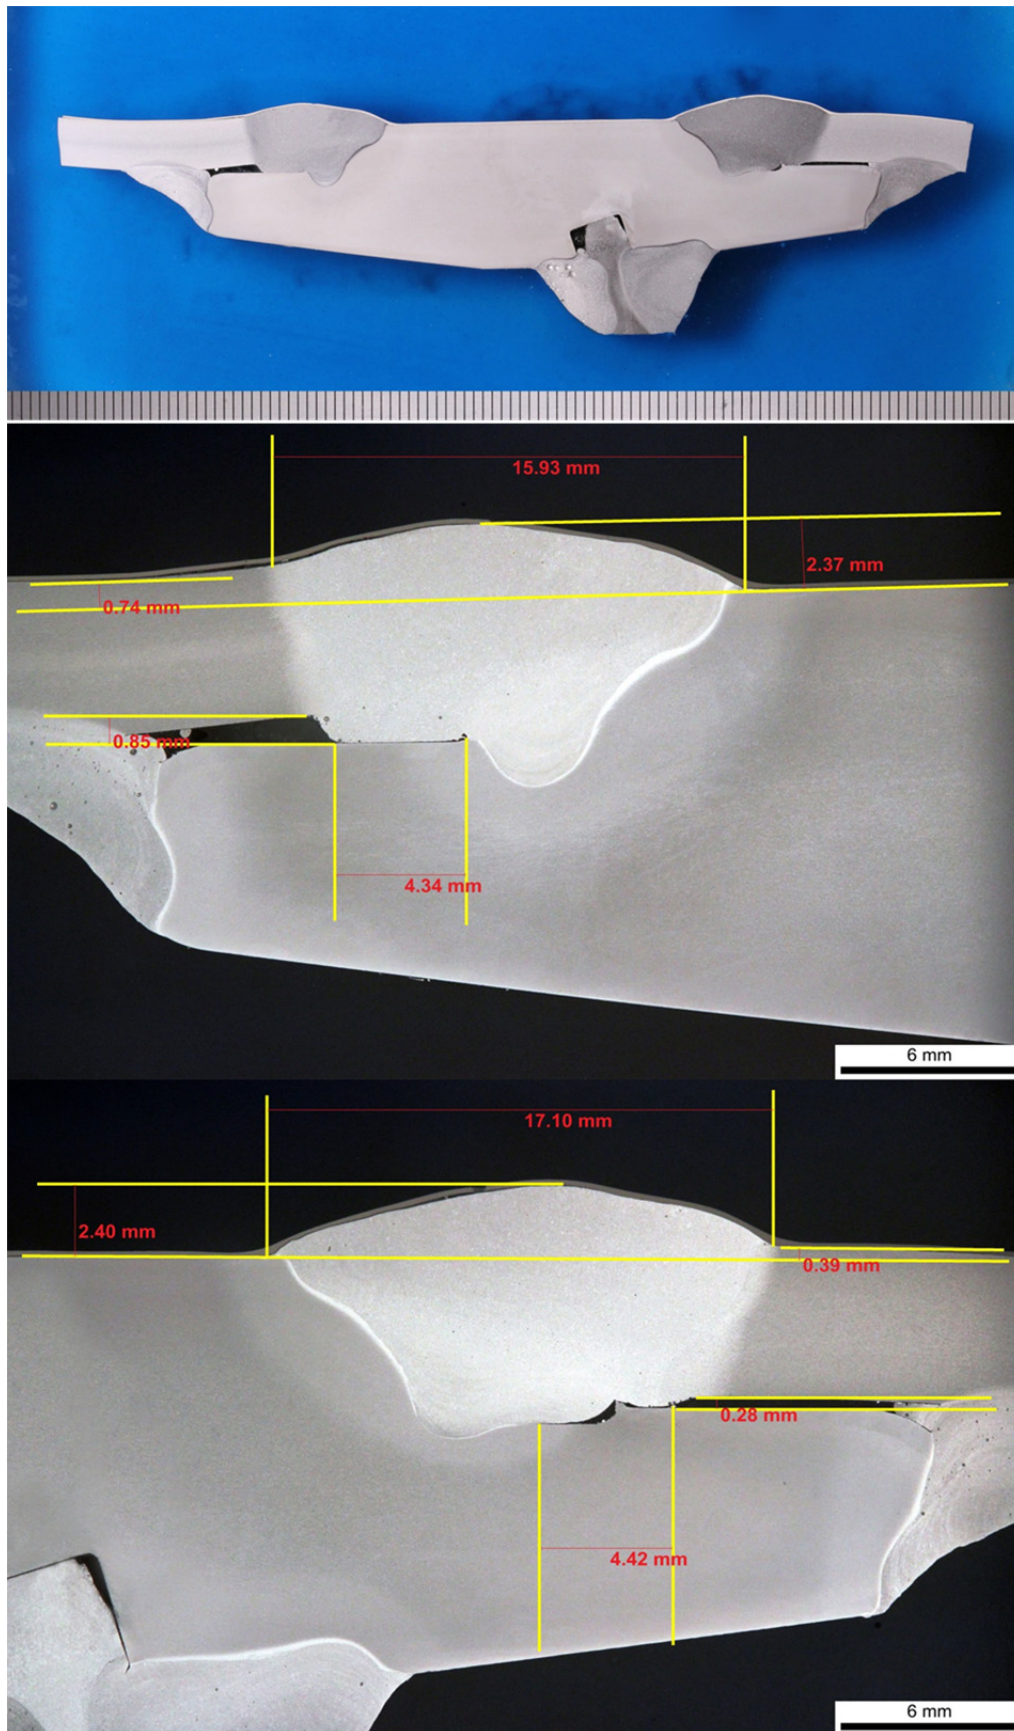
The samples prepared from Band D did not contain any significant crack-like defects such as those found in the samples prepared from Band C. However, there are several lack of root fusion and lack of side wall fusion, embedded-type defects and some significant porosity. Although porosity is expected when welding the specific aluminium alloys in this joint, some of the gas pores have diameter nearly equal to the fillet weld throat thickness, which may negate the strengthening influence of the internal fillet weld under rollover. Additionally there are some macros that exhibit large amounts of misalignment.
