## **Appendix K: Metallographic Examination of Samples from GRW Tanker J3564**

This appendix specifically addresses the examination of sections from J3564.

Sections from the cradle position of bands C, D and G of GRW tanker J3564 were removed and sent to TWI. These samples are located in positions where the fatigue stresses are likely to be relatively high and therefore the main objective of the examination of these samples was to identify whether there was any evidence of fatigue crack growth. Additionally, the circumferential length of these specimens means that they could be subjected to impact under a roll over event. Each of the three sections was sectioned at approximately 100mm intervals and macros were prepared of the cross-section. Table K2 describes the positions of each of the macros that are presented. This table can be cross-referenced with Table K1 for reference to the specific band from which the section was obtained.

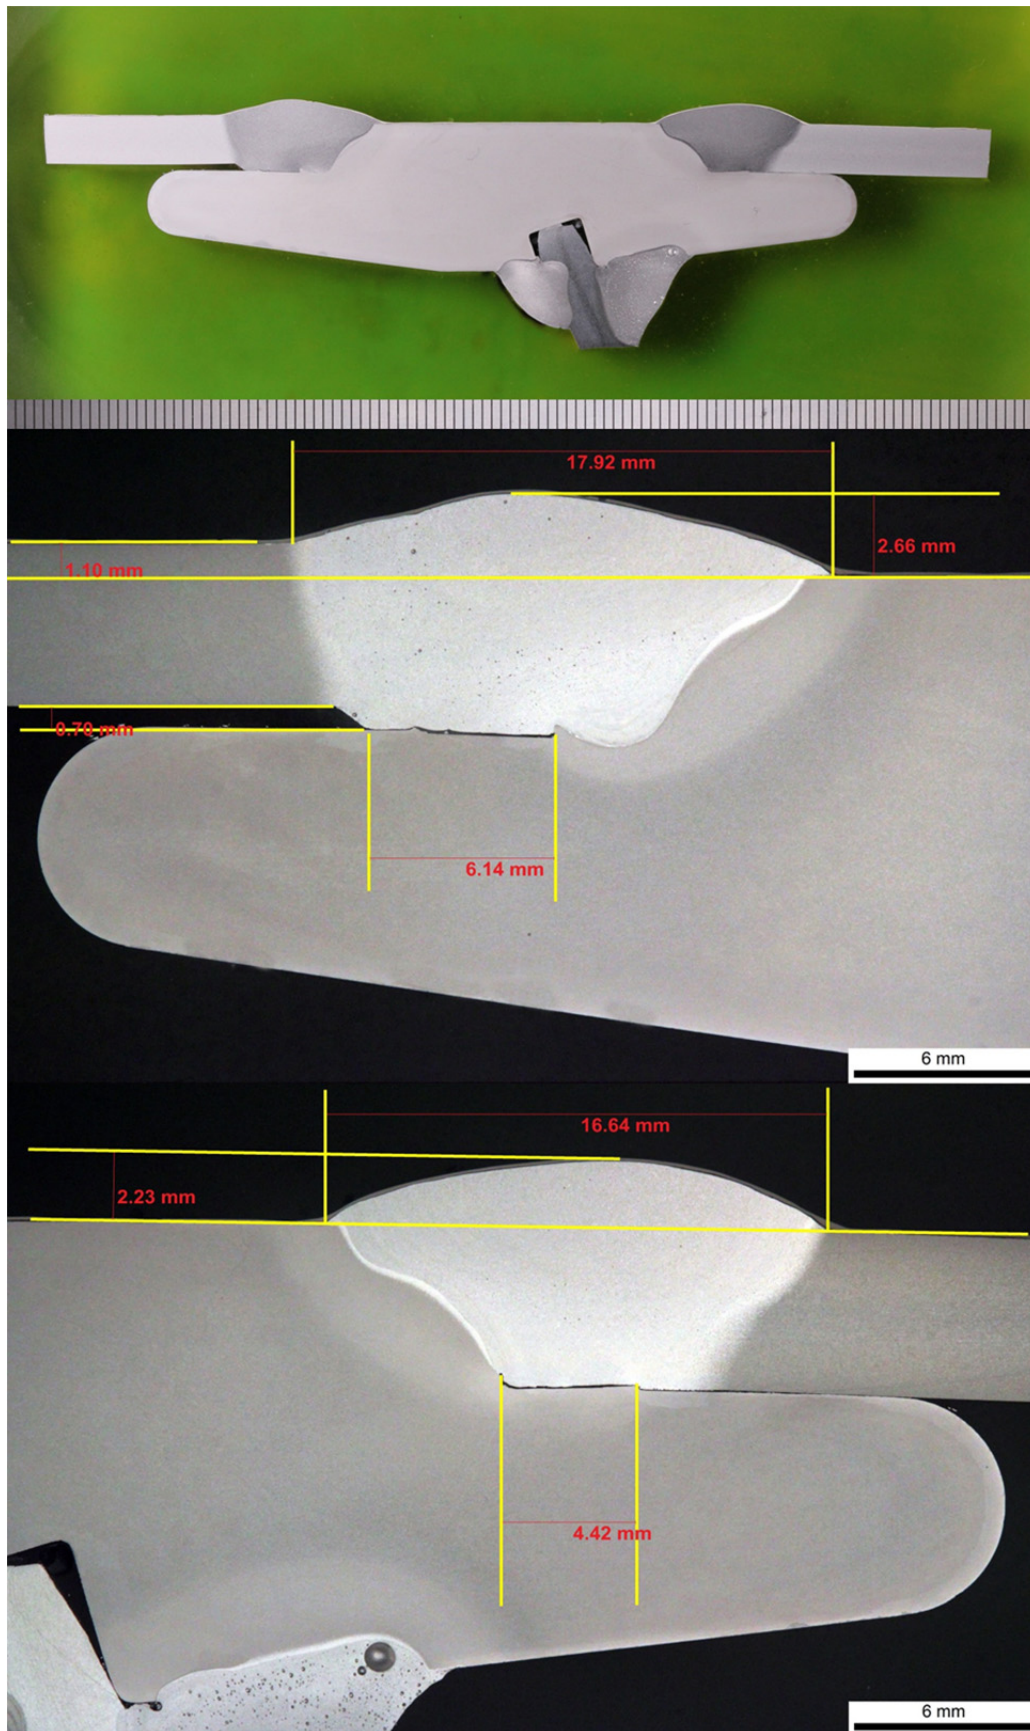
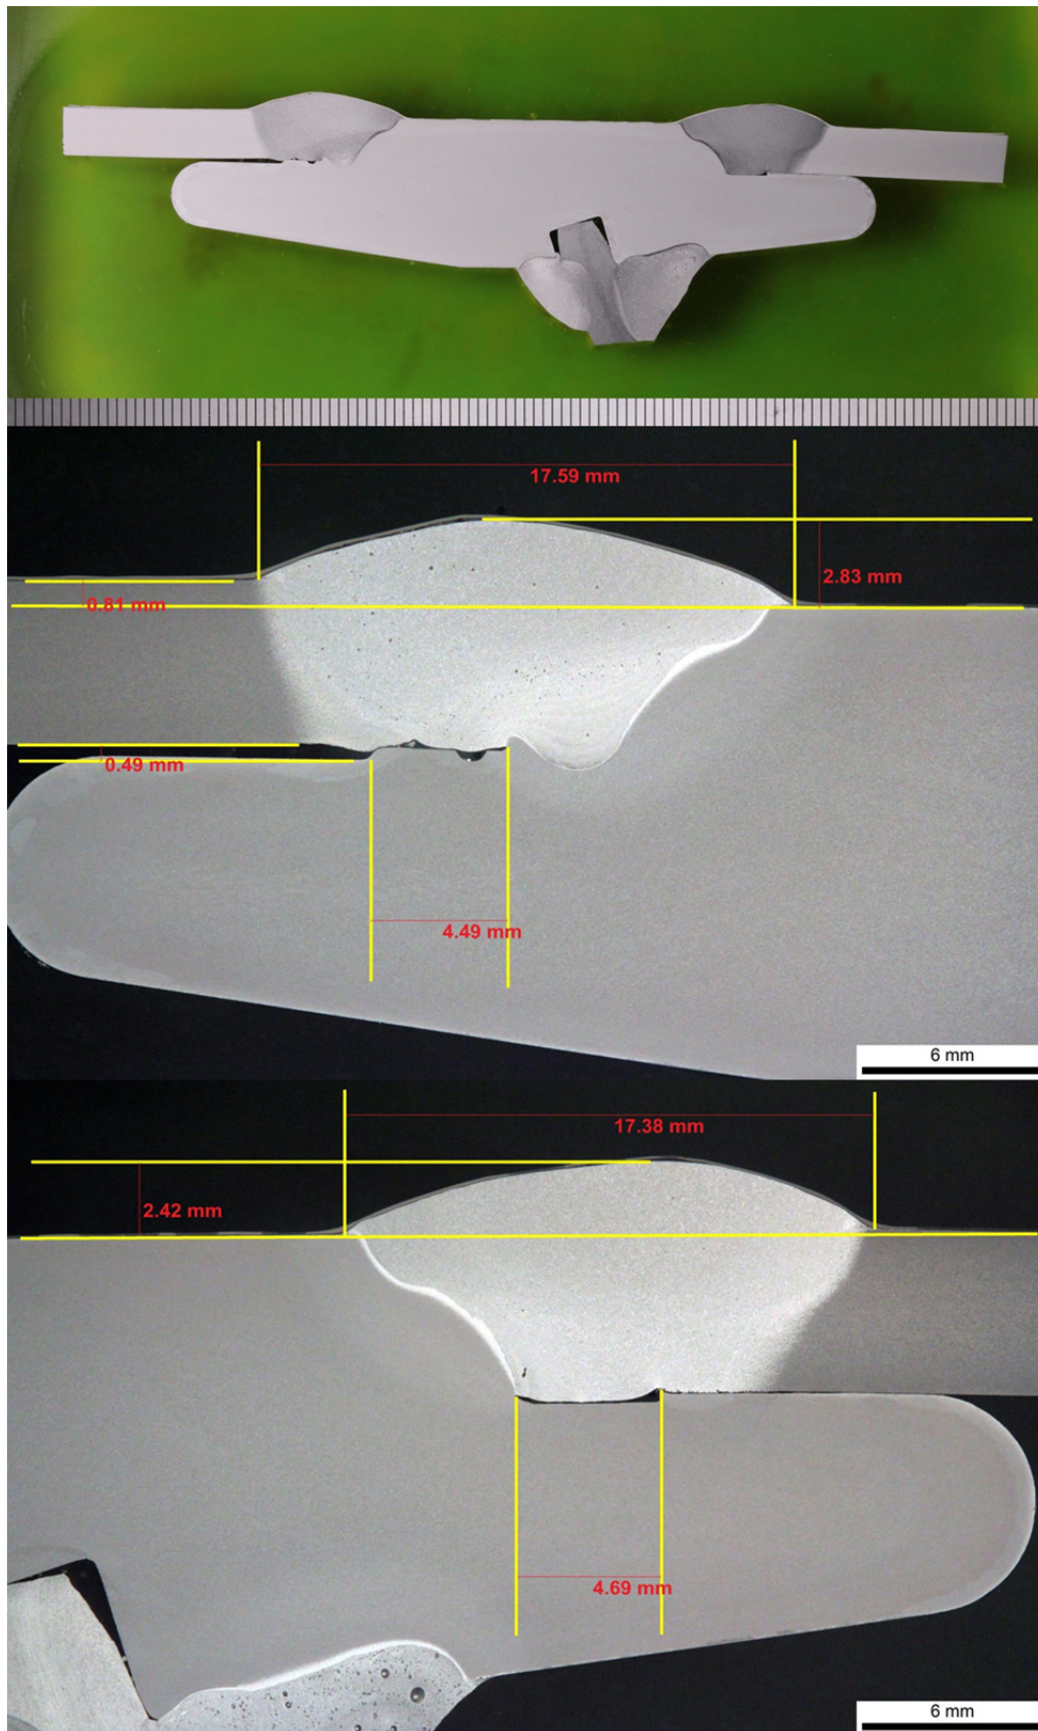
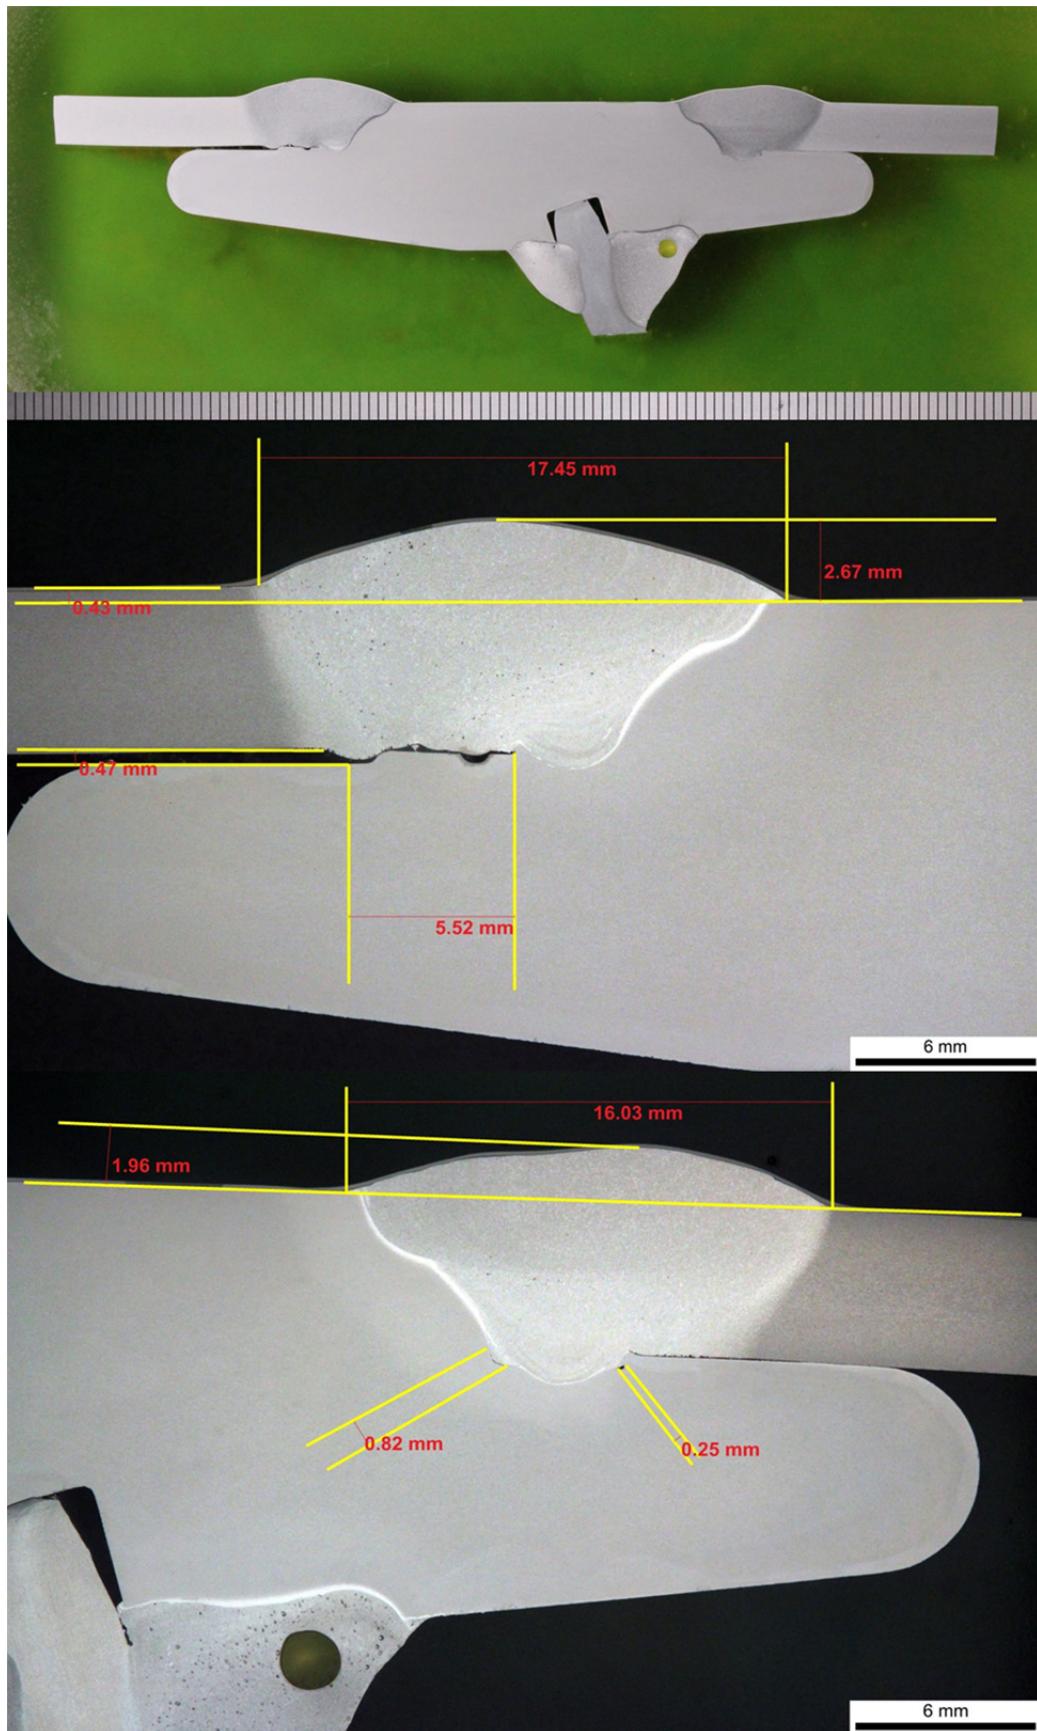
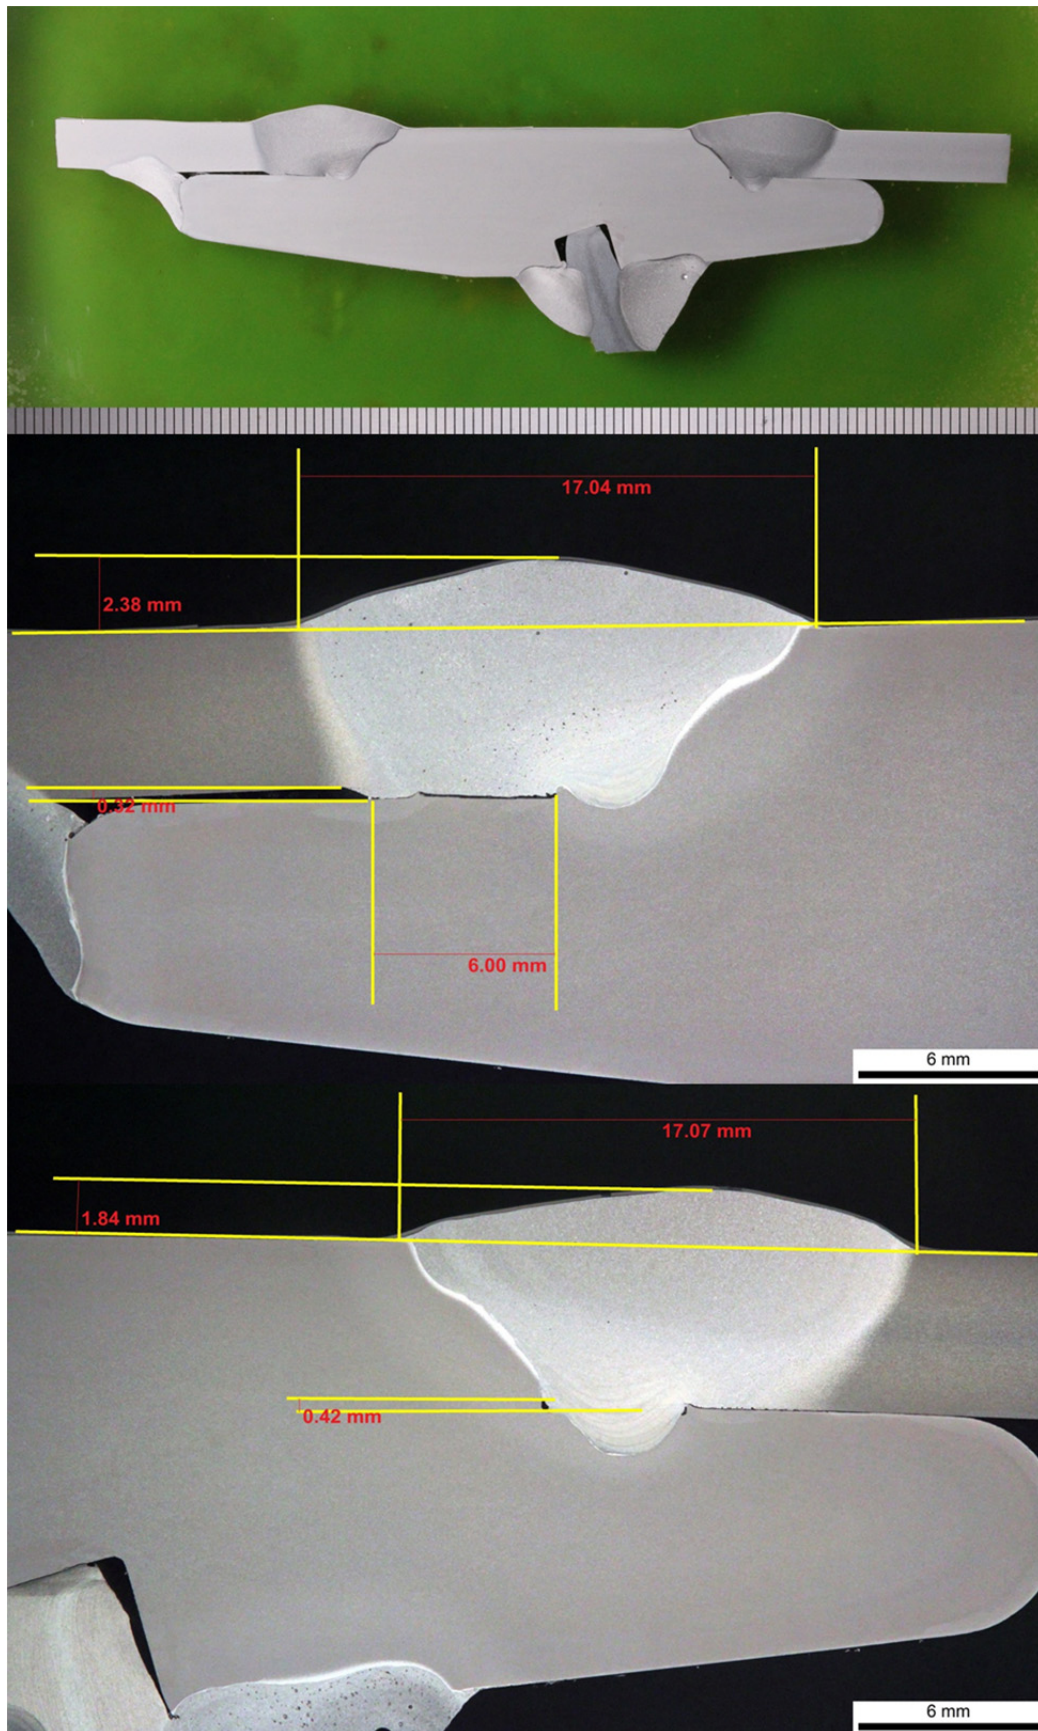
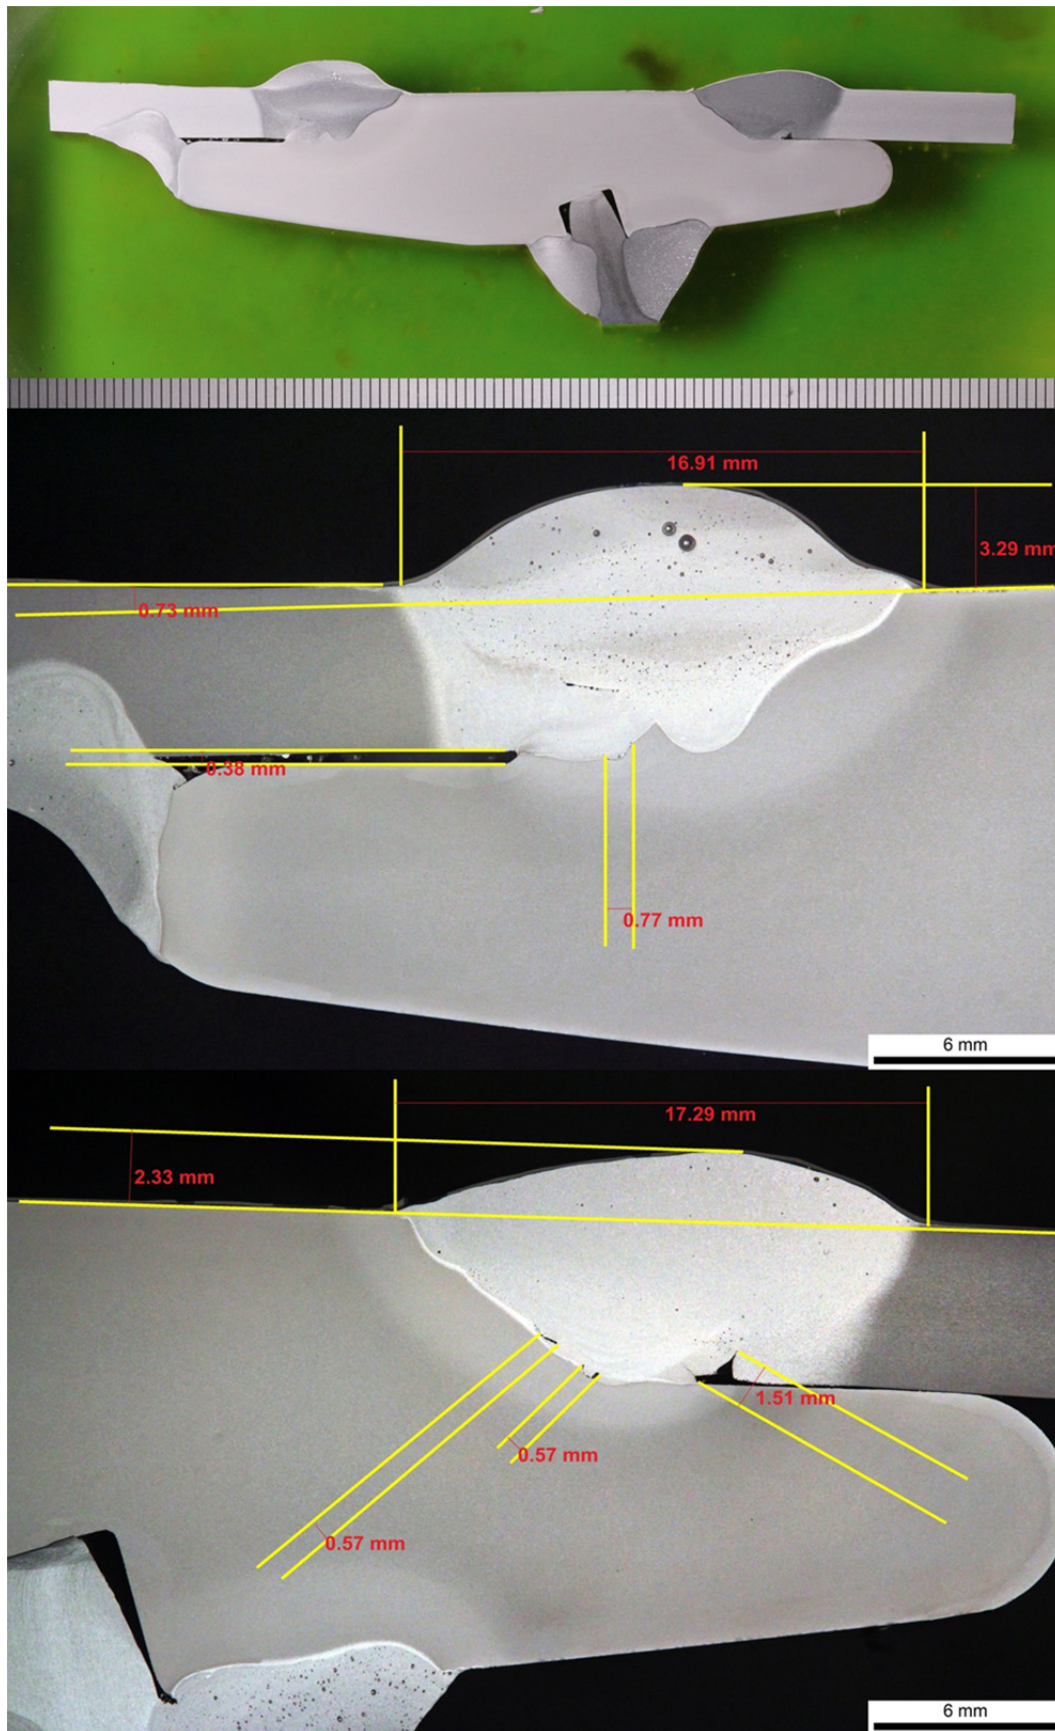
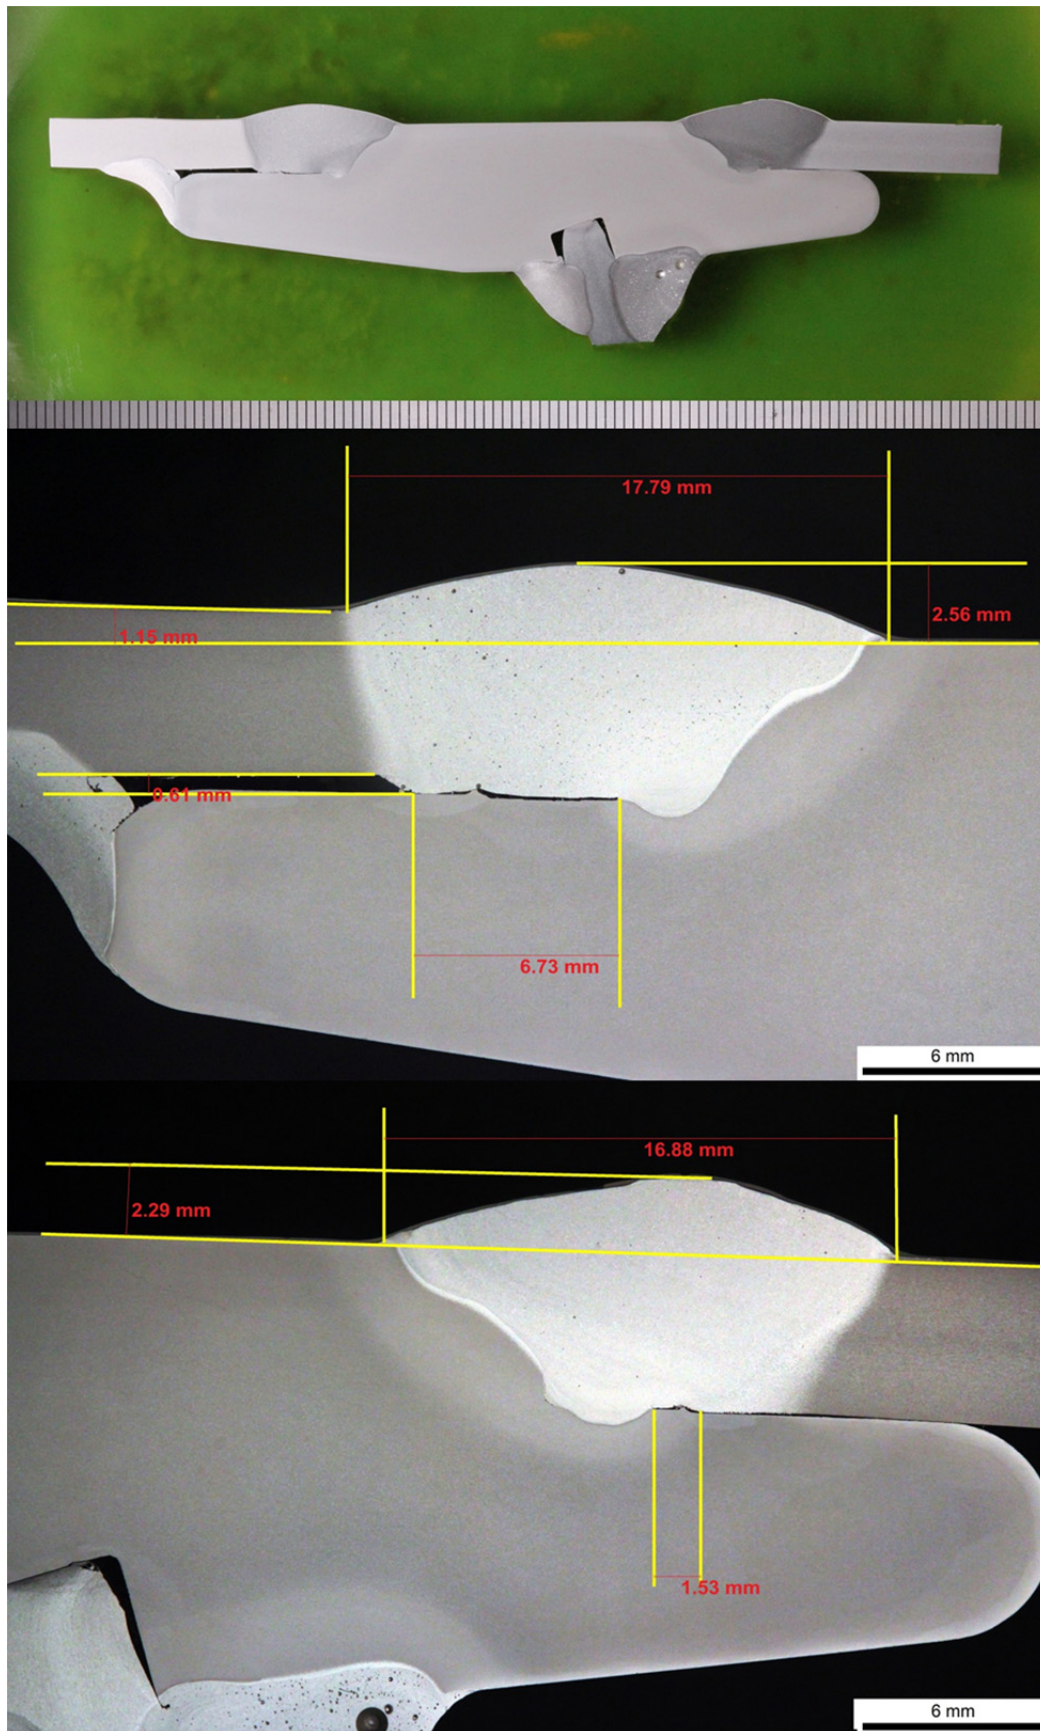
The samples prepared from Band G did not contain any significant crack-like defects such as those found in the samples prepared from Band C. However, there are several lack of fusion, embedded-type defects and some significant porosity.
