AAIB Bulletin

11/2015

ACCIDENT

Aircraft Type and Registration:	Dassault Falcon 20D, G-FRAK	
No & Type of Engines:	2 x General Electric CO CF700-2D-2	
Year of Manufacture:	1969	
Date & Time (UTC):	25 April 2015 at 1650 hrs	
Location:	English Channel, approximately 20 nm south of Portland Bill	
Type of Flight:	Special operations, target towing	
Persons on Board:	Crew - 3	Passengers - None
Injuries:	Crew - None	Passengers - N/A
Nature of Damage:	Wing leading edge torn and dented, winch carrier damaged, target lost at sea	
Commander's Licence:	Air Transport Pilot's Licence	
Commander's Age:	64	
Commander's Flying Experience:	12,700 hours (of which 9,000 were on type) Last 90 day - 121 hours Last 28 days - 32 hours	
Information Source:	AAIB Field Investigation

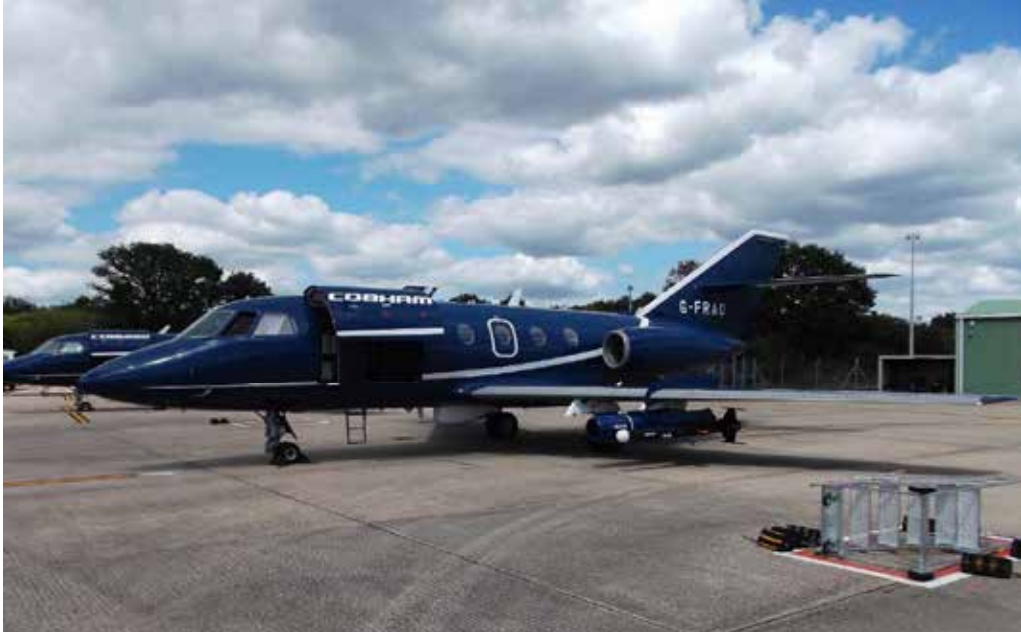
Figure 1

Image of an aircraft similar to G-FRAK with a RM30/ASL winch on its left wing and a target attached to the launcher on the outboard side of the winch

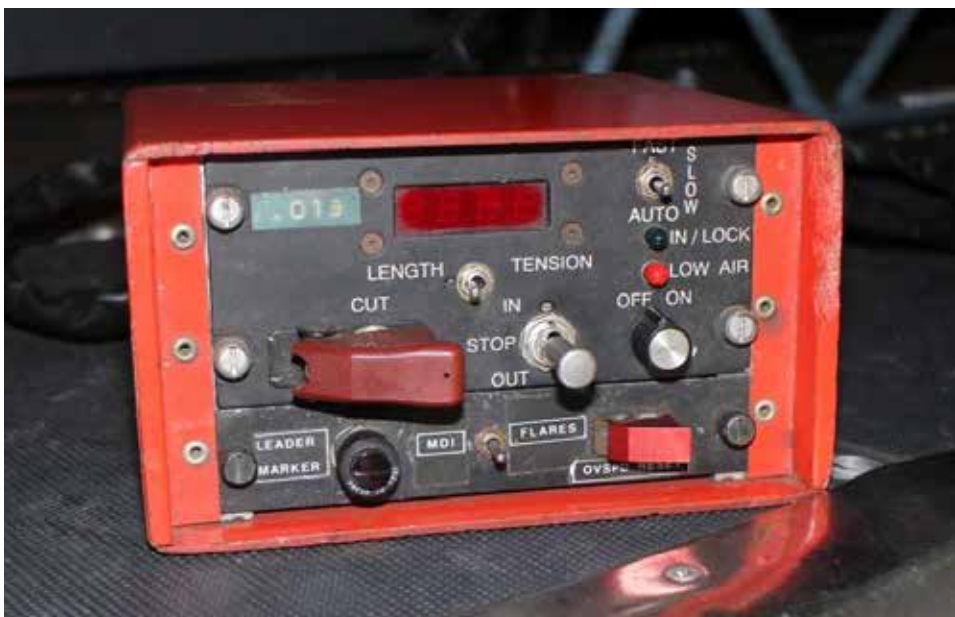
Figure 2

TTO winch control panel
