PART 1.4 – ANALYSIS AND FINDINGS

DETERMINING THE CAUSE OF THE ACCIDENT

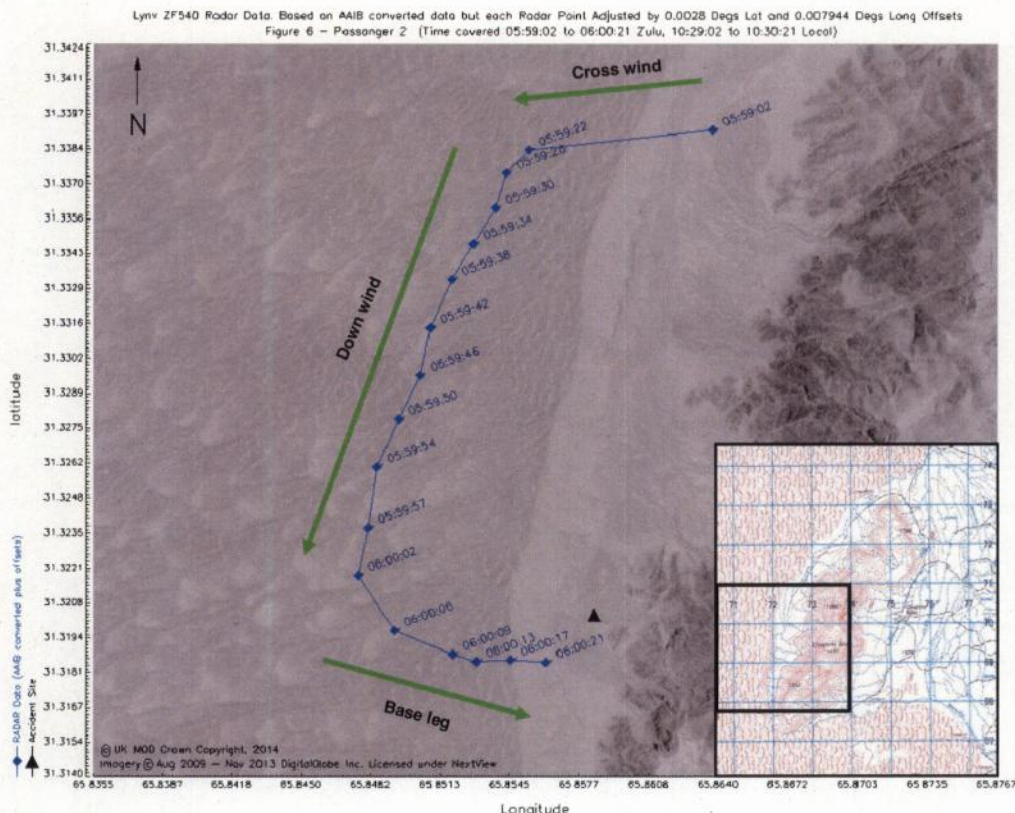
Figure 15 – The Final Circuit

1.4.133 Figure 15 identifies the aircraft track during the final circuit reposition taken from the Radar data. The Panel considered the reposition included:

c. **Base Leg.** Once towards the southern end of the Bowling Alley, the Handling Pilot initiated a left hand turn onto an easterly heading and flew over the Red Desert escarpment towards the centre of the Bowling Alley.

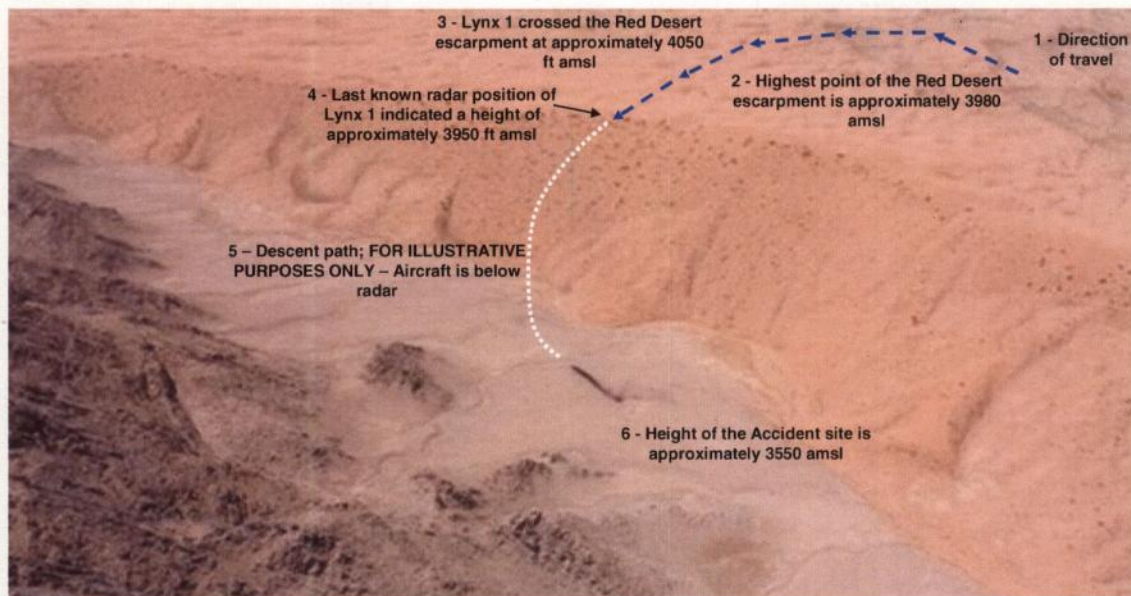
Figure 16 – For Illustrative Purposes Only, Lynx 1 Descent Path

1.4.137 **Serial 6 Bowling Alley Entry Point.** The Bowling Alley entry point used on Serial 6 crossed the Red Desert escarpment at the highest point which is approximately 3980 ft Above Mean Sea Level (amsl). The aircraft crossed the escarpment at approximately 4050⁶⁸ ft amsl (70 ft above the escarpment). The Bowling Alley valley floor at the accident site is approximately 3550 ft amsl. The Radar data indicated the aircraft was starting to descend as it passed the escarpment (Figure 16).

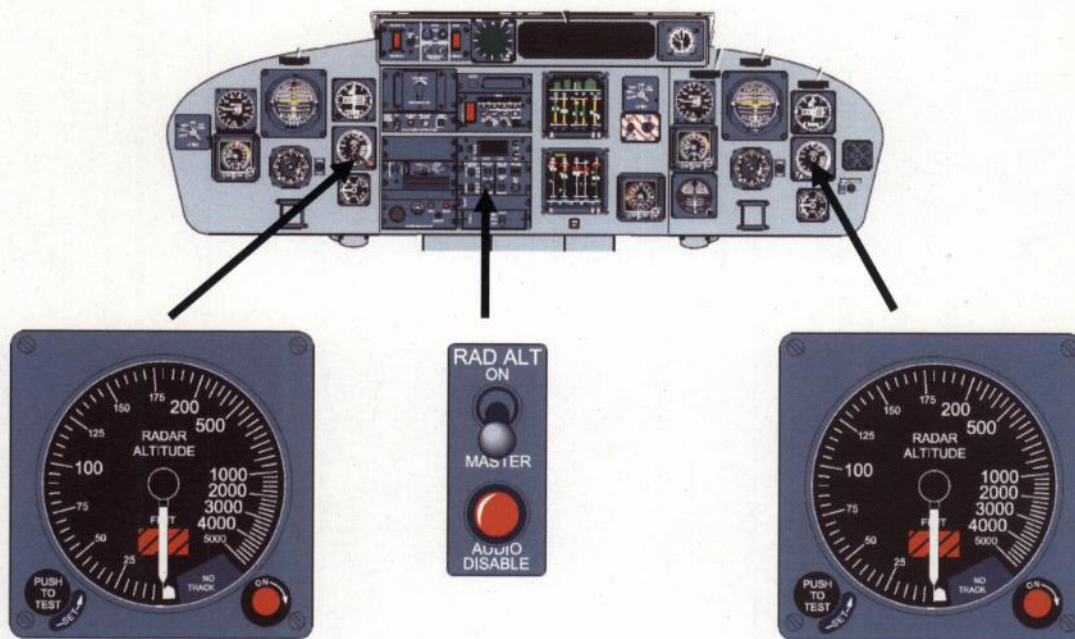
Figure 17 – RADALT Gauges and Indications

1.4.159 The Lynx is fitted with an APN 198 RADALT which provides an accurate indication of the aircraft's height⁸⁴ above the ground. This reading is repeated on indicator gauges, fitted to each pilots' instrument panel. The RADALT audio warning 'bug' can be set independently by each pilot rotating the knob on his RADALT gauge; however the audio warning will only sound as the aircraft descends through the higher 'bugged' setting. There is also a Low Height Warning light on the gauge which is triggered as the aircraft descends through the bug setting, although this is not immediately apparent during day flying (the light is more prominent during night flying). The audio warning can be silenced by either pilot pressing the 'AUDIO DISABLE' button, which is situated towards the centre of the instrument panel (see Figure 17). Once the audio warning has been cancelled it will not sound again as the aircraft descends through the lower bug setting, with the system effectively 're-arming' as the aircraft climbs back above the higher bug setting.

1.4.160 When low flying, the audio warning is a safety system which acts as a ground proximity warning device⁸⁵. If the aircraft descends below the required height, the RADALT audio warning should provide the prompt for the handling pilot to apply power and/or adopt a climbing attitude in order to regain an appropriate height. The Lynx Force Standard Operating Procedure (SOP) 21 articulates the RADALT setting procedure in dusty and desert conditions. SOP 21 indicates that the HP keeps hover height set throughout the sortie whilst the NHP sets the RADALT audio warning bug to an appropriate height, commensurate with the stage of flight.

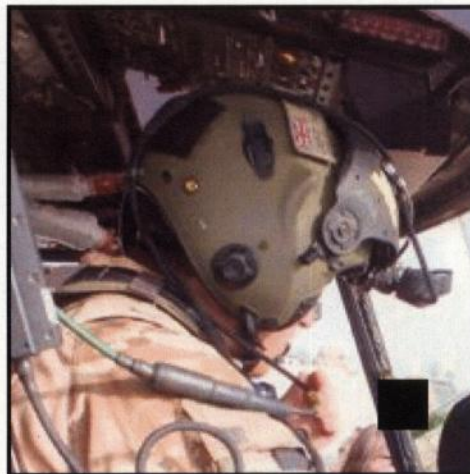
Figure 18 – Alpha 928 Helmet

1.4.181 The Panel considered whether the crew were using the Head Up Display (HUD) and whether this may have caused SD. HUD is a helmet mounted, high resolution, lightweight display unit that projects the aircraft flight and mission data in front of the pilot's and co-pilot's right eye (Figure 18). Whilst the Panel has been unable to ascertain if the crew were using the HUD during the sortie, it is noted that only the Pilot had signed out and received a HUD prior to the flight⁹³. There are two notes⁹⁴ contained within the Lynx AH Mk 9A Aircrew Manual regarding use of the HUD, as follows:

- a. When wearing the HUD, the Field of View is slightly reduced.
- b. When the head is tilted laterally, or turned to the side, the visual horizon will become misaligned with the horizon symbology.
