Rail Accident Investigation Branch

# Rail Accident Report

**Passenger trapped and dragged by a train at  
Hayes & Harlington station  
25 July 2015**

Report 12/2016  
June 2016

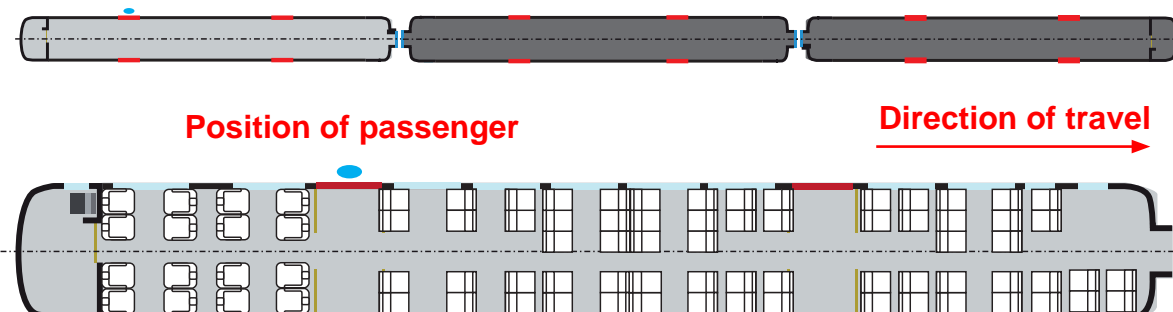
Figure 4: Class 165 vehicle layout and position of passenger attempting to board the rear set of doors of the carriage

- 6 The train involved in the accident was a class 165 Diesel Multiple Unit (DMU) (165101) formed of three carriages. The passenger involved in the accident had been attempting to board through the rear door on the third carriage (figure 4).

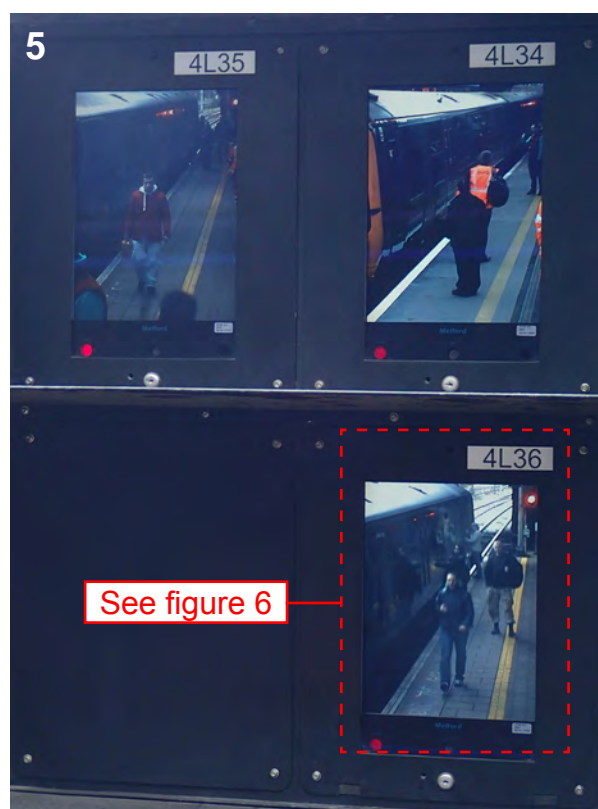
Figures 5 and 6: CCTV at the three-car stopping position on platform 4

- that the CCTV monitor(s) are displaying the correct images; and
  - the quality and contrast of the displayed picture(s).
- 64 The most recent Network Rail assessment was completed five days before the accident on 20 July 2015. No defects were identified, the DOO monitors were cleaned, and the CCTV camera angles were checked.

- 65 Analysis of the platform CCTV shows the train had stopped at the correct position (3 car marker point). No defects were reported by any driver on the day of the accident, and therefore the RAIB consider the quality of the images was unlikely to have been a factor in this accident.

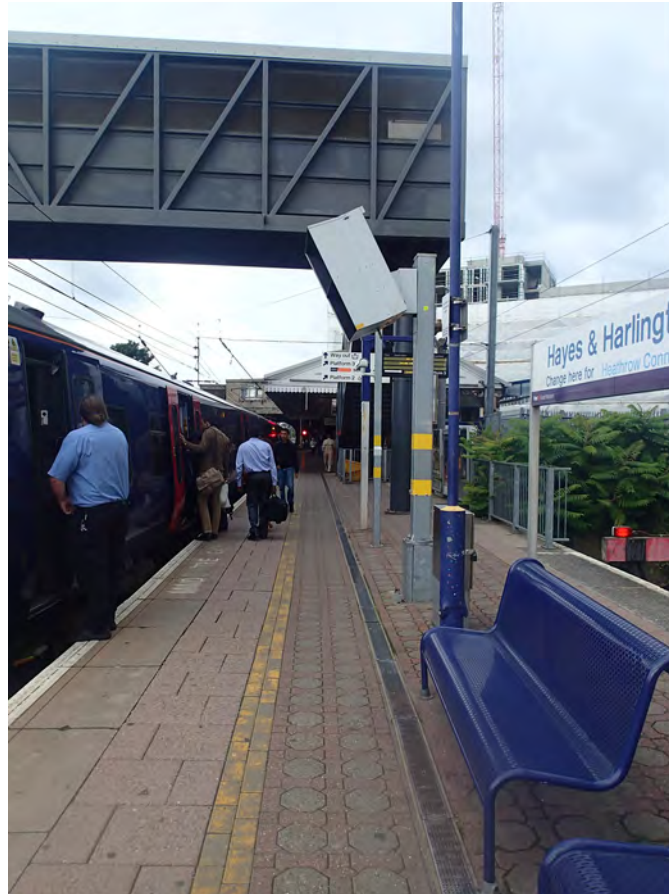
Figure 27: Image showing a train driver checking the platform during the dispatch process. Various methods of DOO dispatch were observed by RAIB (door open / door closed with window open and closed).

56 FGW's Professional Driving Policy (module ARB 48) supplements the requirements of the rule book. The policy outlines the key responsibilities of a train driver and incorporates much of the guidance from RSSB RIS-3703 'Rail Industry Standard for Passenger Train Dispatch and Platform Safety Measures' (Issue Two, March 2013) on the hazards a train driver should look for before and after closing the train doors (paragraph 127b). The policy also states that a train driver must ensure that during station arrival and departure, all procedures are undertaken correctly as accidents where people come into contact with a train can result in them sustaining life-changing or fatal injury (figure 27).
