The Serviceability of Helicopter Passenger
Immersion Suits - A Report
following the ditching of
G-BISO on 2nd May 1984

July 1984

AIRCRAFT EQUIPMENT GROUP REPORT NO. 508

The Serviceability of Helicopter Passenger Immersion Suits - a Report
following the ditching of G-B180 on 2nd May 1984

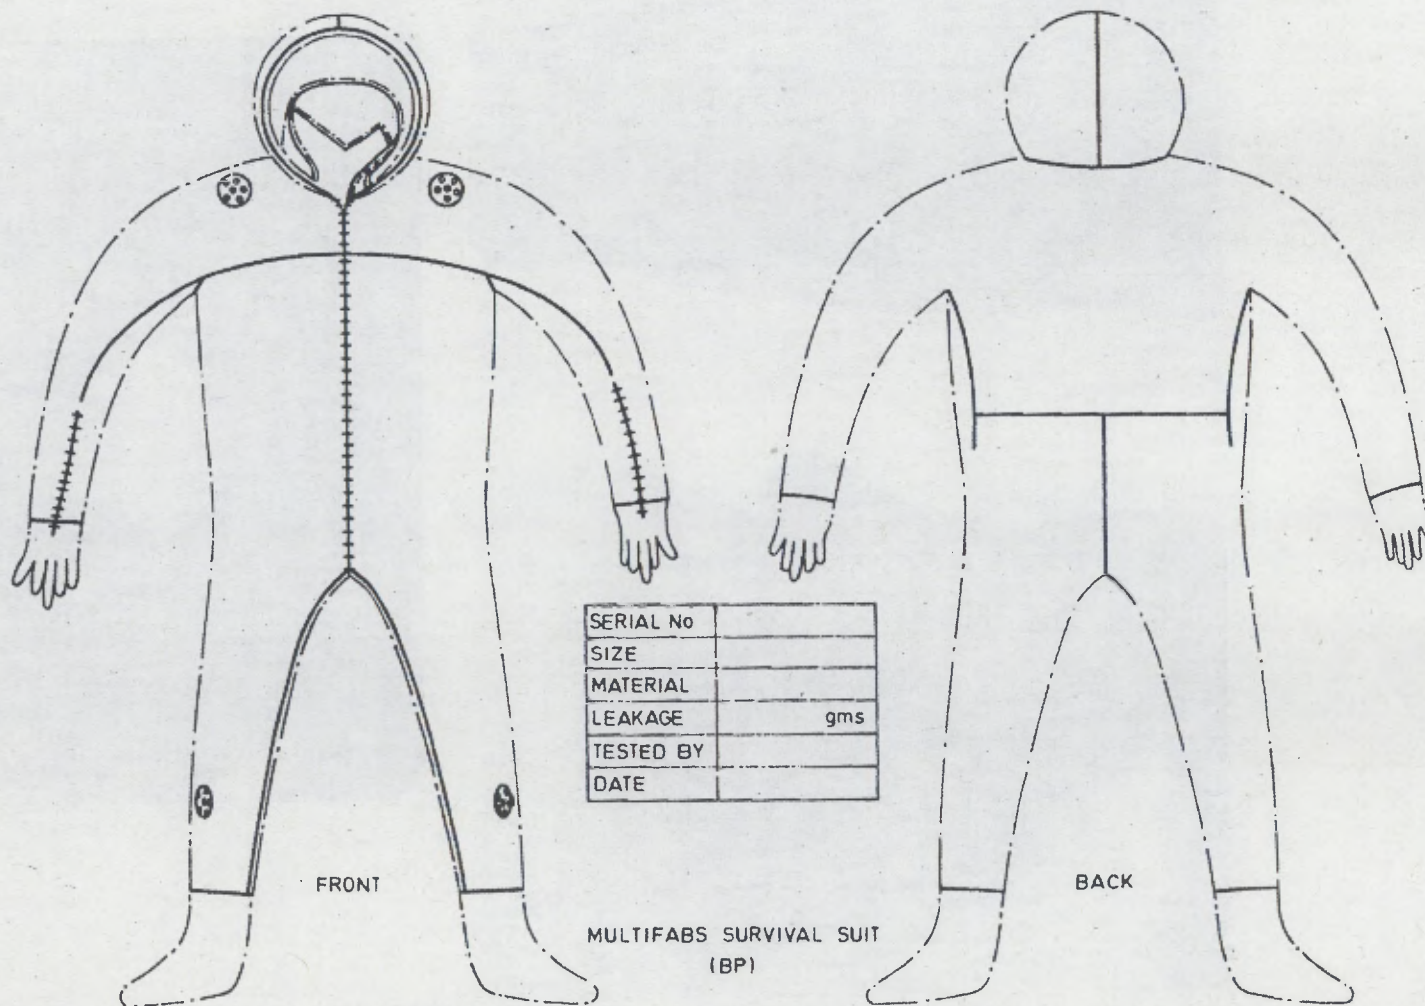
FIG 7

1. Wear and tear of inner layer fabric at wrist, penetrating the waterproof layer.
2. As figure 1.
3. Inner lining wear and lifting of repair patches.
4. Burn damage, probably from a cigarette.
5. External taping failure at wrist zip.
6. "Over enthusiastic" repairs at the wrist.
7. Burn damage, probably from heat sealing machine, with patch over.
8. Suit diagram for recording defects and leaks.
9. Visible defects, incidence and distribution.
10. Sources of leaks at bench test Parts 1, 2 and 3.
11. Defect proforma.

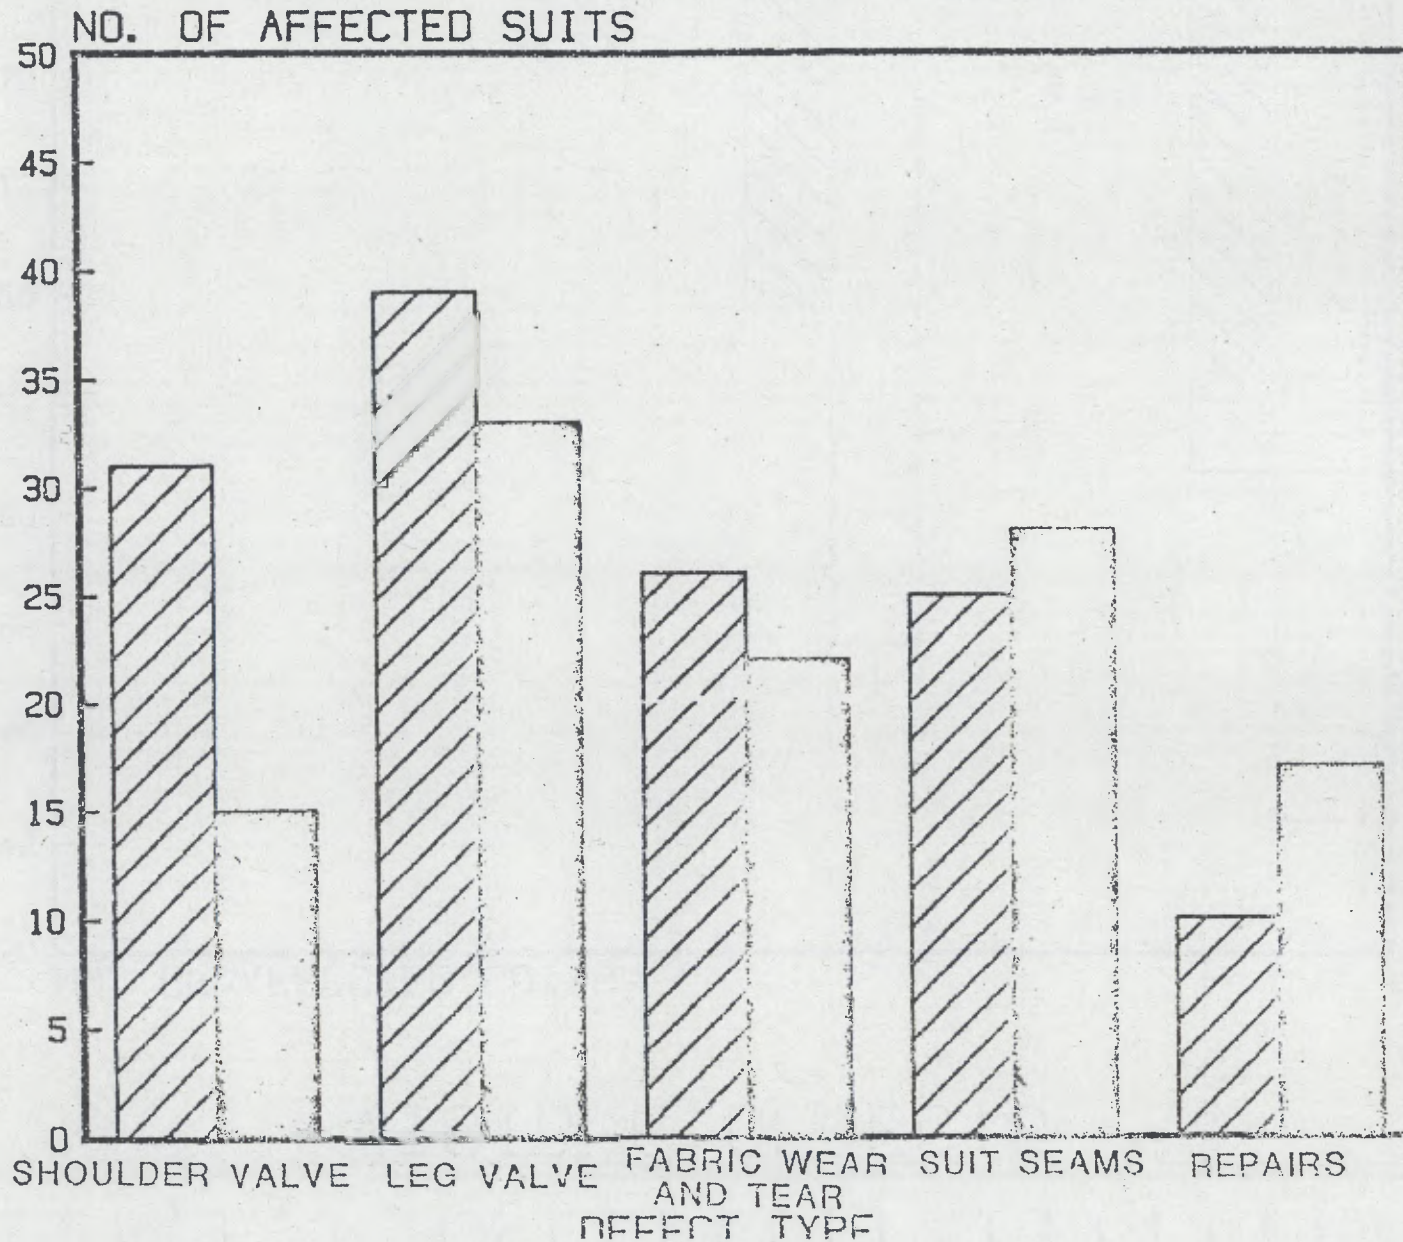
IDENTIFICATION OF LEAKS (1)

SURVIVORS
SUITS
