AAIB Bulletin

5/2015

Aircraft Type and Registration:	BAE ATP, G-BTPF	
No & Type of Engines:	2 Pratt & Whitney Canada PW126 turboprop engines	
Year of Manufacture:	1989 (Serial no: 2013)	
Date & Time (UTC):	7 October 2014 at 2035 hrs	
Location:	Outbound from Bournemouth Airport, Dorset	
Type of Flight:	Commercial Air Transport (Cargo)	
Persons on Board:	Crew - 2	Passengers - None
Injuries:	Crew - None	Passengers - N/A
Nature of Damage:	None	
Commander's Licence:	Airline Transport Pilot's Licence	
Commander's Age:	31 years	
Commander's Flying Experience:	2,570 hours (of which 325 were on type) Last 90 days - 43 hours Last 28 days - 16 hours	
Information Source:	Crew reports and AAIB enquiries

Aircraft Type and Registration:	CZAW SportCruiser, G-EWZZ
No & Type of Engines:	1 Rotax 912 ULS piston engine
Year of Manufacture:	2010 (Serial no: LAA 338-14815)
Date & Time (UTC):	9 August 2014 at 1440 hrs
Location:	Kingarth, Isle of Bute, Scotland
Type of Flight:	Private
Persons on Board:	Crew - 1 Passengers - 1
Injuries:	Crew - 1 (Serious) Passengers - 1 (Fatal)
Nature of Damage:	Aircraft destroyed
Commander's Licence:	National Private Pilot Licence
Commander's Age:	53 years
Commander's F

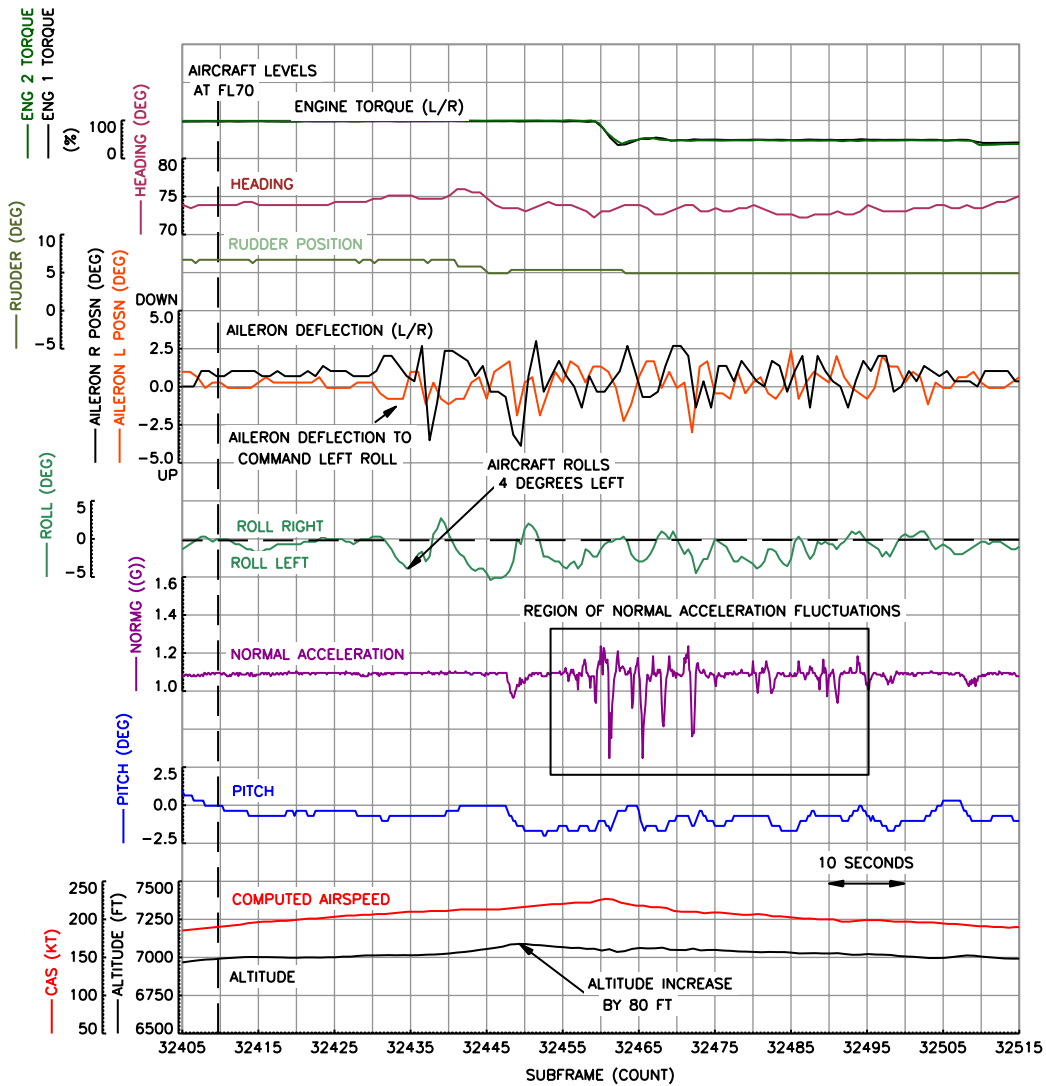
The data recorded the aircraft levelling off at FL70 just over four minutes after takeoff. Twenty four seconds later, the aircraft rolled left to -4° and there followed a number fluctuations in the recorded aileron position and roll attitude (Figure 2). The aircraft altitude increased

The maximum aileron deflection throughout this period was 3.8° (maximum travel is ± 15°) and the maximum roll attitude 5.4° to the left.

Figure 2
G-BTPF FDR parameters

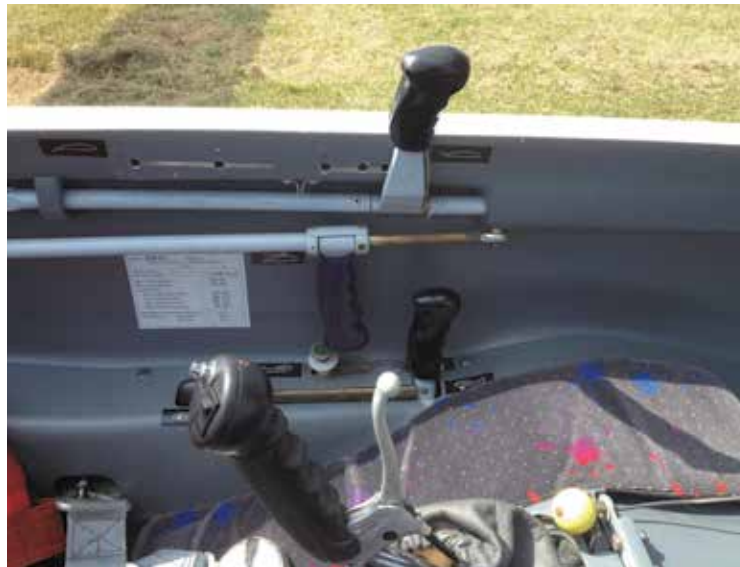
Figure 1

In Figure 1, the flap lever is shown in the high-speed position (-11°), the airbrake lever is shown in a partially extended position and the landing gear lever is in the down position.

Left internal side wall of an ASW20 glider
(This is not an image of G-LYSA.)

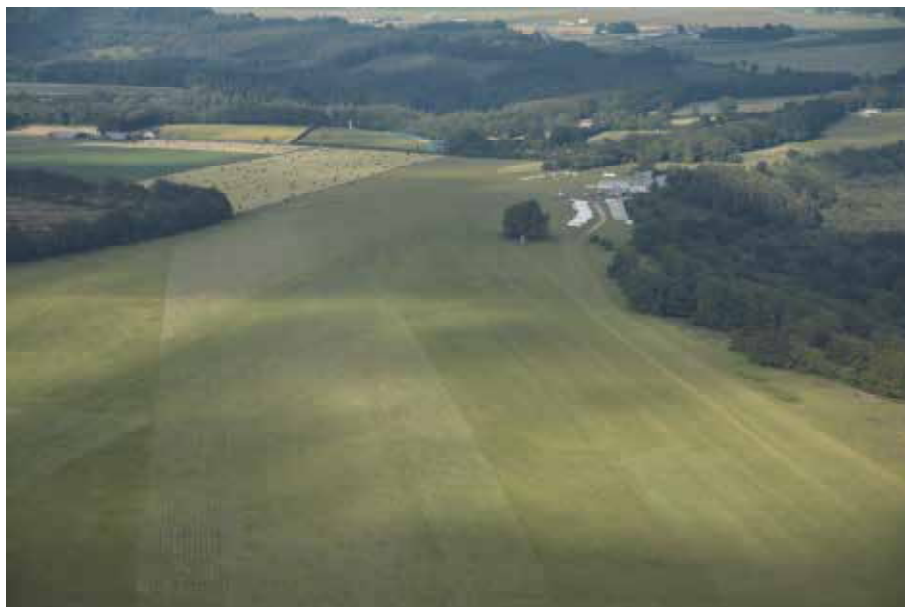
Figure 2

A view of the airfield from the direction of the final approach
(The accident site is at the far end of the field, beyond the isolated tree.)

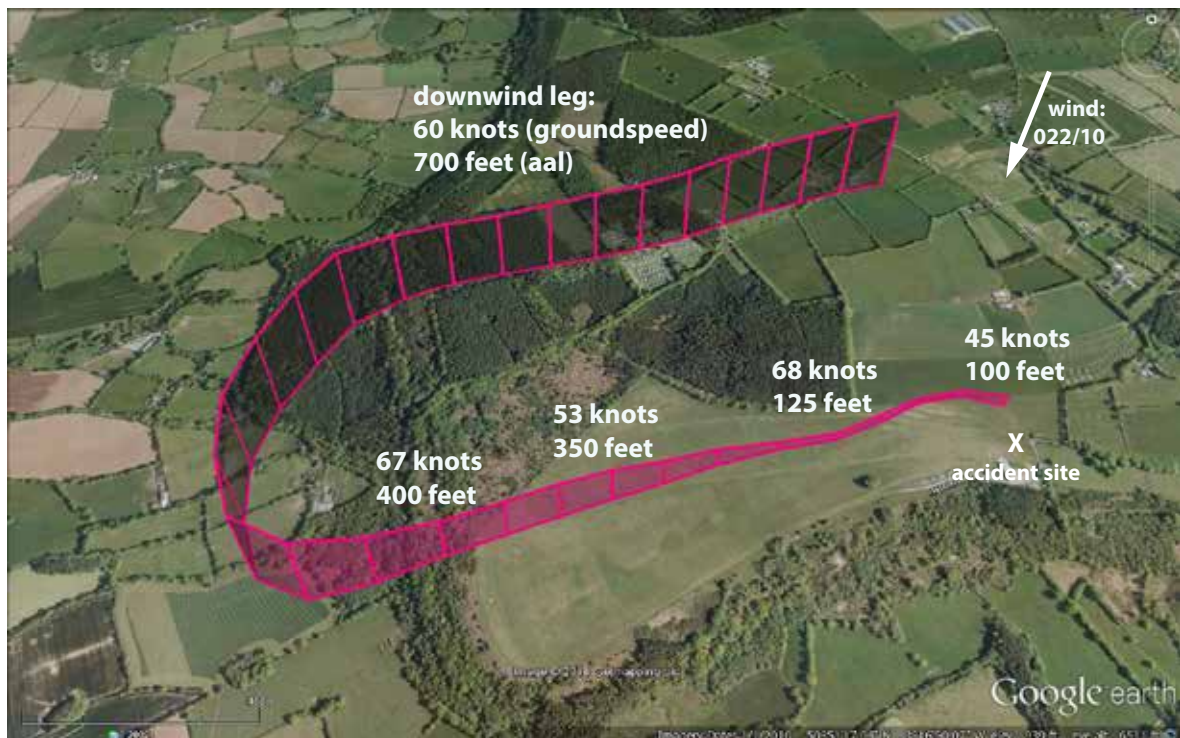
Figure 3 shows the final part of the track, in profile, with spot heights and groundspeeds (averaged between successive points). Figure 4 shows the ground track as a time history. These Figures indicate that the glider was downwind abeam the airfield at 700 ft aal, with a groundspeed of 60 kt, and descended to 400 ft aal above the airfield perimeter when established on final approach. Over the next 12 secs, there were minor variations in the glider's height, before it descended at about 1,250 ft/min to 125 ft aal, above a point just east of the airfield's two launch strips. Over the last 20 secs (to the last recorded point), the glider descended to 70 ft aal and then climbed back to 100 ft aal as it commenced a turn to the right. The groundspeed for this last point had reduced to 45 kt. Using the surface wind measured at the site two minutes before the accident, the airspeed at this point was estimated to have been between 52 and 55 kt. The data indicates that the drag of the glider increased during the approach; this is evident from the reversal in the increasing speed trend, while the descent continued.

Figure 3
G-LYSA approach to North Hill

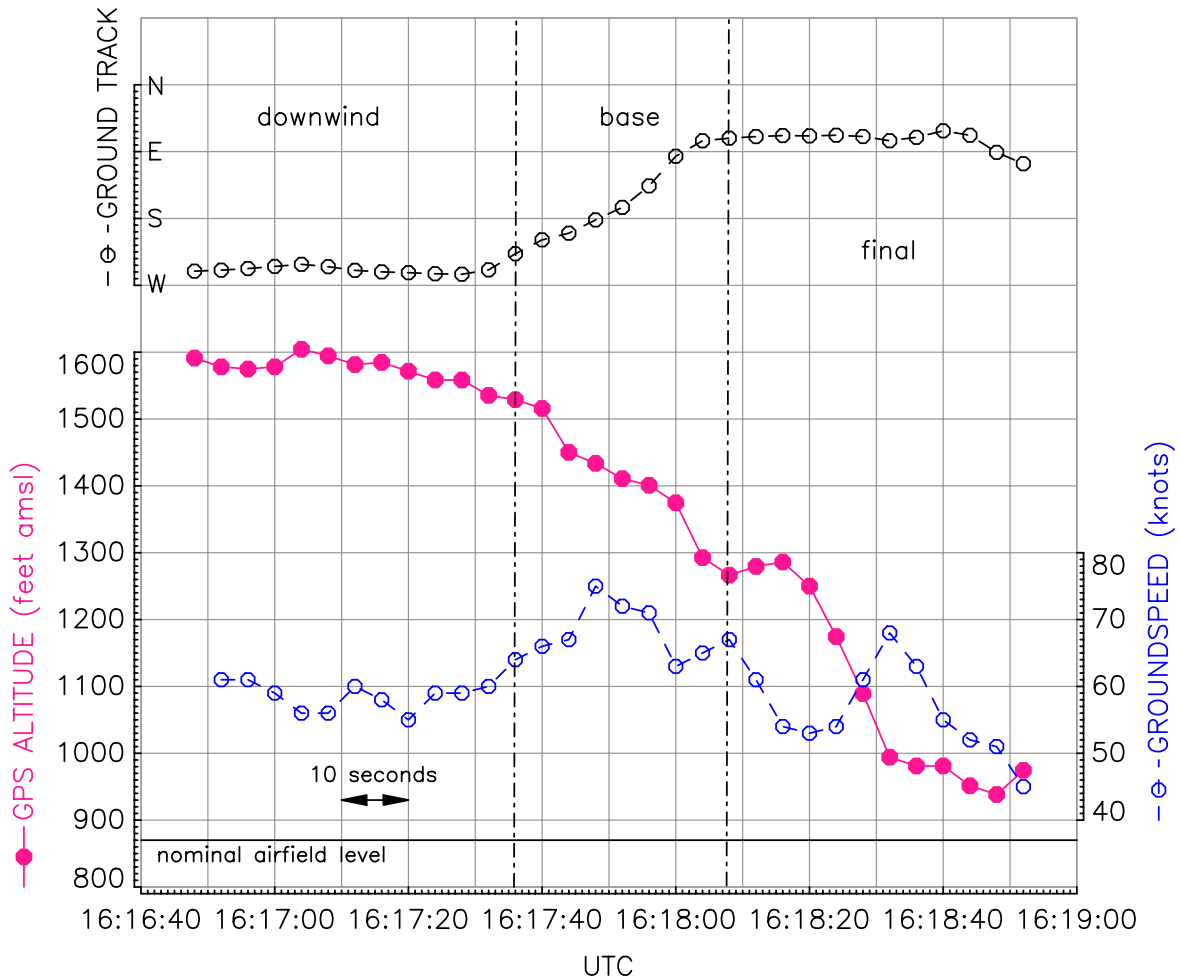
Figure 4
Recorded data for G-LYSA's approach to North Hill
