Rail Accident Investigation Branch

Rail Accident Report

**Signal passed at danger and subsequent
near miss at Didcot North junction
22 August 2007**

Signal passed at danger and subsequent near miss at Didcot North junction, 22 August 2007

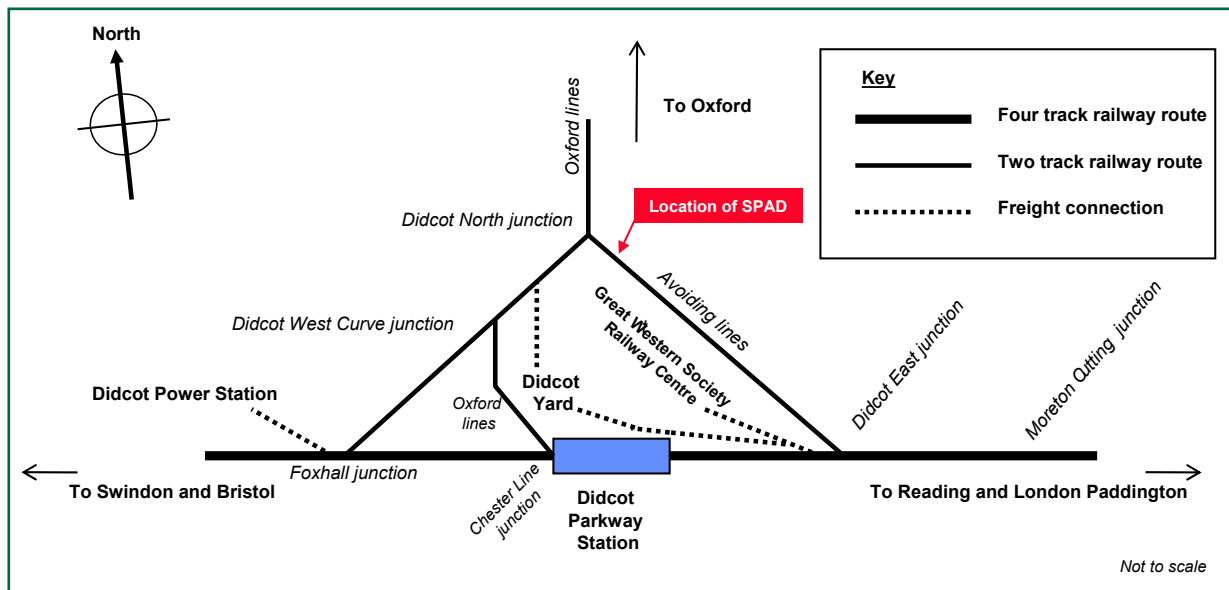
Figure 4: Railway lines in and around Didcot

- 21 Didcot is located on the four track Great Western main line, 17 miles north-west of Reading. Didcot East junction is located about 350 m east of the station. At this junction the route to Oxford diverges from the Great Western main line and passes to the north of Didcot Parkway station before reaching Didcot North junction where the line converges with a line arriving from the direction of Didcot Parkway station and the west (Figure 4). This section of line between Didcot East and Didcot North junctions is known as the Avoiding line (since it 'avoids' Didcot Parkway station) and measures 1¼ miles (2 km) in length.

- 22 The signal that was passed at danger during this incident was located at the north end of the Down Avoiding line, 225 m south of Didcot North junction.

- 49 The weather was overcast and windy, but dry. Visibility was good with no bright sunshine. There is no evidence of any light conditions or other environmental conditions affecting the visibility and clarity of signal aspects.
- 50 At the time of the incident there was activity in the Great Western Society centre at the south side of the Avoiding lines (Figure 4). This included the operation of at least one steam locomotive.

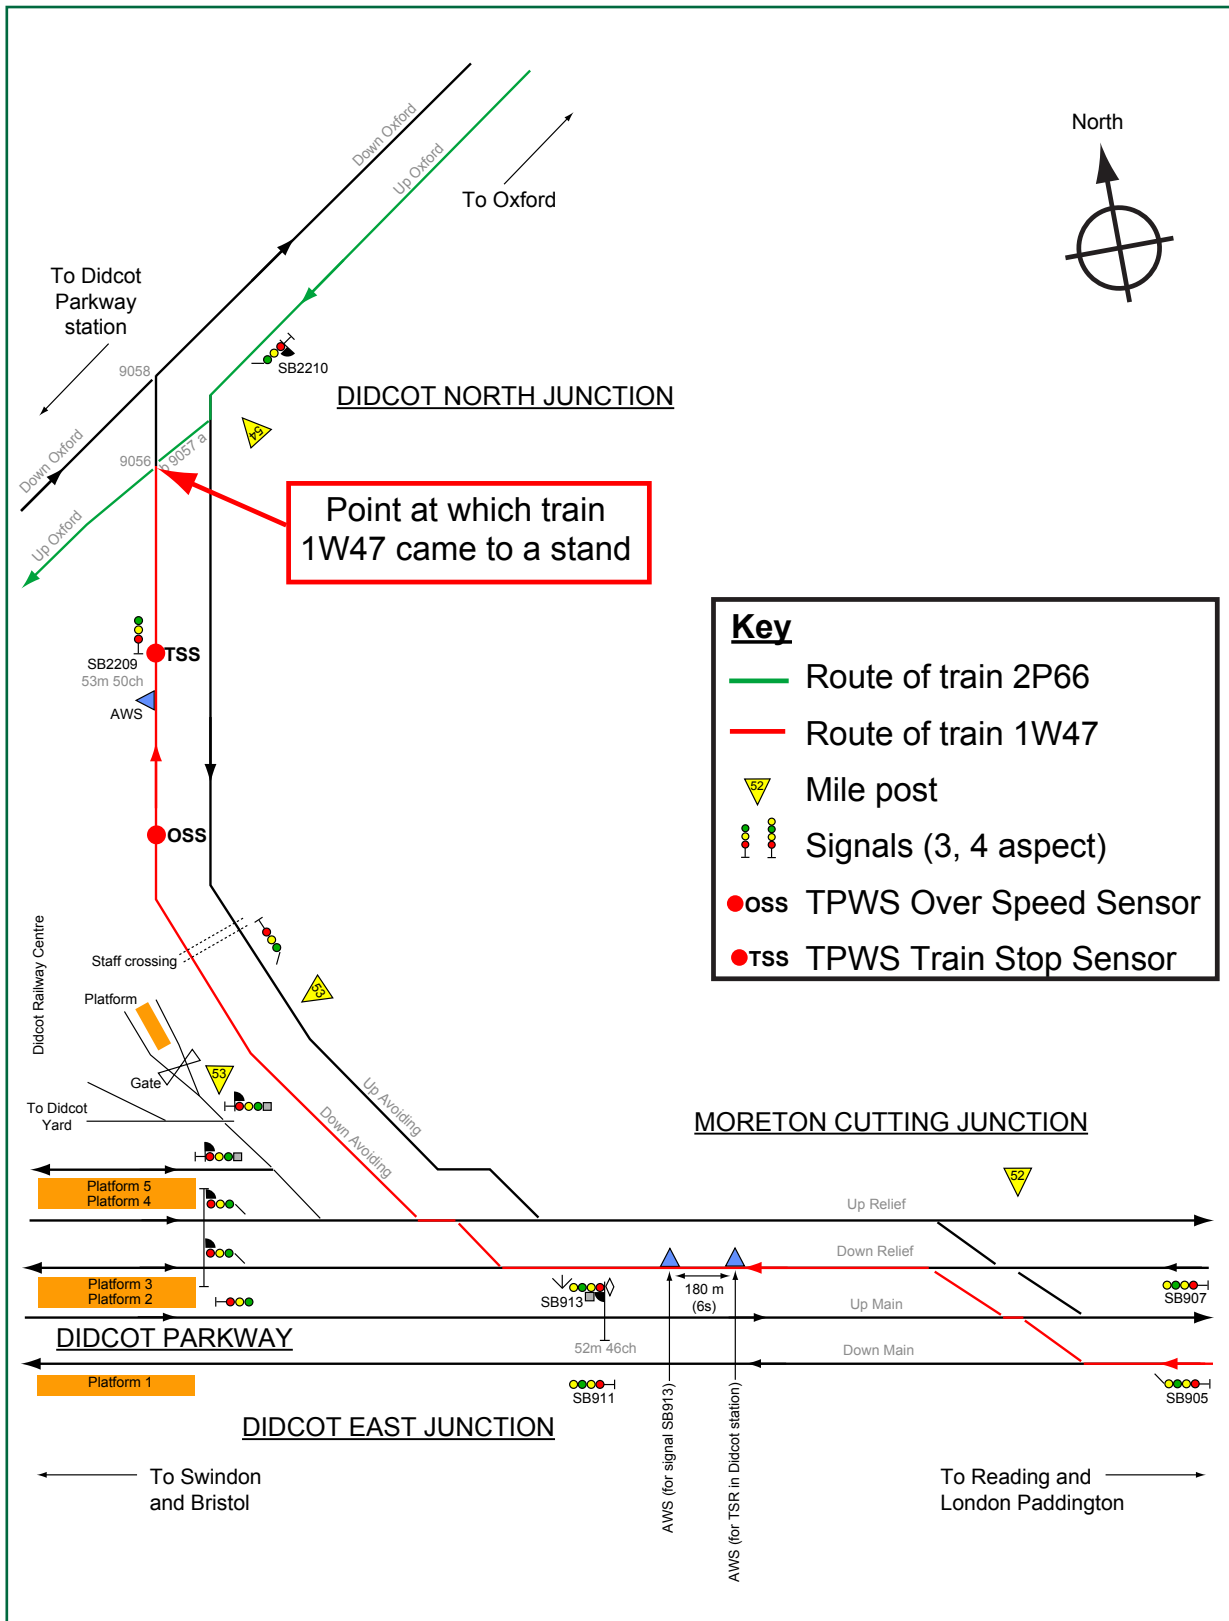
Figure 5: Layout of track and signalling equipment, and the routing of the trains involved in the incident

- Signal SB2209 becomes visible to the driver at a distance of about 400 m. This equates to 13 seconds at 70 mph (113 km/h).
- The track layout at Didcot North junction creates a potential for a head-on collision between northbound trains and those southbound trains that are being routed across the junction towards the Up Oxford line (Figure 5). There is also the potential for a collision to occur between passenger and freight trains. Conflicting freight train movements include loaded coal trains bound for Didcot power station and elsewhere.
- The *overlap* of signal SB2209 is 185 m in length (although compliant with the standards that applied at the time of installation, recent schemes have tended to adopt a longer dimension of 225 m). The fouling point is located only 16 m beyond the end of the overlap giving a total safe overrun distance of 201 m.

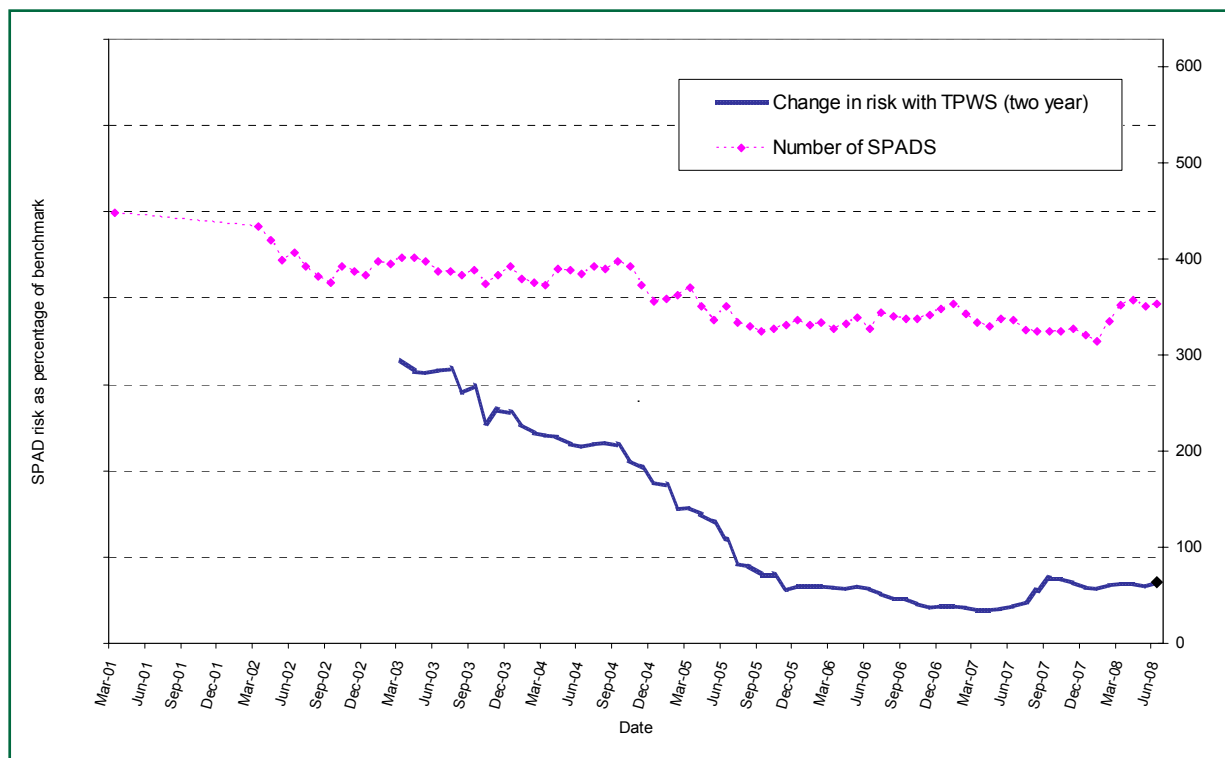
Figure 7: Change in SPAD risk over time

- 84 By the time of the collision at Ladbroke Grove, detailed development and testing of a new system, TPWS, was already ongoing, although the extent of its installation had still to be decided.
- 85 Full-scale installation of TPWS at numerous junctions and high risk locations commenced in 2001 and was completed in the early part of 2004. Since the installation of TPWS there has been a 22 % reduction in the number of SPADs and an estimated 86 % reduction in the overall risk (see Figure 7). This reduction is due in large part to the installation of TPWS but also reflects factors such as driver management, improved train performance and crashworthiness.
