Rail Accident Report

Parting of the live overhead wire at Walkergate station, Tyne and Wear Metro 11 August 2014

Report 09/2015
July 2015

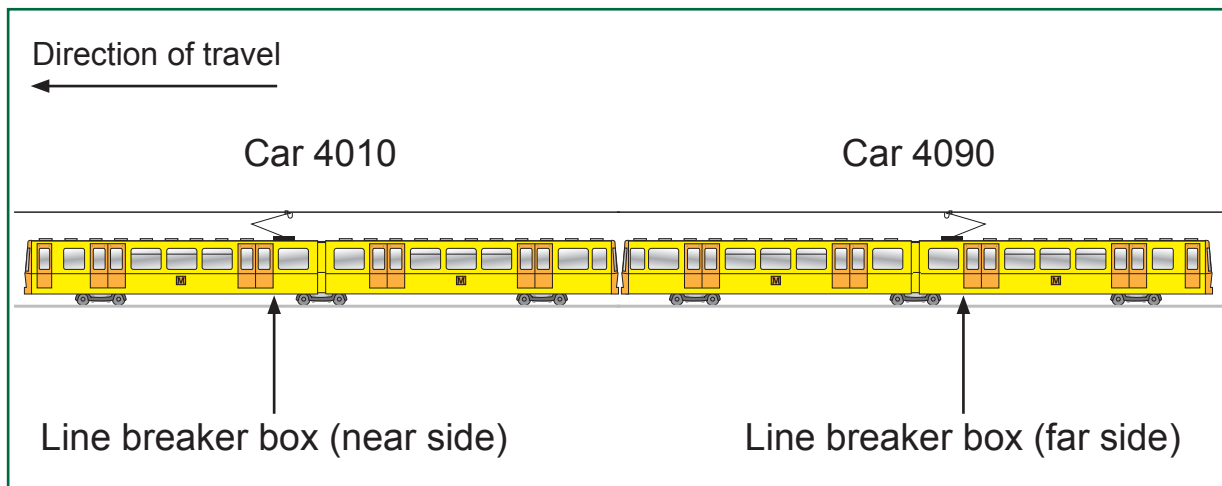
Figure 3: Arrangement of the train looking from the platform side

- 5 Staff in the control centre called the fire service who attended at around 19:04 hrs, by which time the fire was no longer burning. It was subsequently found that a train *line breaker* on the underside of the rear car had suffered burn damage and the parted contact wire had burned a hole in the roof of the leading car.

- 14 The train, reporting number 130, consisted of two cars, each made up of a two-section articulated unit (figure 3). The leading car was number 4010 and the trailing car, on which the electrical fire occurred, was 4090. These cars were built between 1978 and 1981 by Metro-Cammell, in Birmingham.

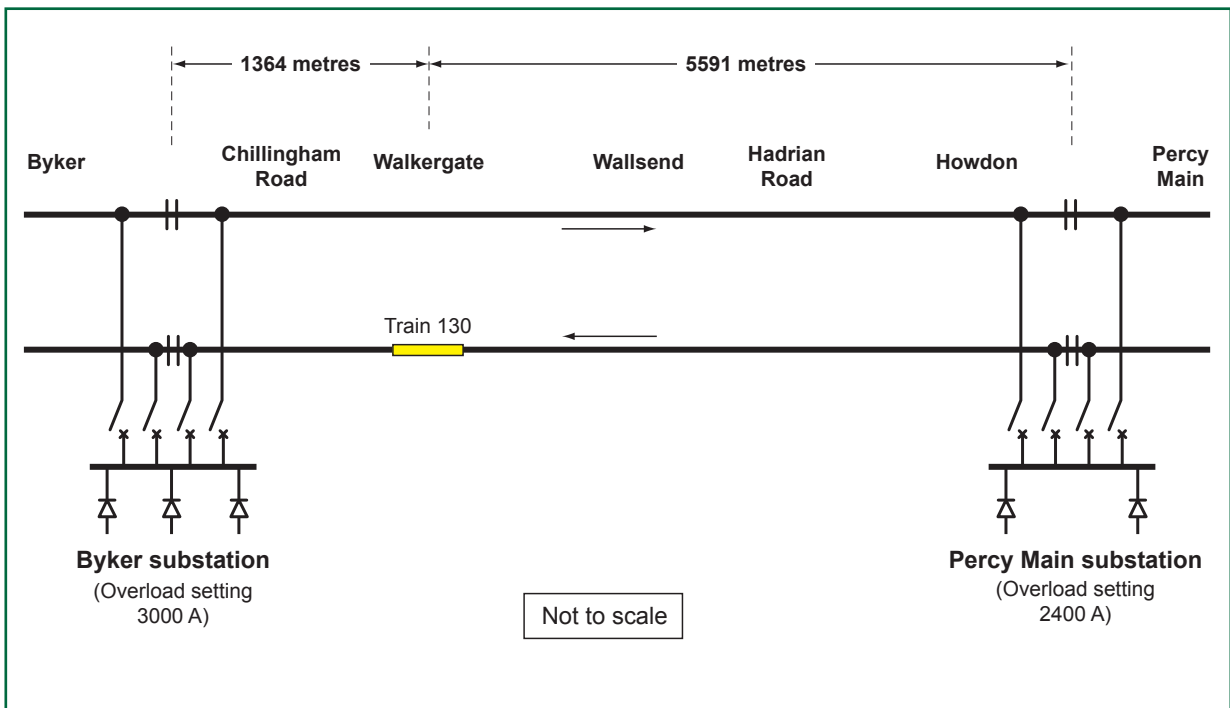
Figure 5: Percy Main to Byker electrical section

- 16 Trains operating on the Metro system are supplied with 1500 Volt direct current (DC) traction power through overhead contact wires. There is a separate contact wire for each track, suspended at intervals by *droppers* from a catenary wire (figure 4). Trains draw traction current from the contact wire through pantographs mounted on the roof of each car and current is returned to the substations via the train's wheels and the running rails.
- 17 The section of overhead line which includes Walkergate station is supplied with traction power at each end of the electrical section from substations at Percy Main and Byker (figure 2). This is known as being 'double-end fed'. There is a separate feed for each of the two tracks. The Byker to Percy Main electrical section is 6,955 metres long; Walkergate station is 1,364 metres from Byker and 5,591 metres from Percy Main (figure 5).

- 18 At the substations, traction power is fed to the overhead wires via circuit breakers which open automatically when an *overload* unit detects current being drawn in excess of designated overload settings. The circuit breakers can also be opened and closed manually by power controllers in the control room at South Gosforth. The circuit breakers at Percy Main and Byker were set to open at 2400 amperes (A) and 3000 A respectively².

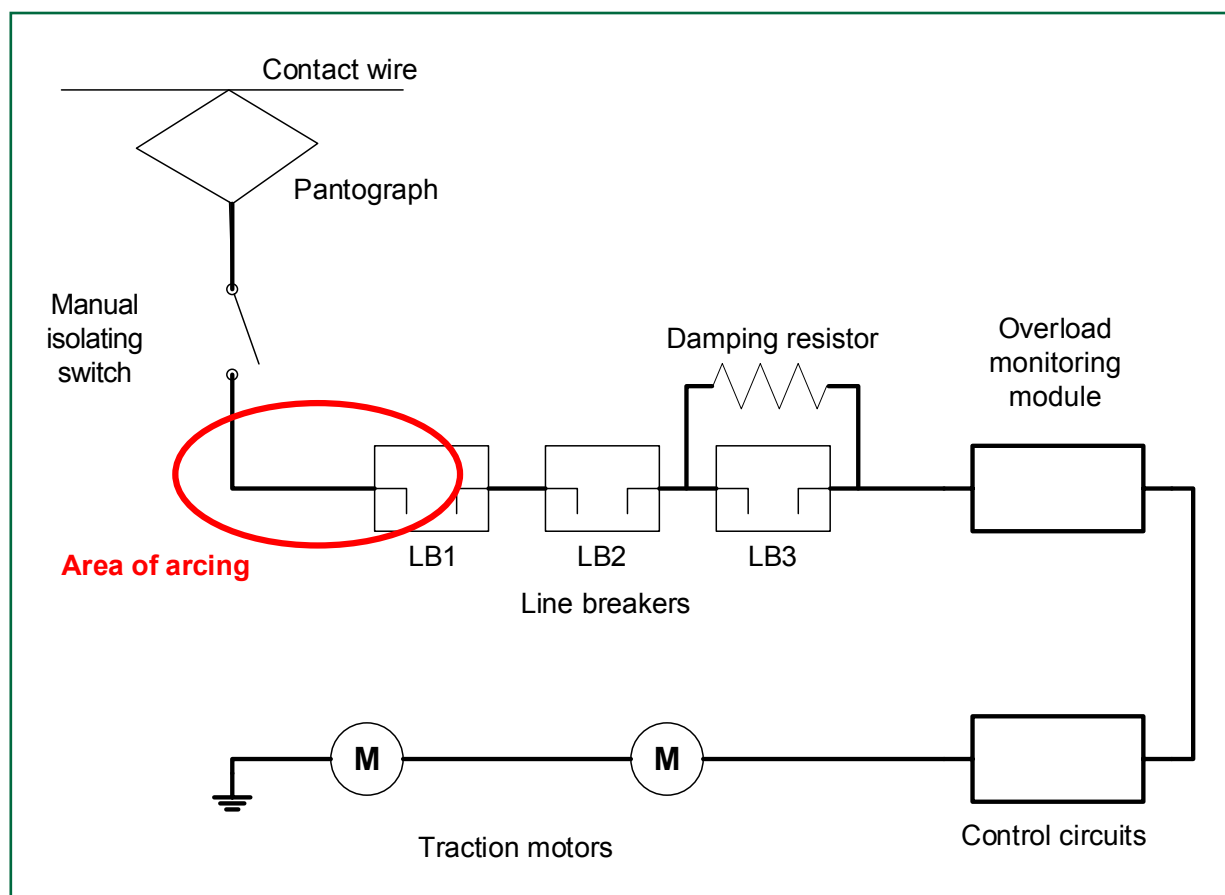
Figure 6: Metro car traction power circuit

- 23 Traction power is fed from the pantographs via a cable to a line breaker box (one on each car) containing three line breakers identified as LB1 to LB3⁴ (figure 6). The line breaker box is mounted below the floor of the car, directly under the pantograph (figure 3).
- 24 The function of line breakers is to control the power supply to the traction circuit of the car. The electrical contacts of the line breakers are only closed when the train is drawing traction power (figures 6 and 7). When the train is standing in a station, for example, the line breakers' contacts are open. However, LB1 remains live on the pantograph side of its open contacts.

⁴ There are three line breakers arranged in series. When commanded to open, LB3 opens first and puts a damping resistance into the circuit. LB1 and LB2 then open, disconnecting power to the downstream equipment. This arrangement is designed to limit and share the voltages that are developed across the line breakers when the contacts open.
