**Tether visibility prior to impact**

### Accident sortie, pre-tether strike – summary

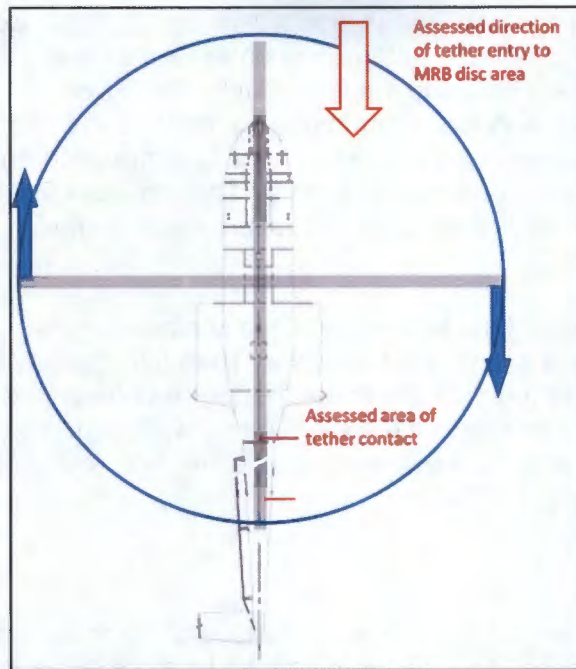
Figure 1.4.21 - Puma HC Mk2 main rotor disc viewed from above

1.4.212 The Panel assessed that a MRB drew the tether onto the right of the tail cone and as it crossed the aircraft's longitudinal axis tension on the tether increased. The Panel judged that the tension would have been further increased by the momentum of the advancing MRB and this caused the tether to part; the PTDS technical specifications stated that the tether was designed to break at a strain of 18,000 pounds (tension). Analysis by 1710 NAS described the failure of the tether as a tension failure due to pulling or stretching, rather than as a result of an instant guillotine-type failure. The end of the tether below the point of failure is shown in Figure 1.4.22.

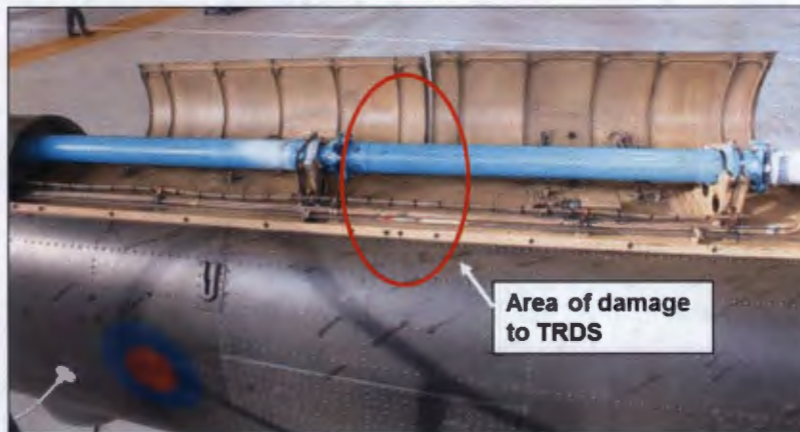
Figure 1.4.31 - Undamaged No 5 TRDS (not XW229)

1.4.258 Technical investigation identified a catastrophic torsional failure of the No 5 TRDS directly in line with the TRDS fairing gap through which the tether is assessed to have passed. Figure 1.4.31 shows an undamaged No 5 TRDS; Figure 1.4.32 shows the torsional failure.

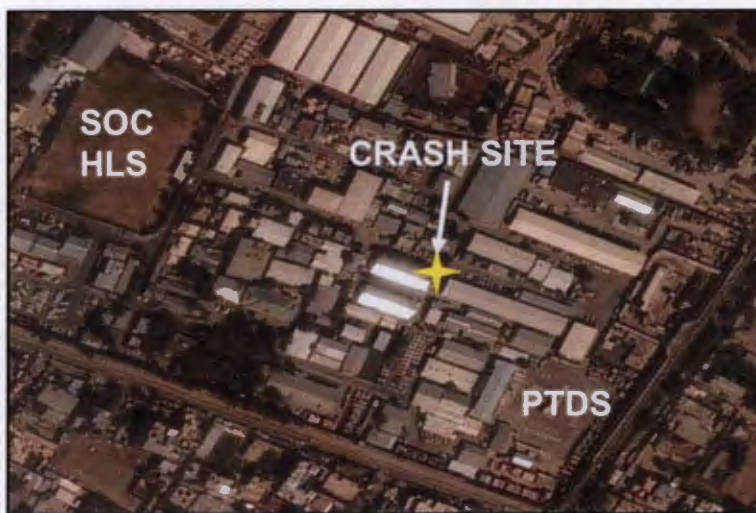
Figure 1.4.36 - Location of XW229 crash between HQRS buildings

1.4.263 The aircraft impacted the ground between buildings within the HQRS compound with no forward and only minimal lateral momentum. The location of the aircraft is shown in Figure 1.4.36 with images of the aircraft between buildings shown in Figure 1.4.37.

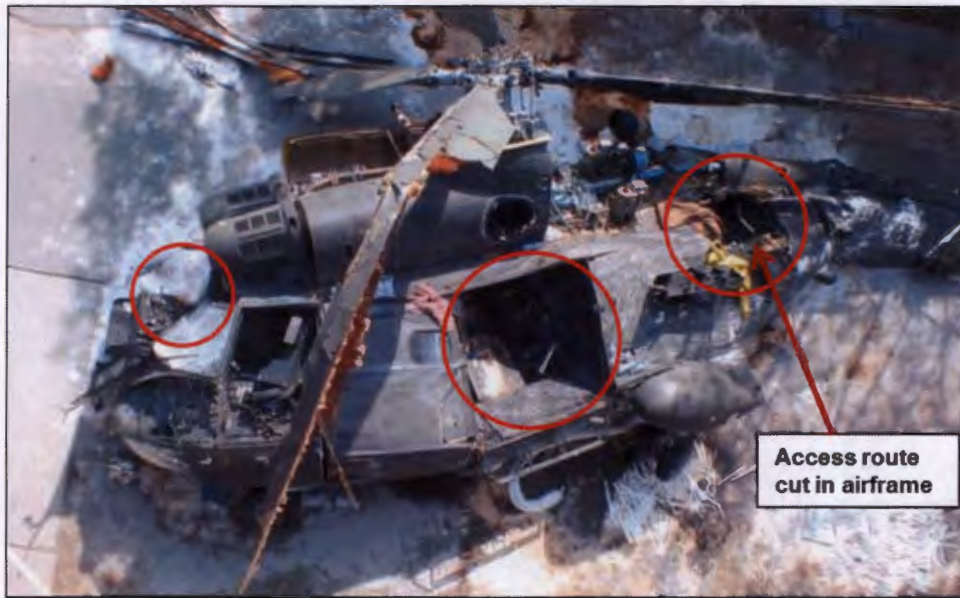
**Figure 1.4.40 - Extraction routes for XW229's occupants**

1.4.276 None of the crew or passengers were able to conduct their own egress either having been trapped within the wreckage or rendered incapable by the force of the impact. Two principle egress points were immediately available to rescuers: the open left cabin door and the left cockpit door (once it had been removed). The left cockpit door was not used to extract anyone from the aircraft. The substantial deformation of the cabin structure and resultant entrapment of passengers forced rescuers to cut an extraction route through the tail cone of the aircraft. Figure 1.4.40 shows the 3 areas used to extract the aircraft's occupants.

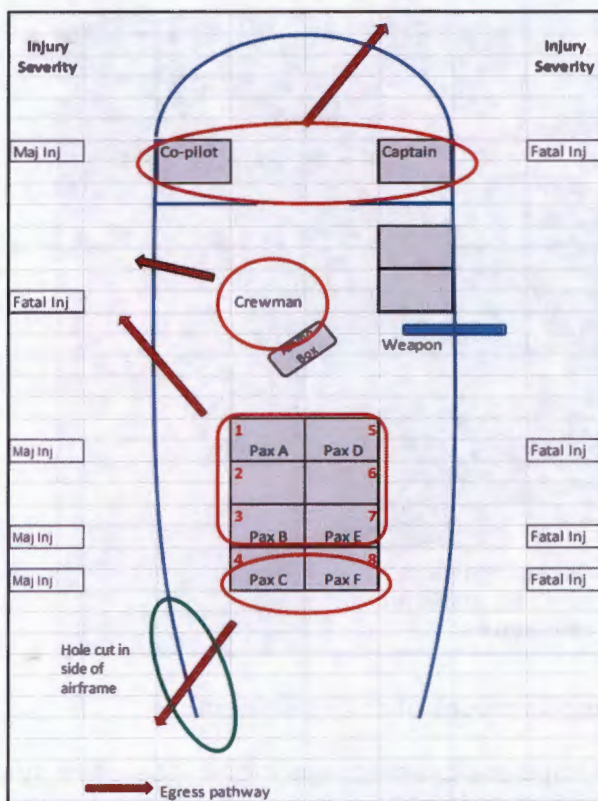
Figure 1.4.42 - XW229 Crew and passenger seating and exit routes

1.4.280 Passengers were extracted via the left hand cabin doorway or through the hole cut in the tail area. Figure 1.4.42 shows seating positions and exit routes. Table 1.4.8 summarises passenger extraction times.

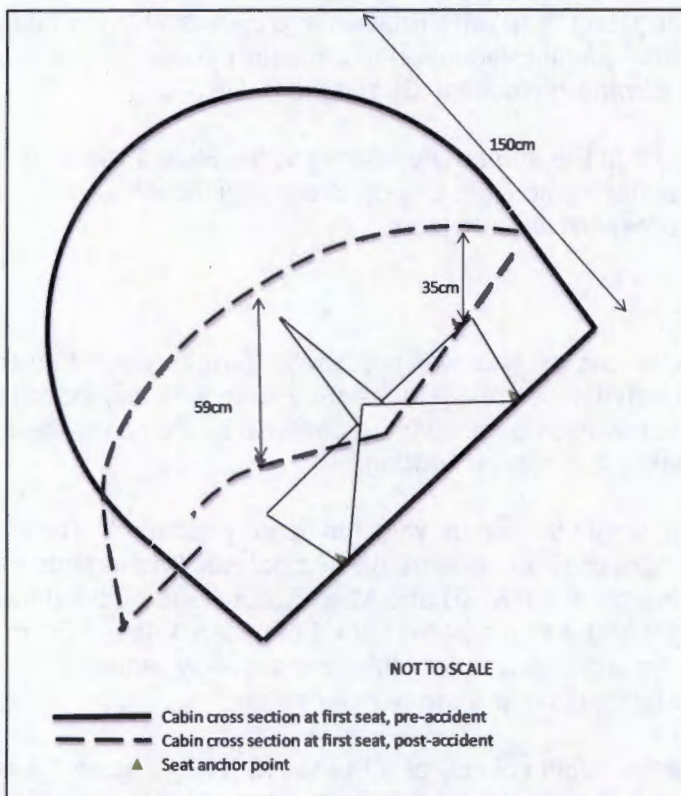
Figure 1.4.44 - Diagrammatic representation of decrease in cabin volume in area of first passenger seats viewed towards rear of aircraft

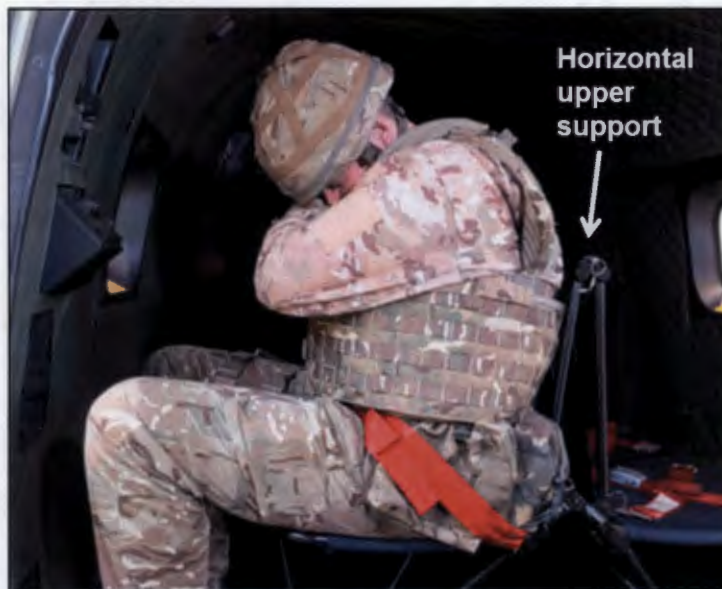
**Figure 1.4.50 - Position of troop seat upper support**

1.4.304 The back of the passenger seat is a canvas panel secured to a horizontal bar at a seated height of 43 cm; a seated passenger, supported across the upper back, who experiences a significant +Gx force will inevitably experience forced neck extension. Injuries were more likely with head mounted mass such as a ballistic helmet and whilst wearing body armour with ballistic plates as these factors would have increased the moment and concentrated the fulcrum around the neck area. The position of the troop seat's upper support in relation to a passenger's back is shown in Figure 1.4.50.

1.4.305 Aeromedical specialist analysis considered that the rigidity and prominence of the tubular bar on the seat back accentuated point loading forces
