# SS RICHARD MONTGOMERY

## Survey and Hull Thickness Report 2013

September 2015

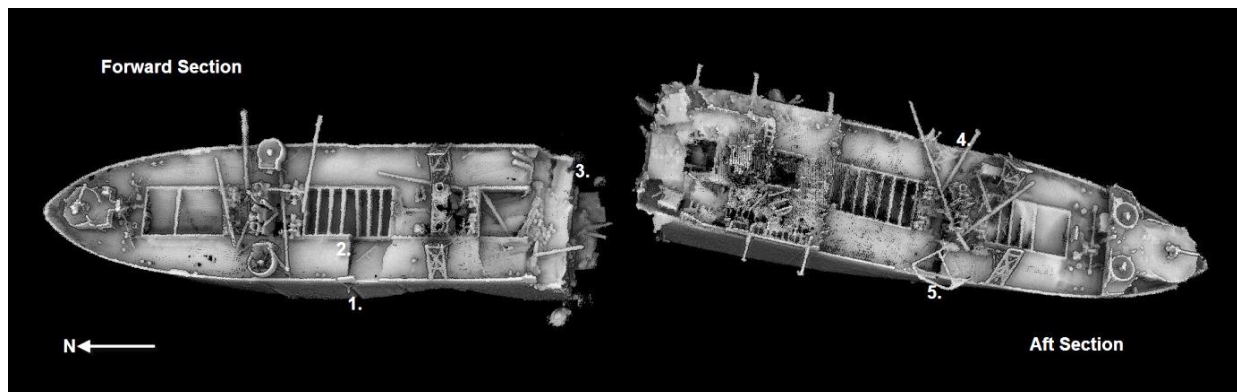
Figure 3. Overview of the wreck with locations of key areas.

4.4.2 Area 1 is the crack in the hull on the port side of the forward section at Hold 2. This consists of a hole in the hull plating just below deck level and a crack which extends to the seabed. This has been noted in survey reports since at least the 1970s.

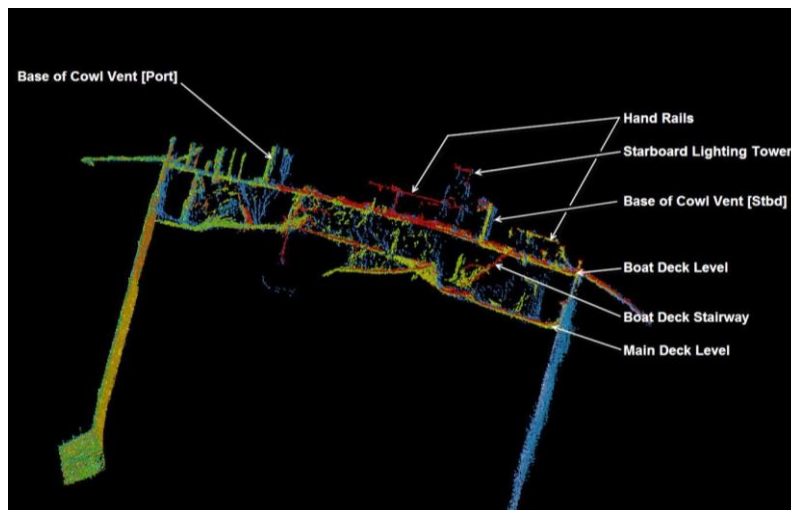
4.4.19 The boat deck, which would have run around the port, aft and starboard sides of the bridge section, was stated to be missing in some previous surveys. Examination of the point clouds shows that the boat deck is in fact in situ on the starboard side. Data comparisons from the 2010, 2012 and 2013 datasets all show the presence of this deck.

4.4.20 As well as highlighting areas of change and deterioration, the MBES data also assists in building up a better general understanding of the wreck structure. For example, the port and starboard lighting towers were reported as standing at the aft end of the boat deck with the information from previous surveys suggesting that the port tower had collapsed and was lying on the deck by Hold 4. Examination of the dataset and comparison with images from sister vessels, such as the SS Jeremiah O'Brien has provided a better general understanding of the layout of this area. This showed that the structures identified in the 2012 survey report as being the bases of the lighting towers are in fact more likely to be the lower sections of cowled vents coming up through the deck from the forward end of Hold 4 or the engine room. The lighting towers stand next to these vents on the SS Jeremiah O'Brien and this is likely to be the arrangement aboard the SS Richard Montgomery as well.

Fig. 14 Cross-section of the aft end of the boat deck with interpretation of the structures present

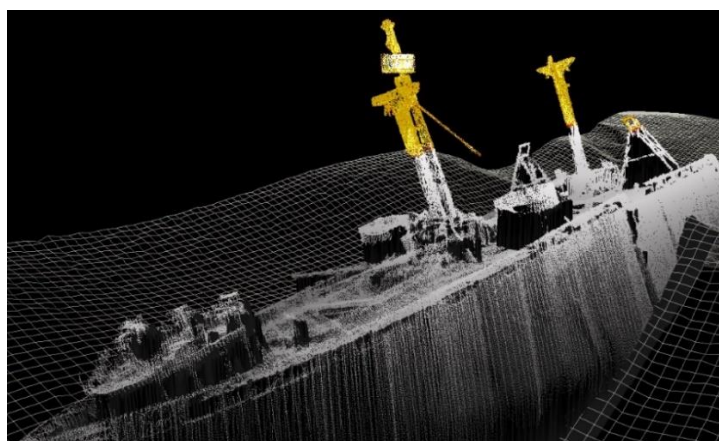
4.6.6 Multibeam data of all three masts showed no signs of deterioration since the last survey. Photographic and laser data demonstrated, as outlined above, that the loose stay on the forward mast is now completely detached. It also showed that a warning sign on the middle mast has become detached since the last survey. The stern mast exhibited no signs of change when compared to previous laser data.

**Fig. 21 Laser and multibeam data of the forward section**

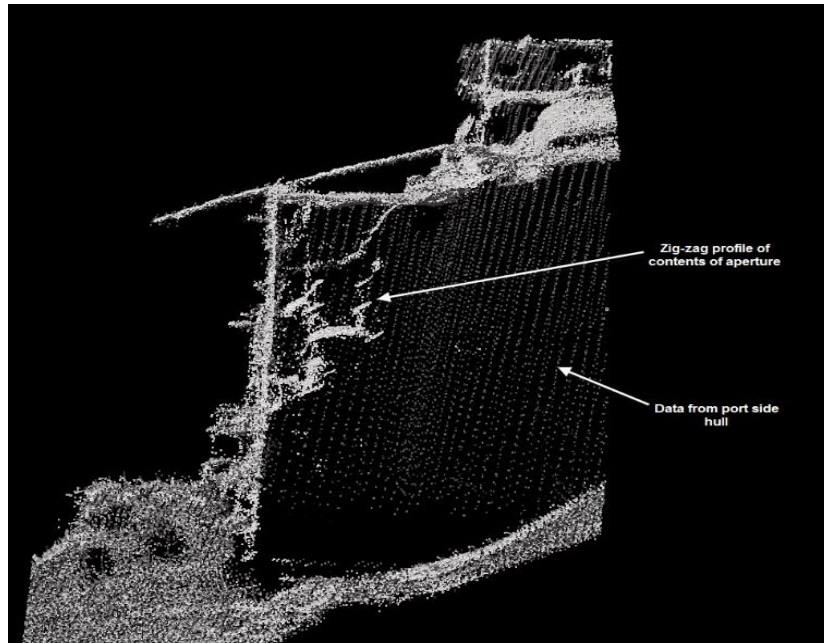
4.8.5 At the aft end of Hold 3 is a bulkhead which is containing the cargo in lower Hold 3. There are apertures in the bulkhead, through which it may be possible to visualise the munitions cargo. This bulkhead was well defined in the 2013 data and the aperture could be

clearly observed. Some penetration of the aperture with sonar beams was achieved however, due to the limitations of the system and the structure of the wreck it was not possible to identify the contents of Hold 3. Image below shows a cross-section through the data at Hold 3 including the outline of what may be cargo material.

**Fig. 26 Cross-section through the aft end of the forward section with contents of Hold 3 shown in profile.**

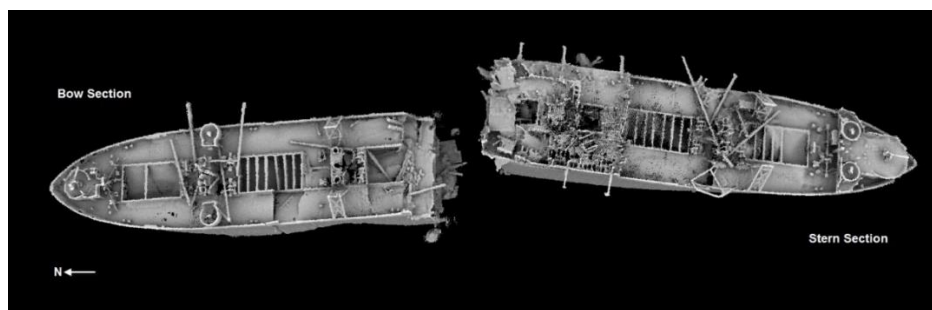
4.9.1 The wreck remains in two distinct sections, as can be seen from the image below, despite the presence of a number of significant structural cracks. The two sections are referred to as the bow or forward section and stern or aft section in this report.

**Fig. 27 Plan view of the wreck of the SS Richard Montgomery**

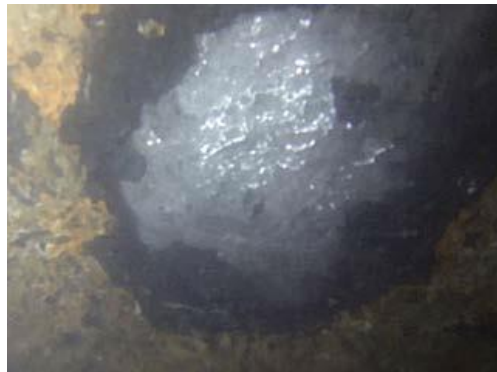
**Fig. 33 Cleaned area of hull showing roughness of surface**

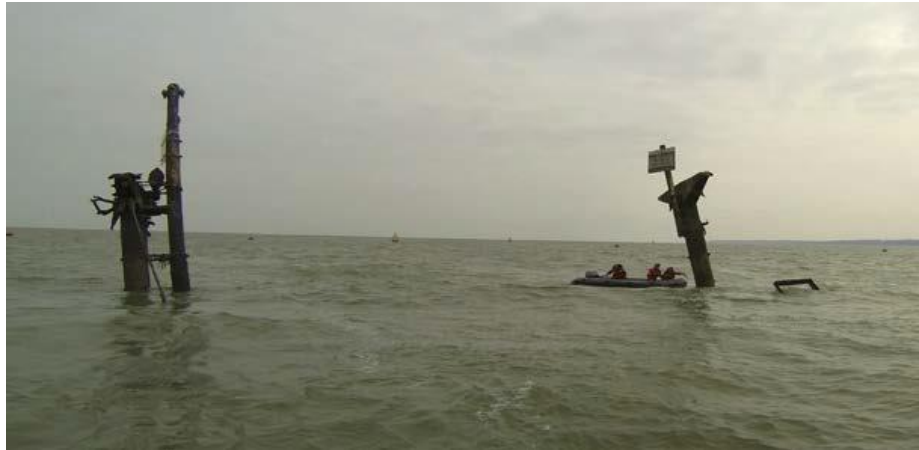
6.5.4 The masts on the forward section of the wreck appear to be in good condition when visually inspected from the surface. The corrosion on the masts appears to be uniform in the intertidal area and whilst there is some pitting, this appears limited in depth and extent.

**Fig. 35 Taking surface mast thickness readings**

6.5.5 The masts appear to lack any perforation therefore it is likely that the water exchange within the tube of the mast is very limited. This will reduce the dissolved oxygen content in the water contained within the mast, therefore reducing the internal rate of corrosion.
