Rail Accident Investigation Branch

Rail Accident Report

Derailment of a freight train at Stoke Lane Level Crossing, near Nottingham 27 August 2013

Report 02/2015
April 2015

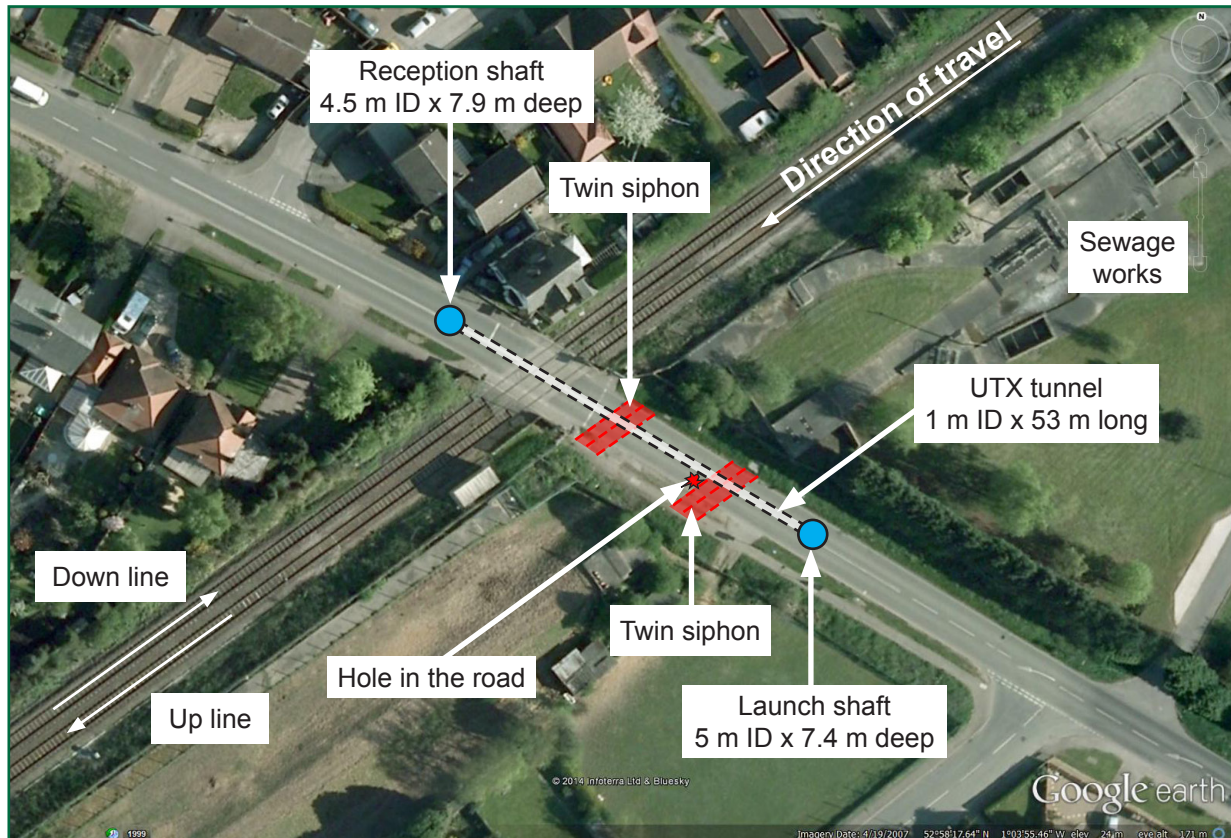
Figure 5: Google image of the level crossing, with microtunnel and construction shafts marked

- 11 At this location there is an *under track crossing* (UTX) which had been built under the road and railway, seven weeks prior to the derailment (figure 5). The UTX was built to carry six 132 kV electrical cables along Stoke Lane as part of a larger project to build and connect a new substation on the east side of Nottingham at Stoke Bardolph. The UTX comprises a *microtunnel* around 53 metres long with an internal diameter of 1 metre and an external diameter of 1.2 metres. The crown of the tunnel lies at a depth of around 5.7 metres below ground level.

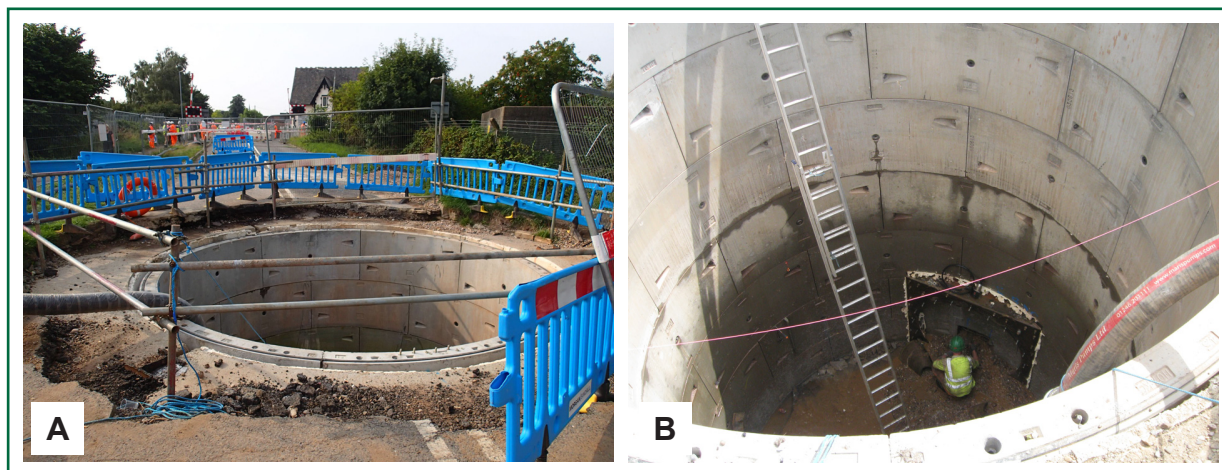
Figure 6: Launch shaft (a) and reception shaft (b) during the works (image courtesy of Morgan Sindall)

- 12 The microtunnel was bored by a *slurry shield tunnel boring machine* (TBM) (appendix D) and lined with 2.5 metre long concrete pipes (called *jacking pipes*), locked together end to end. In order to bore the microtunnel, two vertical shafts had to be built first. The launch shaft was built at the south eastern end of the tunnel and used to insert the TBM into position and then drive it and the jacking pipes forwards, along the path of the tunnel. At the north western end, the reception shaft was used to retrieve the TBM. These shafts (figure 6) are also the entry and exit points for the 132 kV electrical cables. A cross section along the centre line of the road showing the position of the microtunnel and shafts in relation to the railway is shown in figure 7.

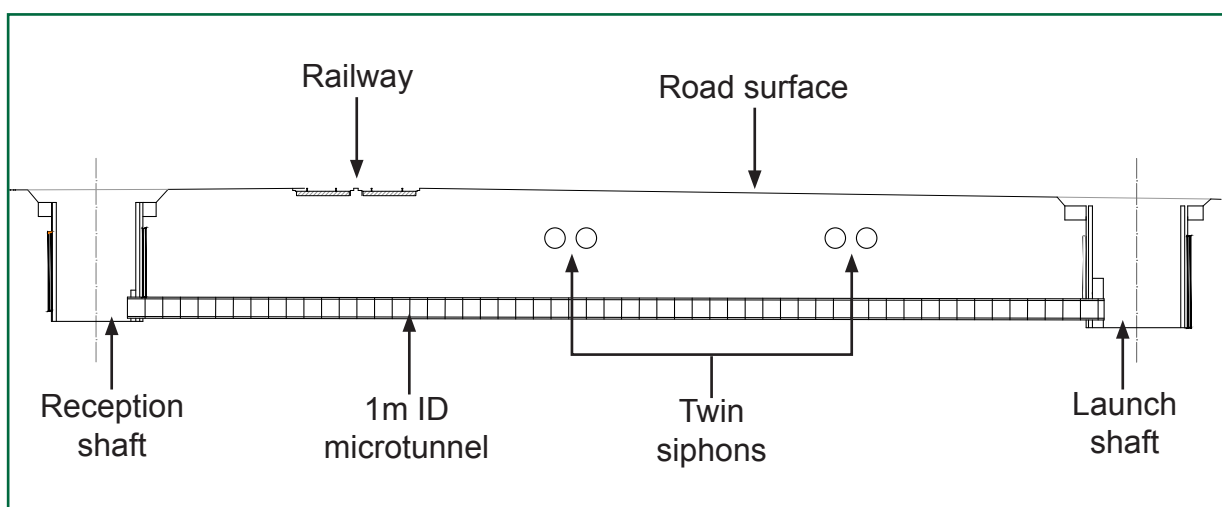
Figure 7: Schematic cross-section through microtunnel and construction shafts

- 13 Between the launch shaft and railway, two twin sewer siphons (figures 5 and 7) run across the road and parallel to the railway and carry sewerage from Nottingham into the Stoke Bardolph sewage works (figure 5). The twin siphons nearest the railway comprise two 1.2 metre diameter cast iron pipes located around 3 metres below ground level and date back to circa 1880. The twin siphons nearest the launch shaft are believed to be cast iron pipes of about 1.3 metres diameter each and encased in concrete. The two twin siphons have a combined flow capacity of around 6 m³/sec and their location was a factor in deciding the depth of the microtunnel.

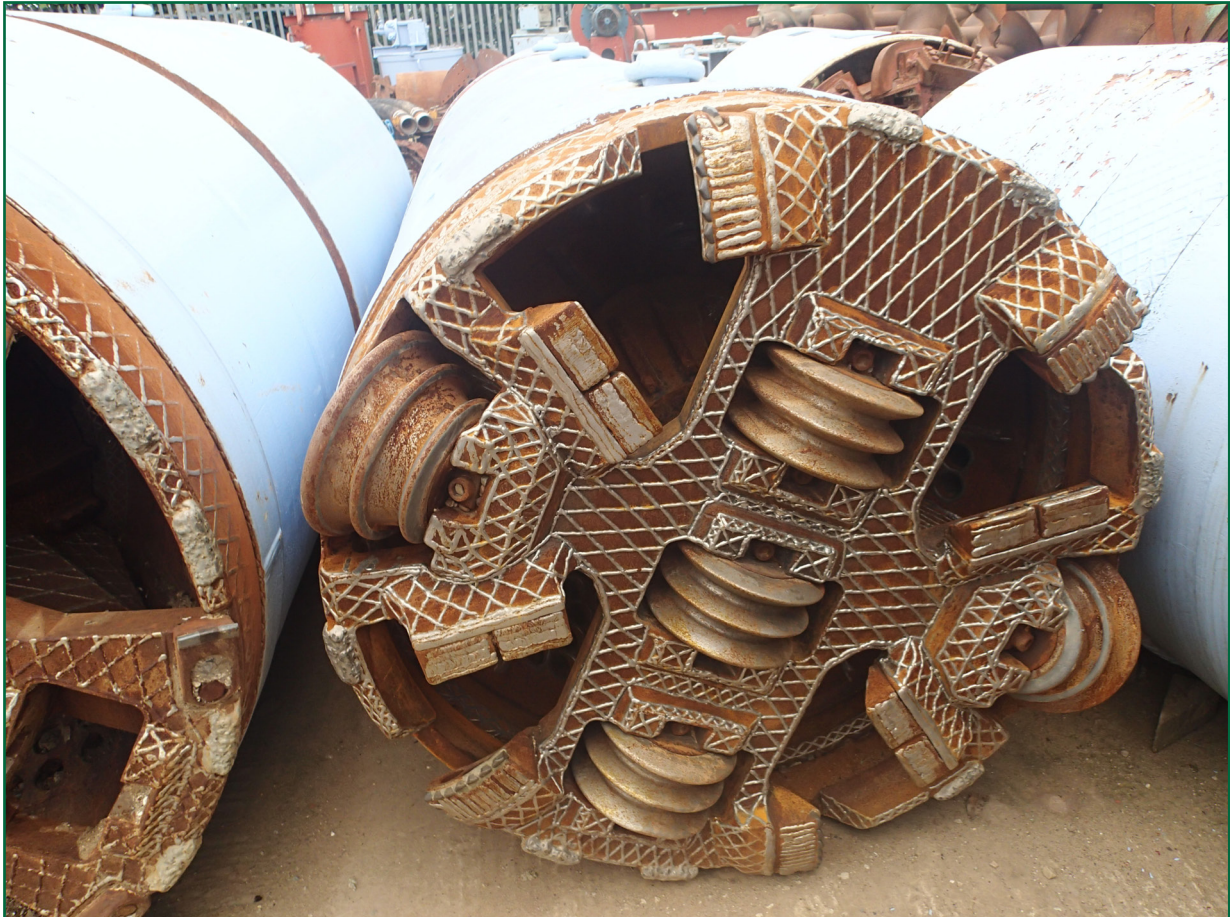
Figure 10: TBM cutter head

- 54 The UTX at Stoke Lane was bored using a slurry shield tunnel boring machine (TBM), described in appendix D. The minimum amount of material that must have been removed by the 1.25 metre diameter TBM cutter head (figure 10) to bore out a 53 metre long tunnel, is around 65 m³. The combined volume of the near surface and deep voids (shown in red and green in figure 9) was around 54 m³, which indicates there had been additional ground loss⁴ of around 80%. The RAIB was advised by its consultant that a typical upper bound value of ground loss for a tunnel of this type and size would be around 5%.

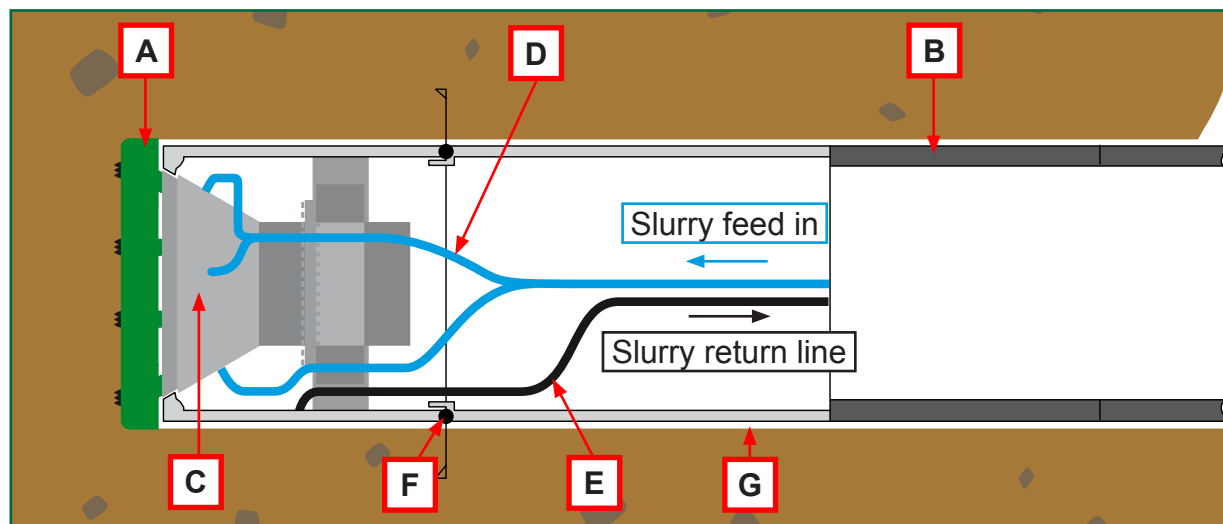
Figure D1: Schematic of a slurry shield TBM

The machine is remotely operated from a control cubicle at the surface. It works by cutting the ground with a rotating cutter head (A), which has rollers, scrapers and teeth, and which is pushed from behind by a series of concrete pipe sections (B). The pipes are pushed along the microtunnel by hydraulic jacks installed in the launch shaft. The process has to be paused periodically to insert a new pipe; at Stoke Lane this was every 2.5 metres. The cut ground falls into the excavation chamber (C) of the TBM. A crushing device (called a 'cone crusher') in the excavation chamber breaks up any large lumps as the cutter head rotates.

If the machine is being used in unstable ground such as wet sands and gravel below the water table, the excavated face must be supported while the TBM is operating, to prevent uncontrolled collapse of the ground into the excavation chamber, potentially leading to overmining. According to industry best practice this is achieved by feeding in a pressurised slurry (D), comprising water mixed with bentonite (or a polymer), into the excavation chamber. The pressure in the excavation chamber (called the face pressure) forces the slurry into the tunnel face in front of the cutter head, where it permeates into the ground, leaving a thin layer of bentonite (called a filter cake) on the surface of the ground. This layer of bentonite impregnated ground supports the areas of the tunnel face which are exposed as the cutter head (figure 10) rotates, while the slurry pressure counterbalances the ground water pressure. For excavation in some types of soil, such as clays, bentonite may not be required. In such cases the slurry may simply comprise water and a proportion of suspended clay material from the excavation face.

The cutter head diameter is slightly larger than the diameter of the main body of the TBM and the pipes and this results in an annular void space around the pipes (G) which, in accordance with industry best practice, should be filled with bentonite to prevent the ground closing in on the pipes.
