IAM REPORT No 648

A REVIEW OF ROYAL NAVY HELICOPTER ACCIDENTS
1972 - 1984

P. VYRNWY-JONES and J.C.D. TURNER

November 1989

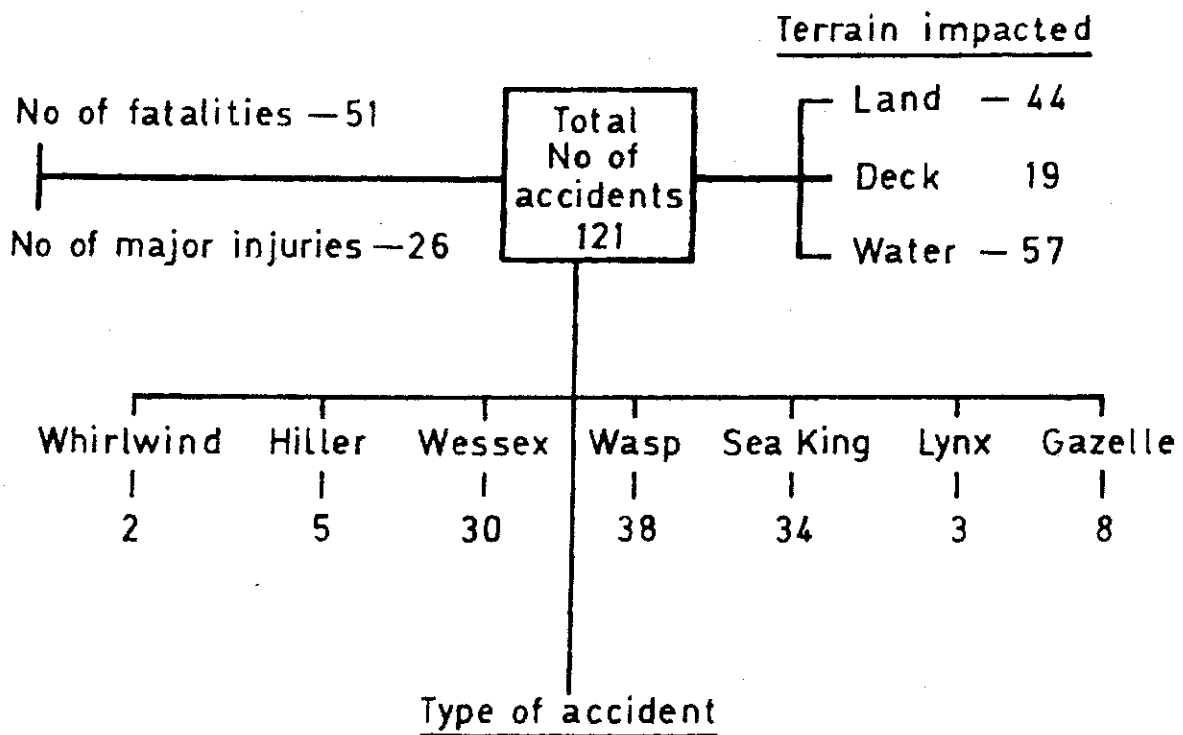
FIG 2 RN HELICOPTER ACCIDENTS 1972-1984

- Low severity - 75 accidents resulting in 1 fatality
- Significant severity - 35 accidents resulting in 26 major injuries, 26 fatalities
- Non survivable - 9 accidents resulting in 24 fatalities

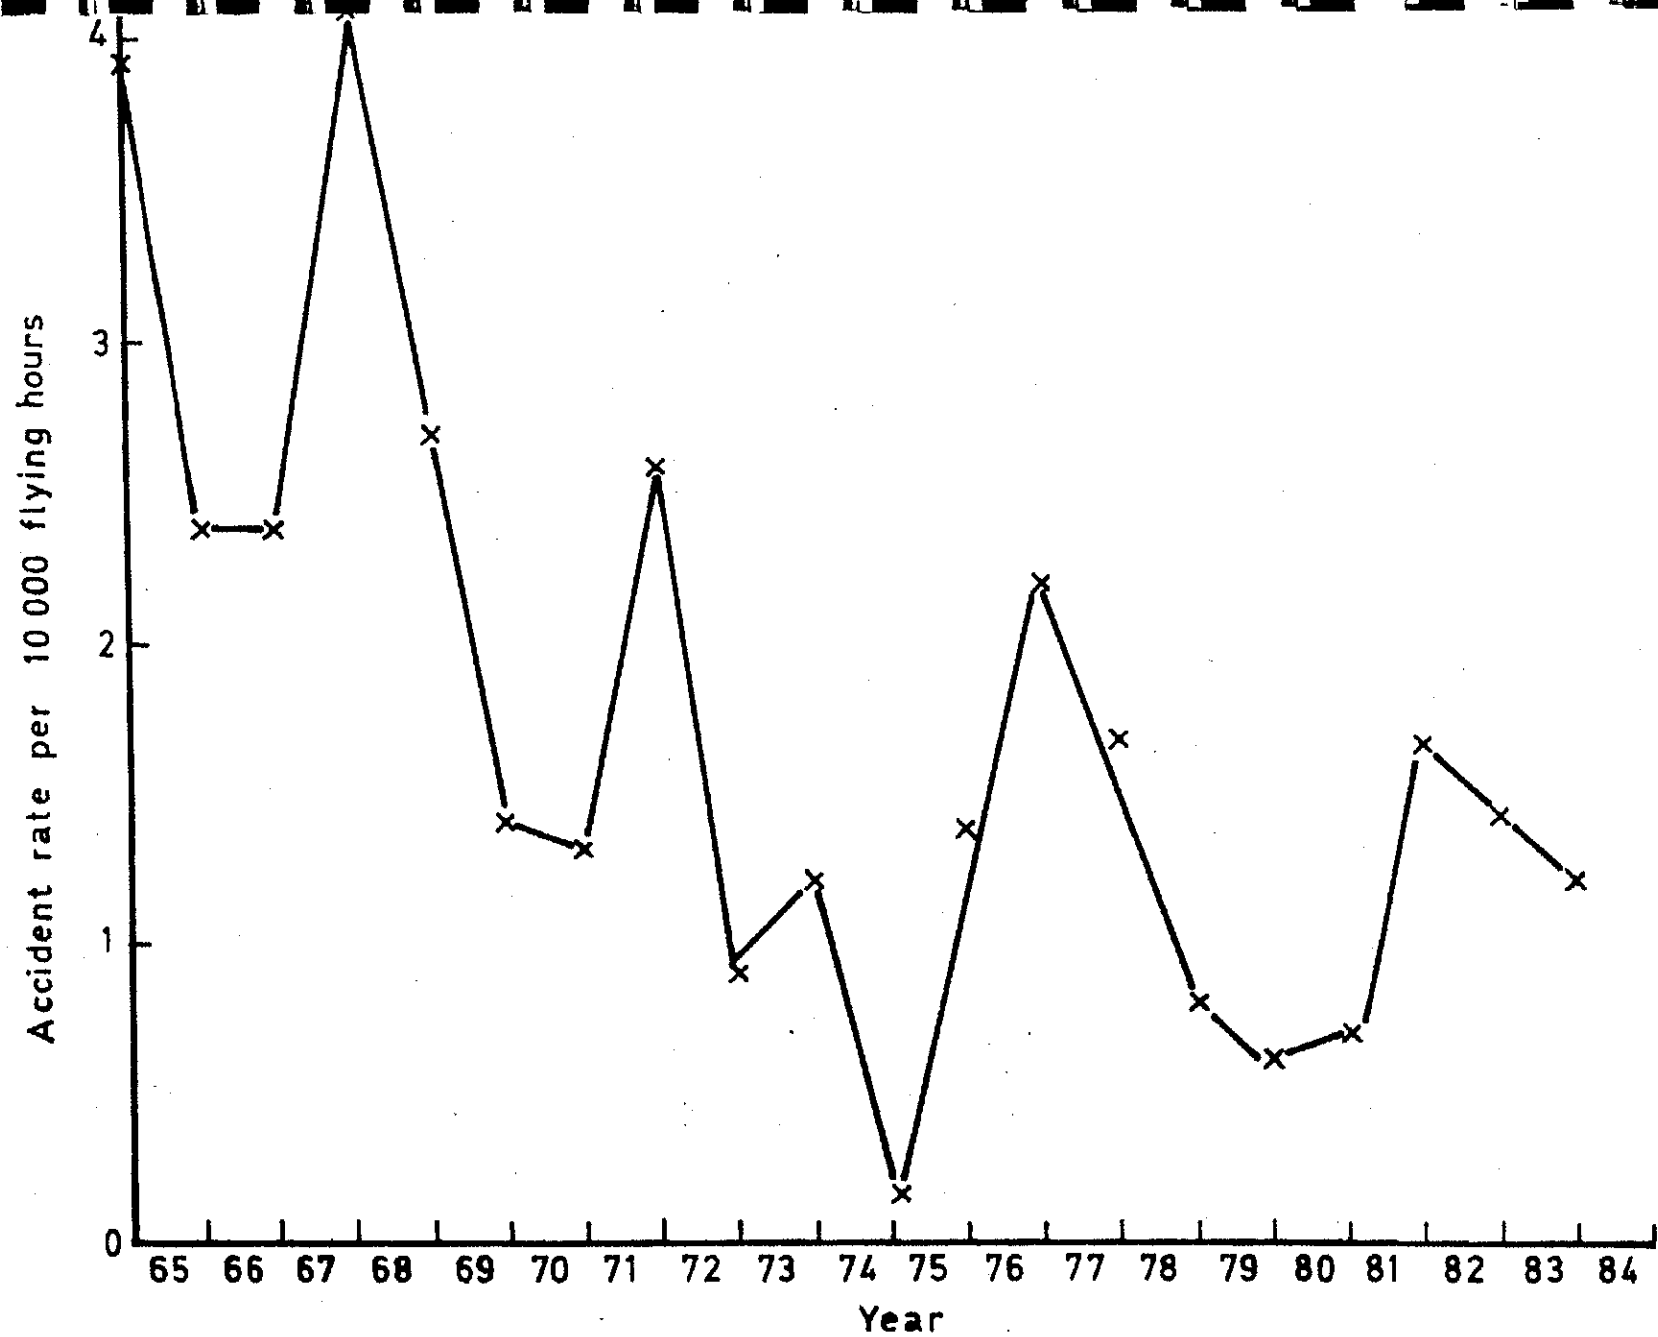
FIG 3 ROYAL NAVY HELICOPTER ACCIDENT RATES 1964 - 1984

Accident rates. The RN flies an average of 71,245 rotary-wing hours per year and during the course of the Falklands Campaign achieved far more than this. A graphical representation of accident rates from 1965-1983 is presented in Fig. 3. As can be seen, there has been a gradual decline, but this is not as clear cut as in the other two Services (Vyrnwy-Jones, 1984 and 1985). The high accident rate in the early years was associated with the operation of fairly primitive helicopters such as the Dragonfly (Fig. 1). The present generation of RN helicopters is considerably more sophisticated, for example the Sea King (Fig 4). The overall accident rate during the period of study averages 1.08 per 10,000 flying hours, though since 1980, this has declined to 0.6 per 10,000 flying hours.

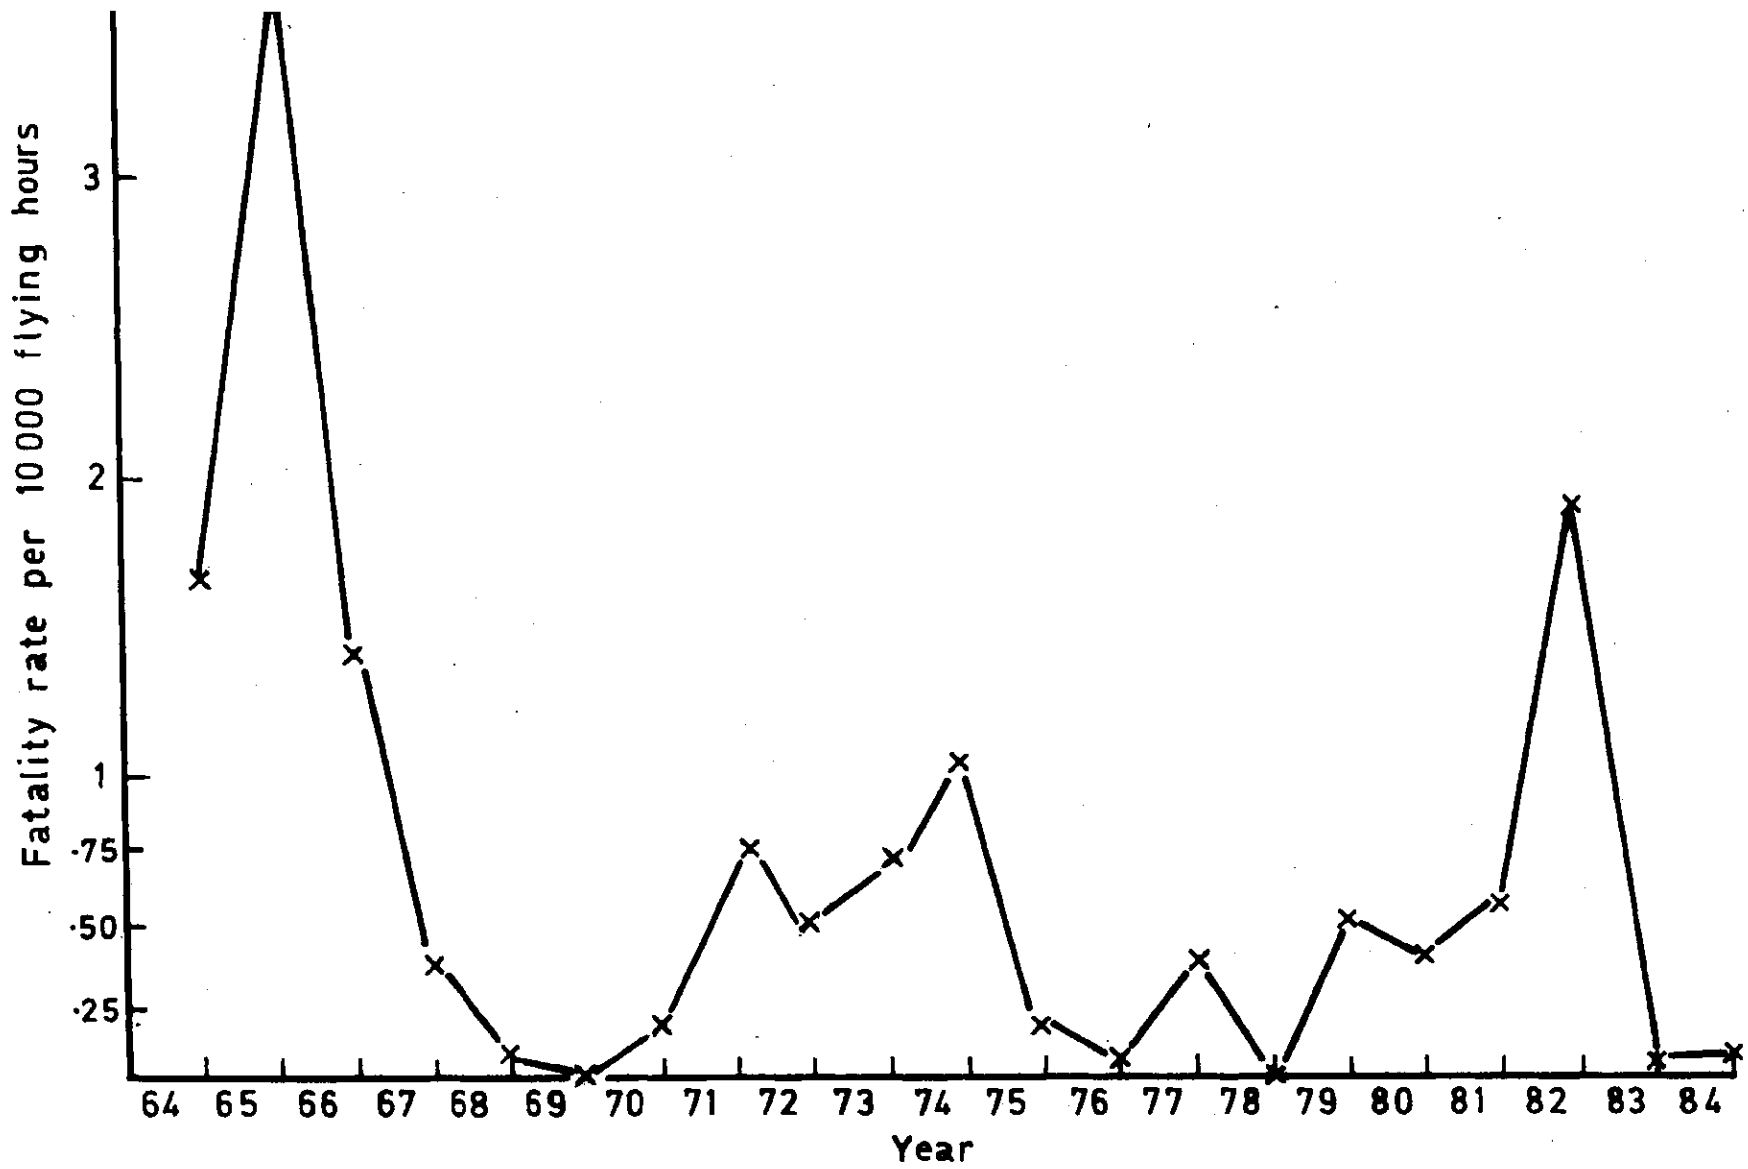
FIG 5 ROYAL NAVY HELICOPTER FATALITY RATES 1964-1984

Fatality rate. Fatality rates have been treated in exactly the same way as accident rates and the trend since 1965 is displayed graphically in Fig. 5. The sharp increase in the fatality rate in 1982 is due to the losses incurred during the Falklands Campaign. The overall fatality rate for the period studied is 0.57 per 10,000 flying hours. If the fatalities due to the Falklands Campaign are excluded, then the overall rate becomes 0.32 per 10,000 flying hours.

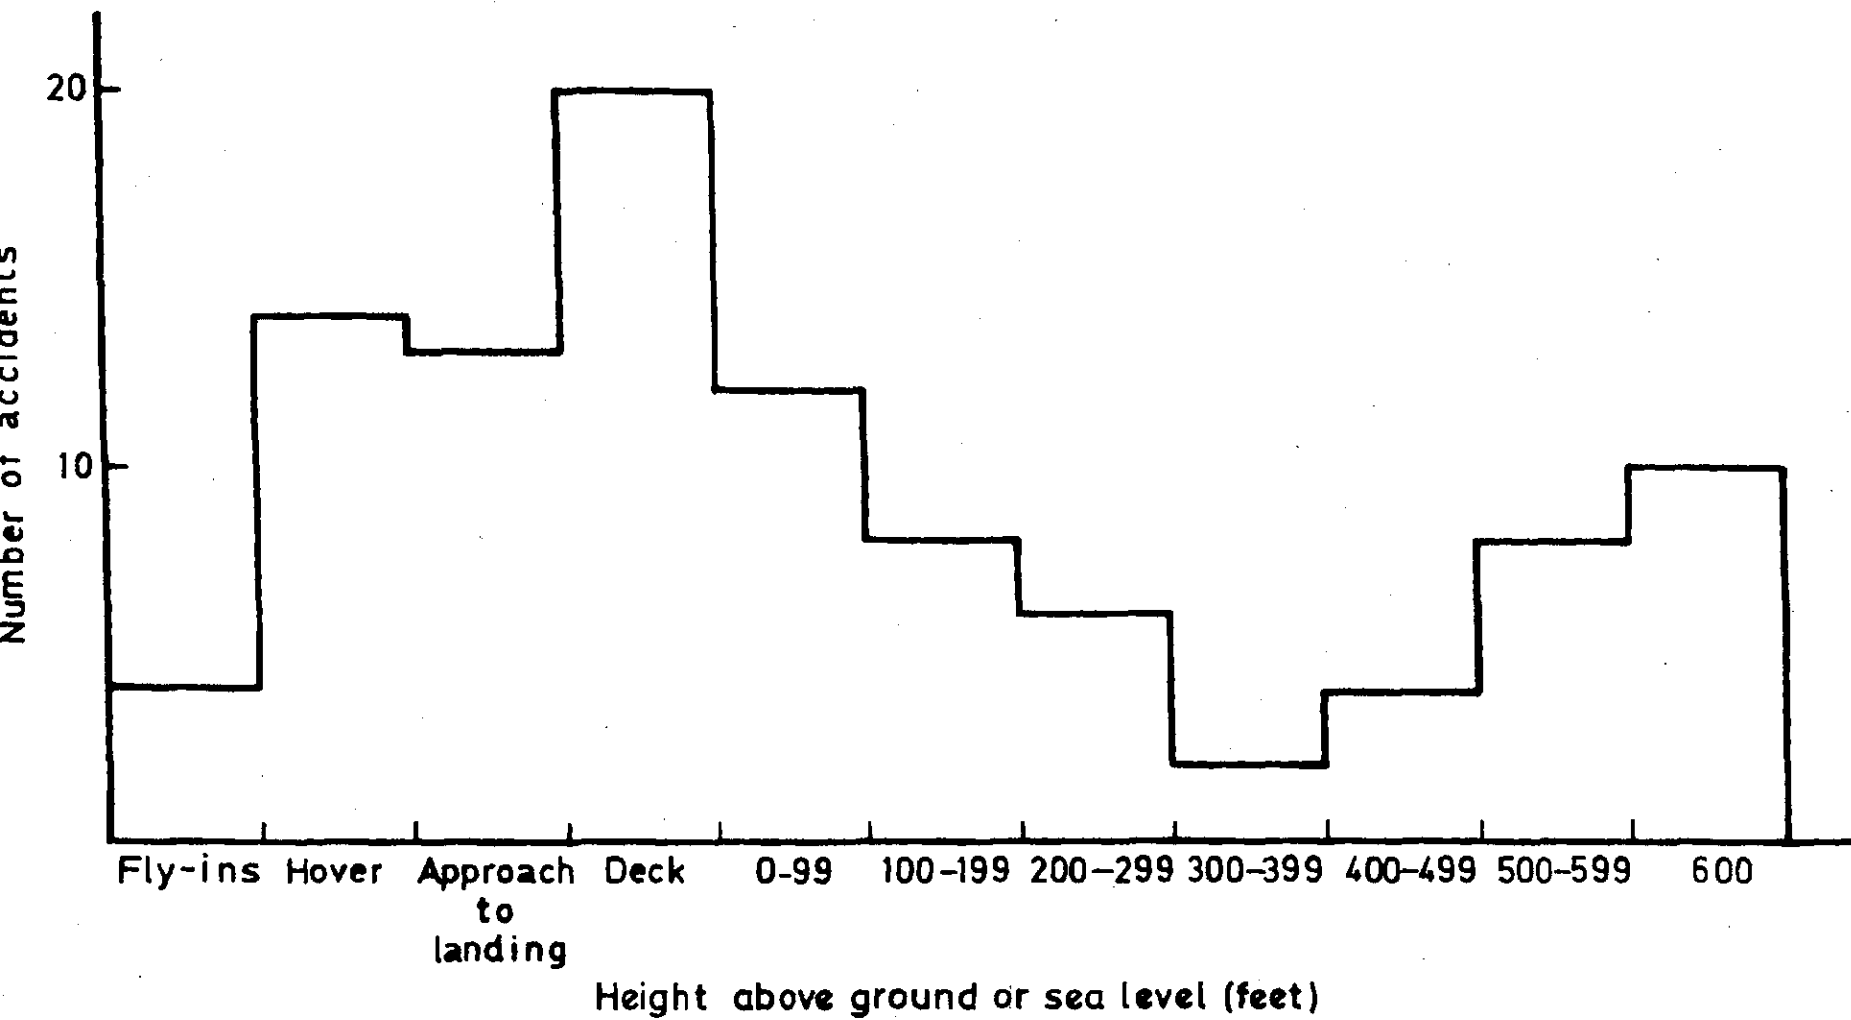
FIG 6 HEIGHT DISTRIBUTION OF ROYAL NAVAL HELICOPTER ACCIDENTS

Altitude Distribution. A height distribution of RN helicopter accidents is shown in Fig. 6; this indicates the height above ground, sea or treetop level at the time the emergency first occurred. Three further categories have been included. These are: accidents which occurred in the hover, approach to landing phase and during deck operations. Analysis of this information shows that 17.5% of the accidents occurred during deck operations, 18% occurred in the hover and 14% during the approach to landing phase. Another way to look at this is to observe that 83.3% of all emergencies occur below an altitude of 500ft and that 43.5% of all emergencies (resulting in accidents) take place in the hover, approach to landing or the deck phase of operations.

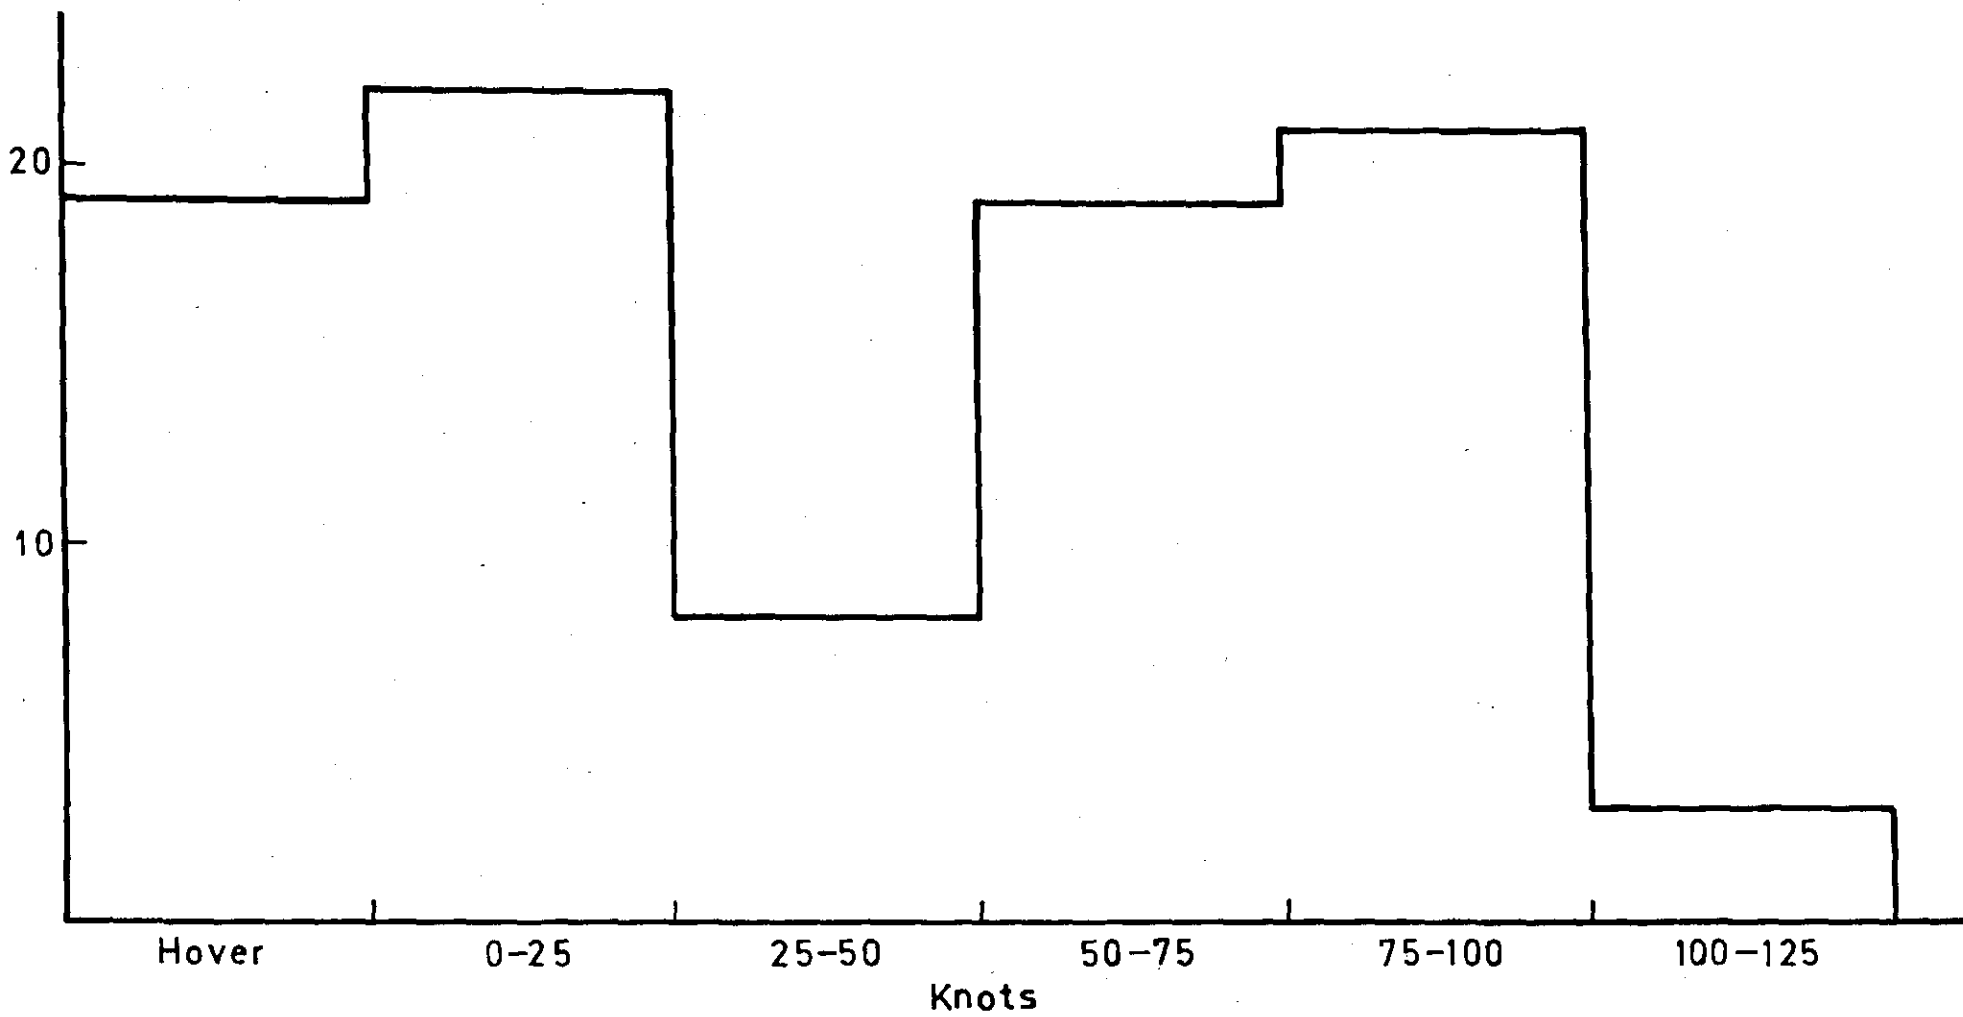
FIG 7 SPEED DISTRIBUTION OF ROYAL NAVAL HELICOPTER ACCIDENTS

Speed Distribution. This is displayed graphically in Fig. 7. Analysis reveals that 40.7% of all emergencies resulting in accidents occurred at speeds below 25 knots, and 18% of emergencies affected helicopters whilst in the hover over deck, sea or land.

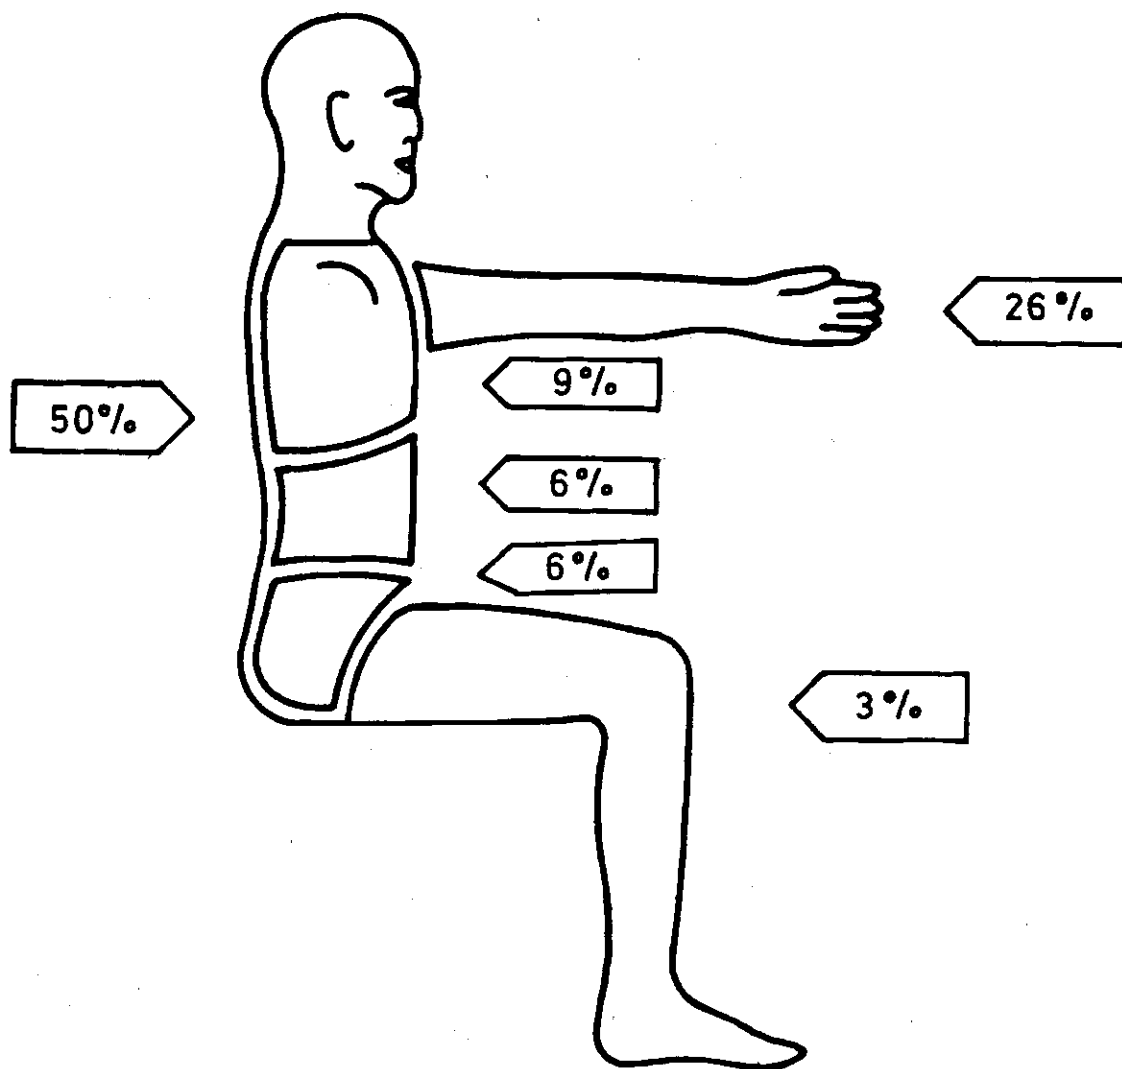
FIG 8 MAJOR INJURIES BY BODY PART (NOT RESULTING IN DEATH
RN HELICOPTER ACCIDENTS 1972-1984

From a total of 535 passengers and crew, 26 suffered major injury in RN helicopters during the period of this study. (Minor injuries have not been included due to a lack of recorded details). The major injuries are summarised in Fig. 8. As can be seen, spinal injury accounts for the largest proportion (50%). This substantiates evidence from Day (1972) where 34% of all major injuries were listed as being due to spinal compression fractures, Fig. 9. A high incidence of spinal compression fractures is to be expected in the maritime environment, where many of the accidents are due to heavy vertical impacts with the water surface. Under these conditions the undercarriage is unable to absorb the impact energy, which is then transmitted directly by the incompressible medium of water to the occupants via the aircraft fuselage and seating system. The spinal injuries are listed in Table 12, which also includes some data concerning the impact parameters involved.

The high incidence of spinal injuries in RN helicopters has already been discussed, this being due to the nature of water impacts where the normal energy absorbing characteristics of the undercarriage system is bypassed. The incidence of spinal injuries in US Army helicopters not equipped with crashworthy seats is shown in Fig. 10 (Hicks, 1982). As can be seen, there is a highly significant risk of spinal injury at vertical velocity changes greater than 22ft per sec and, of course, the deleterious effects of poor posture should also be taken into account. In contrast, Fig. 10 also shows the incidence of spinal injury as assessed from UH60 accidents where crashworthy seats were employed. These data are not, as yet, complete, but the clear indication is that there will be a dramatic reduction in the incidence of spinal compression fractures. The potential benefit from a crashworthy seating system in the maritime environment should be even greater, and should be immediately apparent even in the comparatively small fleet operated by the RN. Such seating systems could be extended to include passenger and crew members.
