AAIB Bulletin

6/2016

Bombardier DHC-8-402	G-FLBC	16-Dec-14	3
----------------------	--------	-----------	---

Aircraft Type and Registration:	Bombardier DHC-8-402, G-FLBC
No & Type of Engines:	2 Pratt & Whitney Canada PW150A turboprop engines
Year of Manufacture:	2009
Date & Time (UTC):	16 December 2014 at 1832 hrs
Location:	En route Glasgow to Belfast
Type of Flight:	Commercial Air Transport
Persons on Board:	Crew - 4 Passengers - 76
Injuries:	Crew - None Passengers - 1 (Minor)
Nature of Damage:	Damage to left engine and engine nacelle
Commander's Licence:	Airline Transport Pilot's Licence
Commander's Age:	36 years
Commander's Flying Experience:	7,847 hours (of which 6,820 were on type) Last 90 days - 185 hours Last 28 days - 59 hours
Information Source:	AAIB Field Investigation

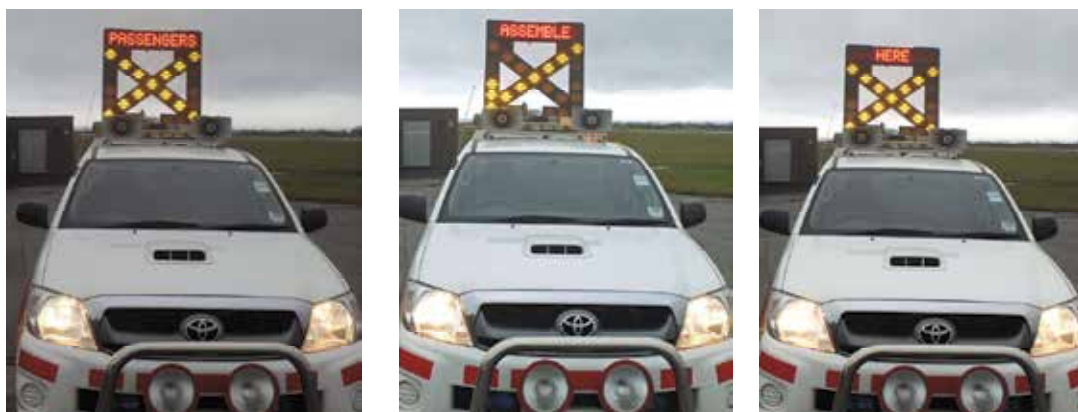
Figure 1

There was an airport vehicle on the runway with a large illuminated sign on its roof, which read: "PASSENGERS ASSEMBLE HERE" (see Figure 1). The same message was also broadcast through the vehicle's loudspeakers. Some of the passengers, particularly those who evacuated from the rear right exit, were confused as to where to go after leaving the aircraft. Most of the fire crew were on the left side of the aircraft, where the fire had been, and within a few minutes all of the passengers were safely on board airport buses, out of the rain. A head count was conducted and, initially, it appeared that a passenger was missing. This was quickly resolved, once it was realised that the positioning First Officer had remained with the crew.

Airport 'Assemble Here' vehicle

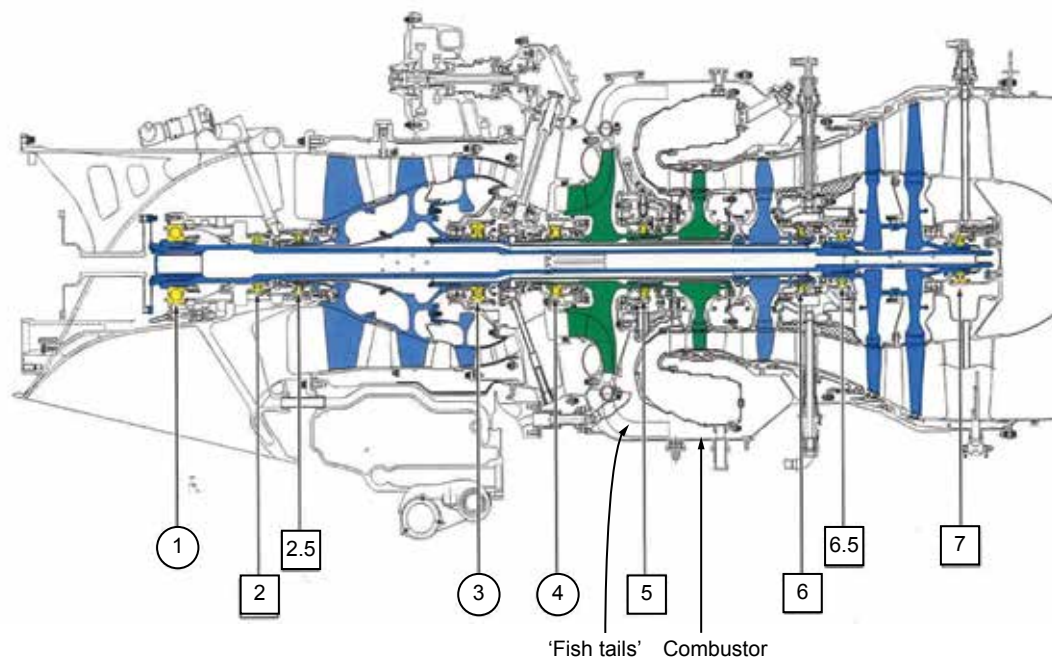
Figure 3

The forward end of the HP shaft is located longitudinally and radially by a ball bearing at the No 4 position, in front of the impellor. The aft end of the shaft is located radially by a roller bearing (No 5), positioned forward of the HP turbine and enclosed by the reverse flow combustor (see Figure 3).

A number of parts of the HP spool rotate in close proximity to fixed parts of the engine structure in the vicinity of the No 5 bearing. Their operating clearance is assured by the No 4 bearing, preventing forward movement of the HP spool.

Layout of bearings and combustor in turbo-machinery section
(reduction gearbox not shown)

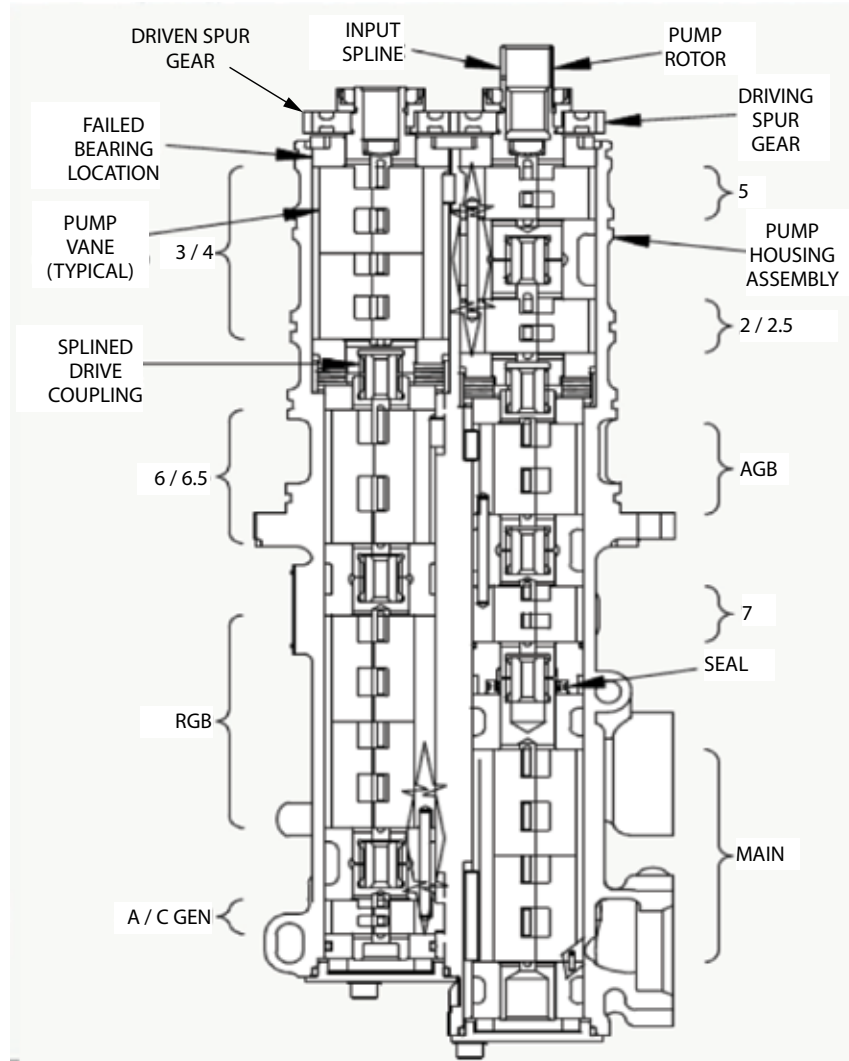
Figure 4

Lubrication is enabled by a vane pump assembly, incorporating a single pressure supply element and eight scavenge elements. The elements are arranged in two stacks, with the parallel axes orientated vertically and the individual elements joined by splined couplings (see Figure 4).

The assembly is driven by a shaft from the accessory gearbox which passes vertically into the 'driving' section and incorporates a shear neck. This driving section consists of the pressure supply element and four scavenge elements. A spur gear at the top of the driving section meshes with a similar spur gear at the top of the parallel 'driven' section. Four further scavenge elements are installed in the driven section of the unit. These include the scavenge pump for the RGB.

Layout of oil pump assembly

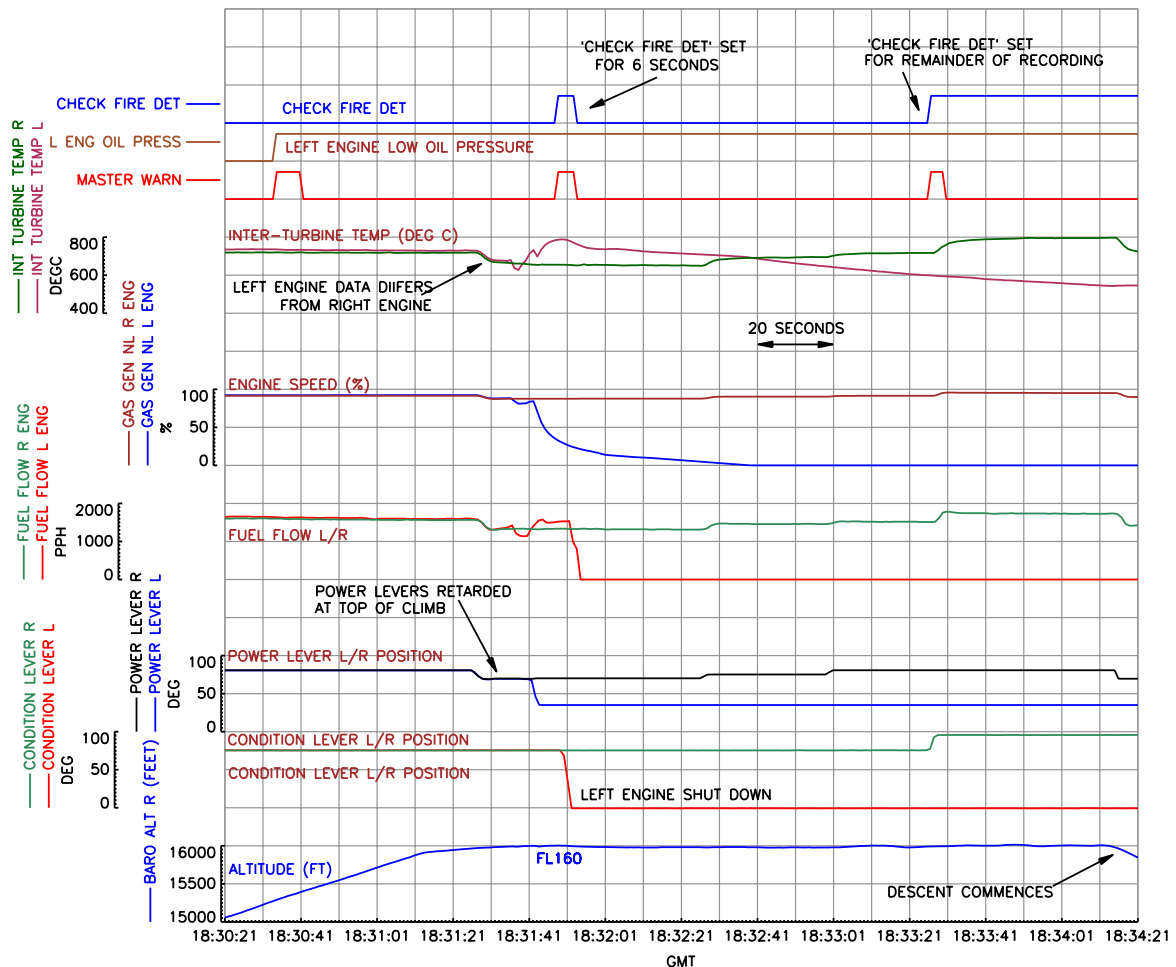
One second later, at 1830:35 hrs, the FDR recorded a MASTER WARNING and a left engine low oil pressure warning, which is triggered once oil pressure reduces below 44 psi. The EMU also recorded a *'main oil pressure exceedance flag'* which is triggered if the oil pressure is less than 45 psi. The CVR recorded the flight crew acknowledging this warning with the aircraft climbing towards its cruising altitude of FL160. Just after both engine power levers were retarded at the top of the climb, engine data started to differ between the left and right engines (see Figure 8). At 1831:36 hrs, the EMU recorded an *'engine flameout'* on the left engine. Thirteen seconds later, the FDR recorded a change of state in the CHECK FIRE DET light on the CWP, along with a MASTER WARNING. This was activated for five seconds, then cleared. The CVR recorded the flight crew acknowledging the warning, which occurred just after the left engine power lever had been retarded as part of the engine shutdown procedure.

Figure 8
FDR parameters

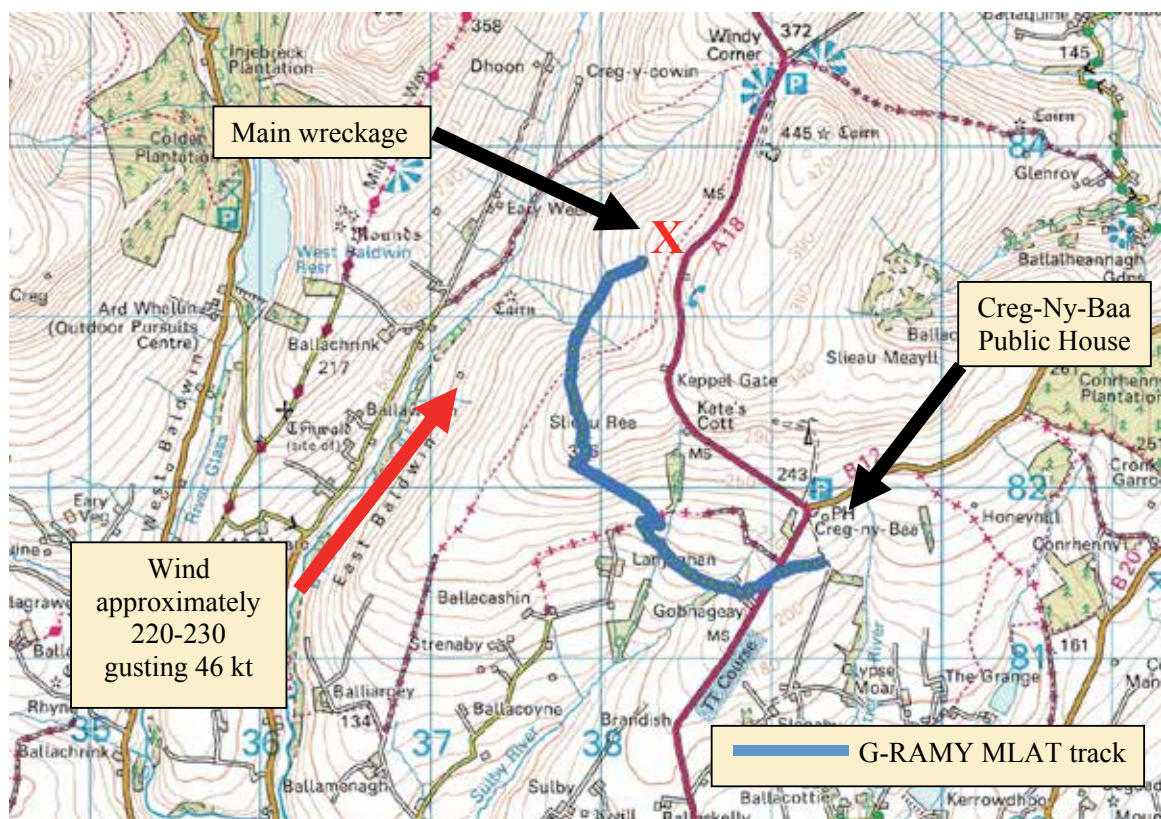
Figure 1

One eyewitness gave the most detailed account of the final moments of the flight. He was on his motorcycle driving south along the Mountain Road (A18), north of the accident site (Figure 1). He described seeing the helicopter flying relatively low towards him, at moderate speed, before the fuselage began to oscillate in roll, pendulously, through 'a few tens of degrees' each way. The fuselage then completely rotated in yaw beneath the rotor disc, more than once. The nose of the helicopter then pitched up into the rotor disc, being destroyed as it did so. Another witness described that *'[the helicopter] had a sudden change of direction that occurred in a split second'* just prior to its descent. Other witnesses' recollections differed in detail but were broadly similar. Witnesses estimated the height of the helicopter at between 100 and 300 ft agl prior to the described oscillations.

The accident location and recorded multilateration track

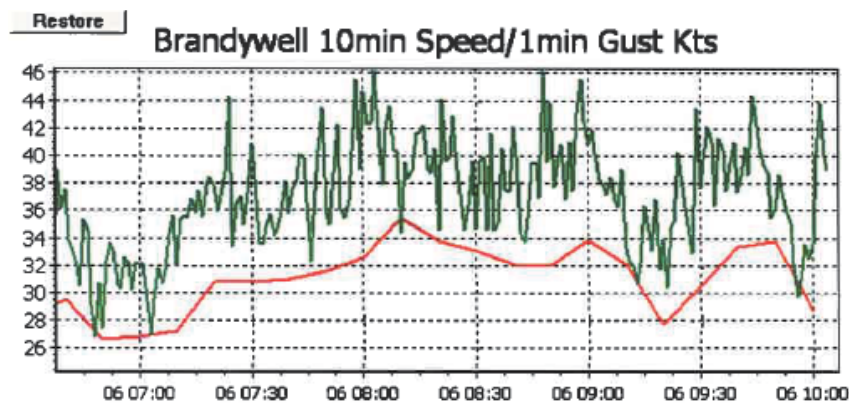
Figure 2

Data from two anemometer sites elsewhere on the Isle of Man was obtained, which showed stronger winds inland. At one site, Brandywell, 1.5 nm north-north-east of the accident site, the recorded wind direction remained relatively constant around the time of the accident, at around 220-230°, but the speed and gusts were more variable, with the highest gust, 46 kt, recorded at about the time of the accident (Figure 2).

Wind speed and gusts recorded at Brandywell
(timeline is 6 June 0630 hrs to 1010 hrs)

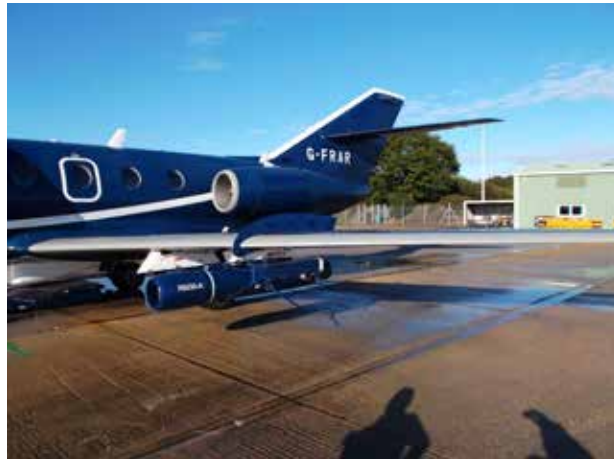
Figure 1

After the flight the TTO discovered that one end of the 10 m length of cable was lodged between the elevator and the horizontal tailplane, and that there was a loop in the cable that had snagged on the winch (Figures 1 to 4). The cable was removed from the gap between the elevator and the horizontal tailplane; this was a simple task and there was no evidence to suggest that the elevator had not been operating effectively during the incident.

Image of aircraft showing winch and tail plane

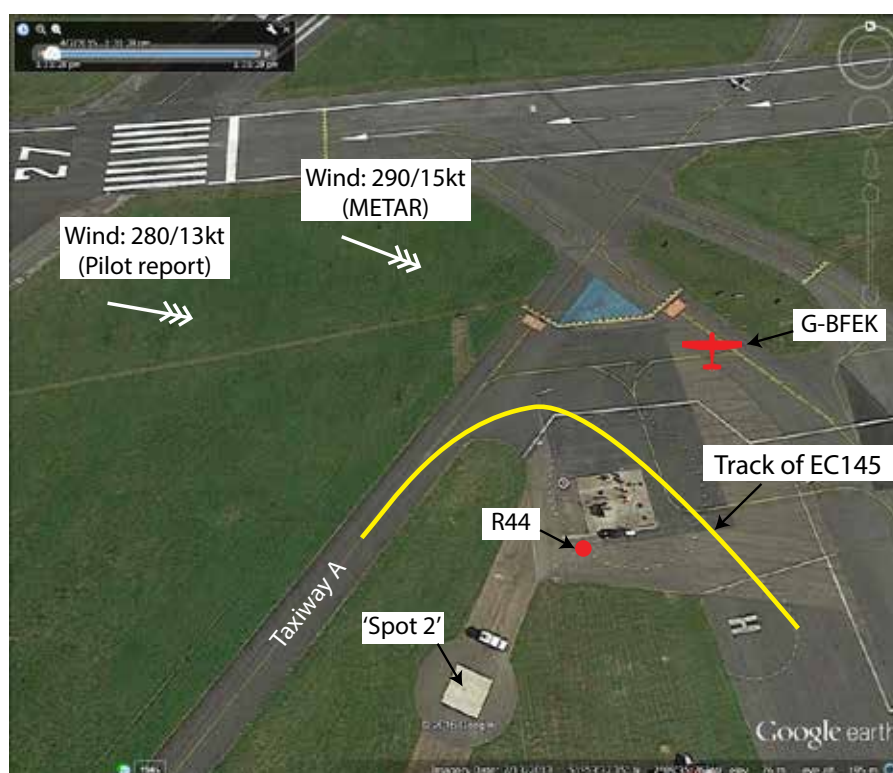
Figure 3

The approximate track of the EC145 is shown in Figure 3; this was based on an Internet-based Flight Tracking application. Whilst the accuracy cannot be guaranteed it accorded with the reports from all three pilots involved. From this it was concluded that the EC145 had, whilst hover taxiing, passed between two and three rotor diameters from G-BFEK. The Civil Aviation Authority (CAA) Safety Sense Leaflet 15, version C, notes that:

Satellite image showing approximate track of EC145 and positions of Cessna 152, G-BFEK, and the Robinson R44
