Rail Accident Report

**Derailment at Birmingham Snow Hill,
Midland Metro
29 January 2007**

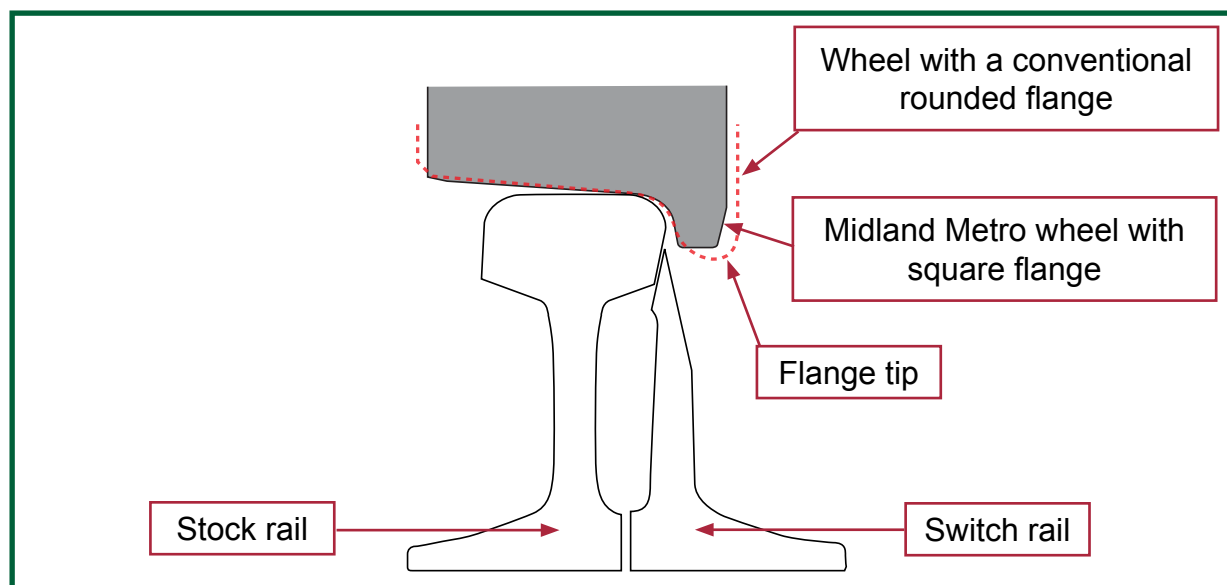
Figure 10: As-designed tram wheel and switch tip geometry

- 37 The as-designed switch rail is chamfered to a 'knife edge' and undercuts the stock rail at its tapered end to ensure that wheel contact occurs away from the switch tip. See Figure 10.
