Rail Accident Investigation Branch

Rail Accident Report

Collision between a train and a tractor at Oakwood Farm User Worked Crossing, Knaresborough 14 May 2015

Report 07/2016
April 2016

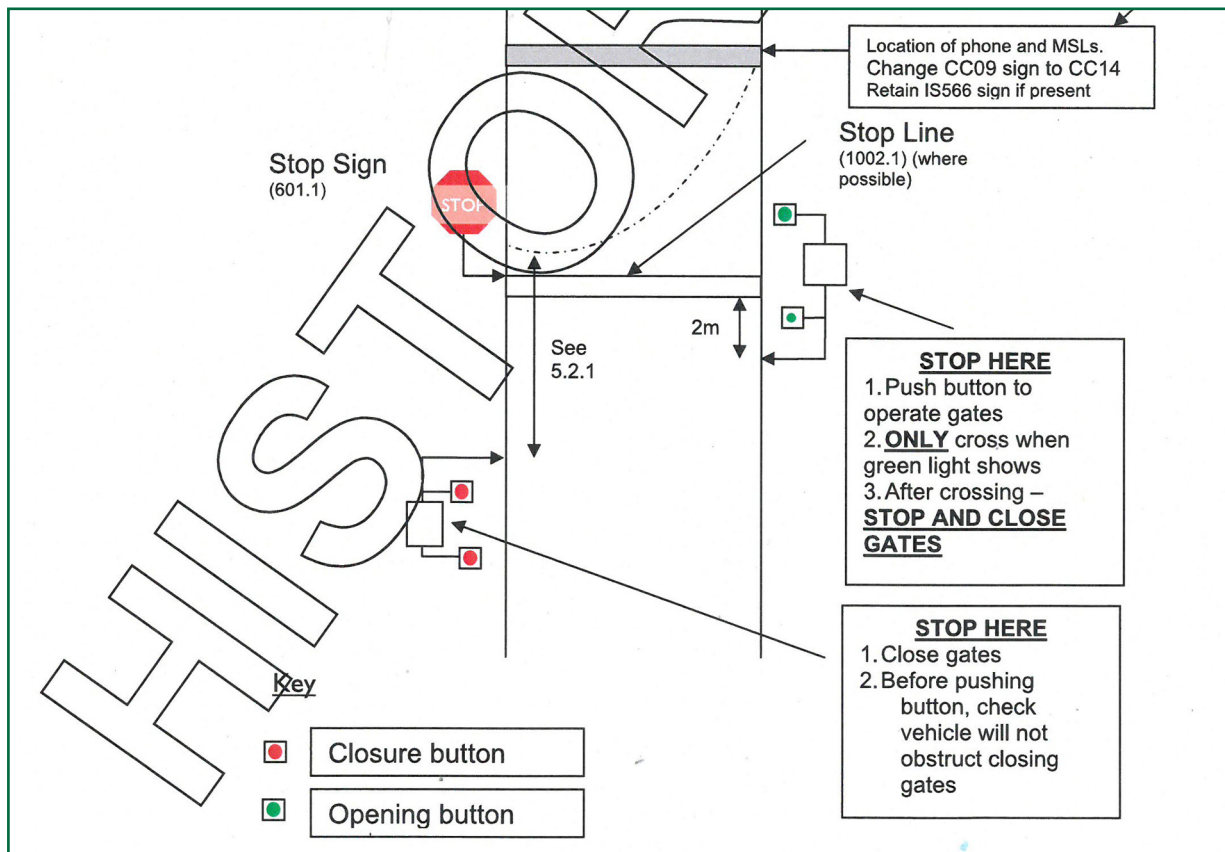
- 74 At the time of the accident, the POGO equipment was the second version that had been fitted for trials at Oakwood Farm UWC. For the first POGO trial, Network Rail created standard NR/L2/SIG/30039 in December 2009. Within this standard was a plan which showed a layout of a typical user worked crossing with MSLs, including the positions of the buttons (figure 12). Buttons located on the right-hand roadside posts (those closest to the gates) were specified as 'opening' buttons. Buttons on the left-hand roadside posts were specified as 'closure' buttons. These 'closure' buttons are located further away from the crossing to allow long vehicles and farm machinery to be clear of the gates when the button is pressed to close the gates. This configuration also allowed drivers of right-hand drive vehicles to reach the buttons without having to leave their vehicles.

Figure 12: Extract from superseded Network Rail standard NR/L2/SIG/30039, Issue 1, December 2009
