Rail Accident Investigation Branch

Rail Accident Report

**Near miss involving a track worker at Tinsley
Green Junction
17 March 2007**

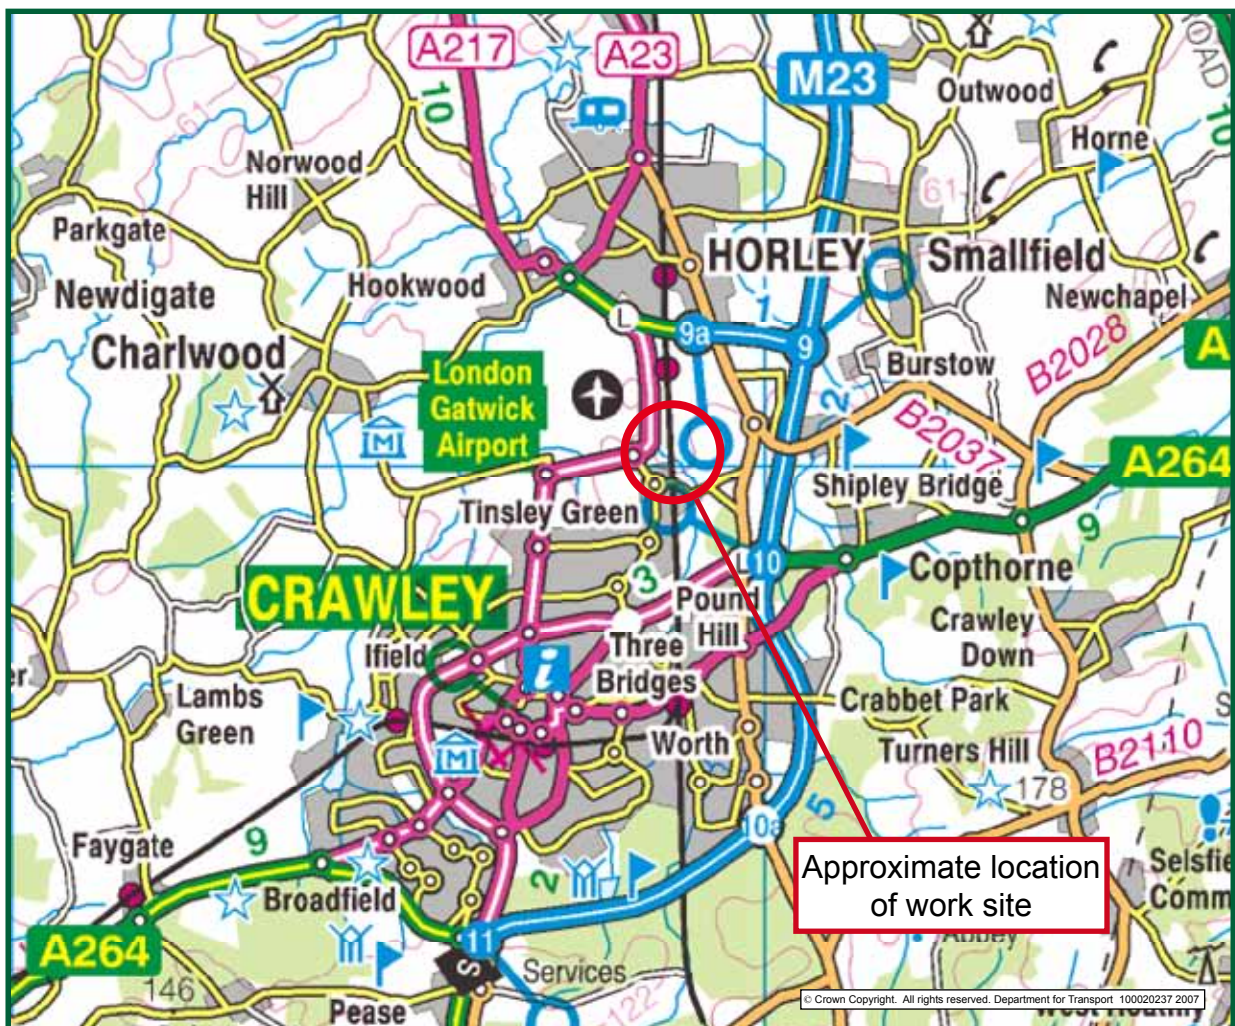
Figure 1: Location of accident

- 5 This incident occurred at 09:33 hrs on the morning of Saturday 17 March 2007, at Tinsley Green Junction, near Gatwick Airport (Figure 1). The driver of train 1M20, the 08:55 hrs Brighton to Watford Junction service, reported to the signaller that a member of track maintenance staff had dived clear of his train with only seconds to spare. The incident had occurred as train 1M20 was being routed from the *up* fast line towards the *up* platform loop via a series of high-speed *crossovers*.

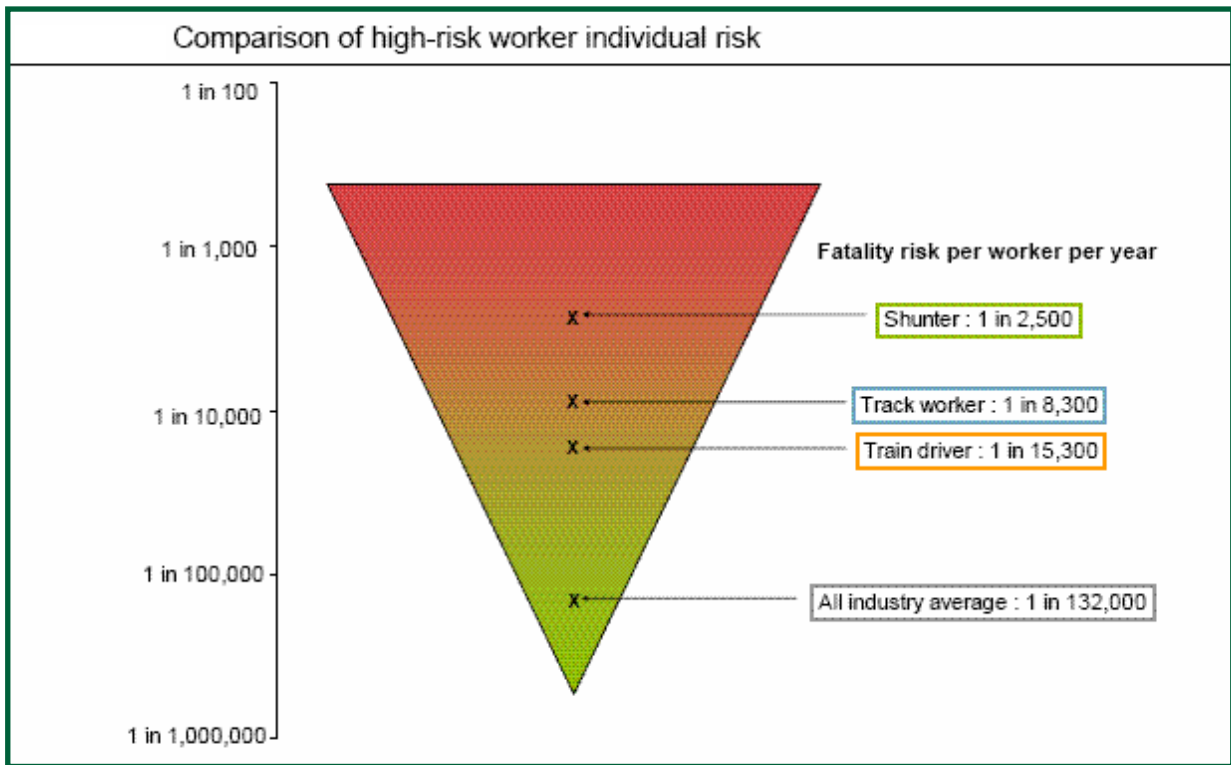
- 53 Track workers are subject to levels of risk well in excess of the average for all workers in the railway industry. The RSSB Annual Safety Performance Report (provisional) for 2006 concludes that the risk of fatality per track worker per year is 1 in 8,300 (see Figure 4). This compares to 1 in 15,300 for train drivers and 1 in 132,000 average for all workers in the industry.

Figure 4: Levels of individual risk (extract from RSSB Annual Safety Performance report)

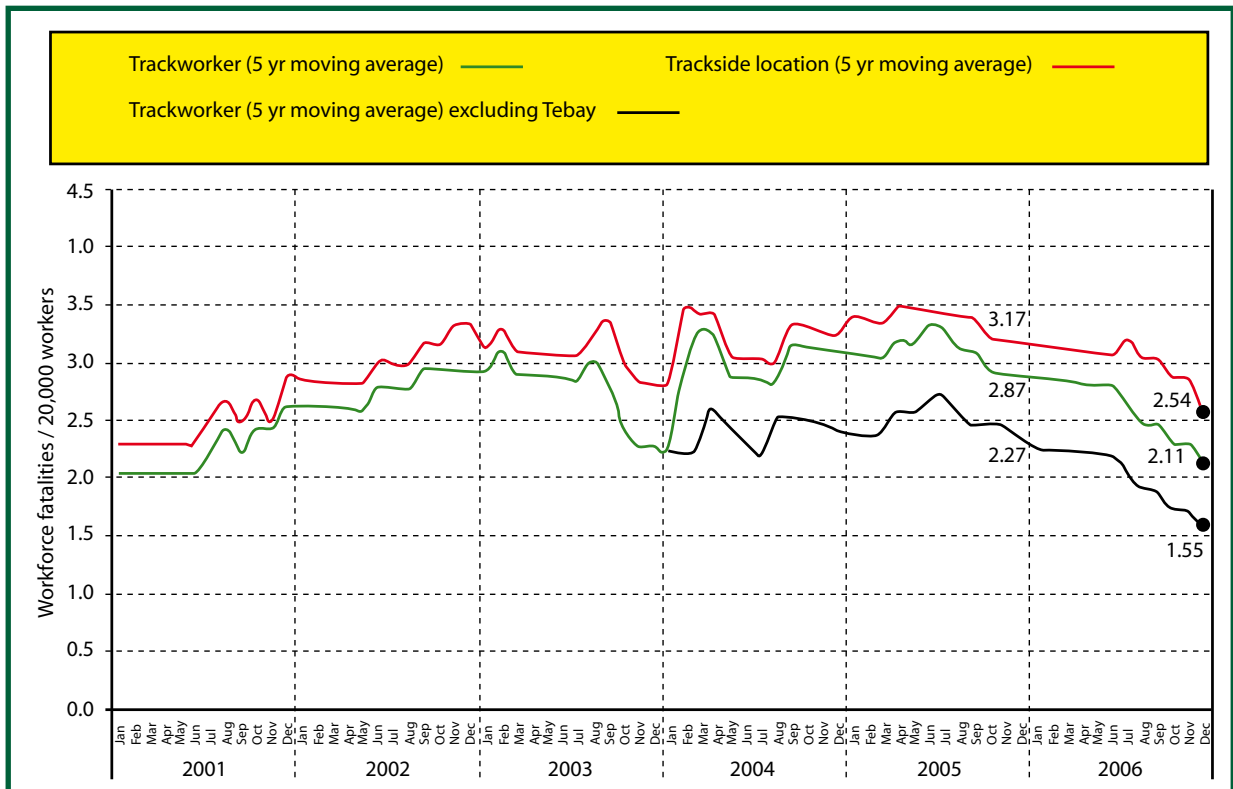
- 54 Statistics provided by the RSSB show that the 5-year moving average track worker fatality rate (normalised by staff numbers) for 2006 was roughly similar to that in 2001 (see Figure 5). However, this average was influenced by the four fatalities that occurred in 2004 as a direct consequence of a criminal act at Tebay. If the impact of this single event is excluded from the data, the track worker fatality rate is calculated to have fallen by 25 percent between 2001 and 2006.

Figure 5: Track worker fatality rates normalised by staff numbers (data provided by RSSB)
