Rail Accident Investigation Branch

# Rail Accident Report

## Fatal accident at Frampton level crossing 11 May 2014

Report 05/2015  
May 2015

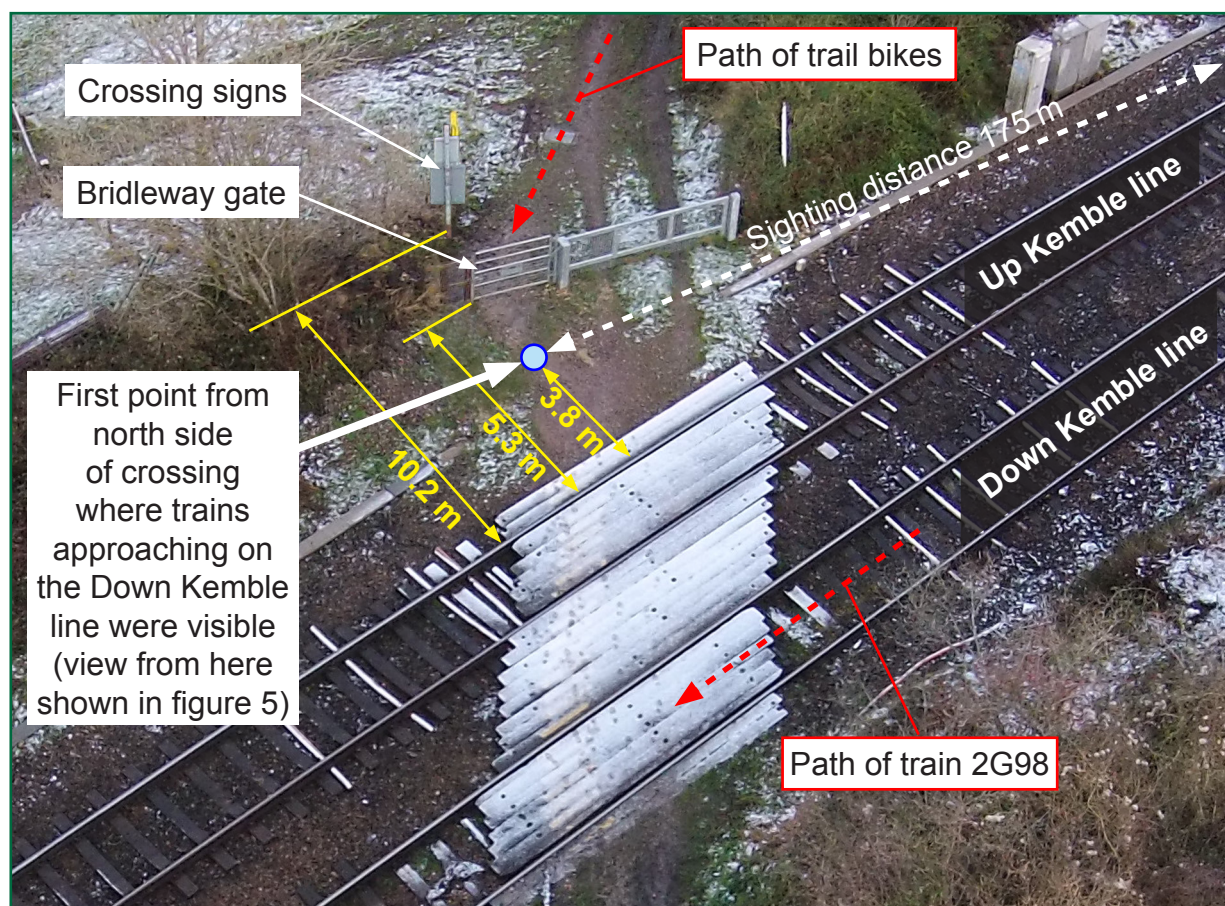
- 10 People approaching the crossing from the north side, the side from which the three riders approached, passed through a crossing gate. At the time of the accident, vegetation growth meant that they then had to reach a position about 3.8 metres from the nearest rail of the Up Kemble line, before they could see trains approaching from the Swindon direction along the Down Kemble line (figures 4 and 5). Because of the track curvature, their *sighting distance* for these trains (the distance to the first point where they could see them) was 175 metres, and their *warning time* (the time taken for a train to travel this distance at the maximum permitted speed) was about 8 seconds.

Figure 4: North side of crossing (January 2015 photograph altered to show crossing signs at the time of the accident)

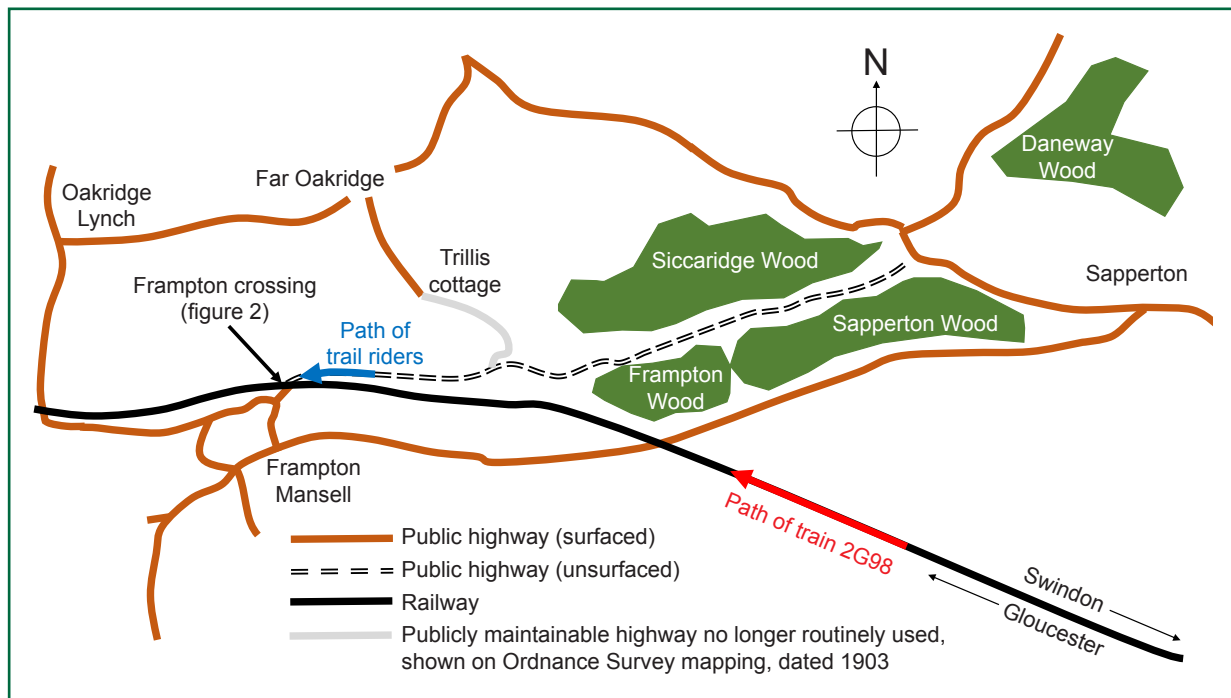
- 14 The northern approach to Frampton level crossing comprises an unsurfaced track leading from a minor road near the village of Sapperton (figure 7). The southern approach comprises a partly surfaced track leading from a minor road near the village of Frampton Mansell (figure 7). Both approaches are shown as a 'highway maintainable at public expense' on Gloucestershire County Council's *Highway Record*. Except where legal restrictions have been imposed, the public are generally entitled to use highways shown on this record for the purpose of passing and repassing on foot, on horseback, with animals or with vehicles. Gloucestershire County Council has stated that it is not aware of any legal restrictions applying to the Frampton level crossing approaches.

Figure 7: Frampton crossing context

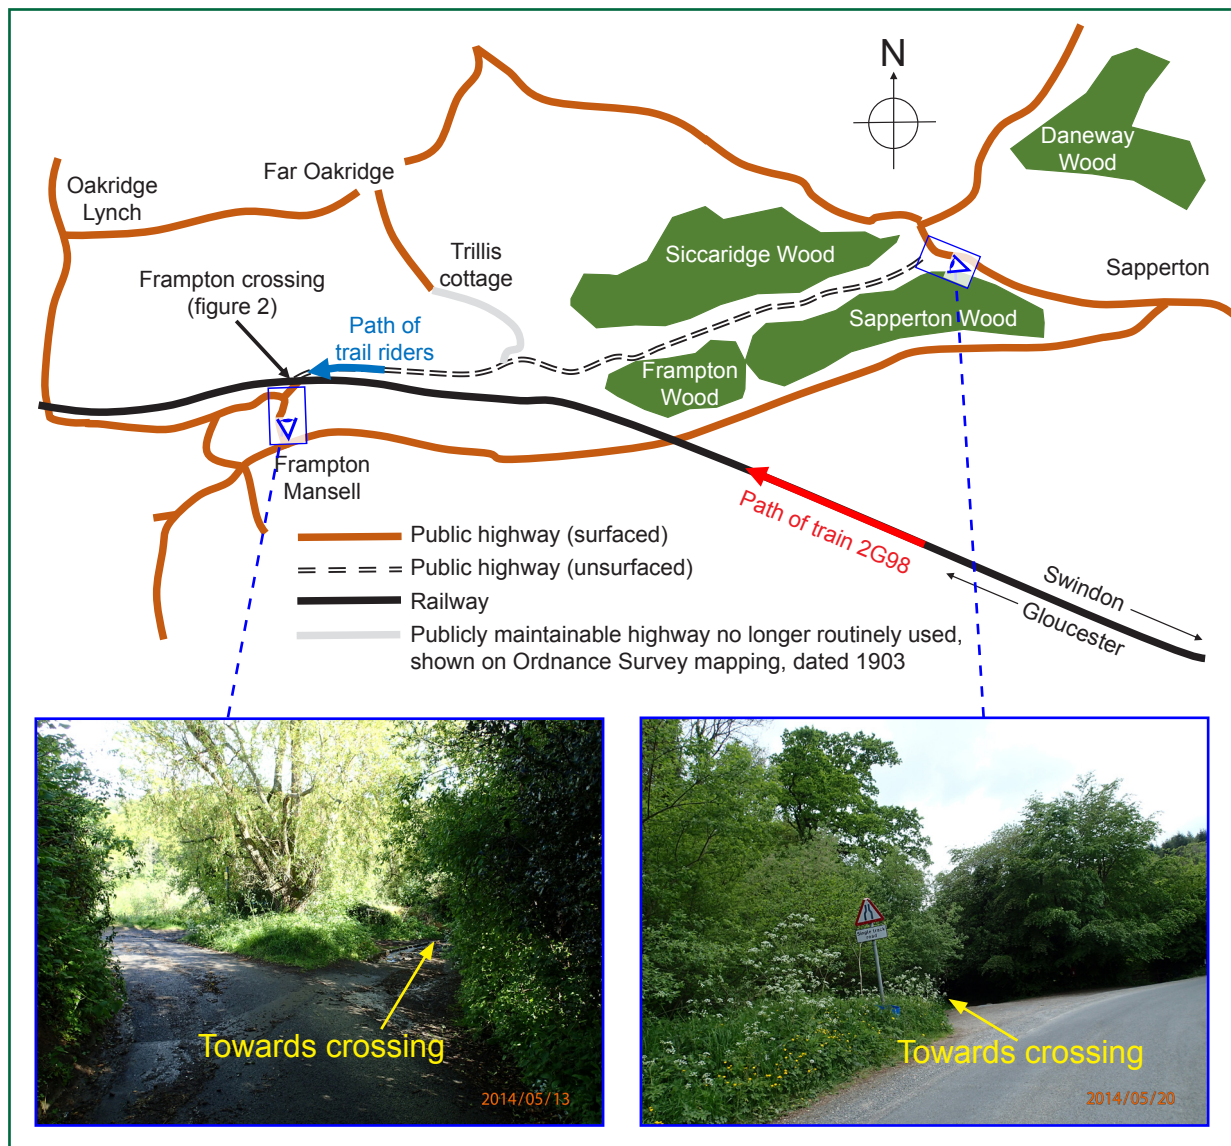
- 82 The route over the level crossing could be accessed from the village of Frampton Mansell, or from the road that leads out of Sapperton village (paragraph 14). There were no road signs on either approach to indicate that the general public were not permitted to take vehicles over the level crossing (figure 11).

Figure 11: Highways leading to Frampton level crossing

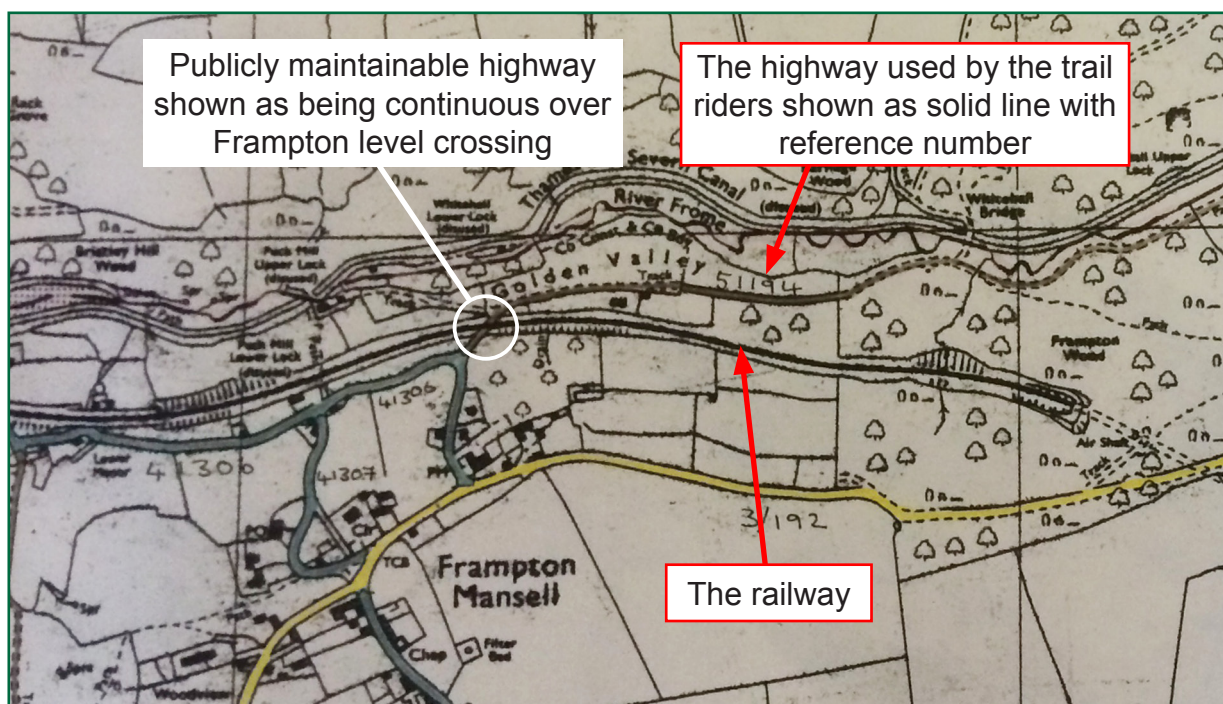
- 84 Publicly available mapping from Gloucestershire County Council and the Ordnance Survey, implied that public vehicles could cross over the railway using Frampton level crossing. Members of the public could view the Highway Record at the County Council's offices in Gloucester and this showed a highway, maintainable at public expense, running continuously across the railway (figure 12). A person seeking further information from the council about the status of this highway, would have been told that there were no known legal restrictions on its use by vehicles (paragraph 14), but that, as the highway was in the lowest maintenance category, the surface of it may be uneven and unsuitable for certain types of vehicle.

Figure 12: Extract from Gloucestershire County Council's Highway Record

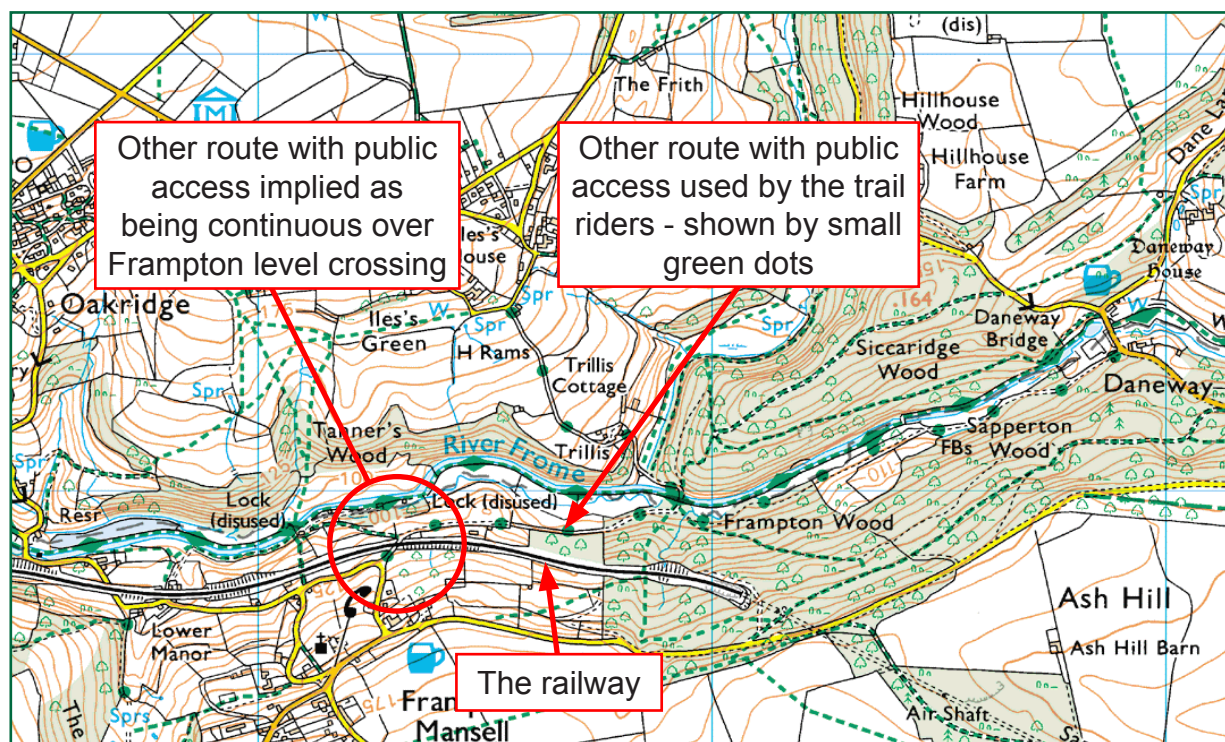
85 Ordnance Survey mapping showed the route as an 'other route with public access' (figure 13). The route is implied as running continuously over the railway. Readers of these maps are informed that the exact nature of this type of route, and the existence of any restrictions, may be checked with the local highway authority. A post-accident enquiry by the RAIB to Gloucestershire County Council (the local highway authority), showed that reference to their records would have provided the information given in the previous paragraph.

Figure 13: Ordnance survey map (scale 1:25,000) indicating 'other route with public access' (indicated by small green dots)
