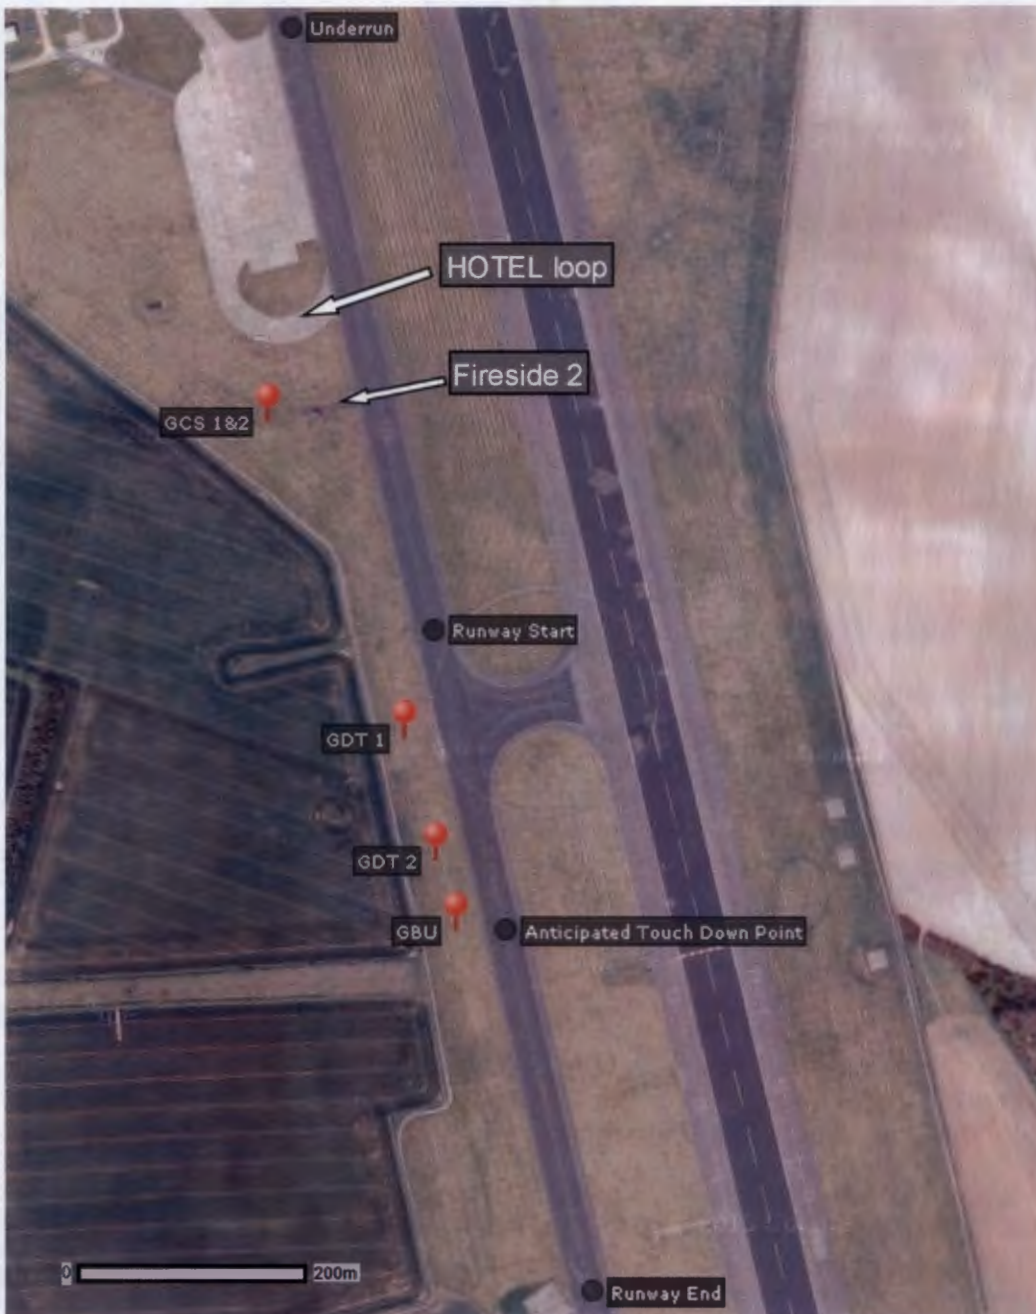
Figure 13 - Overview of Fireside 2 and Hotel Loop

- c. The BDN SOPs stated that the '*WK L&R hold point for a 17W recovery is HOTEL loop*'. The Panel was unable to find a clear written definition of *Hotel loop* but noted its position to be adjacent to the landing strip between the underrun and the defined runway start, as shown in Figure 13.

e. On 2 Nov 15, 3 visitors were observing WK operations and were in the vicinity of the runway when WK006 crashed. The AO stated that he escorted the visitors to 'Fireside 2' (shown in Figure 13) to observe the landing, which was approximately 50 metres closer to the touchdown point than the point taken to be *Hotel Loop* (the documented holding point for personnel during L&R operations).

1.4.2.53. **Recommendation. The Panel recommends that Head Unmanned Air Systems Team ensures sufficient detail is included in the Aircraft Document Set to allow the Delivery Duty Holder to define appropriate safety distances for WK Launch and Recovery operations.**
