Rail Accident Investigation Branch

Rail Accident Report

**Passenger trapped and dragged by a train at
Hayes & Harlington station
25 July 2015**

Report 12/2016
June 2016

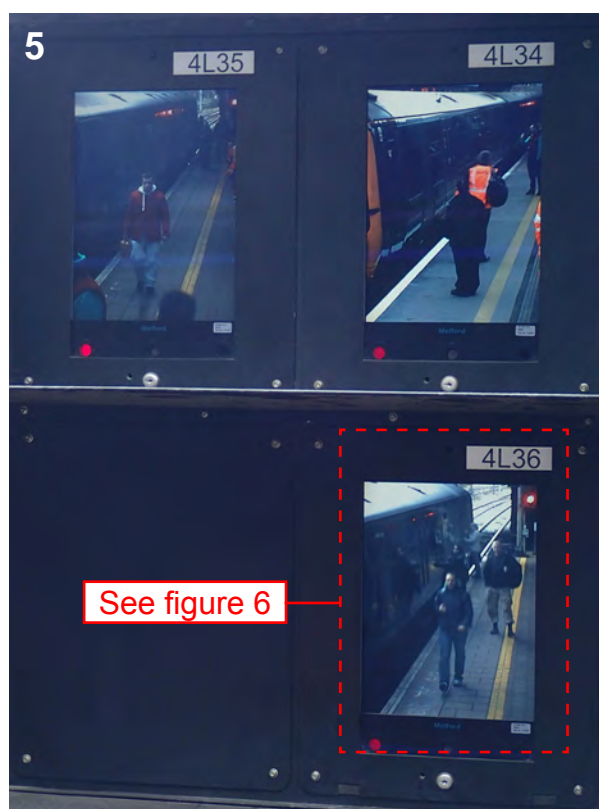
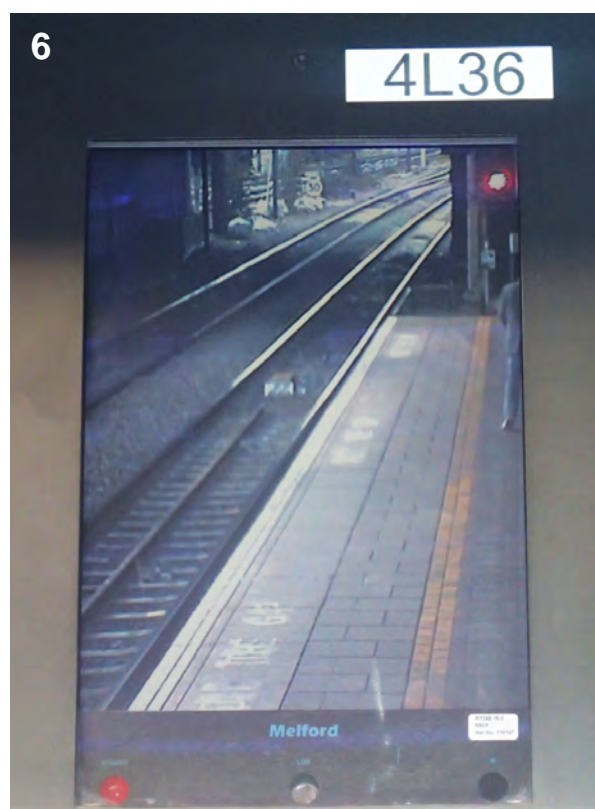
Figures 5 and 6: CCTV at the three-car stopping position on platform 4

- For all trains calling at Hayes & Harlington station, drivers are responsible for door operation and train dispatch (this method of working is commonly known as 'Driver Only Operation' (DOO)).
- Closed Circuit Television (CCTV) monitors on platform 4 (figures 5, 6 and 7) are provided to assist drivers to dispatch the train. The three screens are located within a shrouded cover and provide train drivers with a colour view of the side of the train and all the passenger doorways.

- that the CCTV monitor(s) are displaying the correct images; and
 - the quality and contrast of the displayed picture(s).
- 64 The most recent Network Rail assessment was completed five days before the accident on 20 July 2015. No defects were identified, the DOO monitors were cleaned, and the CCTV camera angles were checked.

- 65 Analysis of the platform CCTV shows the train had stopped at the correct position (3 car marker point). No defects were reported by any driver on the day of the accident, and therefore the RAIB consider the quality of the images was unlikely to have been a factor in this accident.

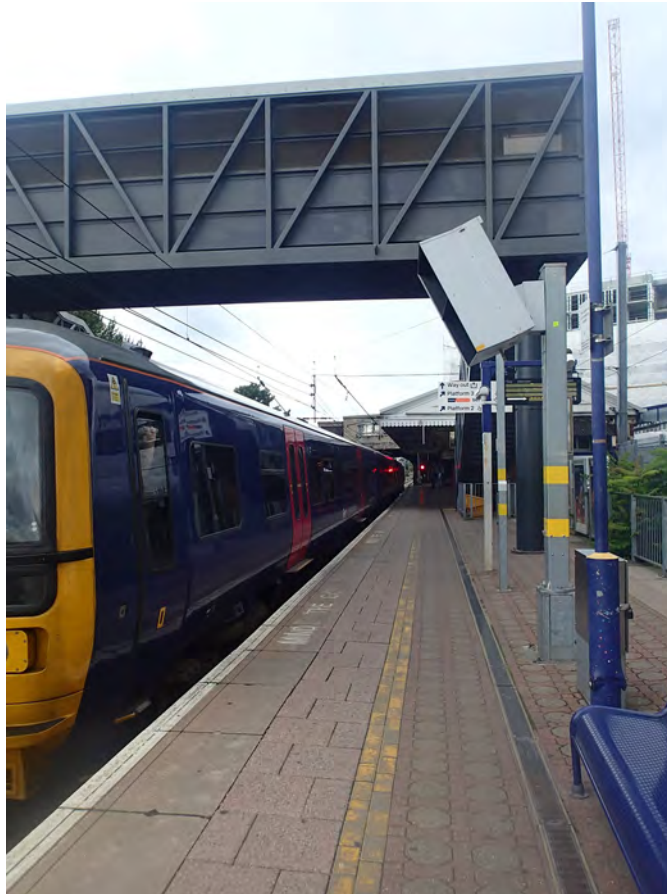
Figure 7: Platform 4 (Up relief line) at Hayes & Harlington

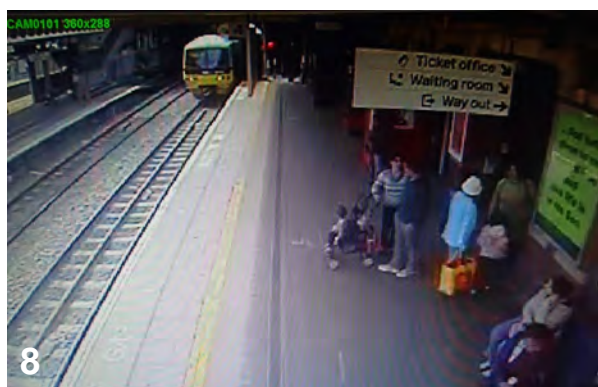
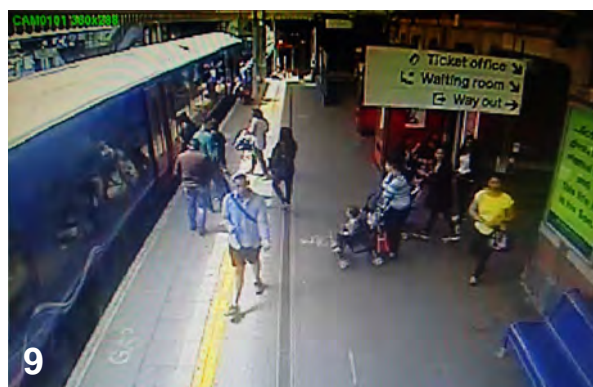
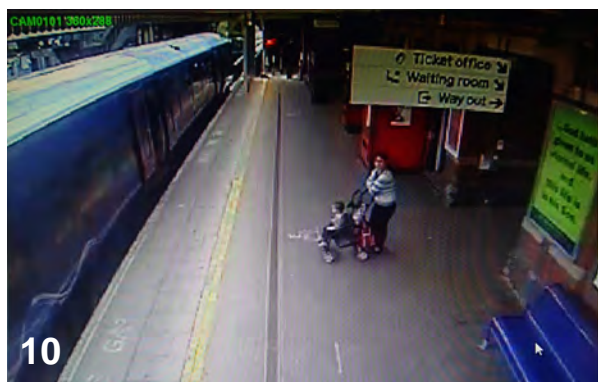
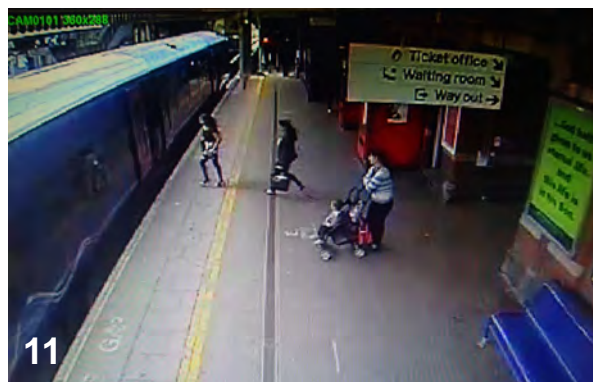
15 Train 2P48 departed from Oxford on time at 11:37 hrs, and remained on time throughout its journey to London Paddington. On arrival at Hayes & Harlington station¹ (figure 8), the driver released the doors at 13:08:36². A few passengers alighted and by 13:08:57 all passengers on the platform intending to travel had boarded (figures 9 and 10). A small number of passengers remained on the platform, waiting for a later train. At 13:09:26, a male and two female passengers arrived on the platform and boarded the train (figure 11).

Figures 8 to 11: CCTV images showing train 2P48 arriving at Hayes & Harlington and subsequent activity on the platform (courtesy of GWR)

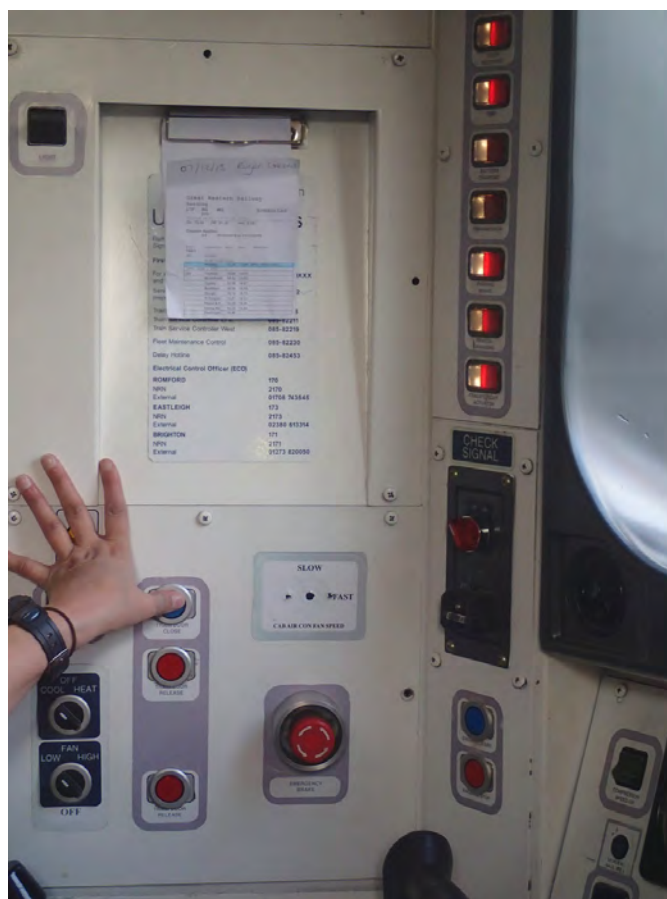
- 49 For the purposes of testing whether the door interlock is working properly, a test object is used. FGW specifies a test object 25 mm thick for testing the door interlock (this is derived from the British Rail Standard GO/OTS 300 and therefore more onerous than the requirement in the current equivalent Standard GM/RT2473, which specifies a test object 30 mm in width). The test involved inserting the object into the closing leaves of a train door and confirming that interlock prevents the driver from taking power (figures 25, 26(a) and 26(b)).

Figure 25: Train driver pressing the button to initiate the door closure

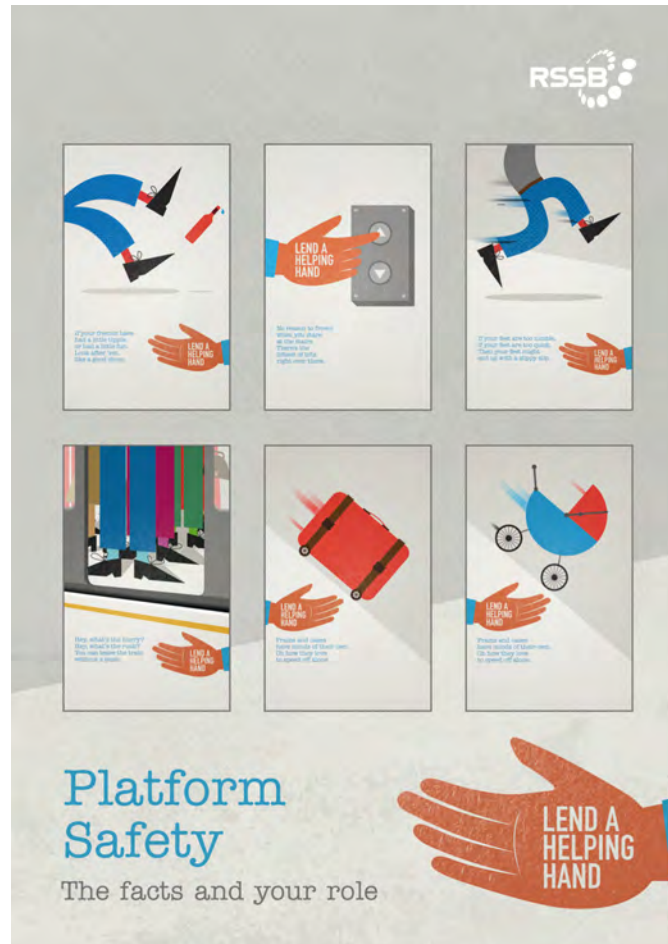
- c. published the platform safety 'Lend a helping hand' booklet. The wording of the booklet (figure 30) was supplemented after the West Wickham and Hayes & Harlington accidents to remind staff to do a thorough visual check of the doors before departing and not to rely on interlock indicators/lights to determine if it is safe to depart because door interlock can still be obtained even if something or someone is trapped in the door.

Figure 30: Cover of RSSB PTI 'Lend a helping hand' booklet
