## **TECHNICAL INVESTIGATION REPORT**

**Concerning the fire on Eurotunnel  
freight shuttle 7340  
on 17 January 2015**

Affaire n° BEATT-2015-001

**Technical investigation report  
Concerning the fire on Eurotunnel freight shuttle 7340  
on 17 January 2015**

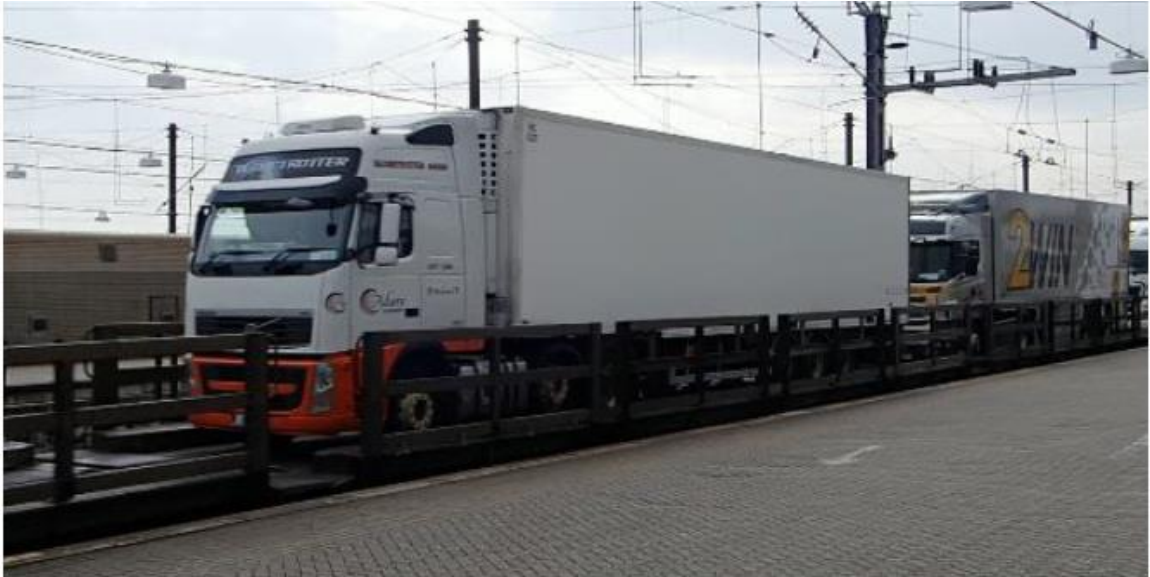
Figure 19: Arbel wagons without pagoda

The fire was caused by an electrical arc between the overhead power line and a CB aerial which had not been detected by the aerial detection system and which was mounted on a lorry which had been loaded onto an Arbel wagon without pagoda.

At the time of the incident all the original pagodas had been removed from the Arbel wagons. However, the wagons of the rear rakes were fitted with a single pagoda of an alternative design covering the front section only.

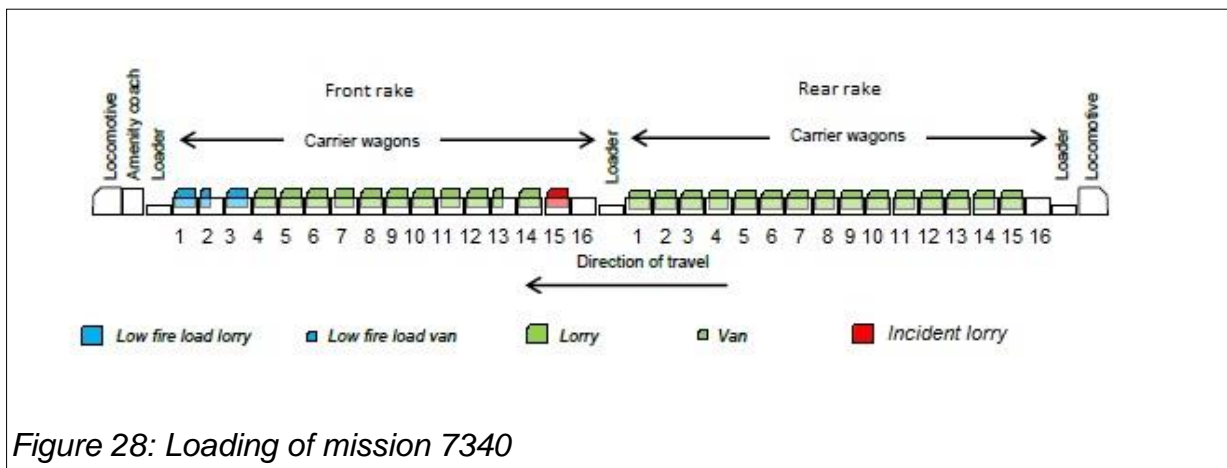
Figure 28: Loading of mission 7340

The incident lorry is loaded on carrier wagon 15 of the front rake.

There are no vehicles carrying dangerous goods identified on the load summary plan<sup>7</sup>. The first three lorries on the front rake have been identified as low fire load vehicles.

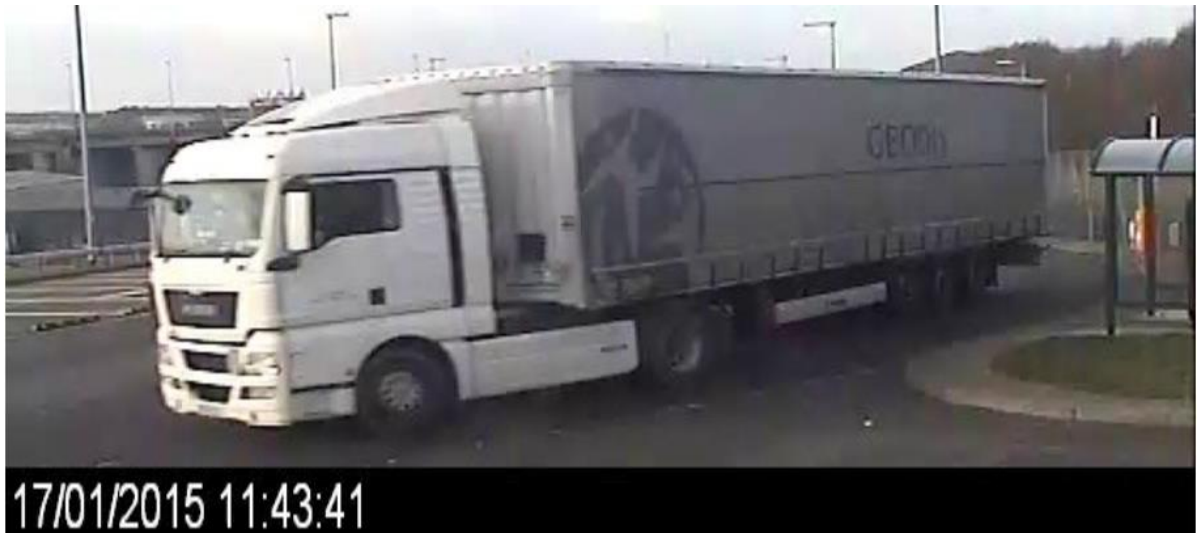
*Figure 29: The incident lorry during the loading phase*

It comprises a MAN tractor unit and a Krone trailer.

The trailer is a 3-axle curtain-sided trailer loaded with iron brake drums.

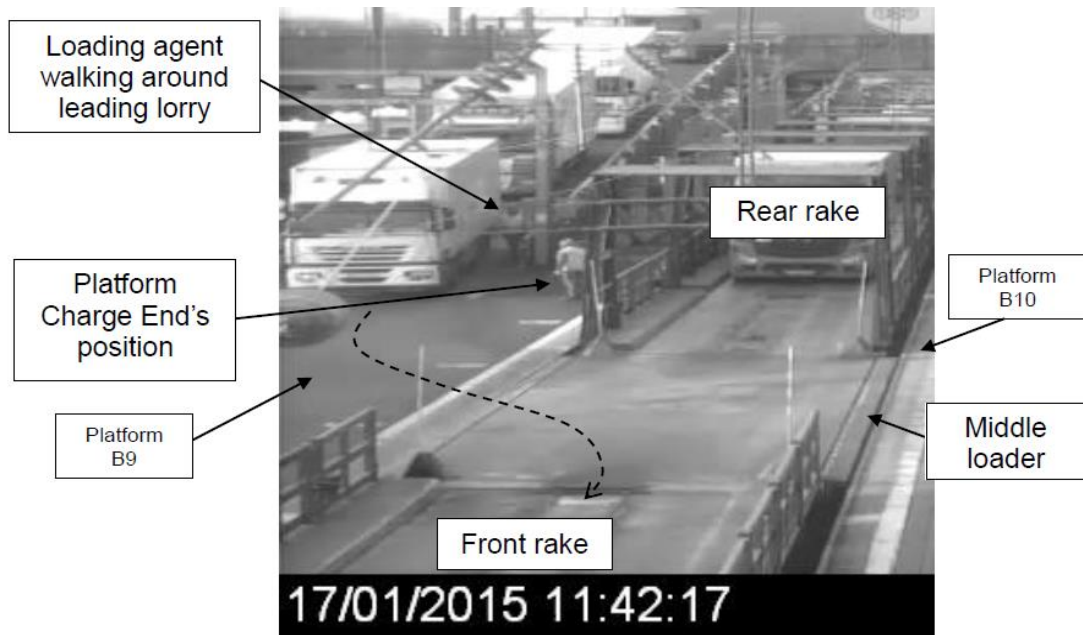
Figure 31: Loading lorries onto the shuttle.

At 11:41 hrs, a line of lorries on over-bridge 2 is ready to board the front rake of mission 7340 with the leading lorry stopped at the bottom of the ramp to platform B9, in line with the aerial detection system (figure 31).

The agent then walks around the back of the leading lorry (figure 31).

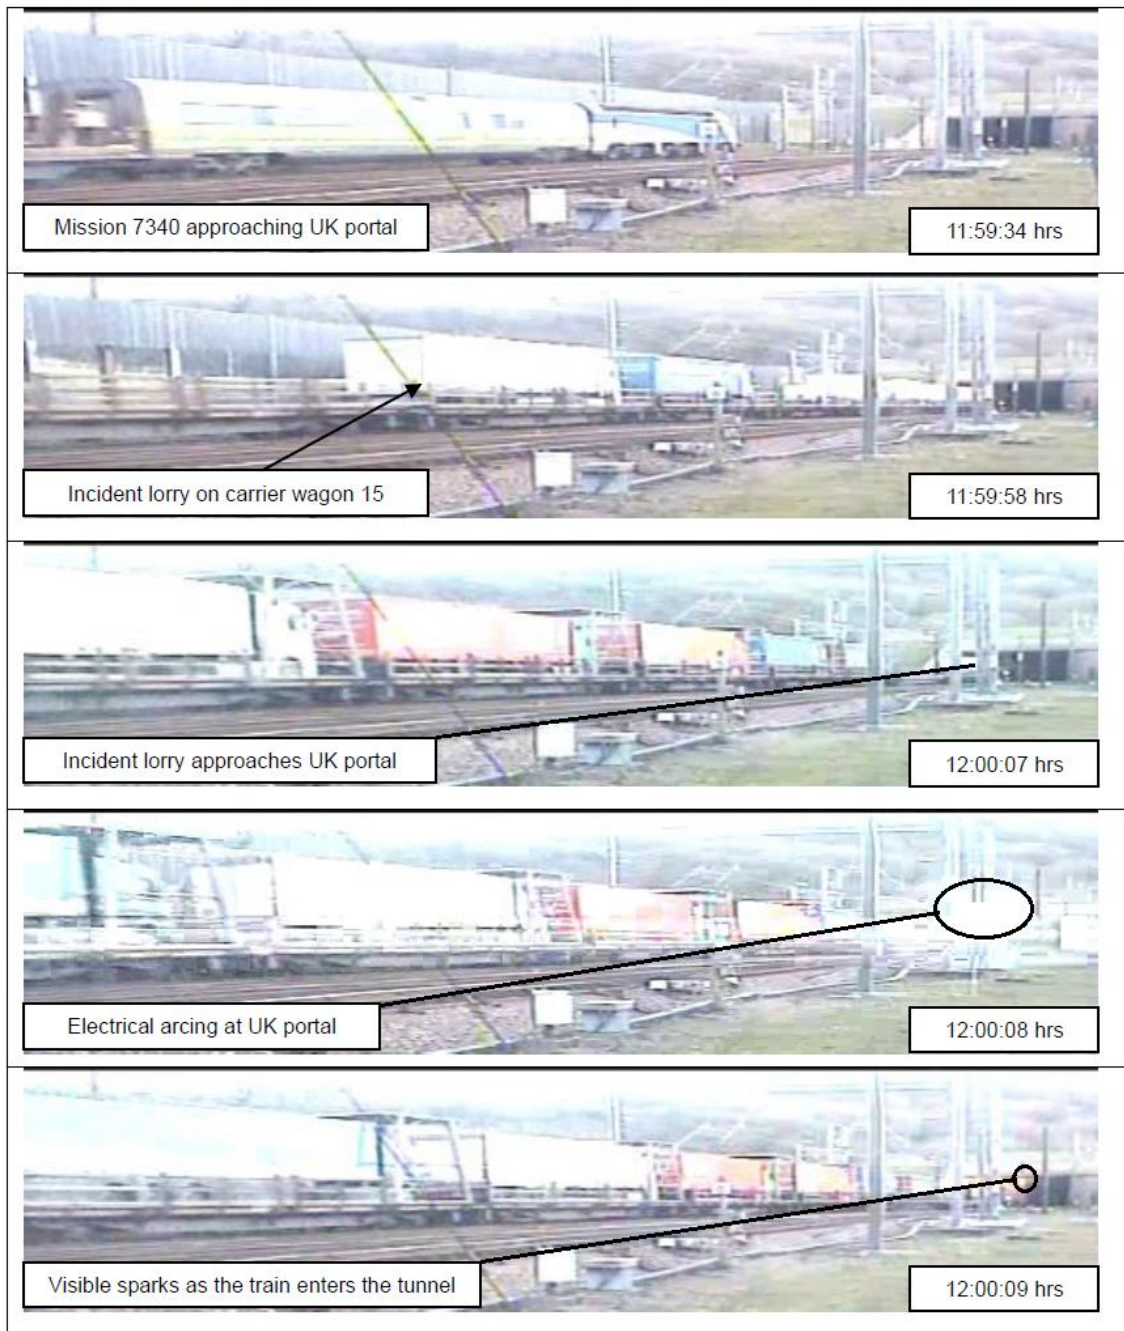
Figure 32: Train 7340 entering the tunnel

At 12:00:08 hrs, as the lorry loaded on carrier wagon 15 of the front rake enters the tunnel, an electrical arc occurs between the overhead line and the lorry.

At 12:00:36 hrs, the trailing locomotive of mission 7340 enters the UK portal. Mission 7340 is entirely inside the Channel Tunnel.

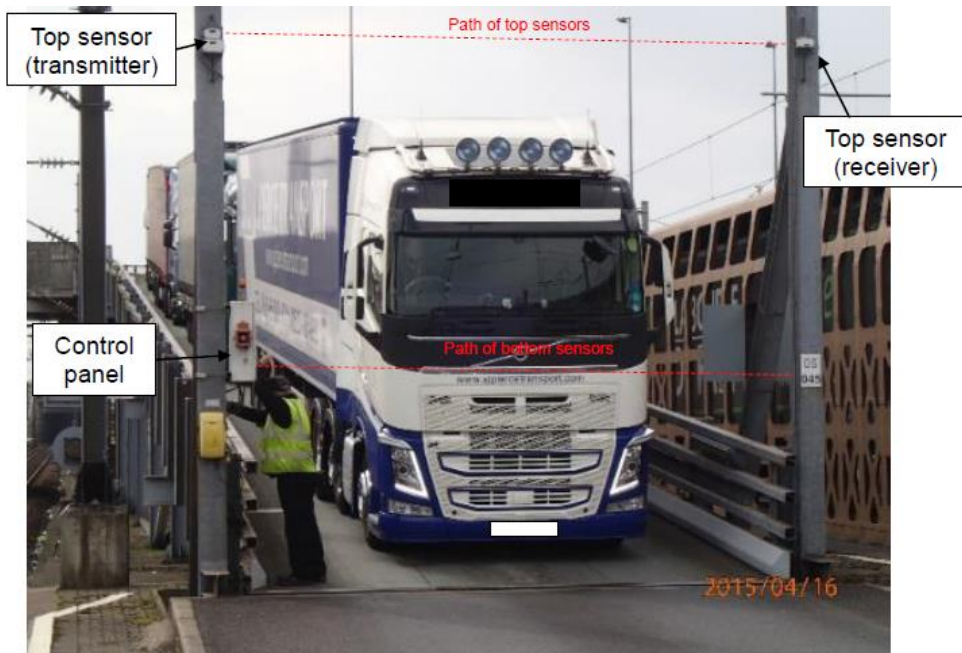
*Figure 34: Aerial detection system*

The bottom sensors (a transmitter and a receiver) are attached to either side of the portal. These sensors are approximately 1.85 metres above road level and are used to detect the presence of a lorry.

The top sensors (a transmitter and a receiver, also on either side of the portal) are used to detect the presence of an aerial at roof level and are installed 4,250 mm above road level.

The logic is that a confirmed activation lasting more than 100 ms at the bottom sensors triggers the scanning by the top sensors for 5 seconds (regardless of any short (< 1 second) loss of detection at the bottom sensors). Hence, it is only the part of the lorry that passes in front of the sensors in these 5 seconds that is scanned for an over-height aerial. At a speed of passage in front of the aerial detection system of 2 km/h, only the first 2.8 m of the lorry are scanned. As the speed of the lorry increases, the scanned length also increases.

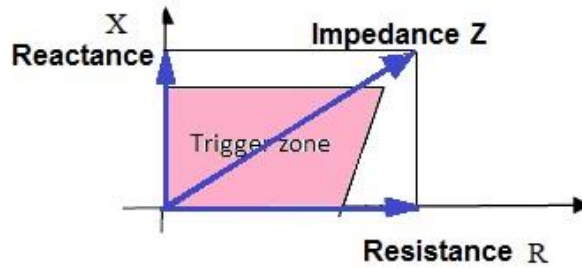
Figure 37: Trigger by minimum Z

There are therefore two trigger requirements for a circuit breaker:

- maximum current (max I) 4,500 Amps for 50 ms which is only efficient in the case of a short-circuit near the sub-station;
- Unexpectedly low impedance (min Z) as measured at the feeder station: where  $Z=U/I$  represented by the graph below where  $Z=R+iX$

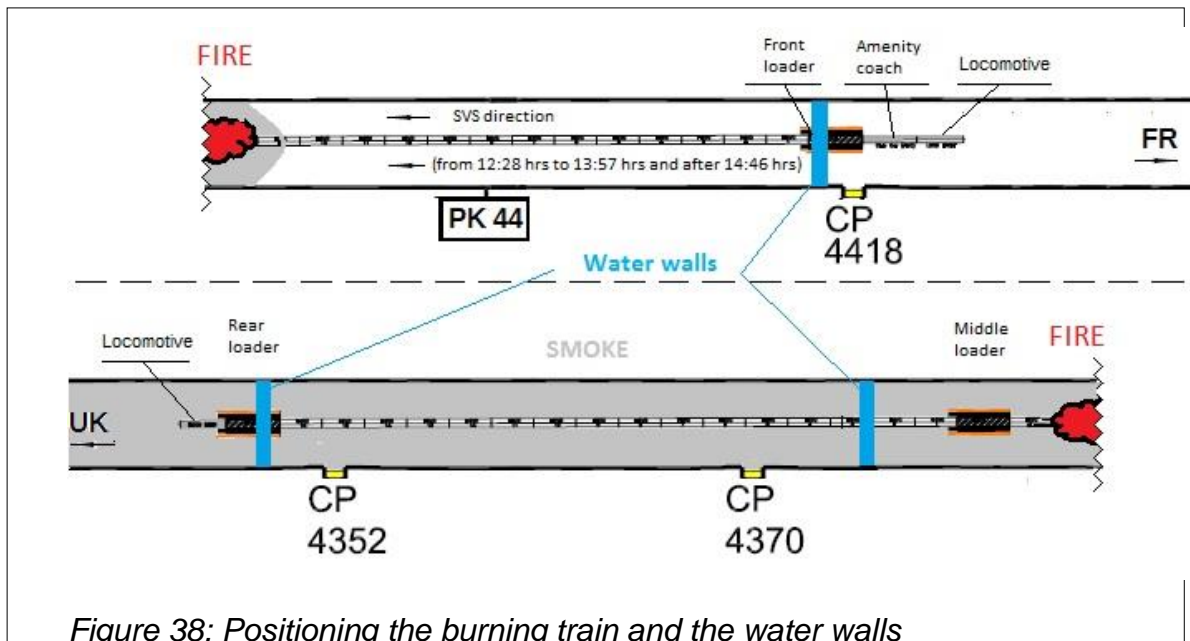
Figure 38: Positioning the burning train and the water walls

At 14:00 hrs, “water walls” are in place at CP 4418 and CP 4370 and a third is being set up at CP 4352.

It is observed that the water walls were set up on the loader wagons from 14:00 hrs which is about one and a half hours after the train on fire had stopped.
