# ***AAIB Bulletin***

***1/2015***

Published: 8 January 2015

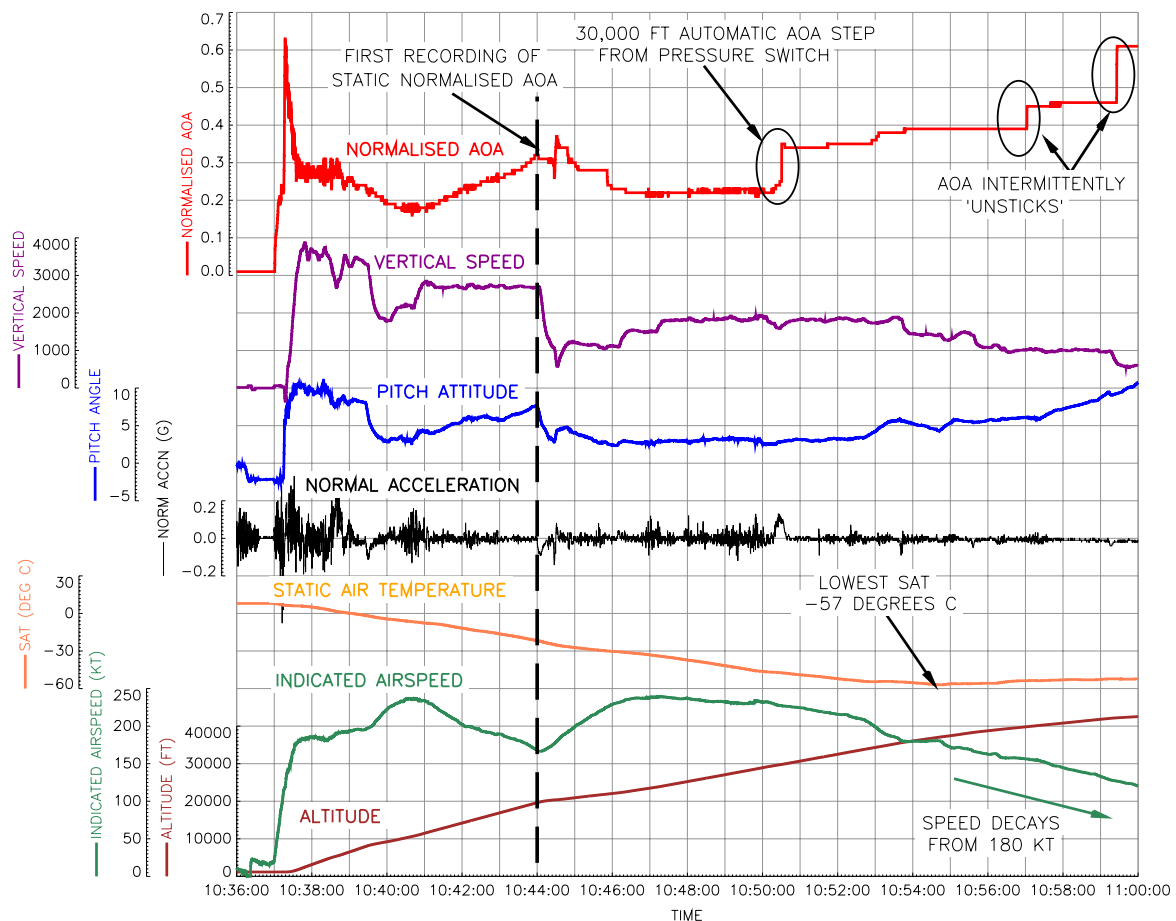
**Figure 3**  
N380CR AReS data during climb

Figure 3 shows that at 1044:02 hrs, the recorded AReS data shows the normalised AOA remaining static as the aircraft climbed through FL197 at a SAT of -22°C. Despite recovering intermittently, as the aircraft climbed and the SAT reduced, periods of static normalised AOA were recorded.

At 1053:43 hrs while climbing through FL356, the indicated airspeed stabilised at 180 kt as the vertical speed reduced from approximately 1,750 ft/min to 1,400 ft/min. This airspeed was maintained for a minute after which it began to reduce. At 1056:41 hrs, the vertical speed reduced further to 1,000 ft/min as the aircraft climbed through FL395 at an indicated airspeed of 158 kt.

At 1059:17 hrs, at FL420 and 128 kt, a further reduction in the vertical speed to 500 ft/min was recorded but this did not stop the decay in airspeed. Nine seconds later, a 'step' change in the normalised AOA was recorded, from 0.46 to 0.61 units, where it remained for the next 45 seconds, despite a reducing airspeed and increasing pitch attitude. This step change (and others noted above FL300) were considered by the aircraft manufacturer to be characteristic of the AOA vane momentarily breaking loose from its static position. At 1100:01 hrs, the indicated airspeed reduced to below 120 kt with a recorded normalised AOA of 0.61 units and pitch attitude of 10.8° pitch-up.

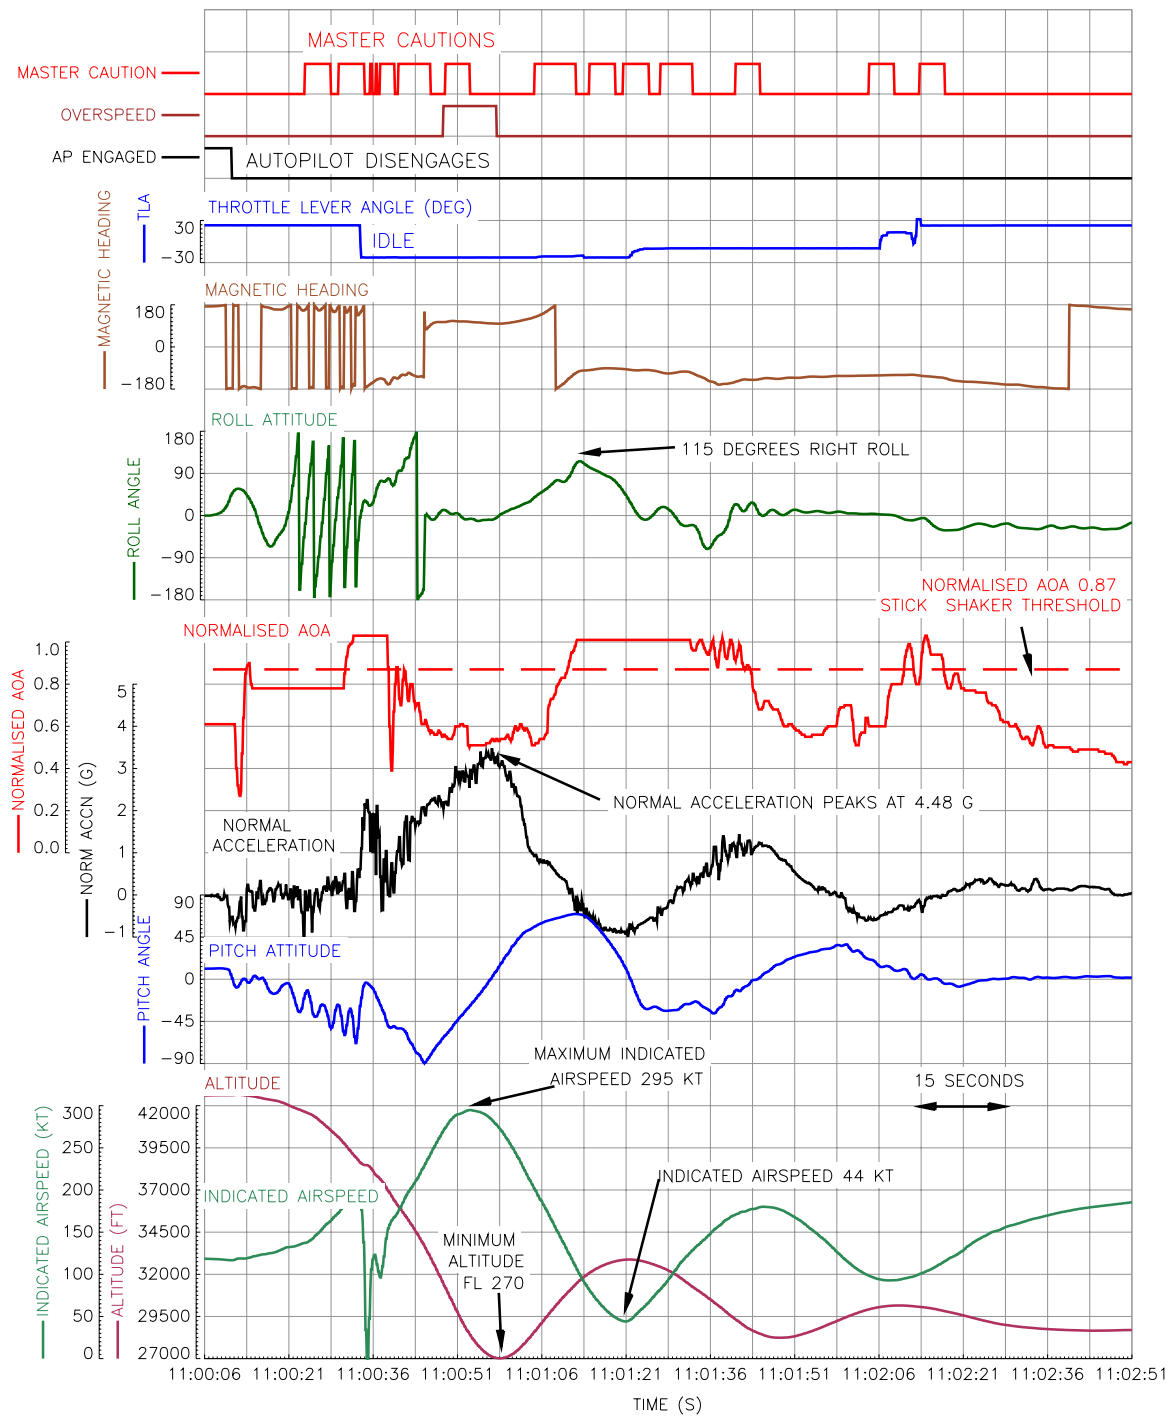
**Figure 5**  
ARes data showing recovery

At 11:00:58 hrs, as the pitch attitude increased, the descent was arrested at FL270, which also corresponded with the peak normal acceleration of 4.48g. The descent of 15,662 ft over 46 seconds equated to a vertical speed of approximately 20,000 ft/min. Ten seconds prior to reaching the maximum pitch attitude of 70° during this pitching manoeuvre, the normalised

AOA increased to above 0.87 (peaking at 1.0) and remained there for the next 33 seconds. The minimum indicated airspeed as the aircraft began to pitch down again was 44 kt.

At the top of the second pitching manoeuvre, the normalised AOA again exceeded 0.87 for two separate periods of two seconds and four seconds, with a minimum recorded indicated airspeed of 93 kt.

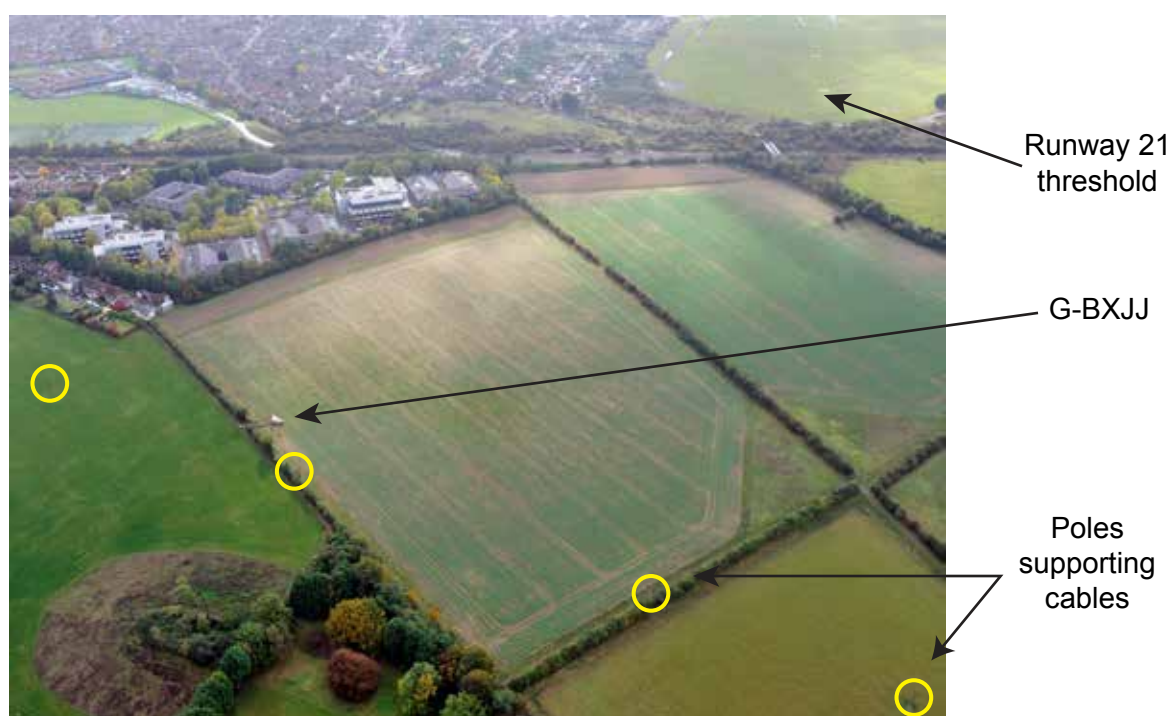
**Figure 1**

order to extend two stages of flap and commence the approach. The aircraft became lower than planned and when the throttle was advanced to add power, the engine did not respond. The instructor took control, declared a MAYDAY on the aerodrome frequency and then conducted emergency drills, which included changing the fuel selector to the other tank. The aircraft descended faster than anticipated and as the height reduced power cables became visible on the approach path. In order to avoid a potential stall by attempting to fly over the cables, the instructor decided to descend and fly under the cables. The aircraft landed short of the intended field (Figure 1) and it collided with a hedge and was severely damaged. The student selected the electrical master and other switches OFF.

Aerial view of the accident site  
(courtesy National Police Air Service)

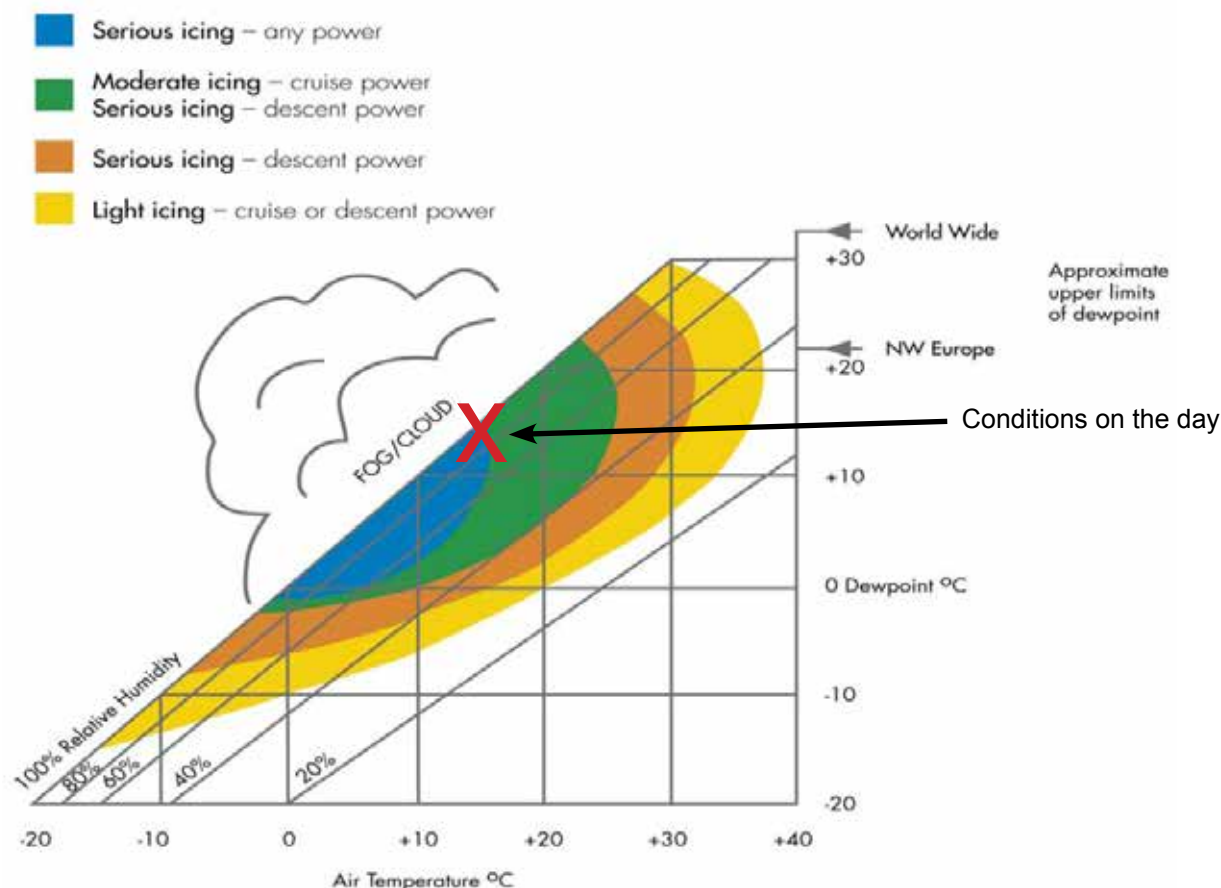
**Figure 2**

The leaflet also includes a chart, Figure 2, to show the atmospheric conditions most likely to cause carburettor icing. Plotting the temperature and dew point reported on the day of the accident onto this chart indicates that serious carburettor icing was likely to be present at any power setting.

Carburettor icing chart from CAA Safety Sense Leaflet 14, *Piston Engine Icing*

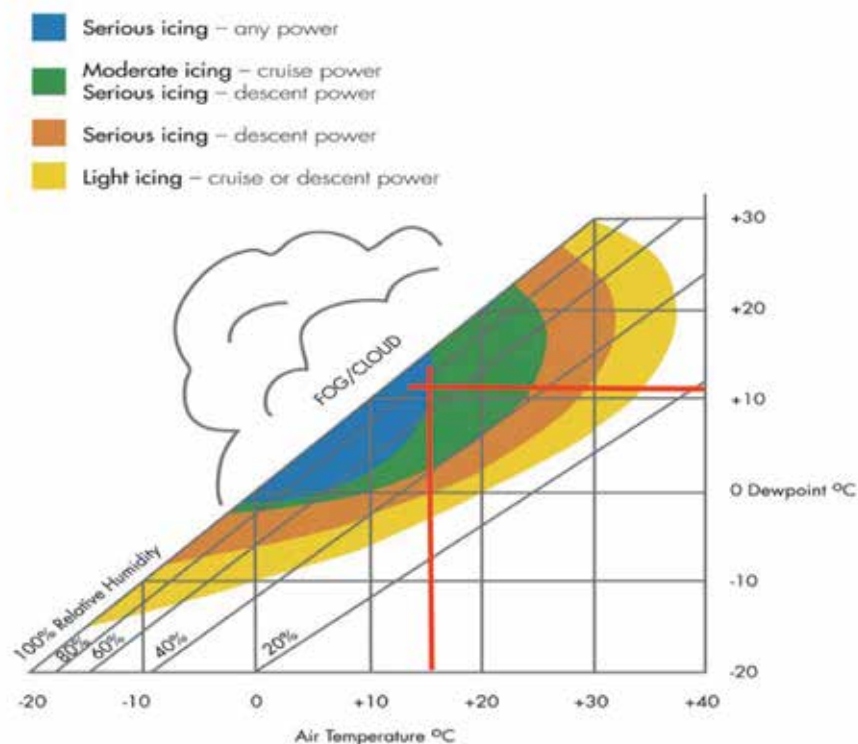
**Figure 1**

The pilot, who was uninjured, reported that the loss of engine power was due to carburettor icing. The meteorological report for Luton Airport (8.5 nm south) at 1520 hrs gave a temperature of 16°C and a dew point of 11°C. Over the next two hours, these values changed to 14°C and 13° C respectively. Figure 1 shows a graph widely used to predict the likelihood of induction system icing. Using the conditions reported at Luton Airport, the aircraft can be seen to have been at risk of moderate icing at cruise power and serious icing at descent power. A more refined version of the graph (not shown here) identifies a risk of serious icing at both cruise and descent power settings for carburettor equipped engines, such as that fitted to G-BSIM.

Graph predicting risk of induction system icing; actual values of temperature and dewpoint shown by red lines
