PART 1.4 – ANALYSIS AND FINDINGS

1.4.1 On 11 Oct 15 at 1623 hours (hrs), a Royal Air Force (RAF) Puma HC Mk2 Helicopter, tail number XW229, struck the tether of a Persistent Threat Detection System (PTDS) aerostat and crashed within the confines of the NATO Headquarters in Kabul, Afghanistan. The aircraft was the subordinate element of a formation of two Pumas that were operating with the callsign [REDACTED]; the lead aircraft, ZJ955, was [REDACTED] (A21), and XW229 was [REDACTED] (A22). Two crew members and 3 passengers were killed. The third crew member and 3 additional passengers suffered various major injuries; one bystander was also injured.

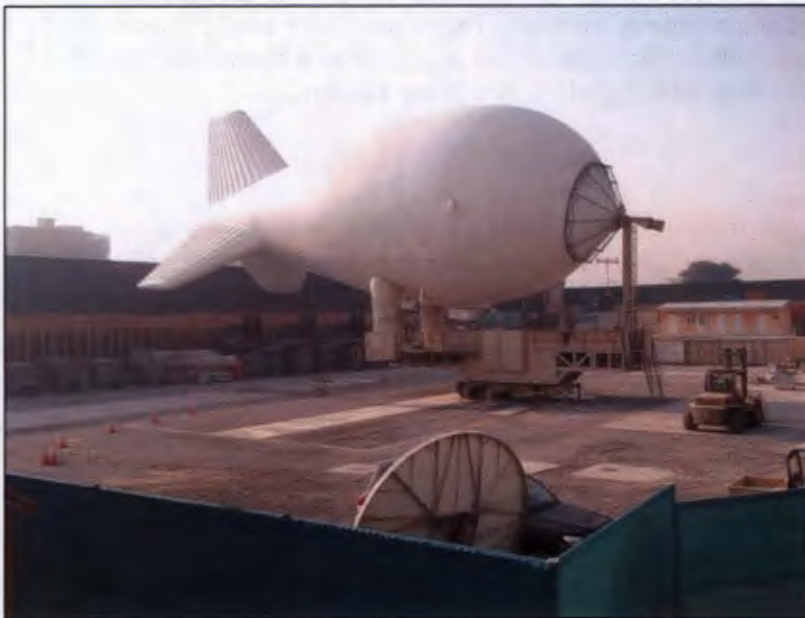
Figure 1.4.15 - HQRS PTDS in down position

1.4.178 The PTDS comprised an aerostat, tether, base station⁸¹, mission payloads and associated ground support and control equipment. The aerostat was helium filled and aerodynamically designed to fly into wind to maintain stability; it had no propulsion system. The tethered aerostat was free to drift with the wind; in strong winds the aerostat was recovered to the base station. The hull of the aerostat was 35 m in length, 12 m in diameter and had a volume of 74,000 cubic feet.

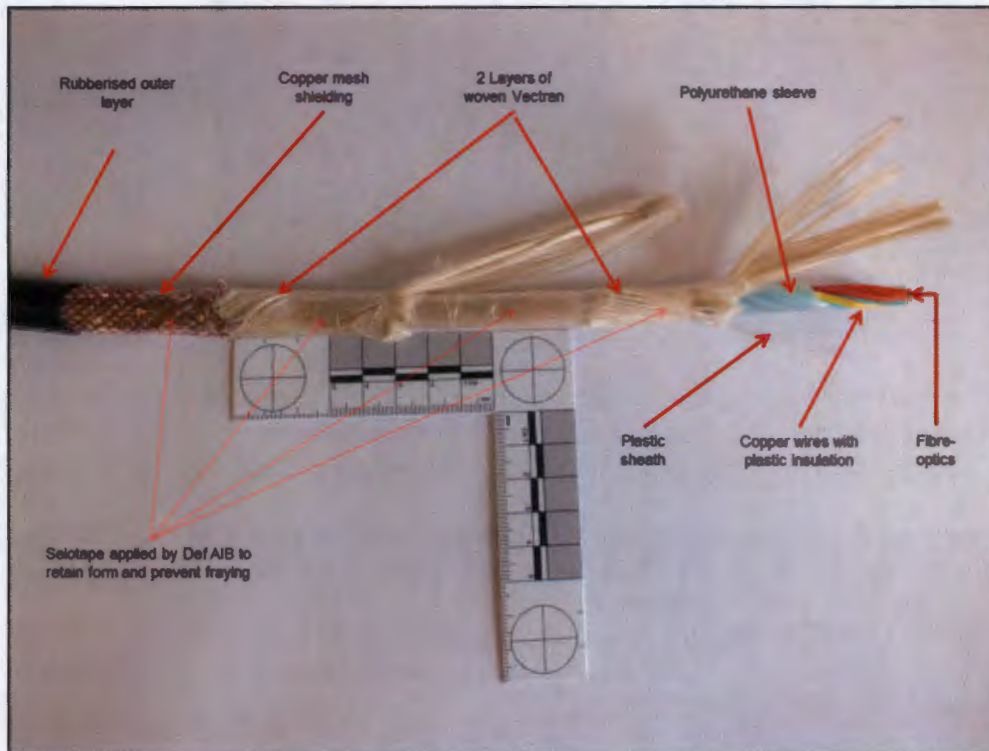
Figure 1.4.16 - PTDS tether construction

1.4.179 The aerostat was connected to the base station by means of a tether which was 0.58 inches (14.7 mm) in diameter and consisted of a central core of fibre-optics, copper cored power cables and a braided Vectran⁸² sleeve all of which were encased in a black rubber environmental outer. The tether was used to restrain/anchor the PTDS to the base station and to provide power and data transfer to and from the payload. Figure 1.4.16 shows an exposed section of tether.

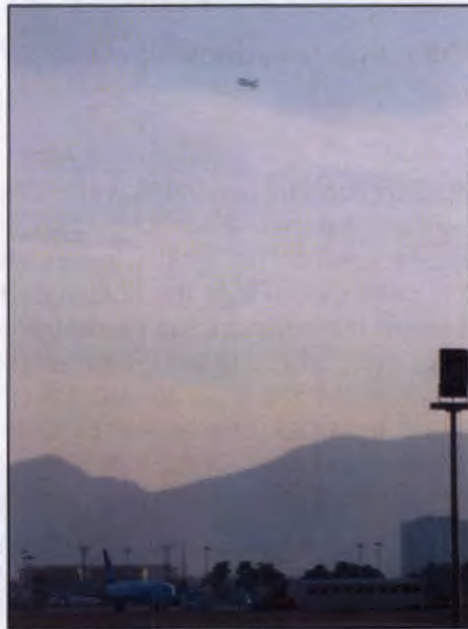
Figure 1.4.18 - HQRS PTDS viewed from HKIA(N), a distance of 2.7 nm

1.4.183 As aircraft transited towards the PTDS, it was reported that pilots would
