AAIB Bulletin

10/2015

Published 8 October 2015

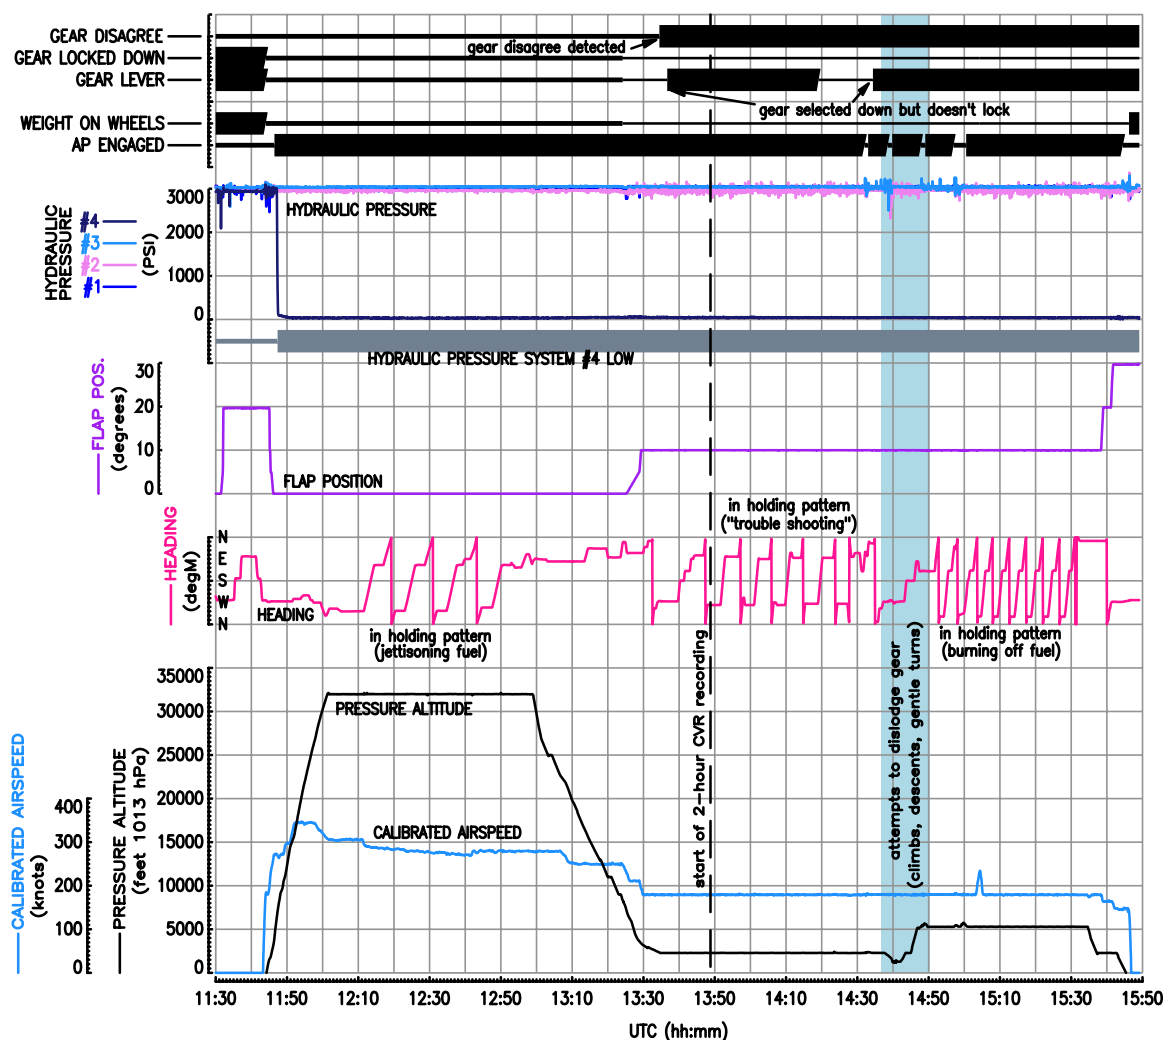
Figure 4
Salient data from FDR

•	1438 hrs	-	Descent to 2,000 ft then climb to 6,000 ft with gentle turns in an unsuccessful attempt to lock the gear down
•	1451 hrs	-	In holding pattern to burn off fuel

•	1535 hrs	-	Begin approach to land
•	1546 hrs	-	G-VROM touches down in a right-wing low attitude of about 4°

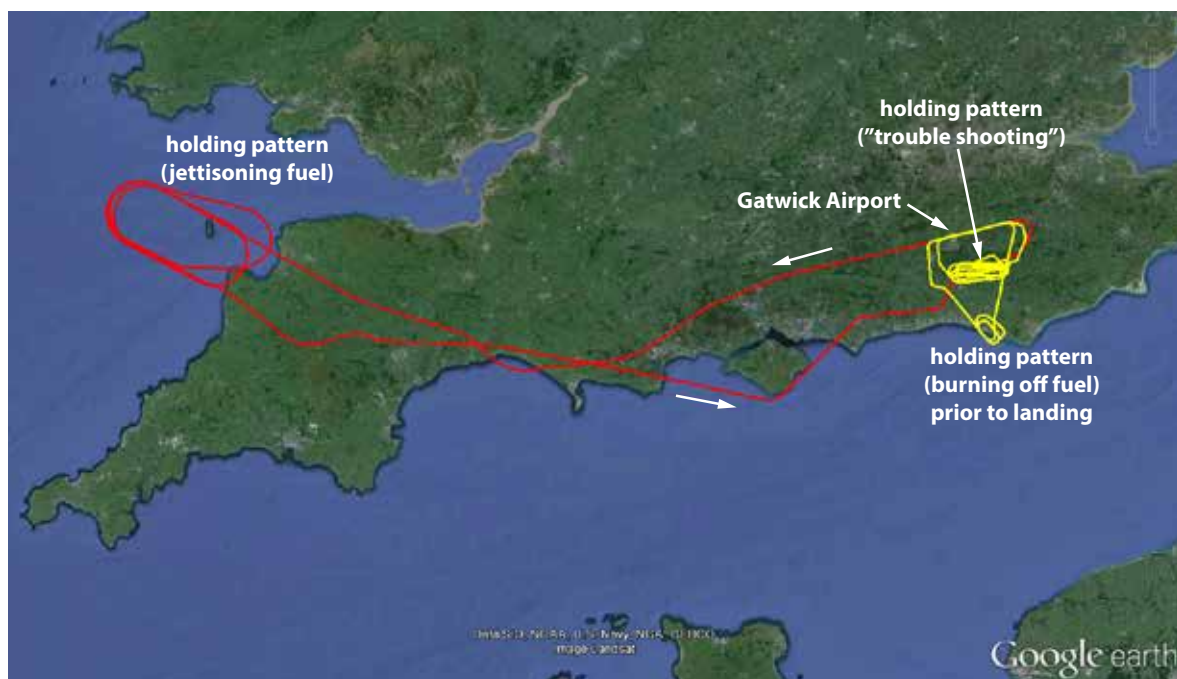
Figure 5

Radar track with portion of flight when the gear disagree was detected highlighted in yellow

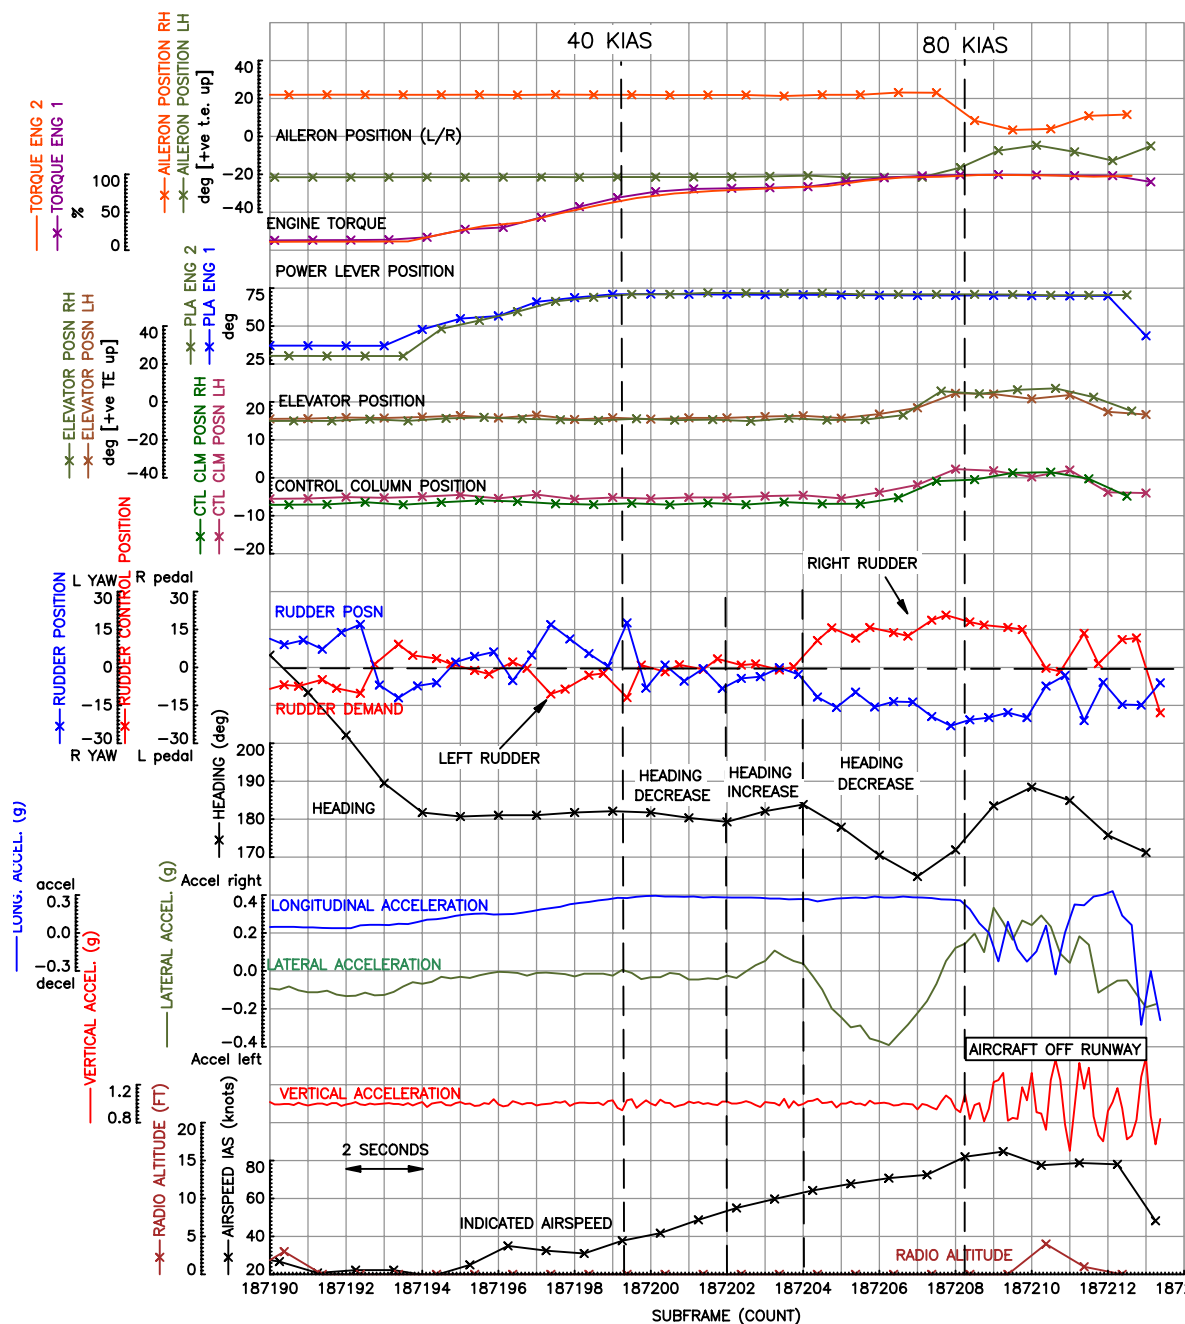
Figure 3
G-LGNL FDR data⁷

The FDR and CVR both ceased recording at the same time. The data shows the aircraft decelerating at approximately 48 kt with the power levers still fully advanced until the last recorded sample. The recording did not capture the engine shutdown or evacuation which suggests that the recordings terminated early⁸. Examination of the aircraft after the accident revealed significant damage and mud ingress in the forward avionics bay which was likely

During the attempted takeoff, the rudder was central from 40 kt and remained so until approximately 65 kt. Between approximately 52 and 65 kt, the aircraft turned right slightly before it turned left sharply at approximately 65 kt (Figure 3). Given that the rudder was central, this change of direction might have been caused by one, or a combination of the following factors:

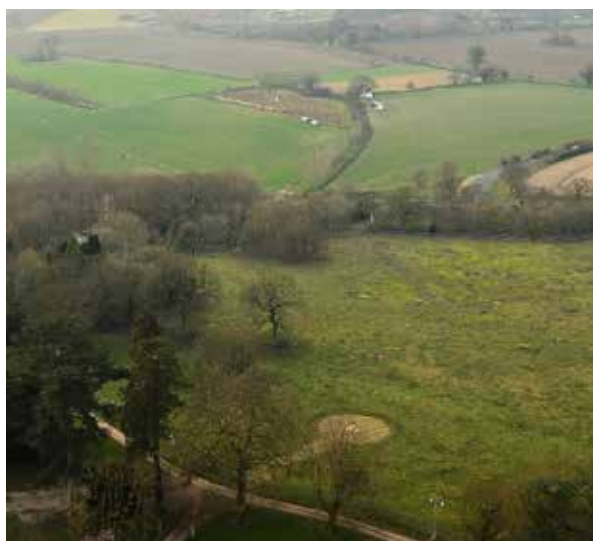
Figure 1

The paddock and helipad (foreground) and accident site (in nearest ploughed field).
Yarmouth Road runs across the middle of the picture,
Ravensingham Road joins it at the T-junction

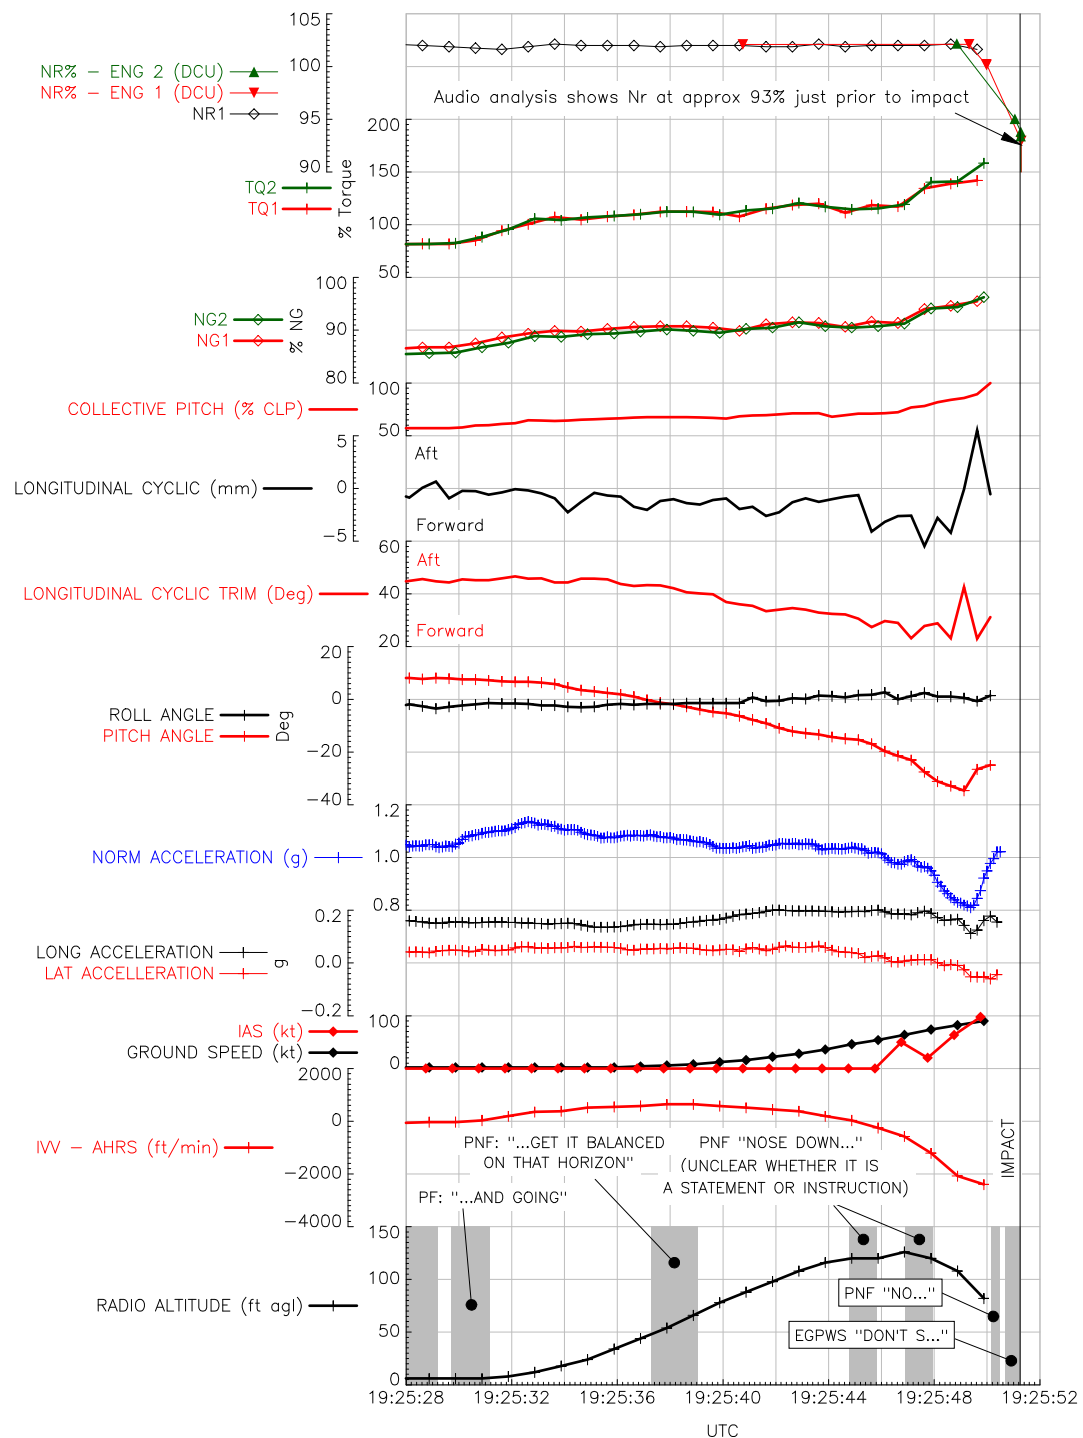
Figure 2

Pertinent engine DCU data parameters and CVFDR recorded data and transcript extracts. The commander was the Pilot Flying (PF) the co-pilot was the Pilot Not Flying (PNF)

The recorded data included parameters relating to cautions, warnings and system status. A gearbox torque caution was recorded by the CVFDR in the last moments of the accident flight. No other CVFDR warnings or cautions were recorded in the air. System status records were all attributed to normal operations for the given aircraft configuration.

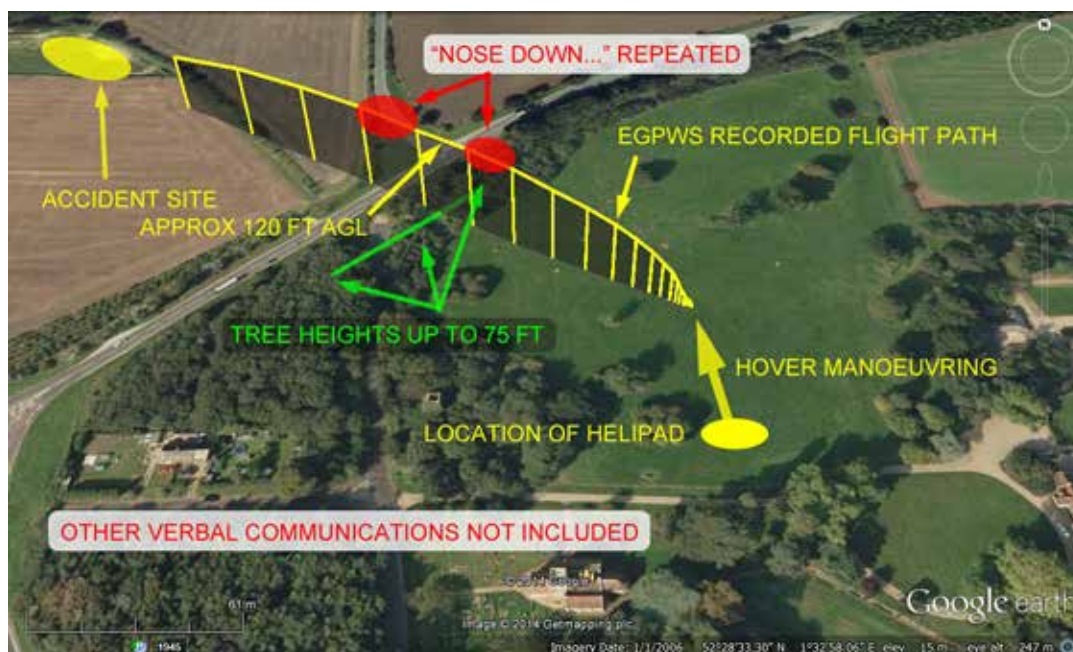
Figure 3
Flight path

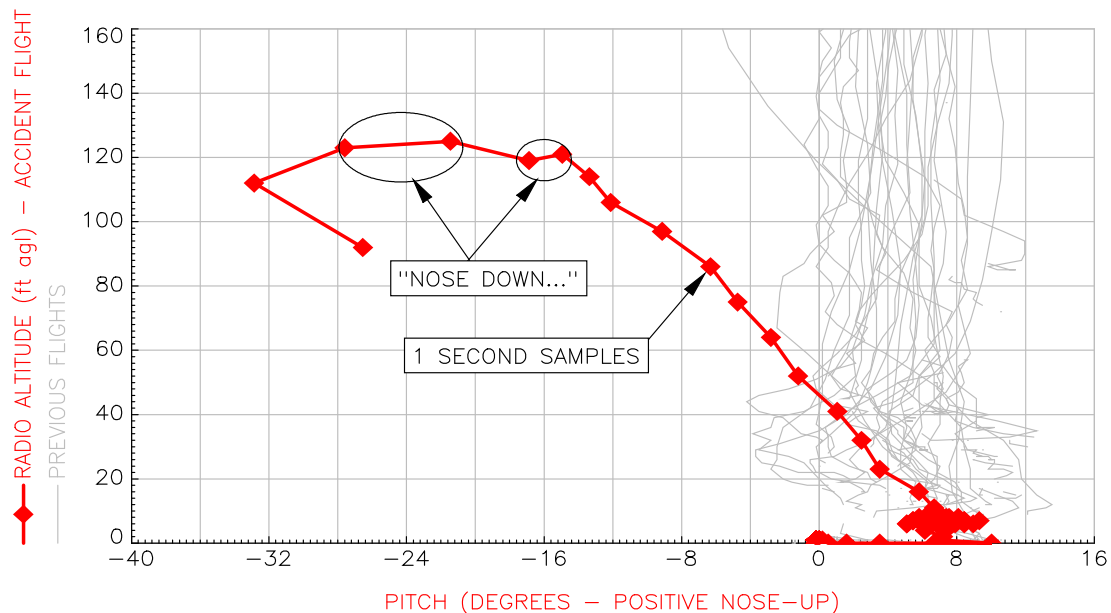
Figure 4

A comparison of the pitch attitude recorded during the accident flight with the previous flights recorded by the CVFDR is given in Figure 4. The maximum nose-down pitch attitude is not plotted as this graph uses a lower sample rate than the FDR data plot in Figure 2.

Radio altitude compared to pitch for the accident flight, compared with the previously recorded climb profiles

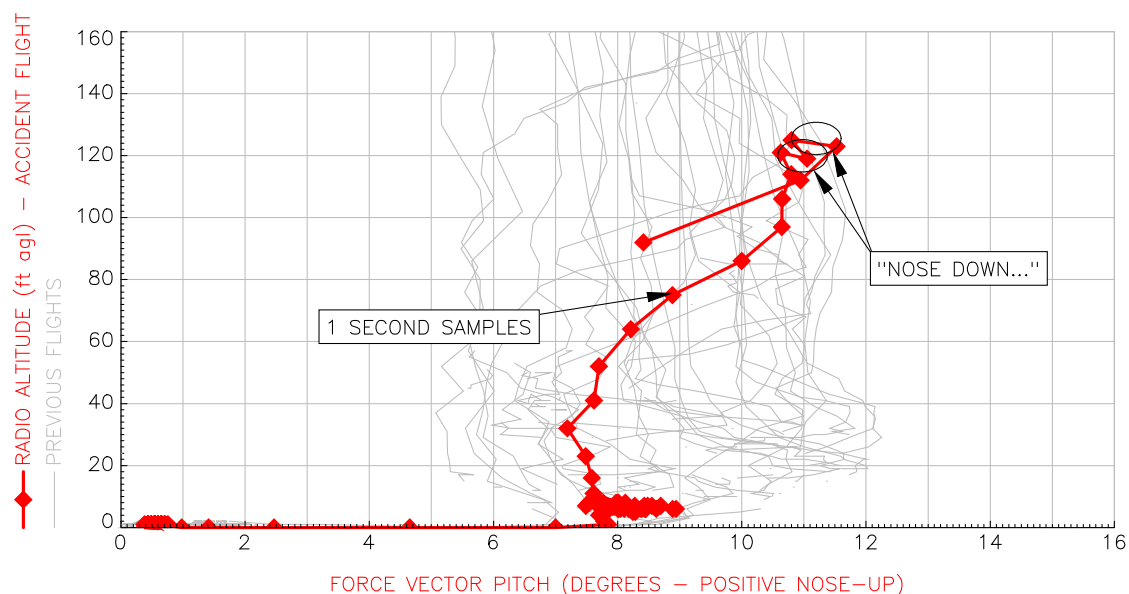
Radio altitude plotted against force vector pitch for the accident flight compared to previously recorded climb profiles

Somatogravic illusion could have led to the progressively abnormal attitude of the helicopter 'feeling' normal to the occupants. It is notable that the point at which the co-pilot began prompting the commander about pitch attitude ("NOSE DOWN") corresponds with the points in Figure 6 when the value of force vector pitch for height is close to outlying the other plotted data. Until then, there was nothing abnormal about the value of force vector pitch, even though the pitch attitude itself had deviated substantially from its usual range of values.

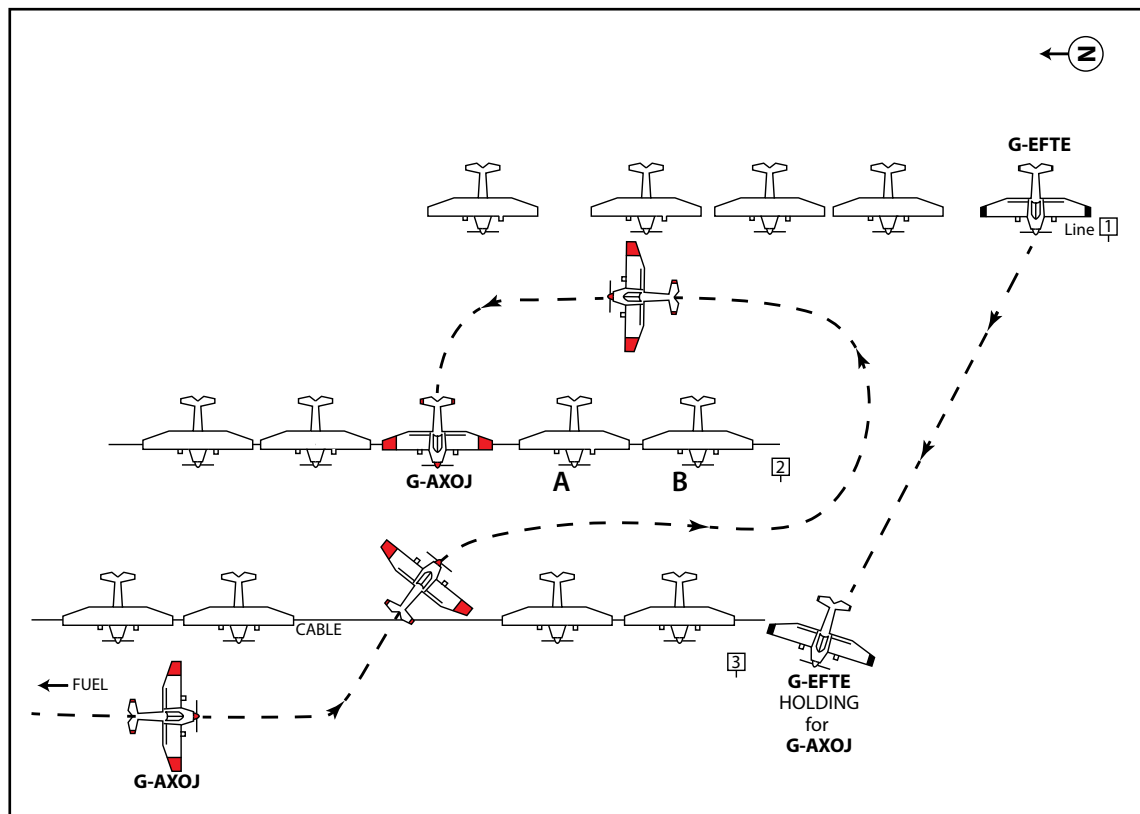
Figure 1

G-EFTE, a Bolkow BO 207 with a tailwheel configuration, was parked on the southern end of parking row 1 at Goodwood Airfield (Figure 1). After pre-flight checks the pilot requested taxi clearance and was told to taxi to the hold of Runway 24. The wind was from 250° at 15 kt. He taxied forwards, into wind, with the stick held full back and as he approached the southern end of parking row 2 he observed a Beagle Pup, registration G-AXOJ, approaching along the taxiway from his right. He stopped the aircraft at the southern end of parking row 3 and expected G-AXOJ to pass in front of him and turn left. However, G-AXOJ turned left through a gap of parked aircraft on row 3 to pass behind G-EFTE (Figure 1). The pilot of G-EFTE then lost sight of G-AXOJ and prepared to move forward but had to hold for another aircraft taxiing in front. As he was about to move forward again, or while starting to move, the tail of his aircraft lifted up and the propeller struck the ground.

Sketch of the parking area and aircraft tracks (not to scale)
