Rail Accident Investigation Branch

# Rail Accident Report

**Passenger trapped and dragged under a train at  
West Wickham  
10 April 2015**

Report 03/2016  
February 2016

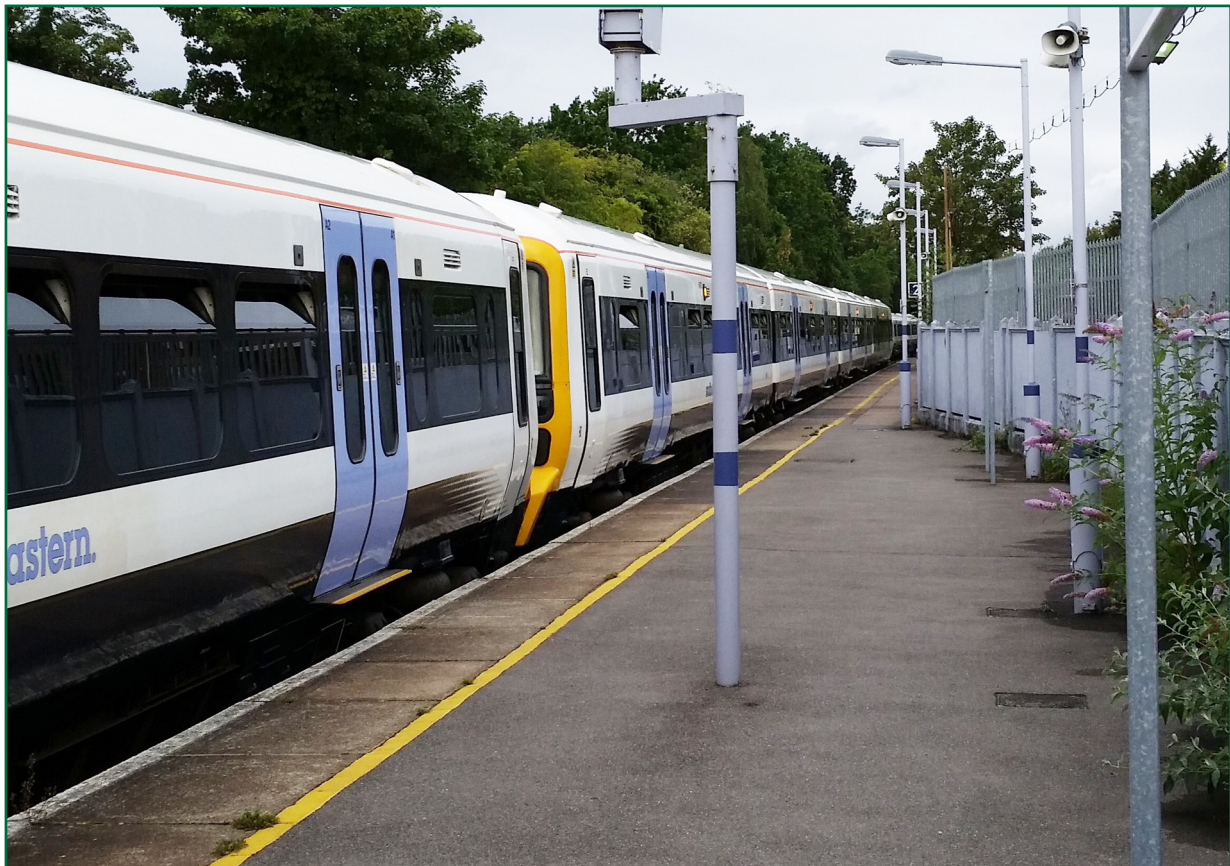
- 5 West Wickham station lies around 4.3 miles (7 km) east of Croydon in the London borough of Bromley (figure 1). It is around 12.5 miles (20 km) measured along the route from London Cannon Street to Hayes in Kent (figure 2). The station has two platforms and the accident occurred on platform 2 (figure 3).

Figure 3: Platform 2 at West Wickham station

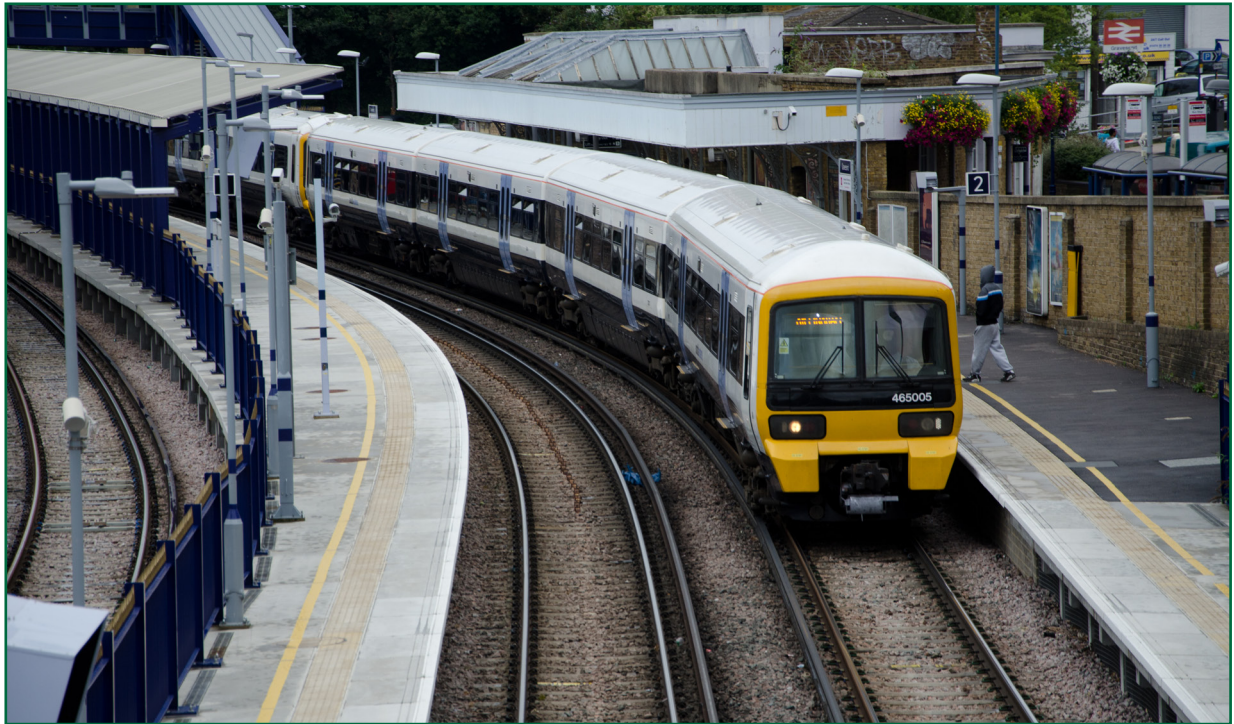
- 13 The train involved in the accident was formed of two four-vehicle class 465 units (figure 4), often referred to as 'Networker' trains<sup>2</sup>. The leading unit was number 465184 and the rear unit was number 465047. The passenger involved in the accident was travelling in the fourth vehicle of the eight-vehicle train (ie the rear vehicle of the leading unit) which was vehicle number 65880.

Figure 4: A class 465 train

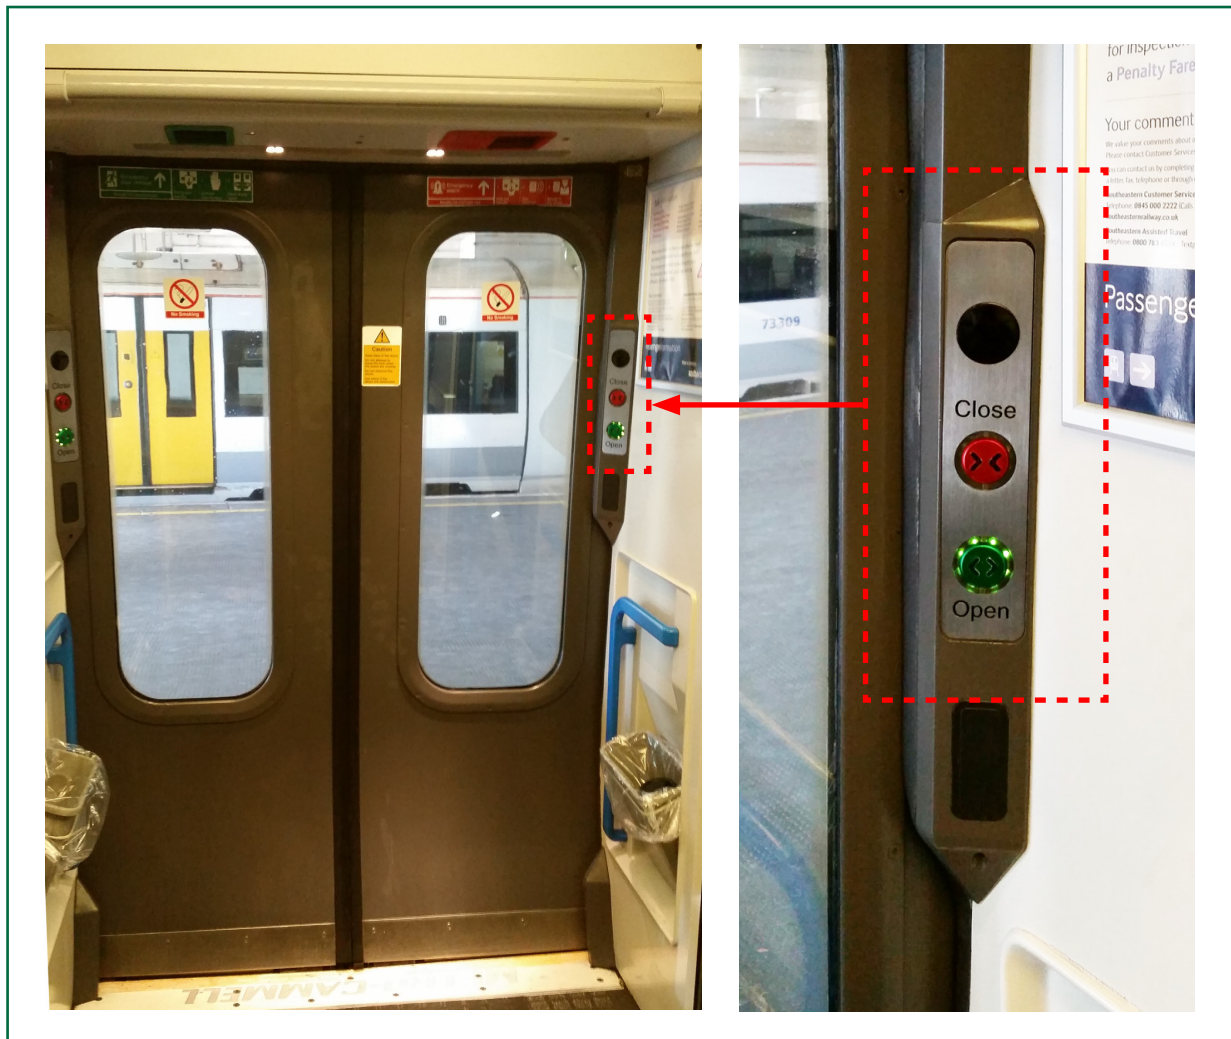
- 16 Class 465 trains have power-operated, bi-parting sliding plug doors at two positions on each vehicle body side. These doors can be operated by passengers using push-buttons located at the passenger doorways (figure 5). The passenger doors cannot be opened using these push-buttons until the train driver has *released* the doors using controls in the driving cab. When the doors have been released for operation by the train driver, the passenger push-buttons illuminate, and become available for use by passengers.

Figure 5: Passenger bi-parting doors and passenger door-open push-buttons

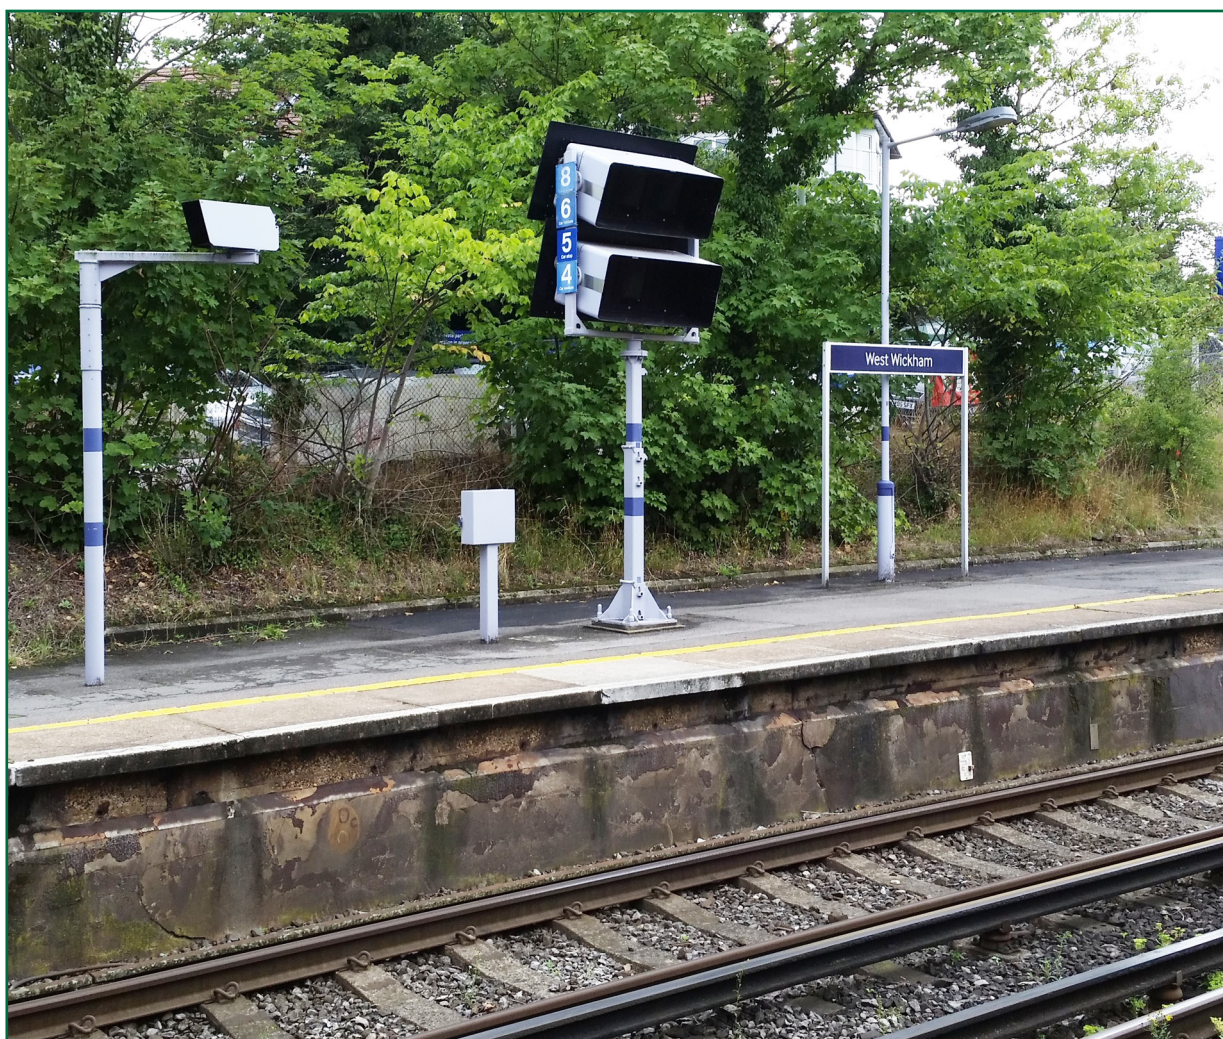
- 18 Two banks of DOO monitors are provided at the eastern end of platform 2 at West Wickham station. The monitor bank relevant to the accident is provided for trains comprising up to eight vehicles, and is located around 70 metres from the end of the platform (figure 6).

Figure 6: The eight vehicle monitor bank at West Wickham platform 2

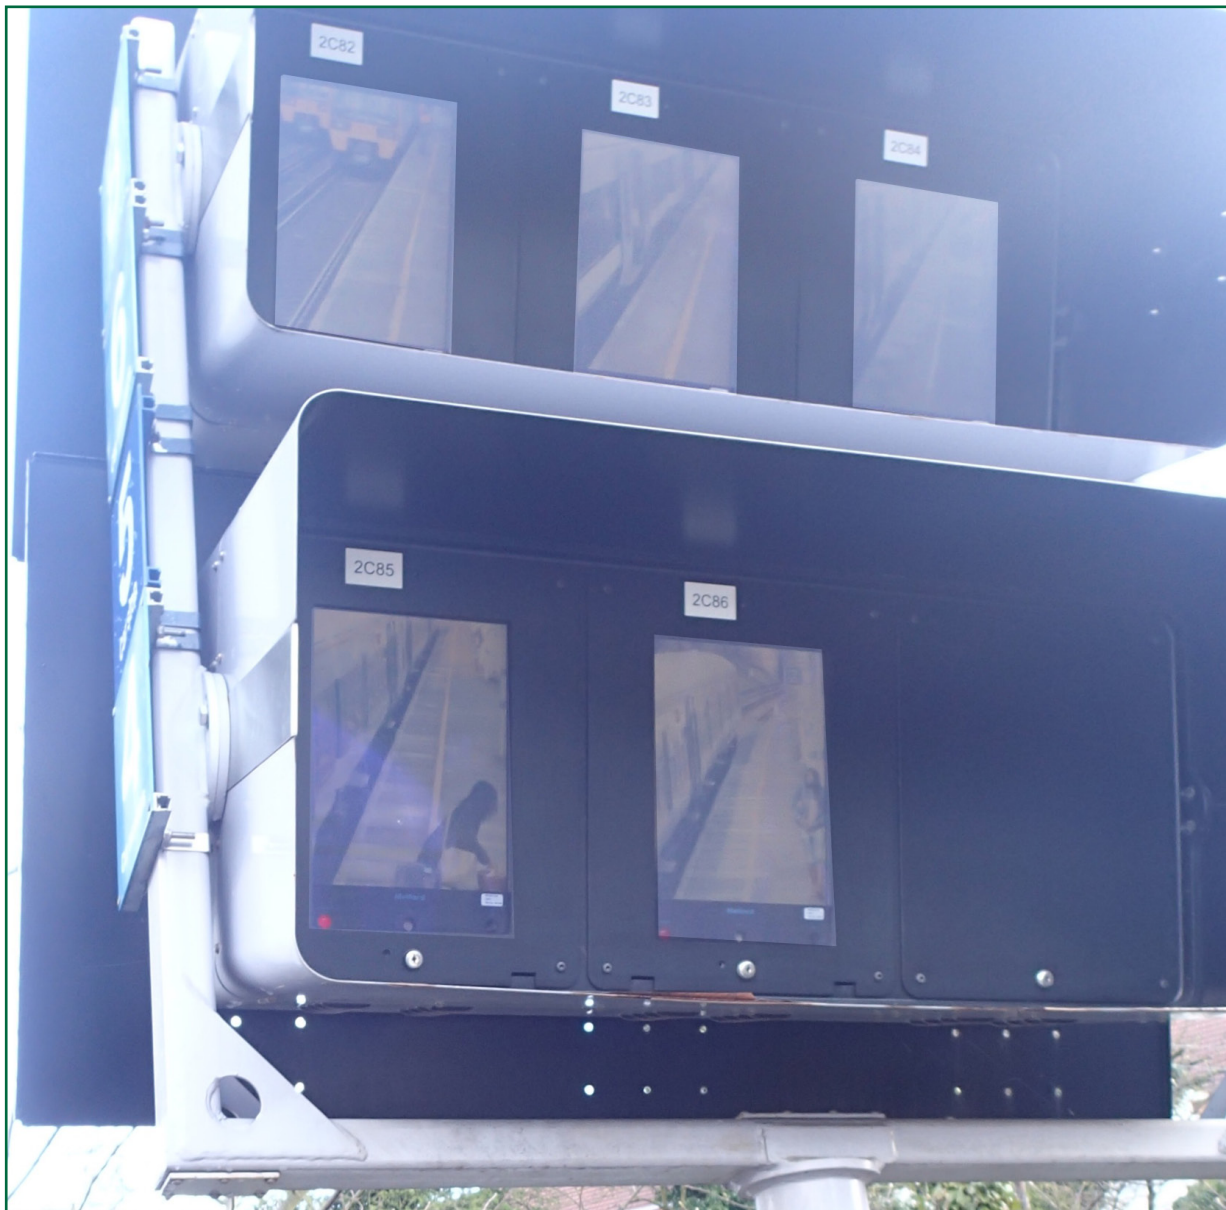
- 19 The eight-vehicle monitor bank houses five *thin-film transistor* (TFT) type monitor screens, each measuring 15 inches (381 mm) diagonally. Each screen is linked to a single CCTV camera. The monitor bank provides train drivers with a colour view of the side of the train and all the passenger doorways (figure 7).

Figure 7: View of a train displayed at the eight-vehicle monitor bank at West Wickham platform 2 (note: the monitor bank images are clearer when seen with the naked eye)

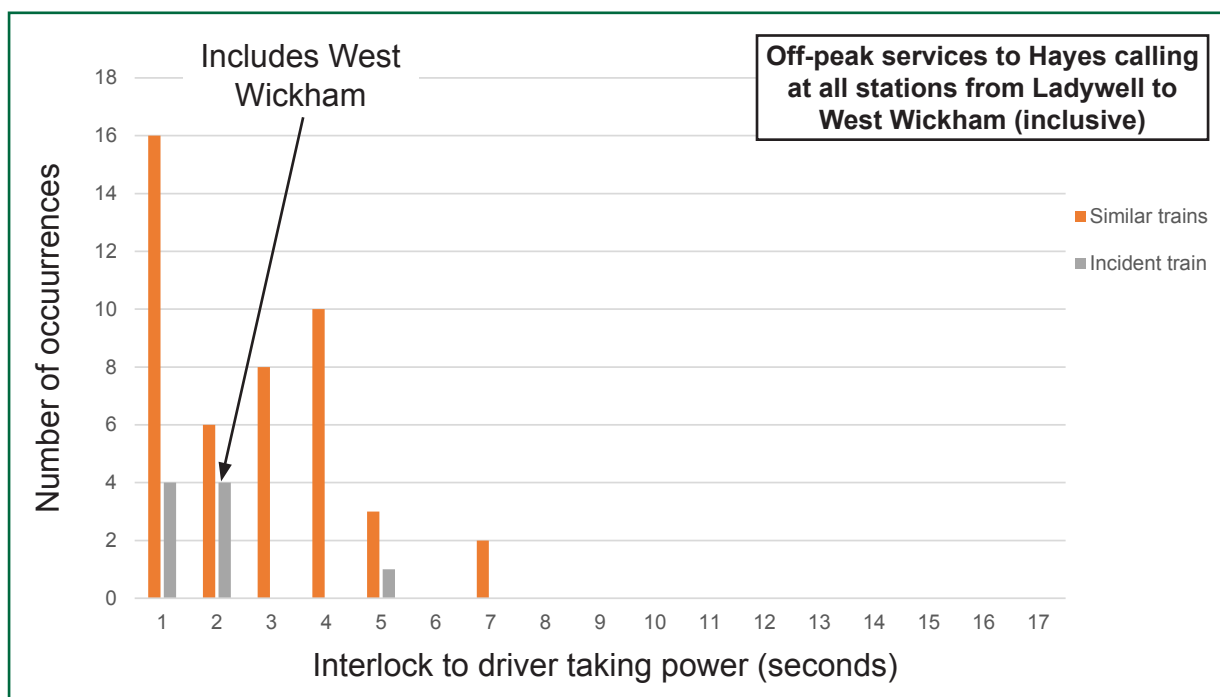
- the instructor's view of the cab window was partially obstructed by the trainee who was on the side of the cab nearest the monitors.
- 93 The OTDR fitted to the incident train recorded that the period of time between the door interlock light illuminating in the driving cab, and the trainee driver operating the train's power controller, was around 2 seconds. The railway rule book requires that the train safety check must be completed after the doors have closed and the door interlock light has illuminated (paragraph 37). Although a relatively short period of time, OTDR data from five other off-peak services from London Cannon Street to Hayes (ie services similar to that involved in the accident) show that the period of 2 seconds was not unusual at West Wickham and similar stations (figure 13). About 13% of stops included a similar period, 36% of stops include a lesser period of about 1 second and about 51% of stops include a period of 3 or more seconds.

Figure 13: Time interval between interlock and taking power
