Royal Navy Flight Safety
& Accident Investigation Centre

Accident Report 3/01 (Field)
Hind Mi24V SL202
On 19 October 2001

Reference: FSAIC/R3/01

ACCIDENT TO HIND Mi24V SL202 ON 19 OCTOBER 2001

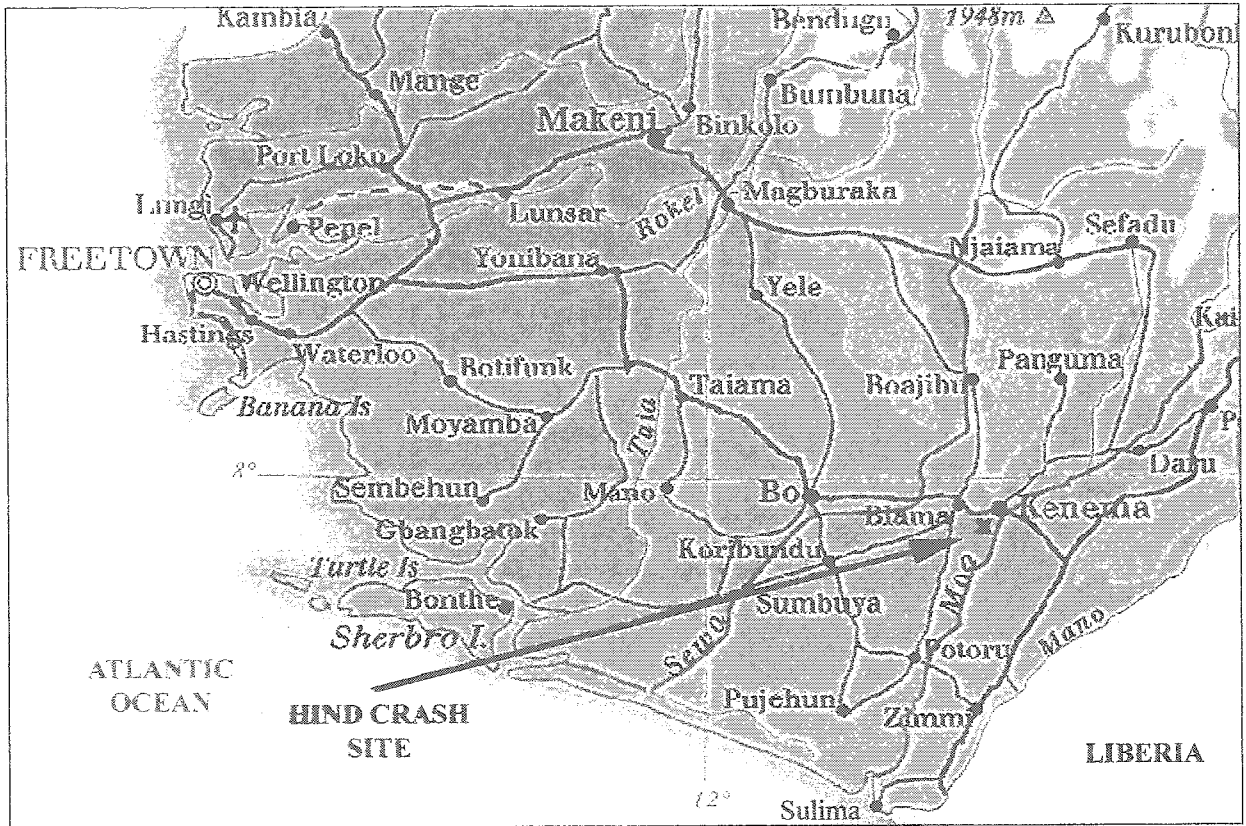
Figure 1 – Crash site location.

3. On the 18 October 2001 the aircraft, a Mi24V Hind (Tail No. SL 202), was tasked to fly from Cockerill Barracks in Freetown Sierra Leone to HQ 3 Brigade at Kenema via Sulima. (See figure 1). The crew consisted of a pilot, co-pilot and air gunner. The pilot was an ex-South African Air Force pilot working as a civilian for Jesa Air West Africa. The co-pilot (Flight Lieutenant) and air gunner (Lance Corporal) were from the (SLA) Air Wing. The crew all occupied their normal positions in the aircraft with the pilot in the rear uppermost cockpit, the co-pilot in the front lower cockpit and the air gunner by the cabin left-hand side doorway. The aircraft was carrying 3 British Forces passengers, working for the IMATT; a Lieutenant Commander (Lt Cdr), a female Army Major and a Lance Corporal (L/Cpl) medic.

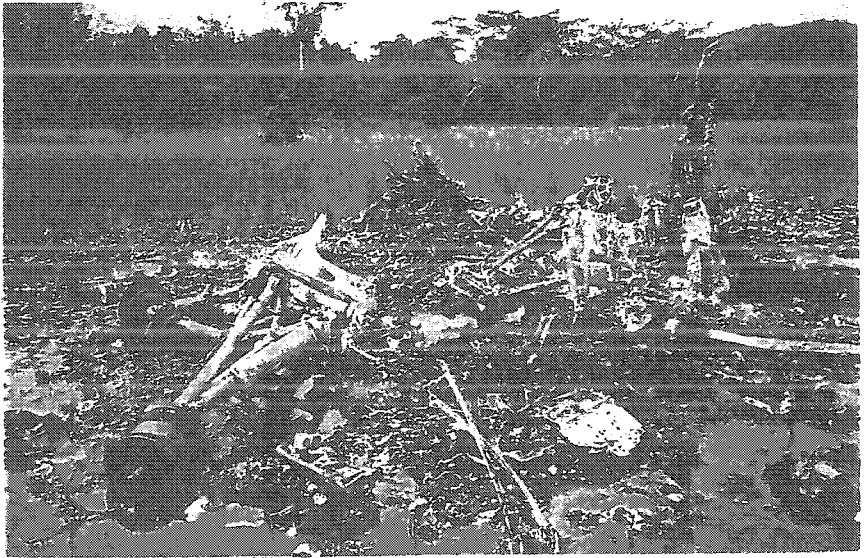
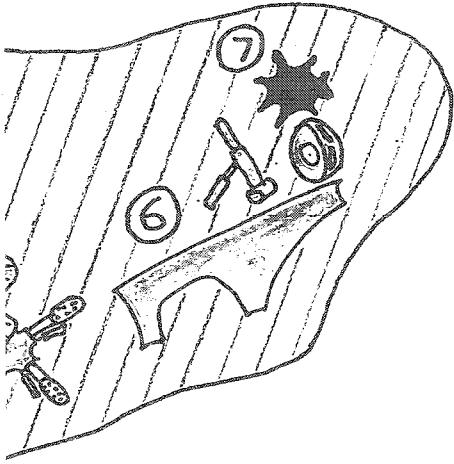
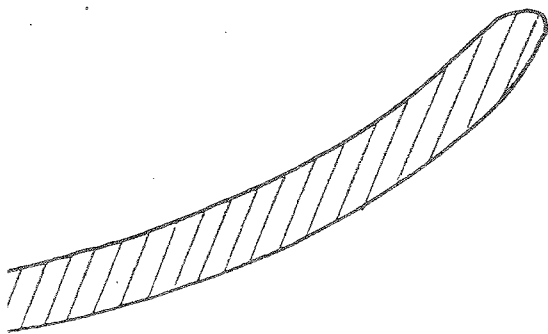
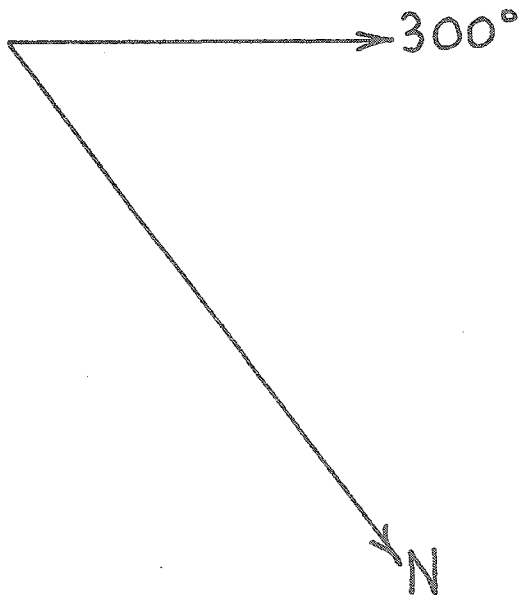
Figure 3

41. Whilst on site, a limited survey was carried out. (See figure 3).

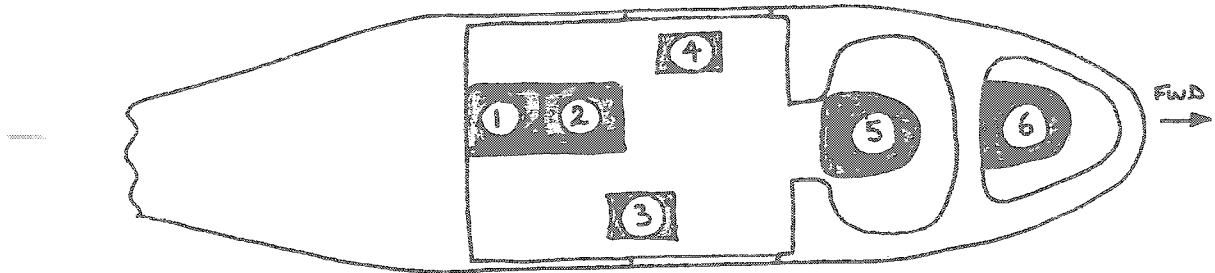
58. Seating Positions. Both the pilot and co-pilot occupied their normal crew positions in their cockpits and were fully strapped into their respective seats with a 4-point harness. [REDACTED]

Figure 4 – Crew and passenger seating positions.

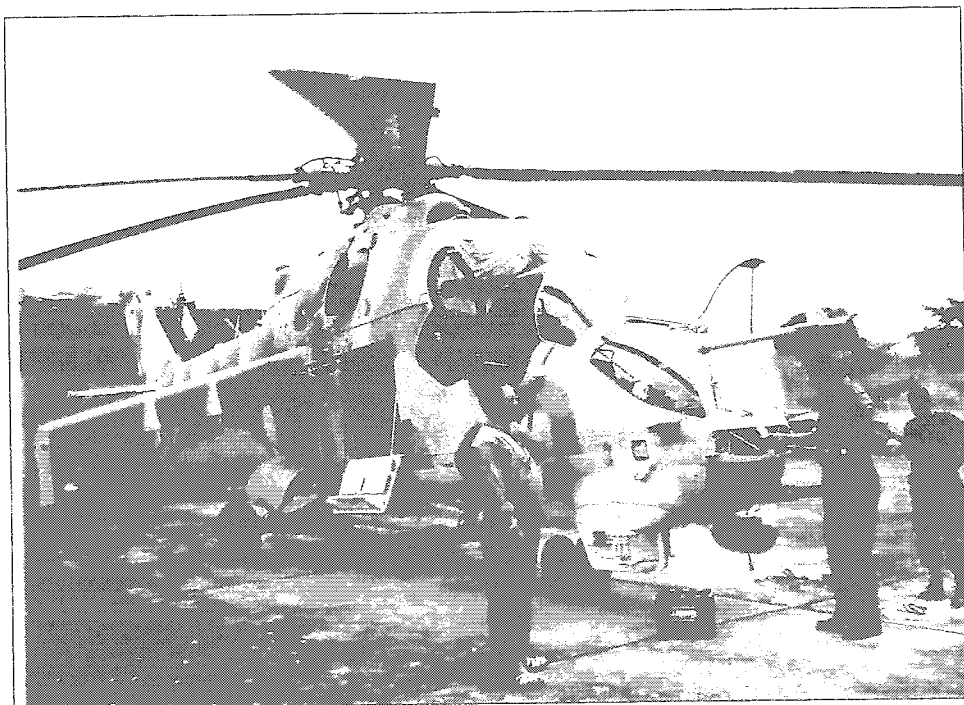
61. After the aircraft had come to rest, the co-pilot immediately opened his cockpit canopy (which hinges on the right-hand side and opens upwards on the left-hand side of the aircraft, (see photograph 14) climbed out of his cockpit and ran out to the front left away from the aircraft for a distance of approximately 5 metres. He then stopped and looked back towards the aircraft and noticed that the damaged main rotor blade root ends were still turning very slowly and the area around both main engines and the front of the main rotor gearbox was on fire. He shouted a warning to get out of the aircraft to the other aircraft occupants. Almost immediately afterwards, the air gunner and the L/Cpl medic climbed out through the cabin's open right-hand side door. The air gunner and the medic

62. Just after the aircraft had come to rest, 1 [REDACTED] he discovered that his cockpit canopy was partially open (having been opened by the air gunner). Because the aircraft was lying at an angle of 45° on its right-hand side and the canopy opened on the right-hand side of the aircraft, the door was prevented from opening fully by the ground. The pilot attempted to operate the fire extinguisher buttons, ensured that both engine fuel shut off levers were retarded (LP cocks) and possibly operated the rotor brake. With the severely damaged main rotor blades stationary, the pilot unfastened his 4-point harness and with difficulty exited through the partially open cockpit canopy. The pilot made his way towards the front of the aircraft for a distance of approximately 10 metres.

Photograph 14 – Hind SL201 showing opened cockpit and cabin doors.
