# **Service Inquiry**

Puma XW229 11 Oct 15

SI/18/15/XW229

# SERVICE INQUIRY INVESTIGATION INTO ACCIDENT INVOLVING A PUMA HC MK 2 XW229 AT HEADQUARTERS RESOLUTE SUPPORT, KABUL, AFGHANISTAN ON 11 OCT 15

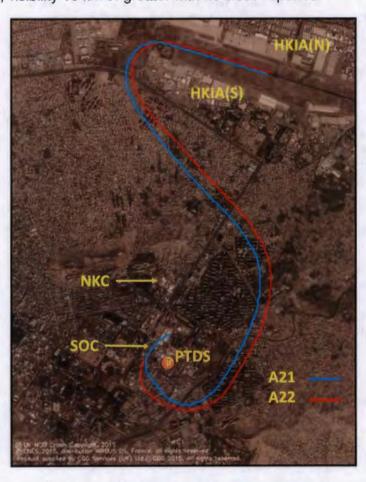
Figure 1.3.1 - Formation route and key locations

1.3.9 The formation departed HKIA (N) at 1617 hrs initially following the track of Runway 29 before turning to the South East for the 2.4 nm (4.5 km)<sup>9</sup> transit towards HLS SOCCERFIELD (SOC) at Headquarters RESOLUTE SUPPORT (HQRS)<sup>10</sup>. The formation route and key locations are shown in Figure 1.3.1. The aircraft flew 'Trail Formation' which allowed A22 to operate between 2 rotor spans and 2 km from the lead aircraft; the formation transited at a height of 500 ft Above Ground Level (AGL). The reported meteorological conditions at SOC were; wind variable 4 kts, visibility 10 km or greater with no cloud reported.
