Rail Accident Report

Derailments at London Waterloo 11 September and 24 October 2006

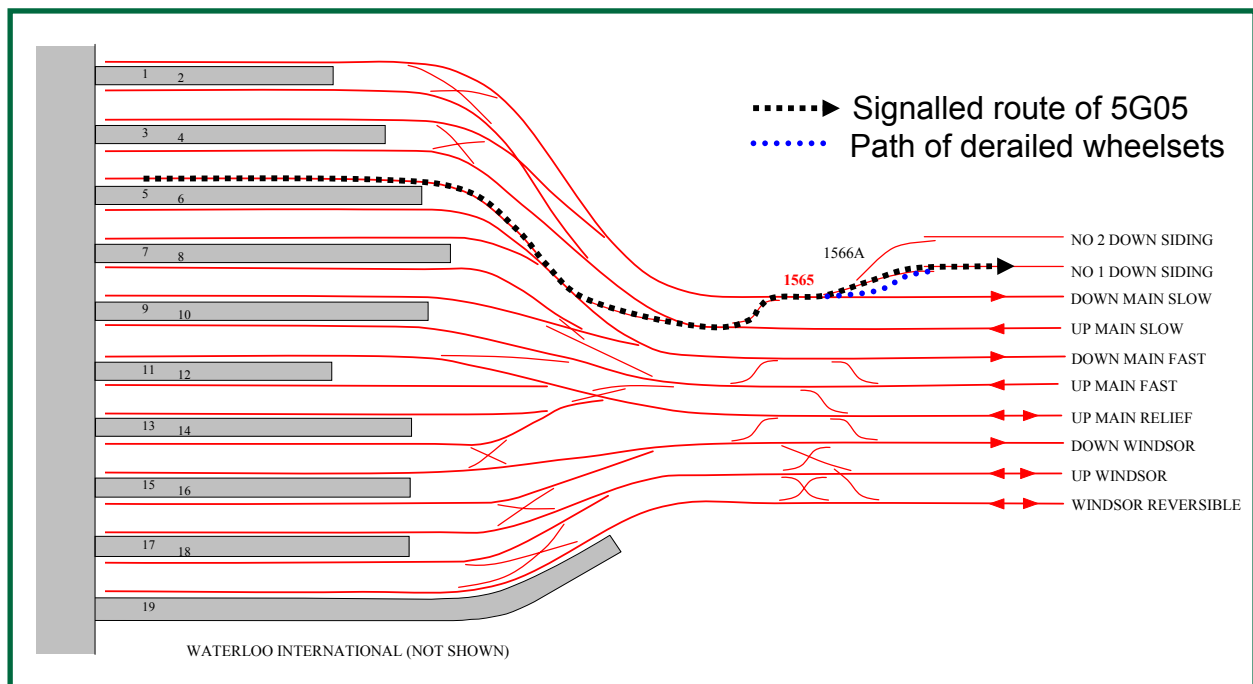
Figure 2: Schematic diagram of derailment at 1565 points

- 31 On 11 September 2006, train 5G05 made a low speed empty-coaching stock move into the Waterloo down sidings from platform 5 (Figure 2). The train, with only the driver on board, derailed at 22:48 hrs when the leading wheelset of the rear coach climbed the switch blade of 1565 points. This allowed the flange to drop into the gap between the stock rail and switch blade 1.2 m from the *switch toes*, and run into derailment. The leading bogie was fully derailed, until its leading wheelset subsequently re-railed itself on 1566A points, within the sidings. The train came to a halt clear of the main lines, and the driver was unaware of the incident until the power supply was lost. There were no injuries.

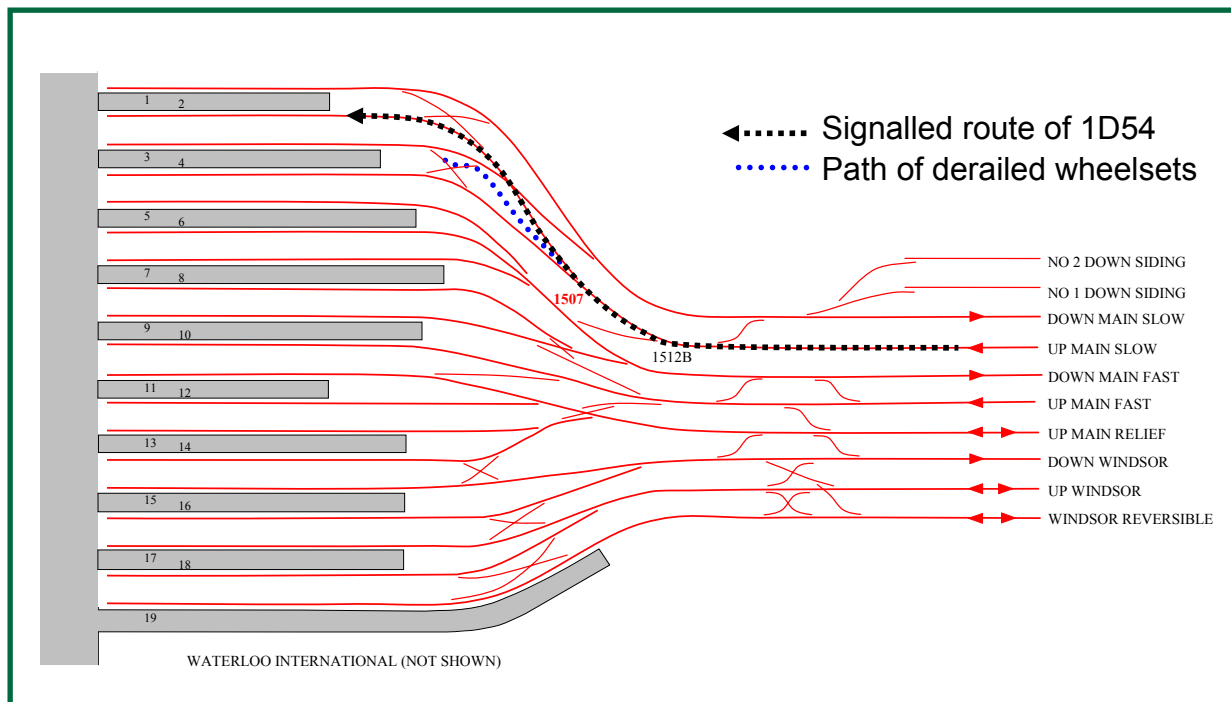
Figure 3: Schematic diagram of derailment at 1507 points

- 32 On 24 October 2006, train 1D54 forming the 1735 Dorking – London Waterloo service was routed from the up main slow line towards platform 2 of Waterloo station via 1512B and 1507 points (Figure 3). The derailment occurred at 18:27 hrs as the 7th and 8th carriages crossed 1507 points at low speed on the final approach to London Waterloo.
- 33 The train came to a halt with the 7th and 8th vehicles upright and still attached to the remainder of the train, but straddling the lines between platforms 2 and 3 (Figures 14 and 15). Stationary trains occupying platforms 1, 3 and 4 became ‘trapped’ by the obstruction caused by the derailed vehicles and consequential loss of the power supply.

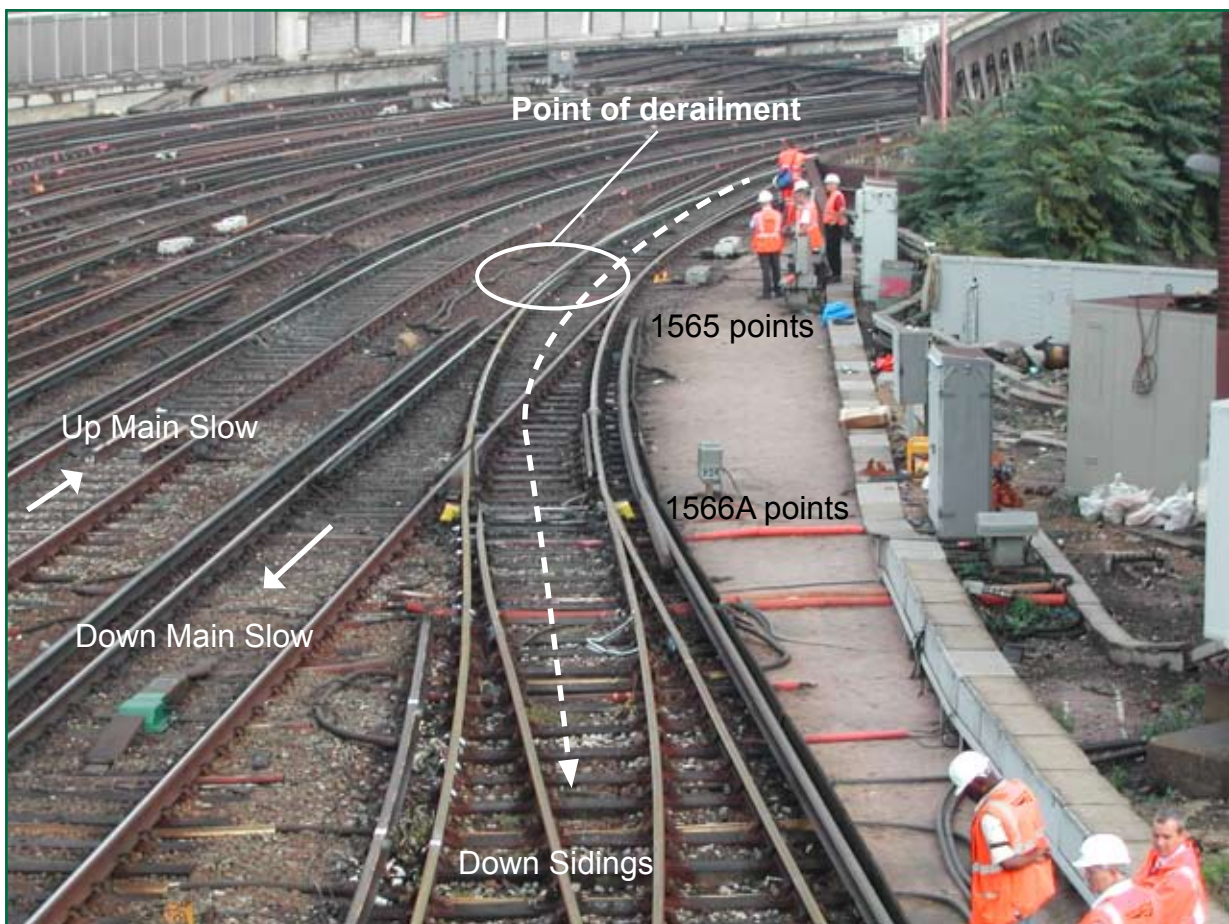
Figure 8: View of 1565 points looking towards London Waterloo, showing route of train 5G05

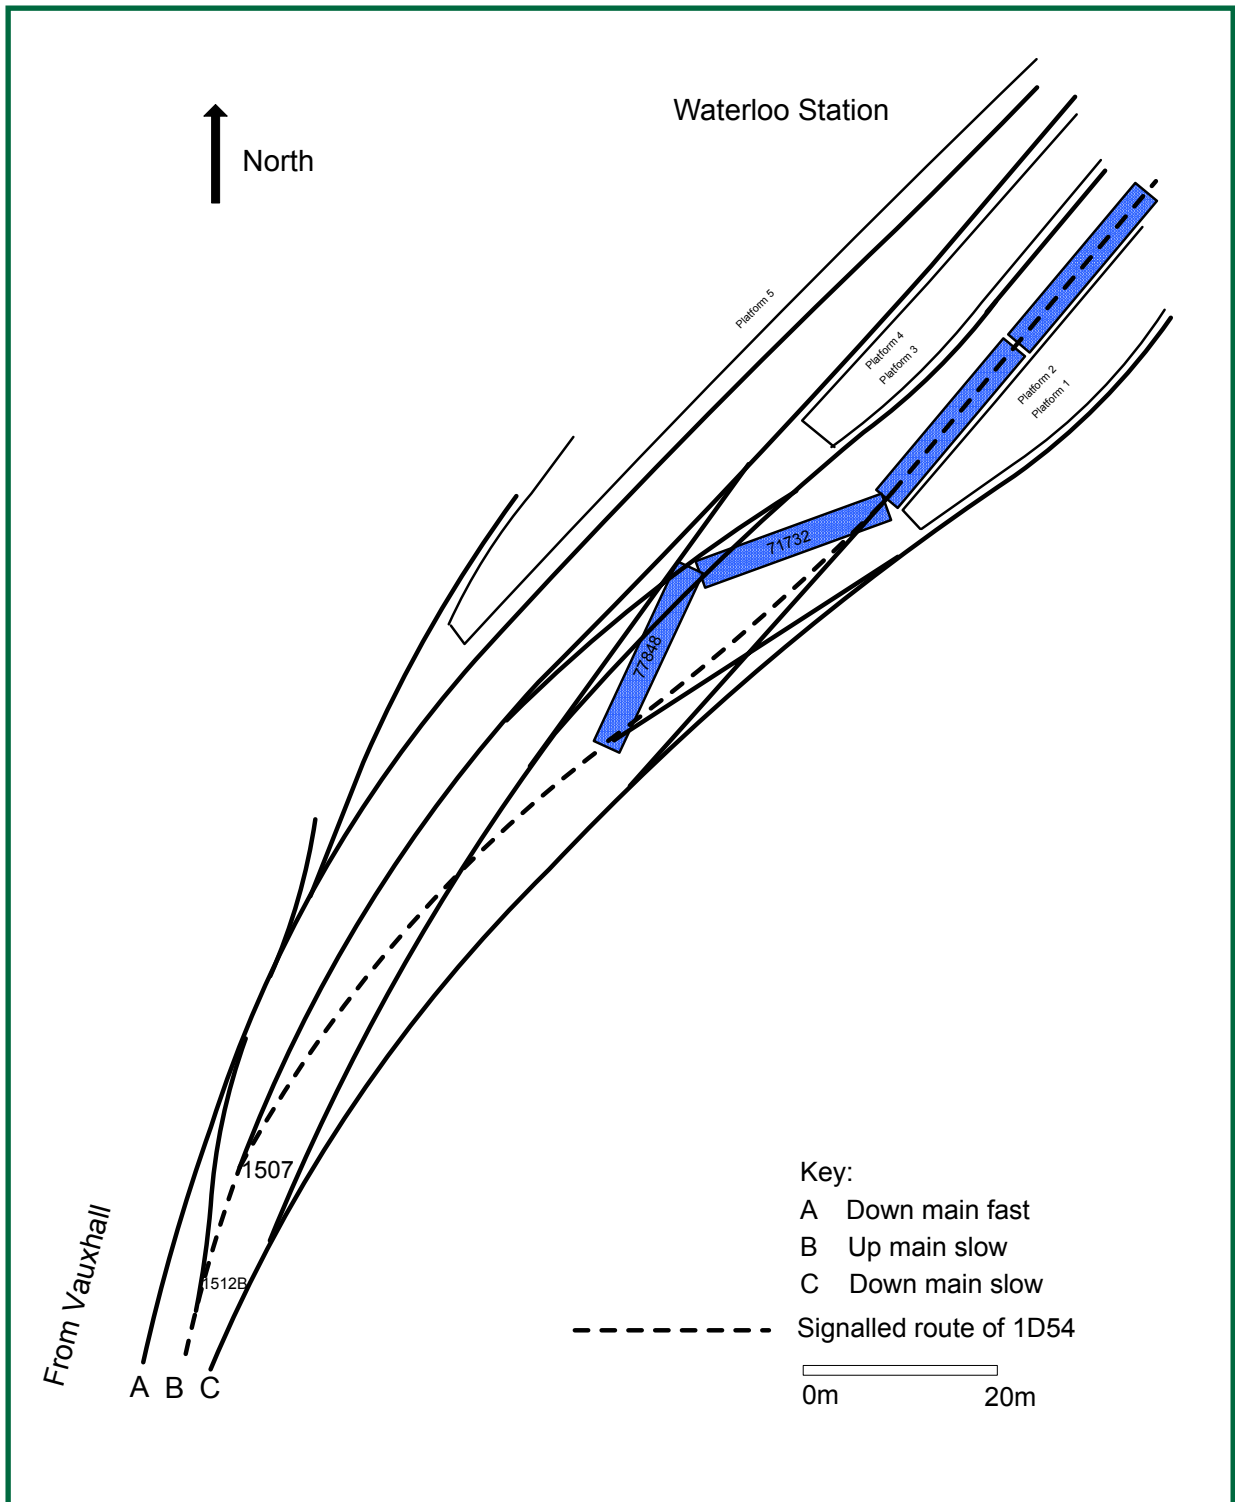
187 The derailment was caused by the flange of the left-hand wheel on the leading axle of coach 7 climbing the left-hand switch blade, before progressing to the stock rail/switch blade interface, splitting the points and running into derailment. The following wheelsets were all derailed. There was also evidence, from marks on the rails, that several other wheelsets had attempted to climb the left switch blade but had corrected themselves without proceeding into full derailment.

Figure 14: Diagram showing position of train 1D54 following derailment
