Rail Accident Report

Derailment of a freight train near Moor Street station, Birmingham 25 March 2008

Report 07/2009
March 2009

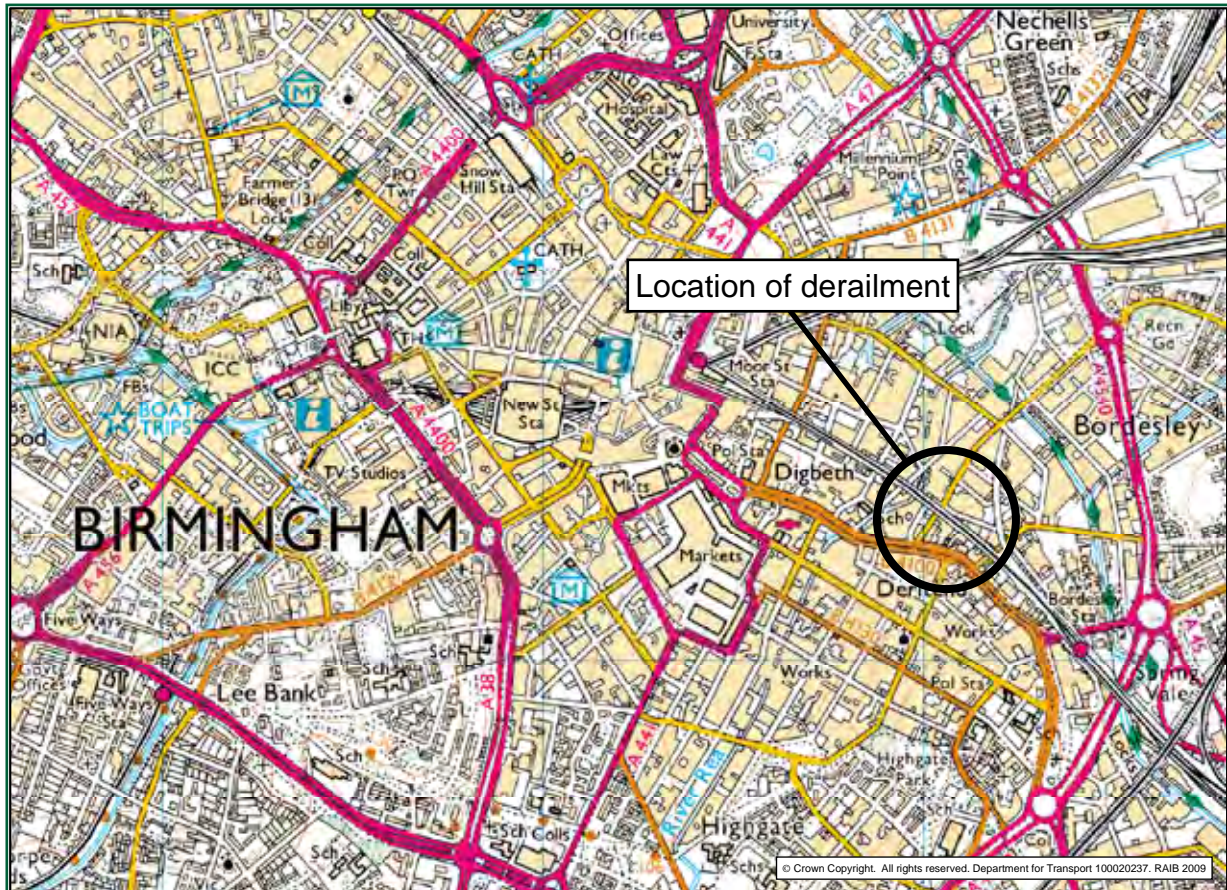
Figure 1: Location of the derailment

- 6 At 06:37 hrs on 25 March 2008 train 6M15 became derailed on *plain line* on the *up* and *down* goods line on the approach to Moor Street South junction (Figure 1). The train, the 01:46 hrs Aldwarke to Handsworth, consisted of a class 66 locomotive and 30 empty SSA four-wheel box wagons, and was travelling at 15 mph (24 km/h) at the time of the derailment.
