AAIB Bulletin

9/2016

Aircraft Type and Registration:	BAe ATP, G-BUUR
No & Type of Engines:	2 Pratt & Whitney Canada PW126 turboprop engines
Year of Manufacture:	1990 (Serial no: 2024)
Date & Time (UTC):	26 January 2016 at 1950 hrs
Location:	On approach to Guernsey Airport
Type of Flight:	Commercial Air Transport (Cargo)
Persons on Board:	Crew - 2 Passengers - None
Injuries:	Crew - None Passengers - N/A
Nature of Damage:	None
Commander's Licence:	Airline Transport Pilot's Licence
Commander's Age:	60 years
Commander's Flying Experience:	6,843 hours (of which 1,512 were on type) Last 90 days - 74 hours Last 28 days - 23 hours
Information Source:	AAIB Field Investigation

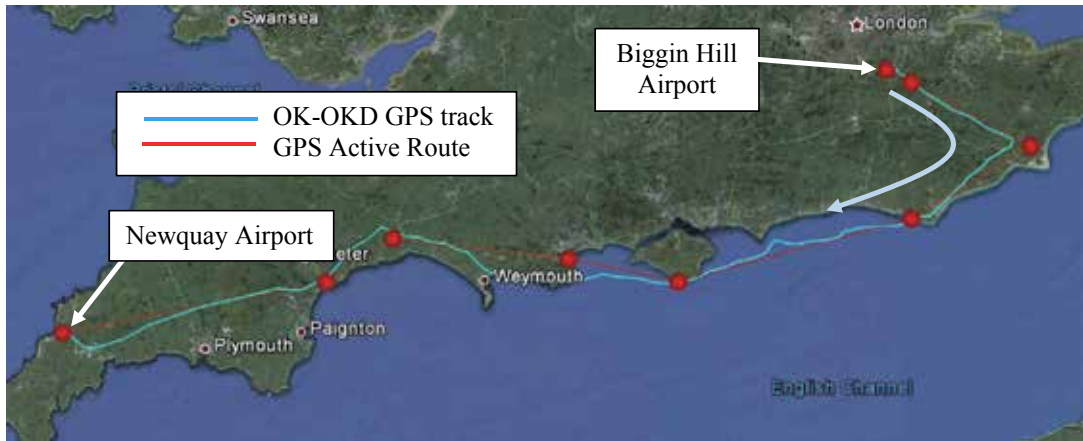
Figure 1

The aircraft departed for Newquay at 1634 hrs. It flew south-east towards the coast and then turned west. A plot of the nine waypoints on the planned route, together with the aircraft's recorded track, are shown in Figure 1.

OK-OKD recorded GPS track

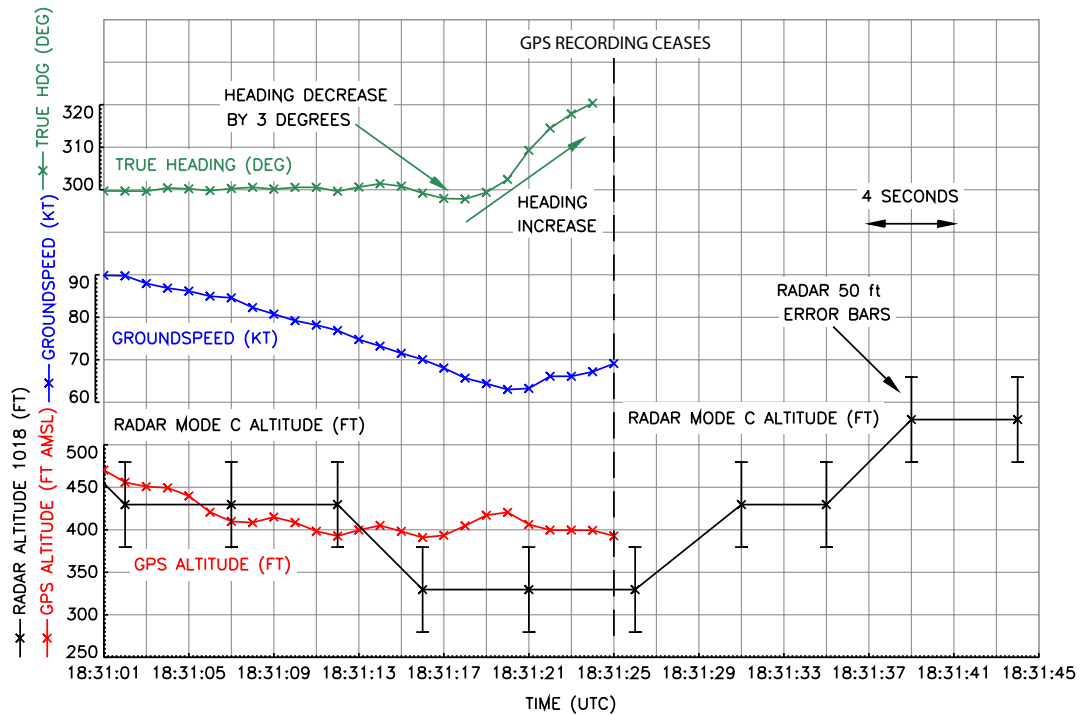
Figure 5

The heading then increased and continued to do so until the end of the GPS recording (see Figures 4 and 5). At 1831:20 hrs, the aircraft reached its minimum derived groundspeed of 63 kt as the GPS altitude increased to 421 ft amsl, over the runway. The GPS recording

OK-OKD GPS and radar data
