Rail Accident Investigation Branch

Rail Accident Report

Trains struck platform at Moston, Manchester 28 January 2015

Report 17/2015
October 2015

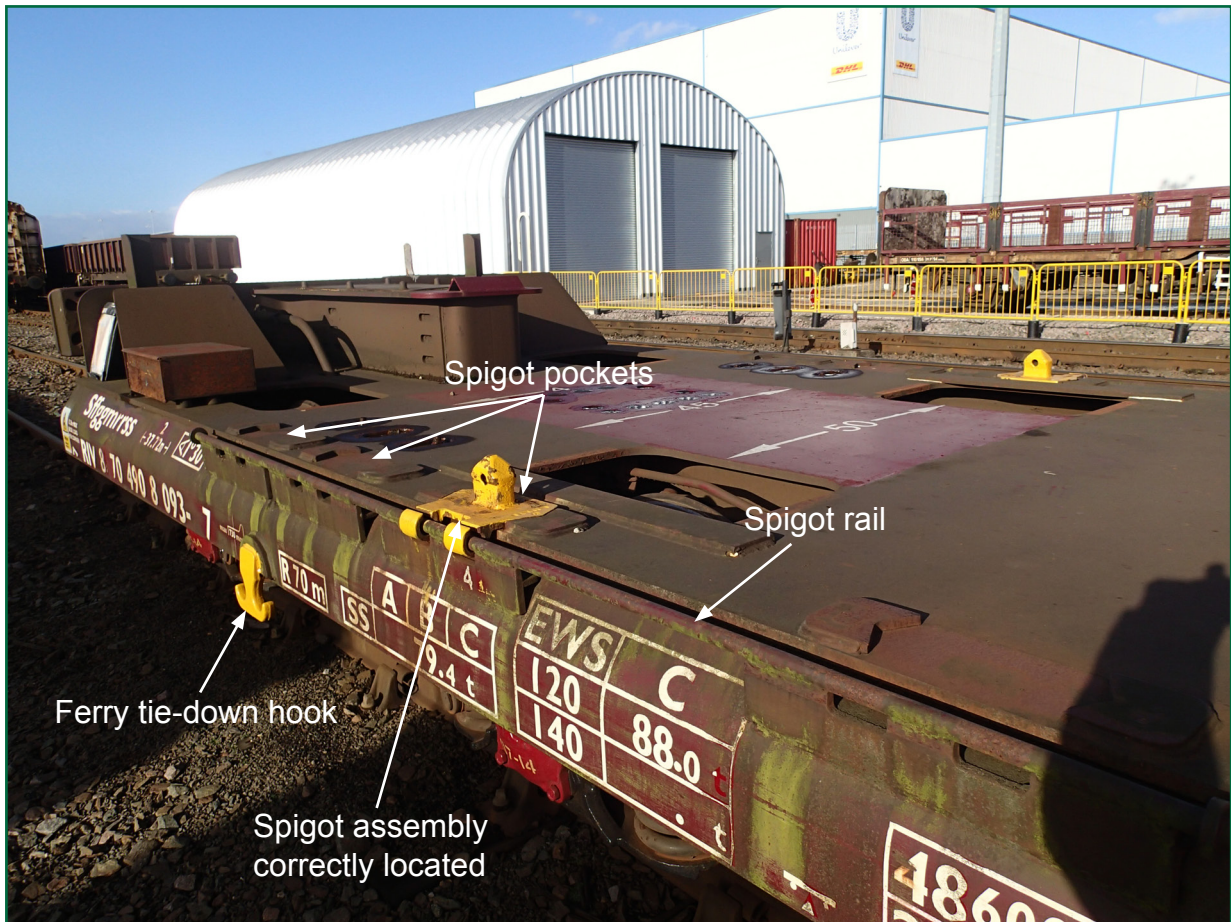
Figure 6: FKA wagon

- 15 Spigots, left out of their pockets on the FKA wagon that formed part of train 6E33, struck platform supports and dislodged coping stones from the Down platform at Moston.
- 16 FKA wagons comprise two semi-permanently coupled elements, each intended to carry one container secured by four spigots on the wagon which engage with sockets located at the bottom corners of the container. Each vehicle is therefore provided with four spigots, including two which slide along rods to accommodate containers of varying length. The spigots hinge about the rod allowing them to be rotated into, and out of, pockets on the top surface of the wagon. They can also be rotated outwards so that they rest against the outer side of the wagon in a position where they project outwards, and extend further from the centre of the track than any other part of the wagon (figures 6 and 7).

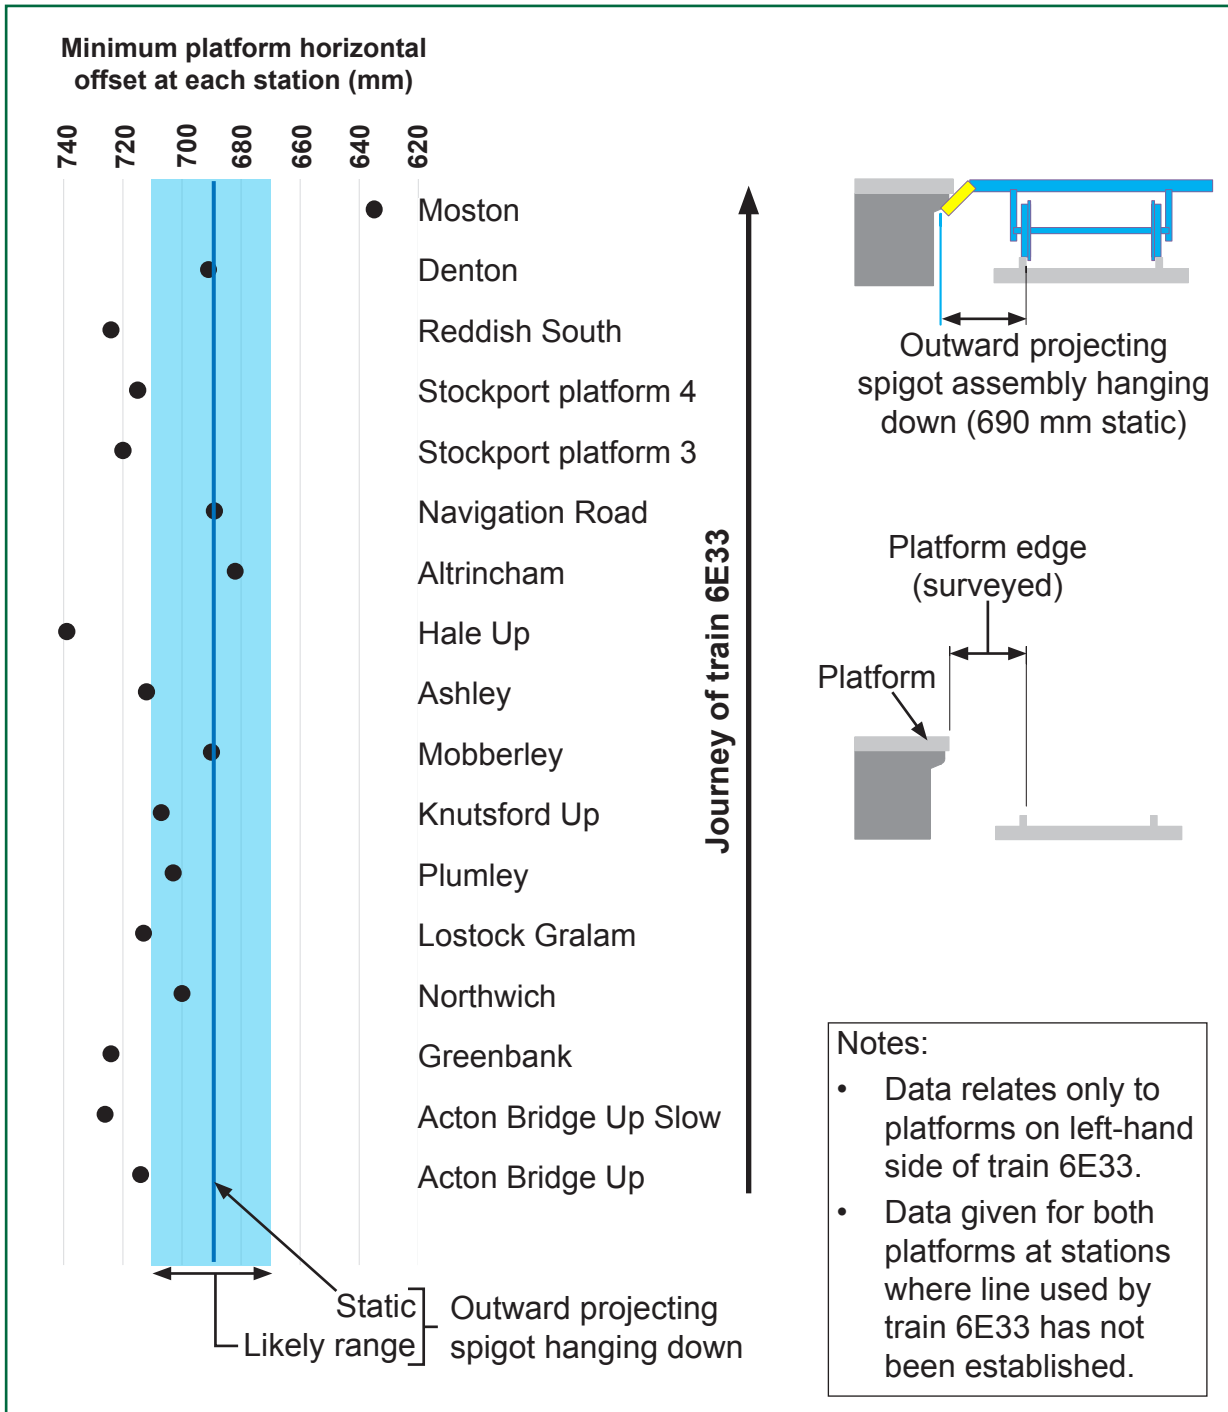
Figure 16: Minimum track to platform offsets on journey of train 6E33

- 43 Evidence that many station platforms are not compliant with modern design standards is provided by considering the minimum distance between the platform and track at the 14 stations which train 6E33 passed through between Warrington and Moston. This data, obtained from routine surveys (paragraph 38) and plotted on figure 16, shows that:

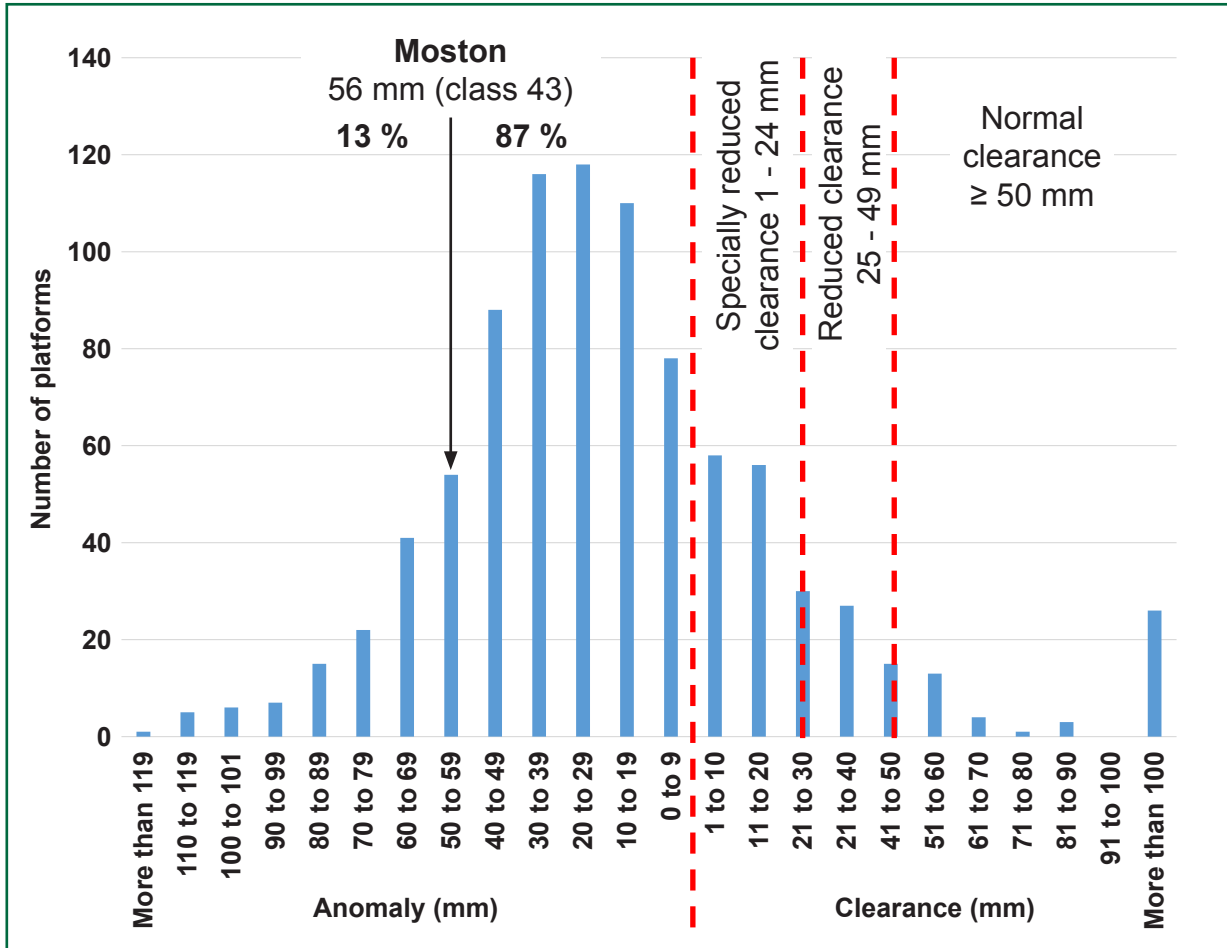
Figure 17: Platform clearances in northern part of London North Western route

- 48 A download from TiCleD database provided to the RAIB in March 2015 showed that around 13% of 894 platforms on the northern part of the London North Western route have a greater anomaly than that at Moston down platform, 61% have a lesser anomaly, 21% have a specially reduced or reduced clearance and 5% are classified as having a normal clearance (figure 17).

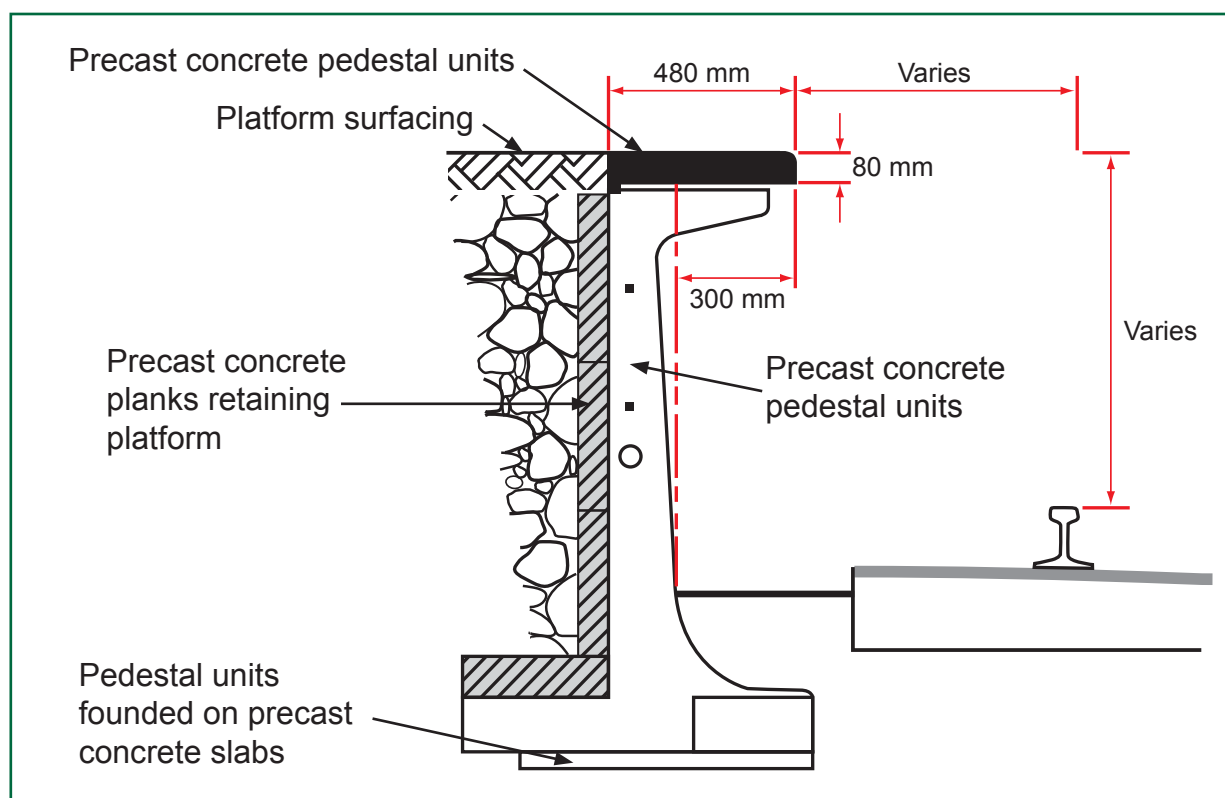
Figure 18: Platform support as-designed (detail provided by Network Rail)

- 52 Evidence of historic and recent movement of the down platform at Moston includes the following:
- Pre-accident inspections by Network Rail showing that concrete supports along the front edge of the platform had moved towards the track so that they projected beyond the coping stones, rather than the coping stones projecting beyond the supports (figures 18 and 19).

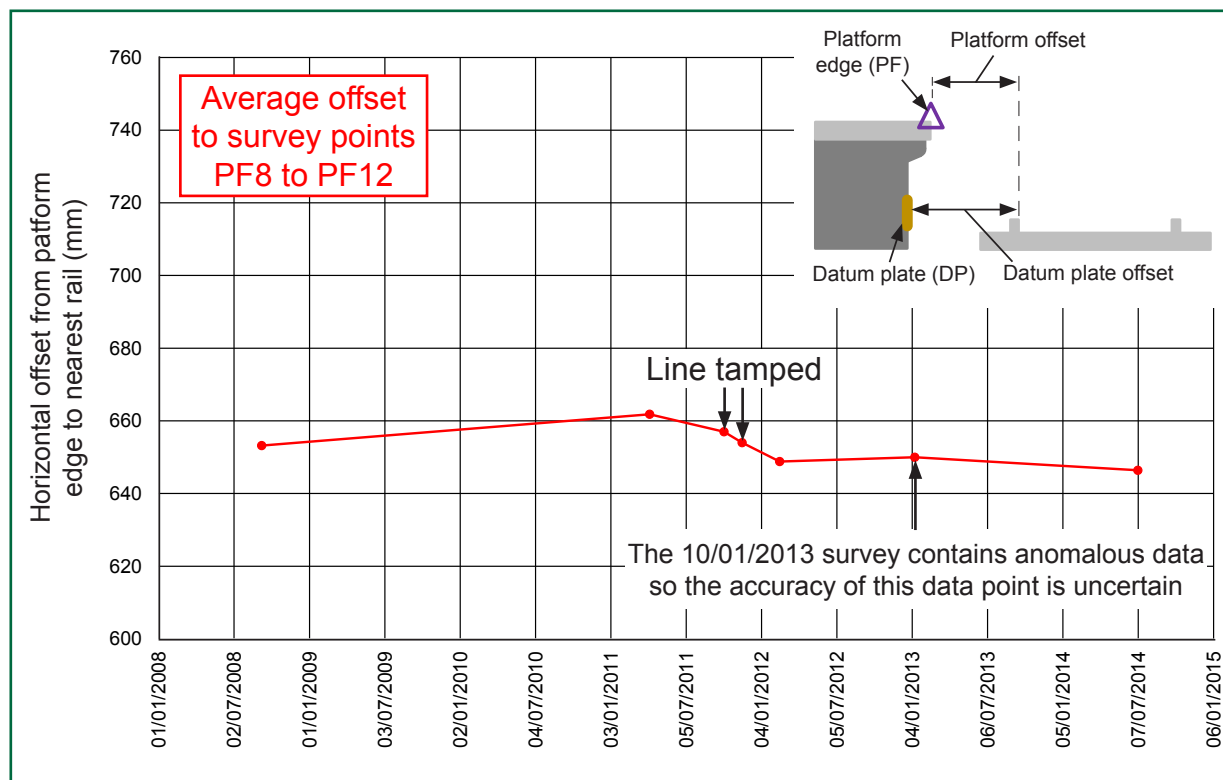
Figure 23: Incident area platform edge movements 2008 to 2014

- 57 Platform edge survey data recorded by Network Rail since 2008 was analysed by the RAIB and shows no evidence of the platform-track spacing reducing significantly since January 2009 (figures 22 and 23). It is possible particularly tight offsets in the area of the accident (figure 22) are a consequence of historic platform movements, but it is also possible that they are a consequence of deliberately positioning the track to achieve a good track alignment.
