# ***AAIB Bulletin***

***5/2016***

S1/2016 Hawker Hunter T7	G-BXFI	22-Aug-15	3
--------------------------	--------	-----------	---

<b>Aircraft Type and Registration:</b>	Hawker Hunter T7, G-BXFI
<b>No &amp; Type of Engines:</b>	1 Rolls-Royce Avon Mk 122 turbojet engine
<b>Year of Manufacture:</b>	1959 (Serial no 41H-670815)
<b>Location:</b>	Near Shoreham Airport, West Sussex
<b>Date &amp; Time (UTC):</b>	22 August 2015 at 1222 hrs
<b>Type of Flight:</b>	Private
<b>Persons on Board:</b>	Crew - 1                      Passengers - None
<b>Injuries:</b>	Crew - 1 (Serious)      Passengers - N/A Others                      - 11 (Fatal)
<b>Nature of Damage:</b>	Aircraft destroyed
<b>Commander's Licence:</b>	Airline Transport Pilot's Licence
<b>Commander's Age:</b>	51 years
<b>Commander's Flying Experience:</b>	14,249 hours (of which 40 were on type) Last 90 days - 115 hours Last 28 days - 53 hours
<b>Information Source:</b>	AAIB Field Investigation

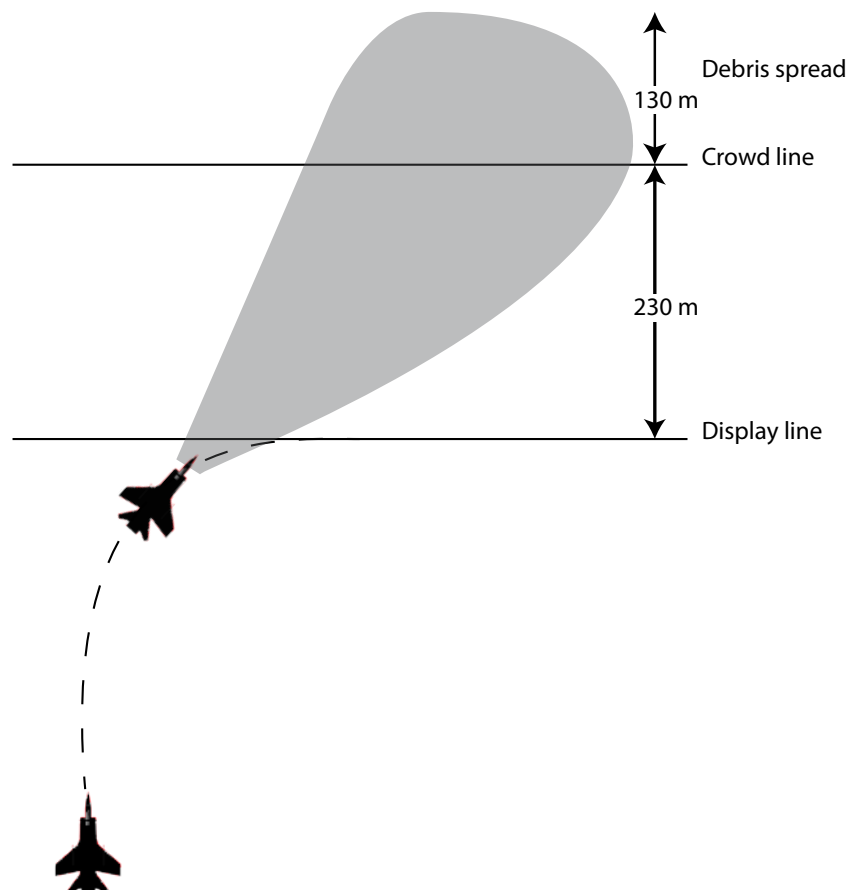
**Figure 2**

The study did not determine the likely number or severity of casualties. It showed that in the circumstances considered, and in the case of both types of aircraft, substantial pieces of wreckage such as engines would cross the crowd line. In the case of the fast jet aircraft it was predicted that the engine(s) would enter the crowd area by at least 130 m. (Figure 2).

It is recommended that the Civil Aviation Authority require that displaying aircraft are separated from the public by a sufficient distance to minimise the risk of injury to the public in the event of an accident to the displaying aircraft.

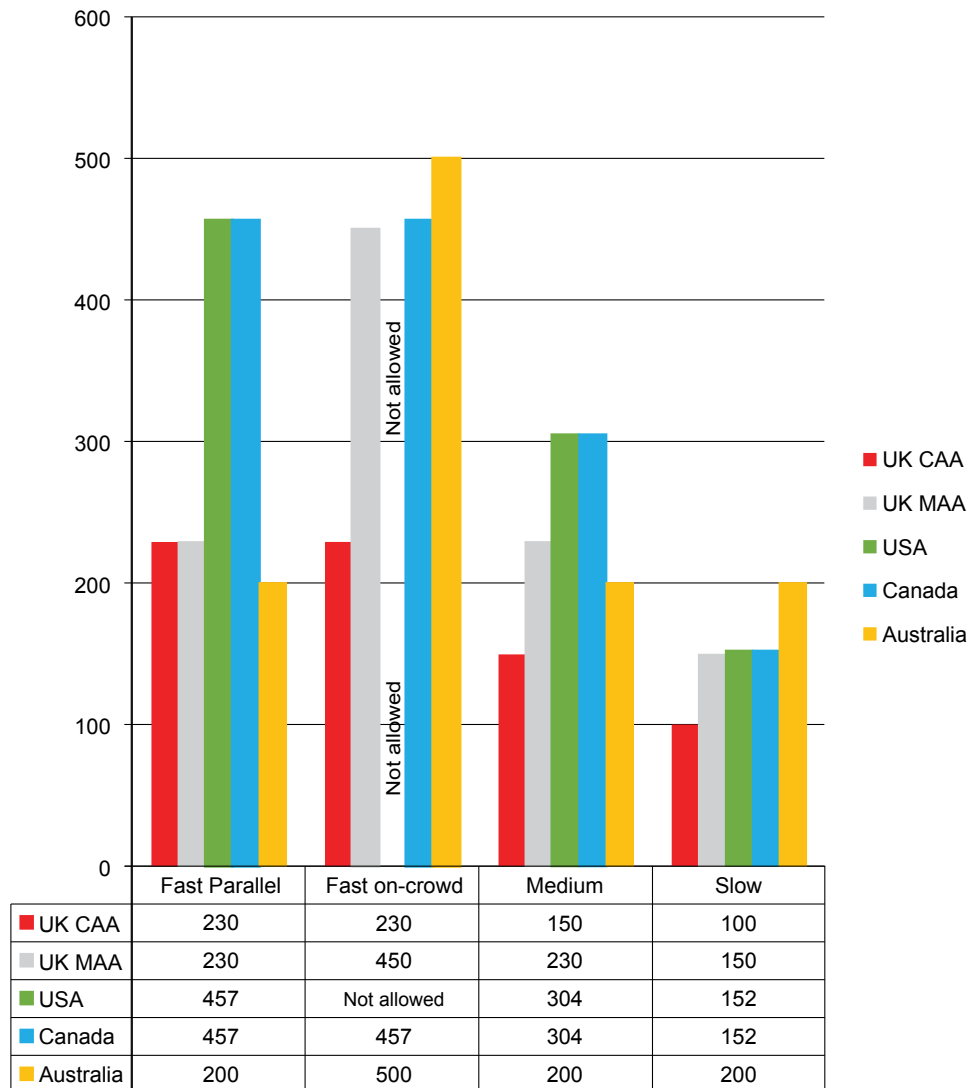
**Figure 3**

The UK Military Aviation Authority (MAA) requires a minimum separation distance of 450 m for military fast jet aircraft participating in air displays with a flightpath toward the crowd<sup>22</sup>. NATO, Transport Canada and Australia's Civil Aviation Safety Authority use similar minimums (see Figure 3). The FAA does not permit fast jet displays by civil operators to have on-crowd energy vectors for aerobatic flight.

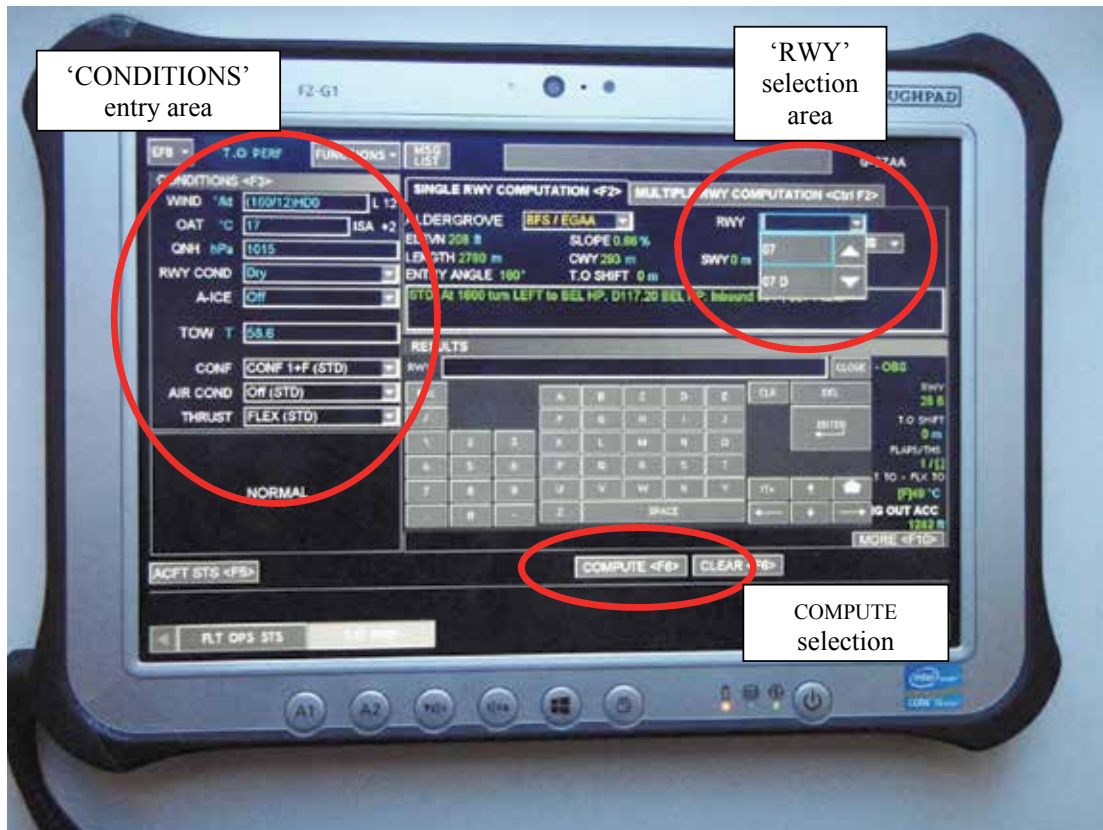
**Figure 2**

The operator provided a 13-page list detailing nine known anomalies / limitations of the FlySmart software applicable to Version 1507. In addition to this, during the course of this investigation, another anomaly was highlighted which can allow an involuntary change of runway selection and airport in the takeoff and landing performance screens. This was also raised in a separate ASR by the operator after the event.

One method of modifying the runway selection is to use the touch-screen on the RWY drop-down menu. If this is performed, the selected runway will blank and the menu will open to display a list of the available runways which can then be selected. The on-screen keyboard will also display and a blue box will frame the first entry in the drop-down menu which will be the lowest numbered runway (see 'RWY' selection, Figure 2).

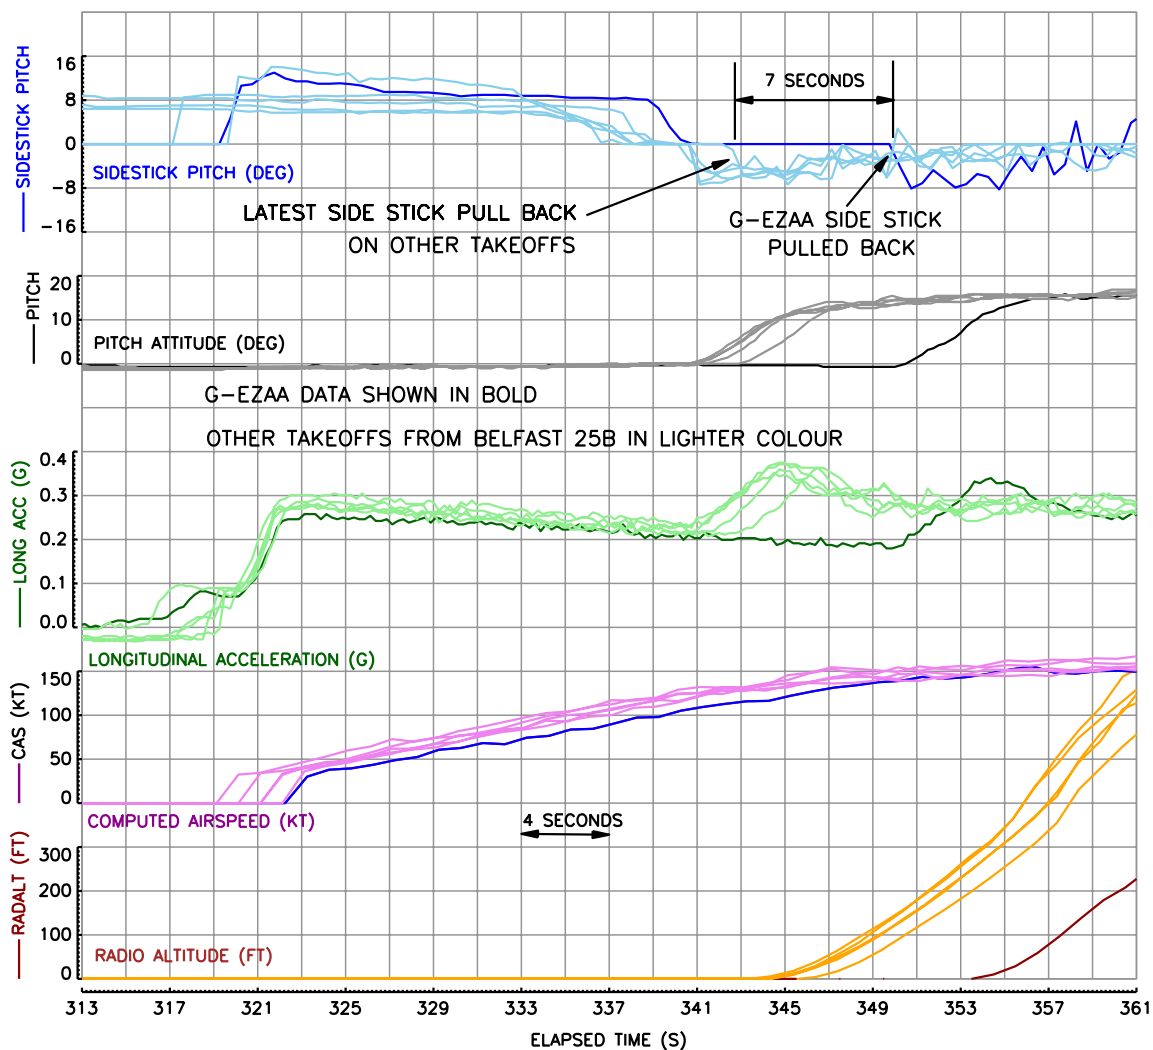
**Figure 3**  
G-EZAA QAR data and other Runway 25B takeoffs

This data shows that the G-EZAA longitudinal acceleration was only marginally lower than other FLEX takeoffs. What is more notable is the time difference between when the G-EZAA sidestick is pulled back to initiate the aircraft rotation, and that from other takeoffs. This shows the effect of using a  $V_R$  which was 10 kt higher than it should have been and that the aircraft remained on the runway for longer. This also reduces the margins available in the event of a rejected takeoff ( $V_1$  was also 17 kt too high).

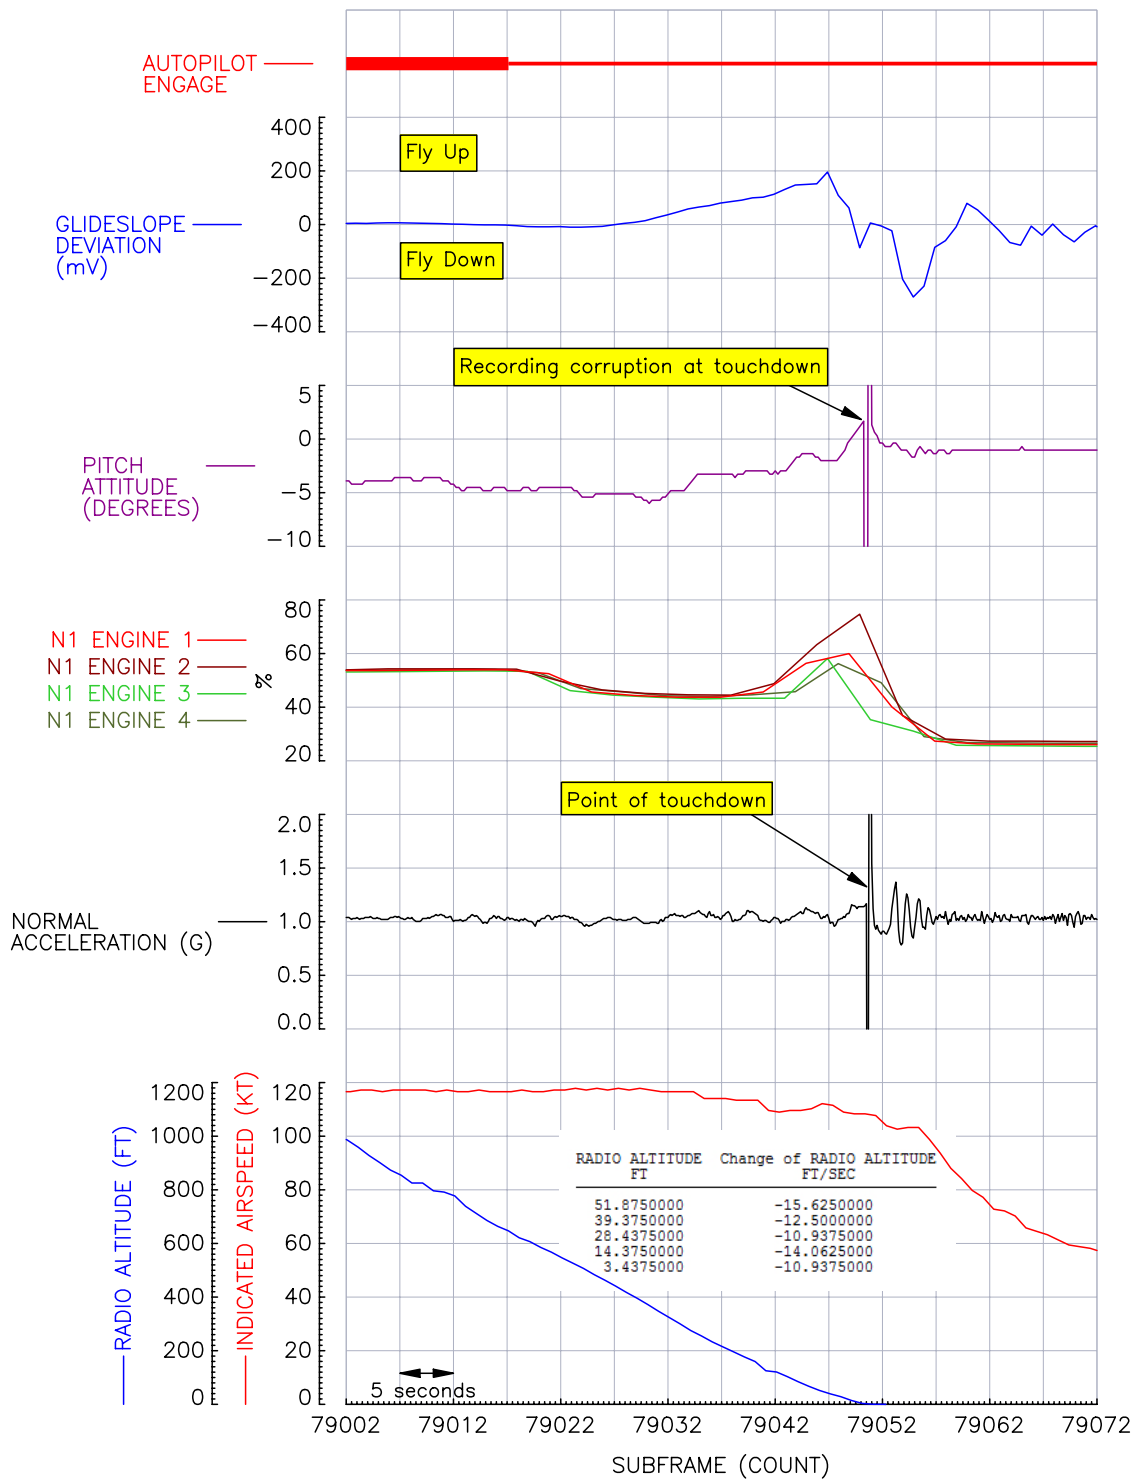
**Figure 5**

The FDR was used to plot the key parameters that were available for the landing and these are shown in Figure 5. However, it should be noted that around the point of touchdown the recording was corrupt for a number of parameters. Tape-based recorders are more sensitive to impact shock and such corruption does not affect solid-state devices.

Flight Data Recorder parameters for the landing sequence including tabular information on the change of Radio Altitude over the last 5 seconds of flight

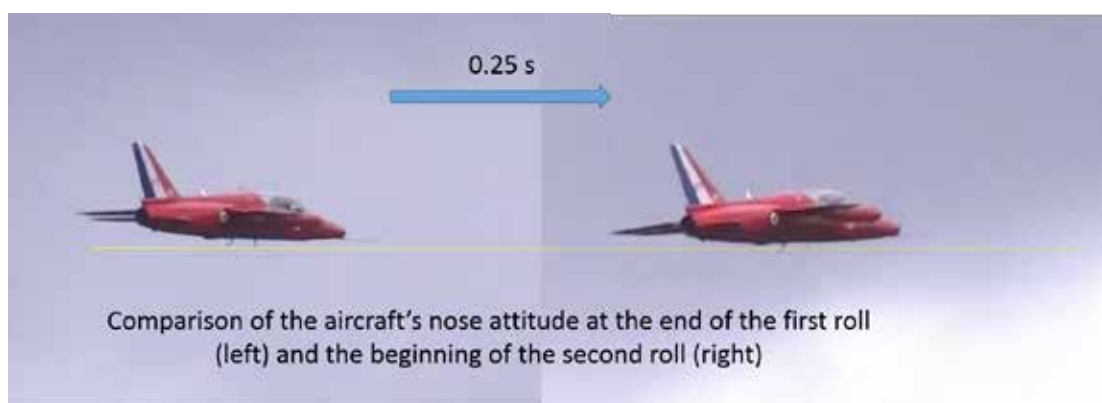
**Figure 9**

G-TIMM approached the display line from 'crowd left' and commenced a roll about its longitudinal axis, and the left image in Figure 9 shows the aircraft attitude at the end of that manoeuvre relative to the horizontal yellow line. The pilot then appeared to increase the attitude of the aircraft prior to commencing the second roll, as shown in the right image in the Figure, although the increase appeared slight on the video.

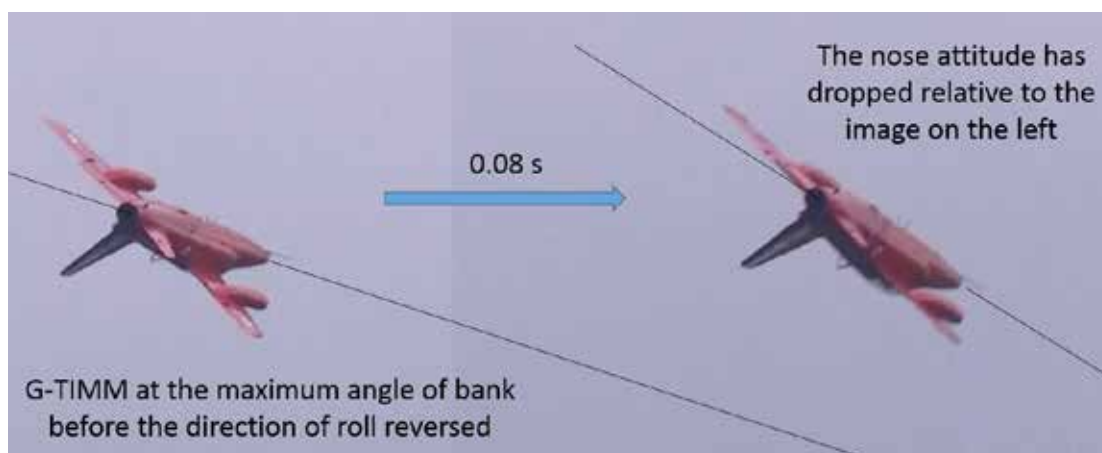
**Figure 10**

When G-TIMM reached the attitude shown in the left image within Figure 10, the nose attitude dropped relative to the horizon, a drop which was marked on the video. The black lines on the Figure are drawn along a line from the nose of the aircraft through the centre of the jet pipe at its rear to illustrate the drop in nose attitude (shown by the fact that the lines are not parallel).

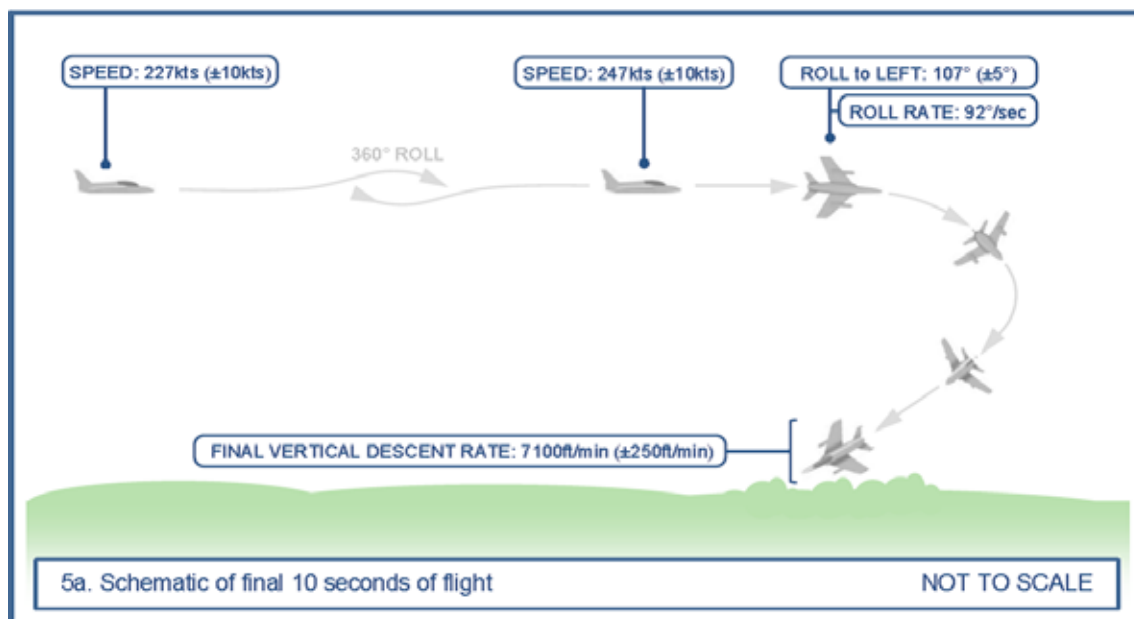
The video was submitted to the Ministry of Defence (MOD) for analysis. Measurements were made from individual frames with reference to known dimensions of the aircraft, and by matching a 3D computer aided design (CAD) model of the aircraft to sequential images captured from the video. It was not possible to determine the height and attitude of the aircraft relative to the ground from the video evidence but the remaining results, taken from the MOD's report, are presented in Figure 14 and Table 2.

Schematic representation of the final 10 seconds of flight

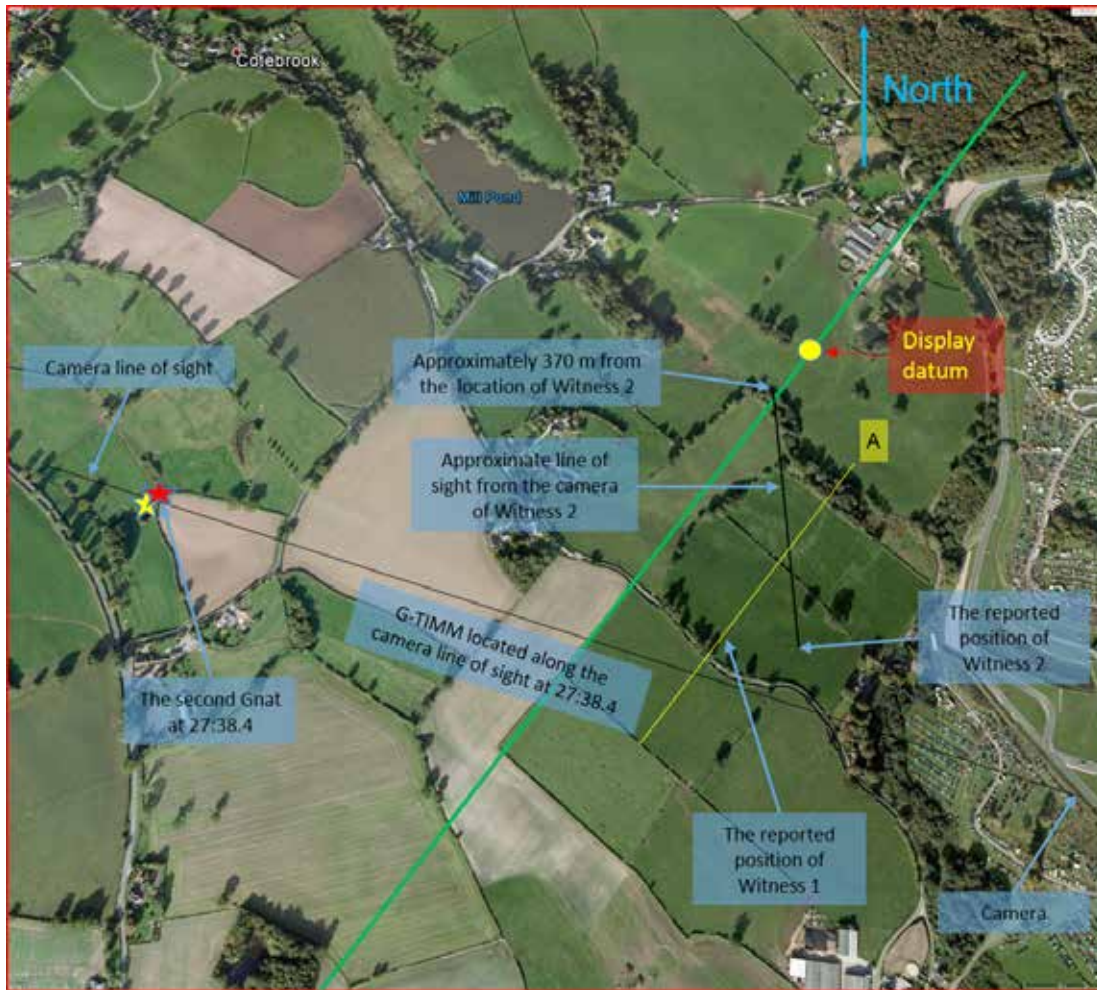
**Figure 17**

Figure 17 shows a sight line from the camera of Witness 2 passing the tree shown in Figure 8 and the MOD measured the distance of G-TIMM along this line to be approximately 390 m. Using the last known height of G-TIMM (375 ft above the display datum), this is equivalent to a ground distance of approximately 370 m which suggested that G-TIMM was flying close to the display line (Figure 17). Evidence from Witness 1 suggested that the aircraft's location was bounded by a south-easterly limit shown by the yellow line 'A' in Figure 17.

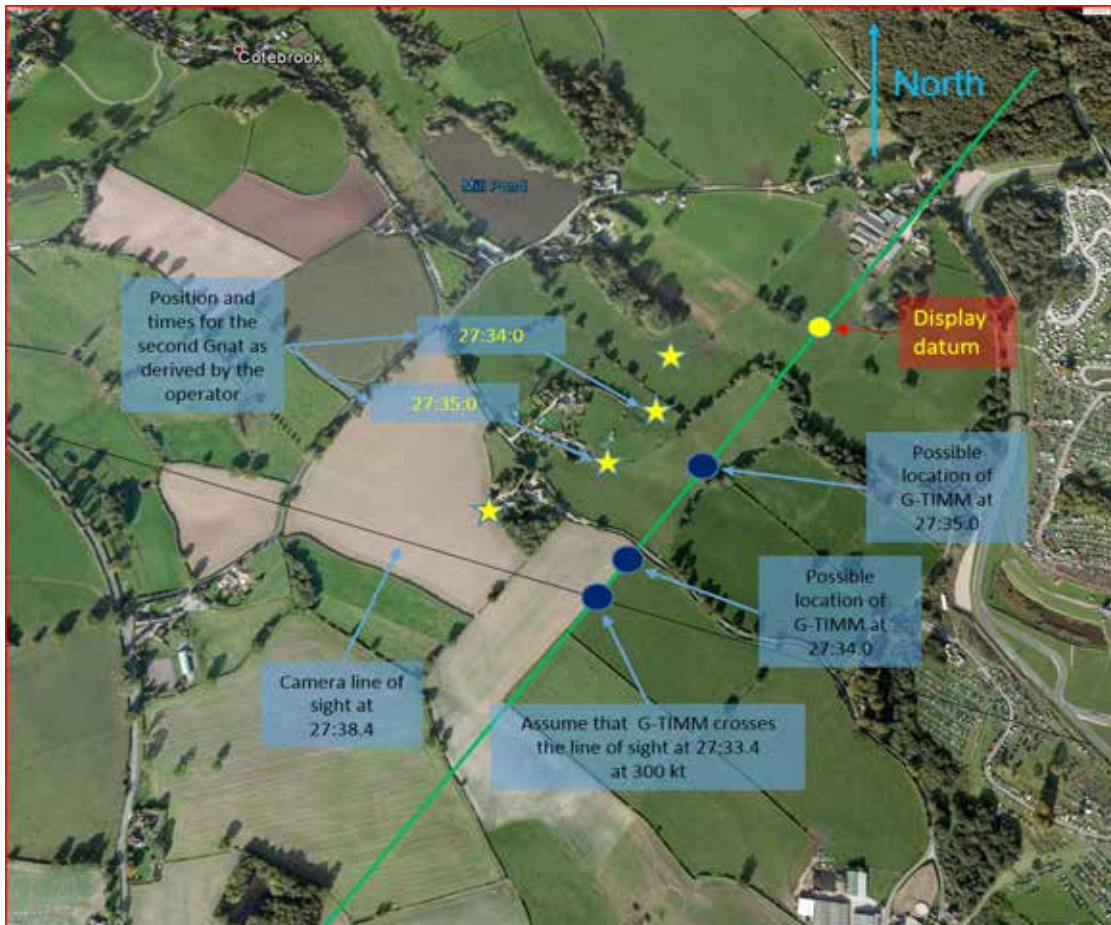
**Figure 18**

Figure 18 shows the relative locations of G-TIMM and the second Gnat, had G-TIMM arrived on the camera sight line five seconds earlier than it actually did, travelling at 300 kt<sup>20</sup>. Although the Figure shows the outcome of a hypothetical set of circumstances, it suggests that, had G-TIMM not slowed down, the possibility existed that it would have reached the display line before the second Gnat had vacated it. This would have been contrary to the 'contract'<sup>21</sup> used by the operator to ensure safe separation on the display line and, if anticipated by the pilot of G-TIMM, provides a plausible reason for him to slow down. The second Gnat was flying a manoeuvre with vertical extent and it was unlikely that the pilot of G-TIMM perceived that there might be a risk of collision near the display line. Nevertheless, it was possible that G-TIMM was flown slower than usual, at least in part, to delay its arrival on the display line.

Hypothetical plan view of the aircraft had G-TIMM crossed the camera sight line at 27:33.4
