# BRE Global Client Report

**BS 8414-1:2015 + A1:2017 test referred to as DCLG test 2.**

**Report Number:** B137611-1037 (DCLG test 2) **Issue: 1.2**

Prepared for:  
Department for Communities and Local  
Government  
2 Marsham Street  
London  
SW1P 4DF

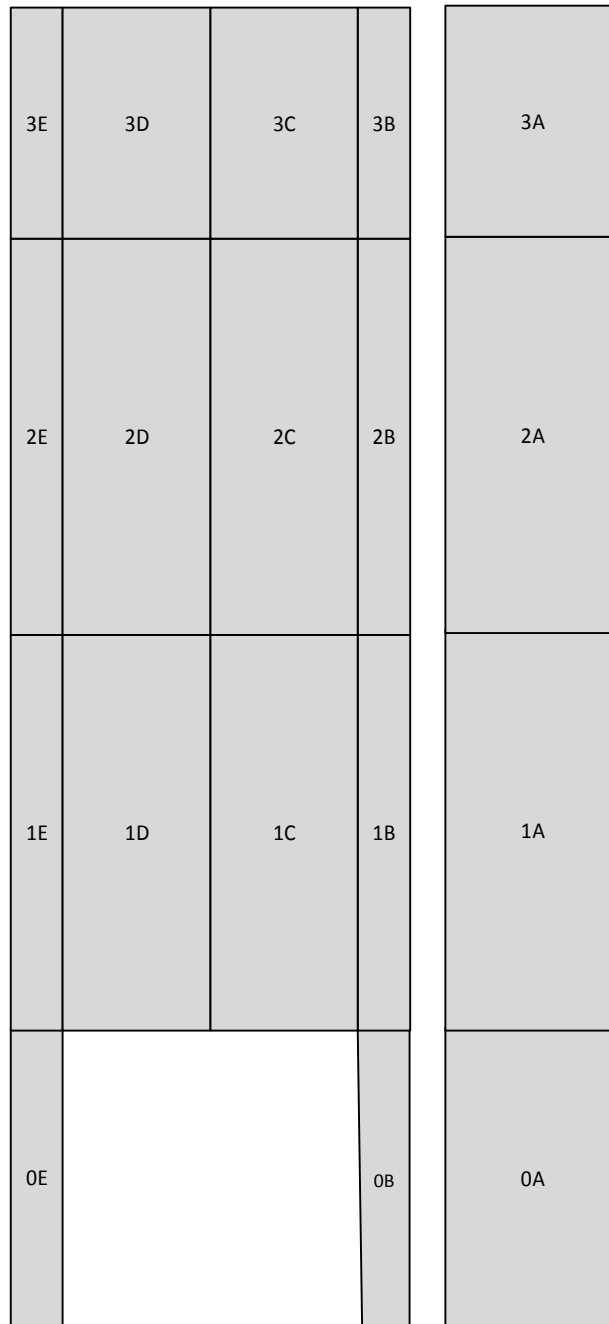
On the main wall, approximately 20% of ACM panel 1C was consumed - see *Figures 1, 21&22*. This damage was sustained in a strip approximately 250mm-wide×1800mm-high positioned directly adjacent to the centre line of the combustion chamber, and extended from 500mm above the opening to the height of the second cavity barrier – see *Figures 21&22*. Partial consumption (inner aluminium layer of panel remained intact) affected a 200mm-high x 450mm-wide strip at the base of the fully consumed section of panel 1C.

Figure 1. Layout of panels and labelling system used for reporting purposes. Not to scale.

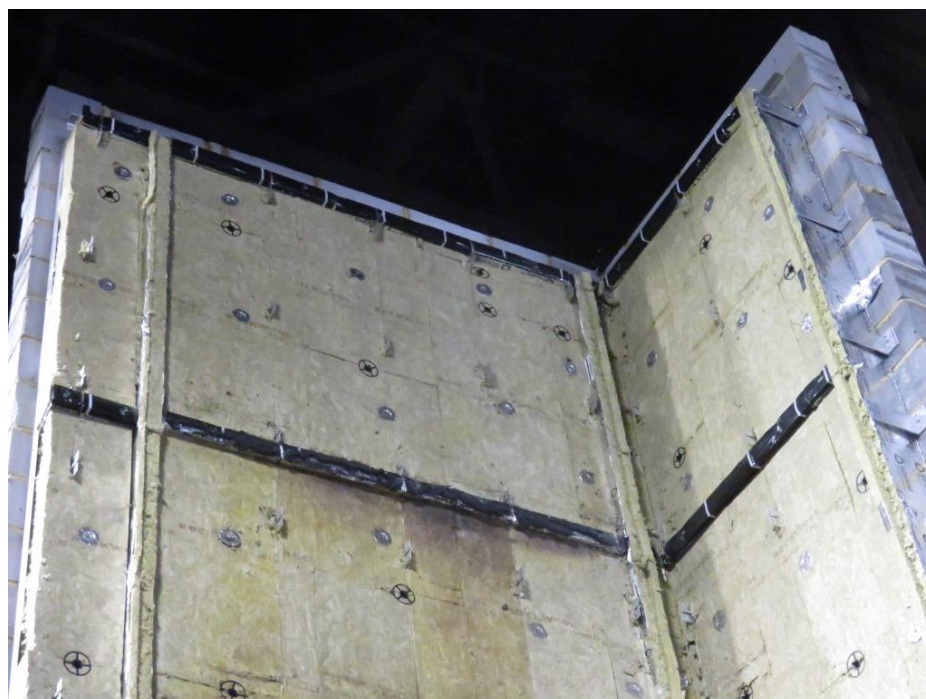
Figure 31. Cladding system beneath ACM panels between the third and fourth horizontal cavity barrier (approximately 4700-6360mm above the combustion chamber).
