AAIB Bulletin

9/2017

Published 14 September 2017

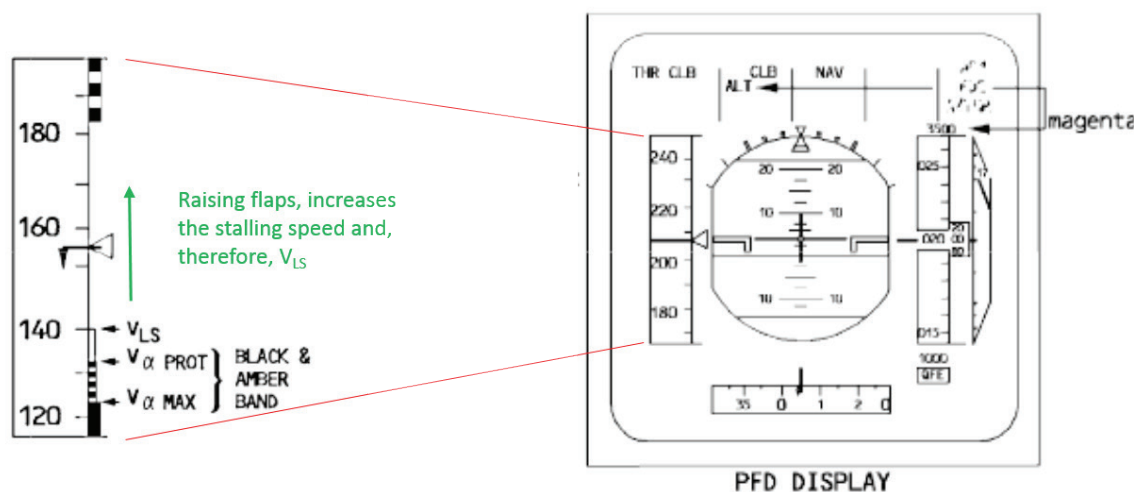
Figure 1

After the flaps were selected up, the PF saw the VLS⁴ indication on the PFD⁵ "shoot up" to 180 kt, 30 kt above the current speed (Figure 1). He asked the PM to extend the flaps again and the PM moved the flap lever back to position 1, which caused the slats to begin to extend. The aircraft was at 710 ft RA and 183 kt. The VLS indication reduced below the instantaneous airspeed and, when the aircraft accelerated to S speed⁶, the PF moved the thrust levers to the CLB detent to reduce thrust to the climb setting. The PF asked for the slats to be retracted, which the PM did at approximately 850 ft RA and, passing 870 ft RA, the autopilot was engaged and the climb continued.

The V_{LS} indication moves up the airspeed scale on the PFD when the flaps are raised

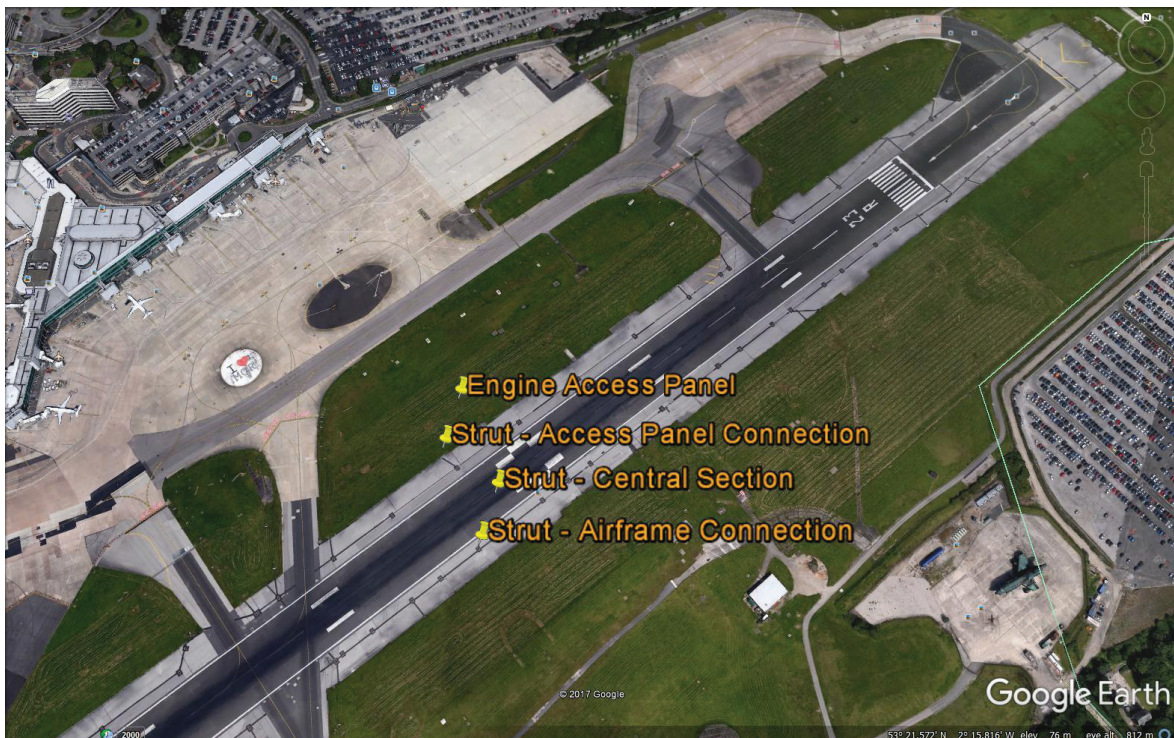
Figure 1

After the aircraft had parked on the stand and the passengers had disembarked, the ground crew informed the cabin crew that a panel was missing from the No 1 engine. The message was relayed to the flight crew, who inspected the aircraft prior to contacting the operator's maintenance control department. The operator informed Manchester Airport operations staff at 0836 hrs, who then conducted an inspection of Runway 23R. The panel was recovered from a grass area to the side of the runway, approximately 440 m from the runway threshold. Sections of the panel hold-open strut were also recovered from the runway and adjacent paved areas in the same vicinity (Figure 1).

Location of items released from the aircraft during takeoff

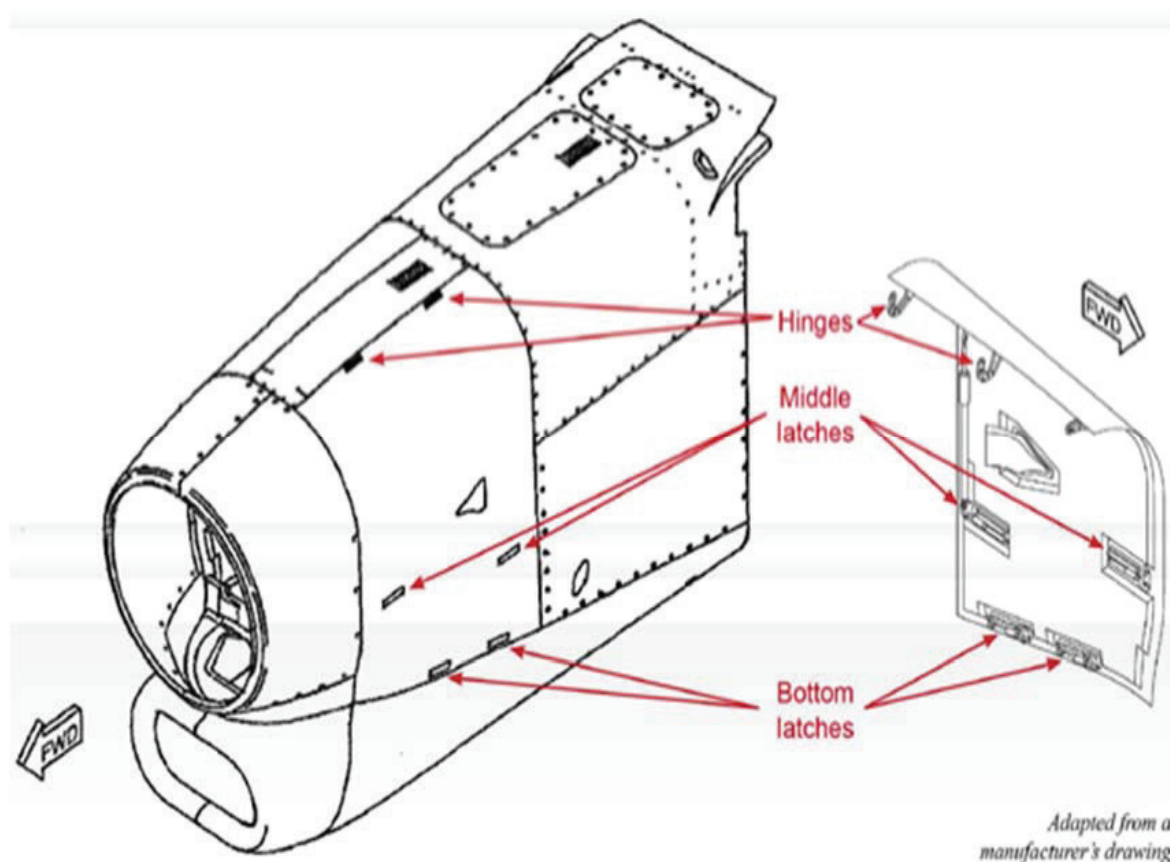
Figure 2

Forward engine bay access panel

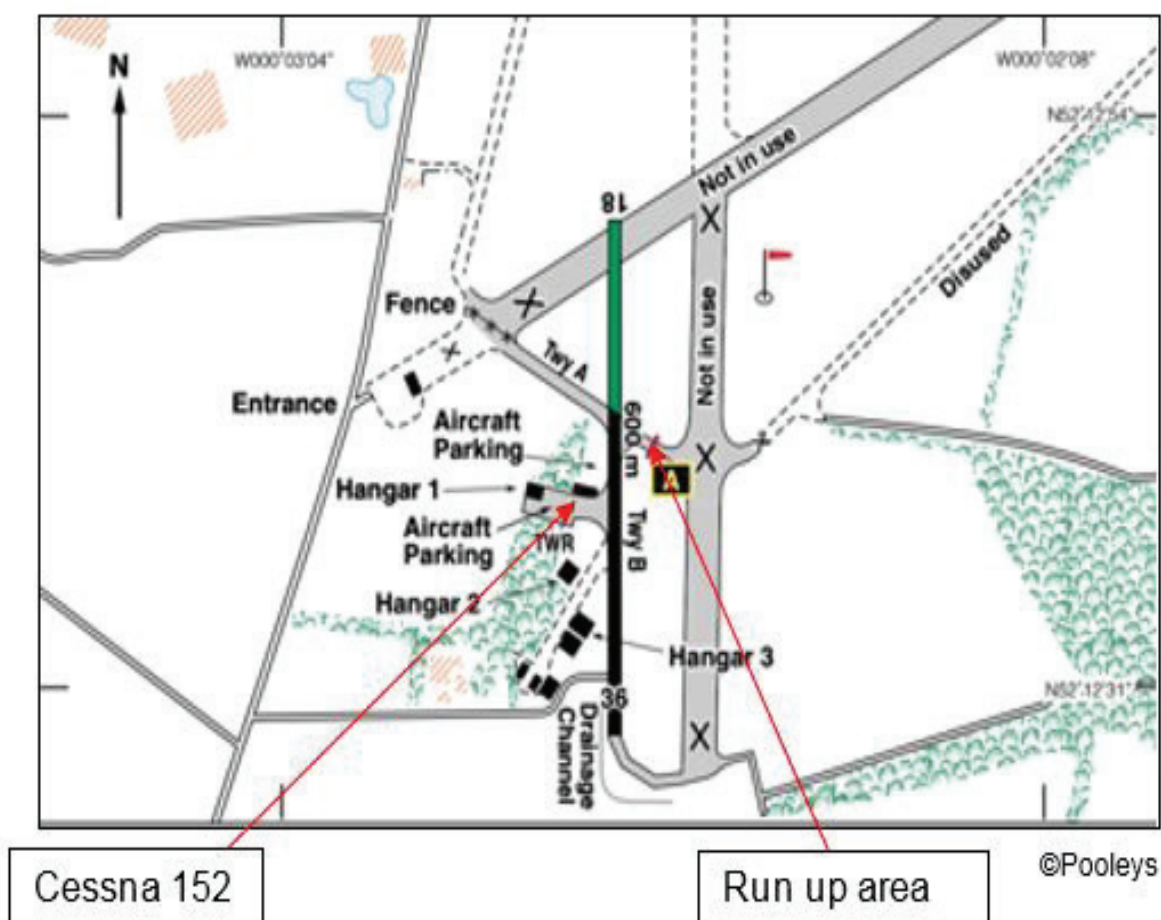
Figure 1

The pilot, with his passenger on board, started the engine and taxied from behind the C152 across to the run-up area, located on an old taxiway to the east of Runway 18 (Figure 1). He remained there a short while and then taxied towards the threshold of Runway 18, out of view of the occupants of the C152.

Aircraft parking and run-up areas at Bourn Airfield

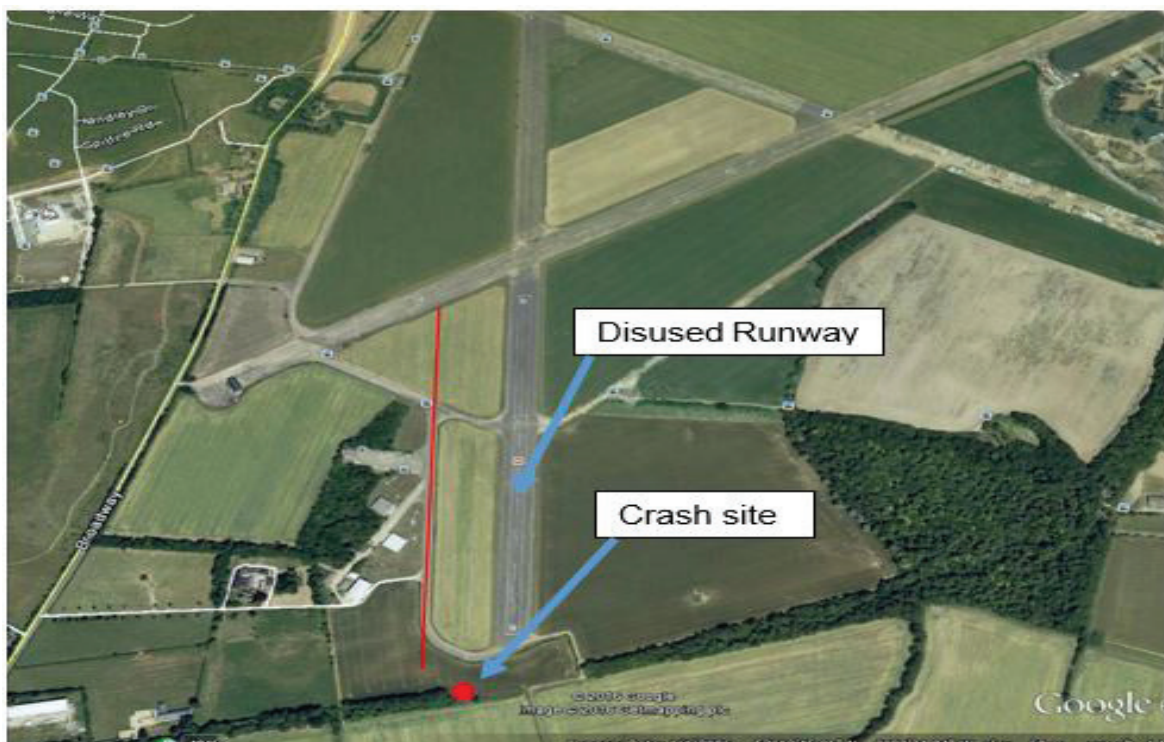
Figure 2

The aircraft had come to rest against some trees located on the southern boundary of the airfield (Figure 2). The accident site was some metres to the left of the extended centreline of the runway.

View of airfield showing accident site location relative to the extended centreline of the runway (red line). The 'old', disused runway is visible to the right.

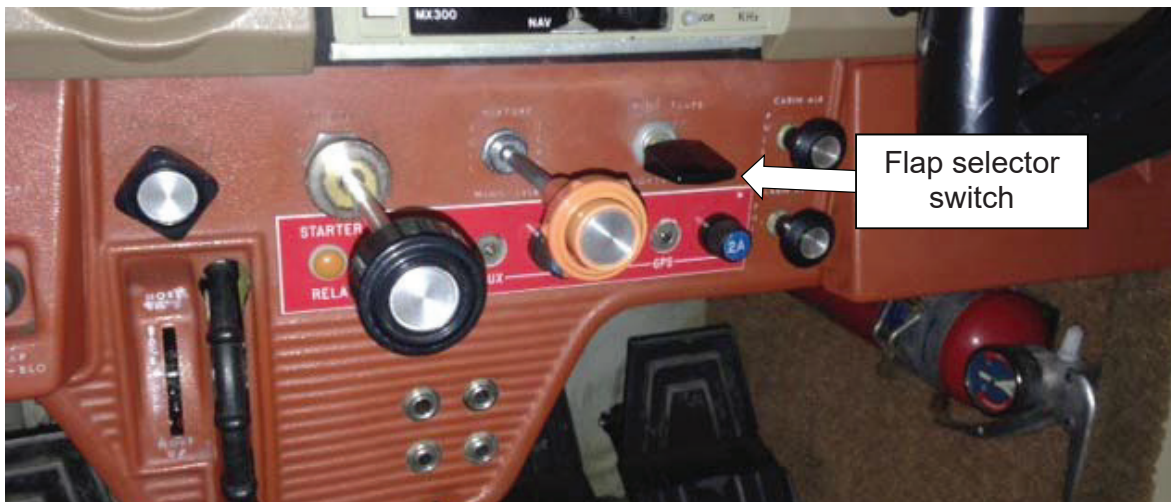
Figure 4a

Wing flap selection on G-BDZC was controlled by a switch on the lower centre instrument panel (Figure 4a). To extend the wing flaps the switch must be held against spring pressure in the DOWN position; when released the switch will return to the centre NEUTRAL/OFF position. To retract the flaps the switch had to be selected and held to the UP position; the switch would return, under spring pressure, to the neutral position when released. It would take

approximately 9 seconds to fully extend the flaps in flight and 6 seconds to retract them. The flap switch did not give a visual indication of the selected flap position.

C150 flap selector switch as fitted to G-BDZC

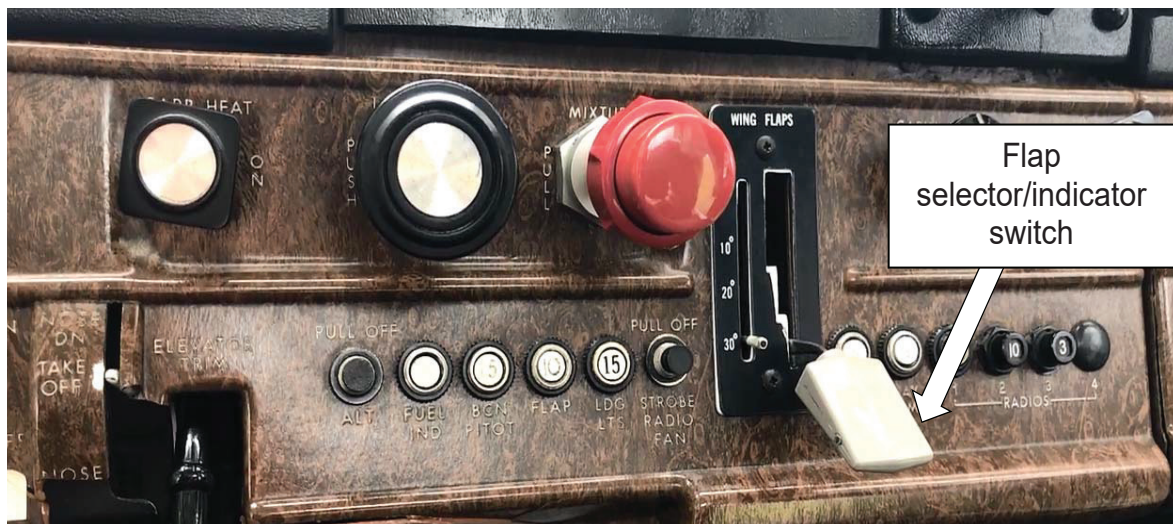
Figure 4b

The final production models of the C150 were fitted with a re-designed flap selector with detents for the flap positions and a position indicator located beside the switch. The C152 flap selection and indication is similar (Figure 4b), but the maximum flap travel was reduced from 40° to 30°.

C152 flap selector/indicator switch

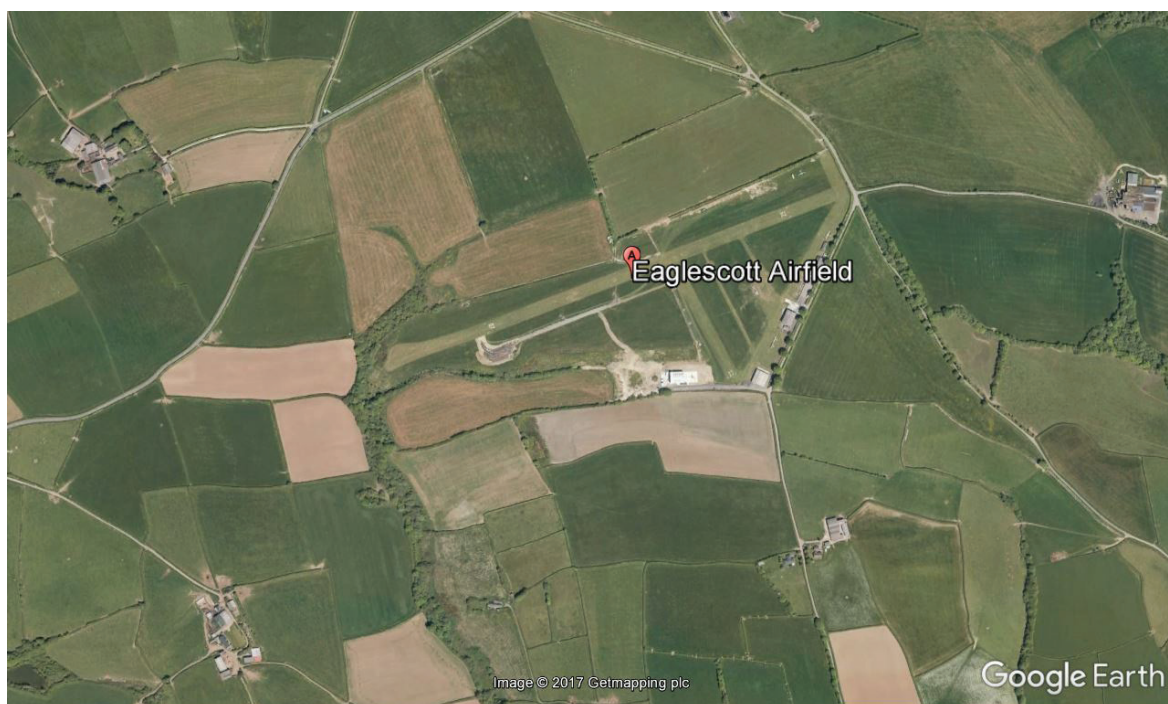
Figure 1

Eaglescott Airfield has two grass runways and the western end of the airfield is surrounded by fields with a similar alignment to Runway 07 (Figure 1). The airfield instructions for visiting pilots is that Prior Permission is Required (PPR) by telephone and the arrival procedure is to make a radio call 10 miles out and then fly a standard overhead join at 2,000 ft QFE and a left-hand circuit at 800 ft.

Eaglescott Airfield

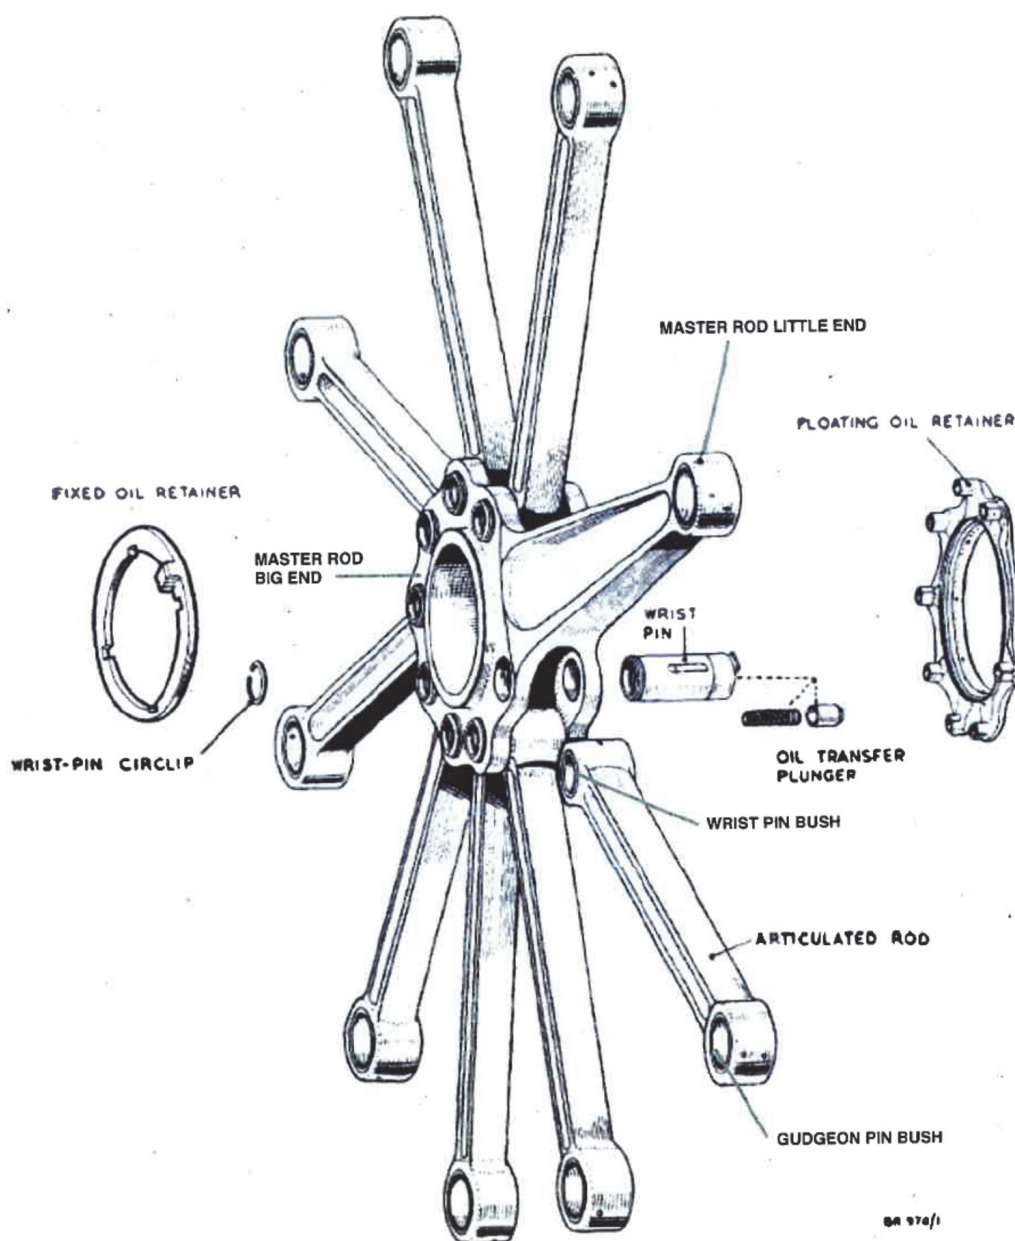
The Bristol Centaurus engine is an eighteen-cylinder double-row sleeve valve supercharged radial, with a 53 litre capacity, capable of producing 2,500 horsepower. Figure 1 and Figure 2 show the arrangement of the master con-rod, articulated rods, crankpin and floating retainer assembly.

Master and articulated connecting rods with the floating oil retainer
