AAIB Bulletin

1/2018

Published 11 January 2018

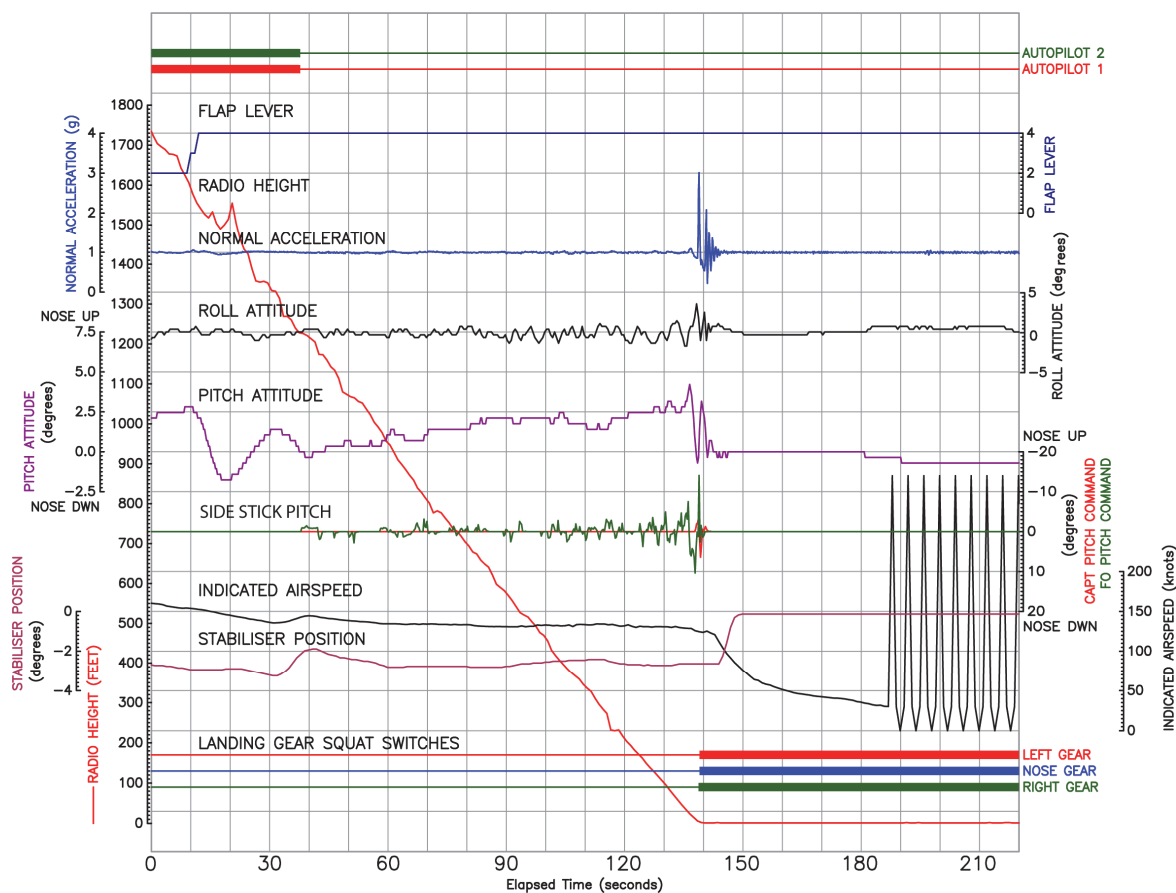
Figure 2

The data (Figure 2) shows the aircraft established on a stable ILS approach, correctly configured and at the approach speed. At 1,228 ft radio altitude, the AP and A/THR were disconnected. As the aircraft approached 30 ft radio altitude, there was a forward sidestick input and the pitch attitude began to decrease. The aircraft reached close to 1° nose-down less than a second before touchdown. At around 10 ft radio altitude, the PM applied a small amount of aft stick but this had a negligible effect on the pitch attitude and touchdown.

The LOAD <15> report showed that, at touchdown, the aircraft's attitude was 0.7° nose-down with a slight roll to the right, and its rate of descent was 11.9 ft/sec. The maximum recorded vertical acceleration was 3.01 g.

Salient FDR parameters for the approach and touchdown

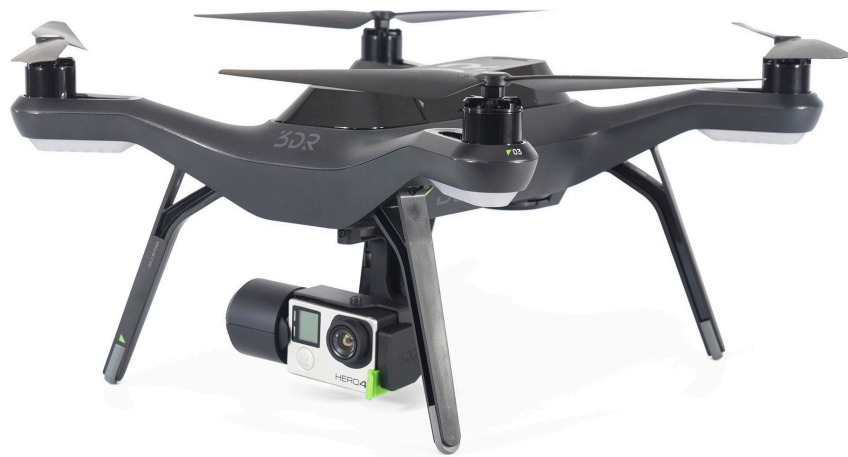
The 3DR Solo is an unmanned aircraft (UA) with a maximum takeoff weight of 1.8 kg (Figure 1). With its flight controller it forms an unmanned aircraft system (UAS). It was being flown to document a construction site using a Go Pro Hero 4 camera mounted on a gimbal below the aircraft.

Figure 1
3DR Solo UAS with Go Pro Hero 4 camera

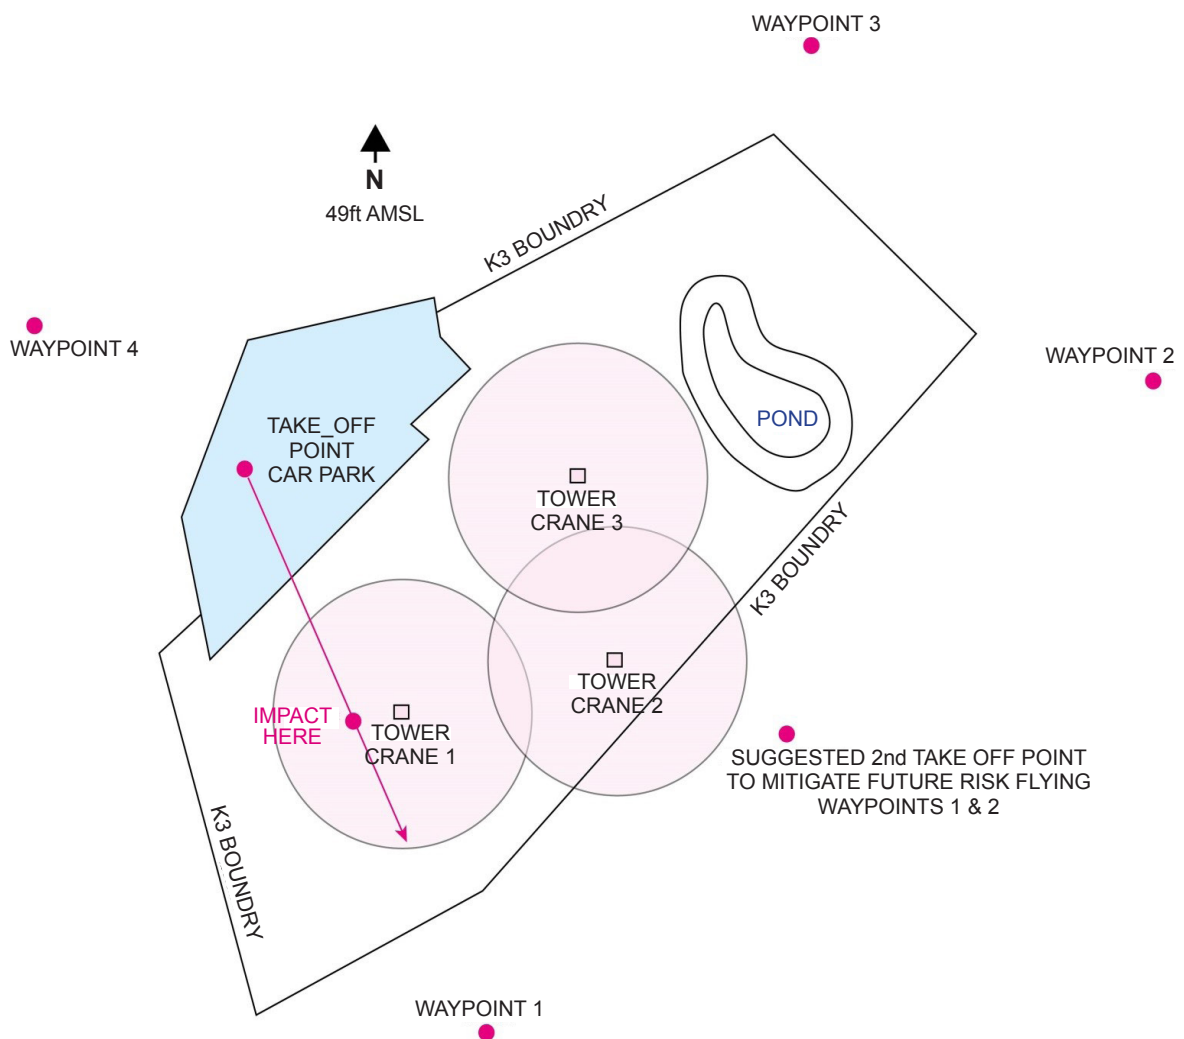
The pilot had flown the UA previously at the construction site using a pre-programmed mission profile with four waypoints. All waypoints were programmed to be flown at 400 ft agl, which was above the height of the three cranes at the site. The UA took off from a car park on the north side of the site and started climbing to its first waypoint at the south-western tip of the site (Figure 2). Before it reached 400 ft agl it collided with the jib of a crane. The crane had not been at the site during the previous flight, and from where the pilot was situated in the car park it was difficult for him or his observer to tell that it was about to strike the crane because of a lack of perspective. The UA fell to the ground and was damaged but there was no damage to the construction site.

Figure 2
The planned route and location of the collision
