Appendix B. Air tightness test reports

Air tightness test field reports

LEEDS
METROPOLITAN
UNIVERSITY
Leeds Sustainability Institute

Dwelling C-01, before and after retrofit

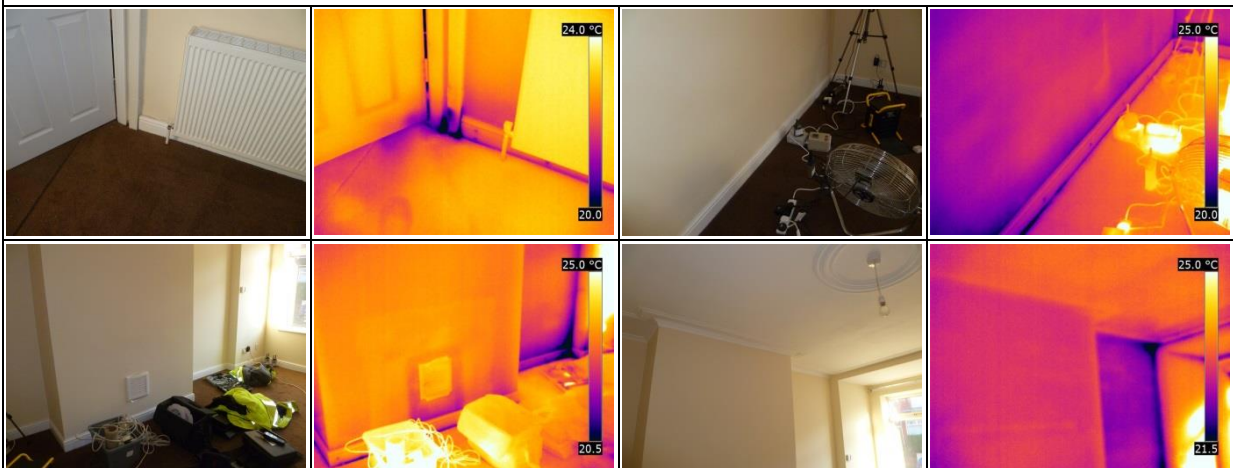
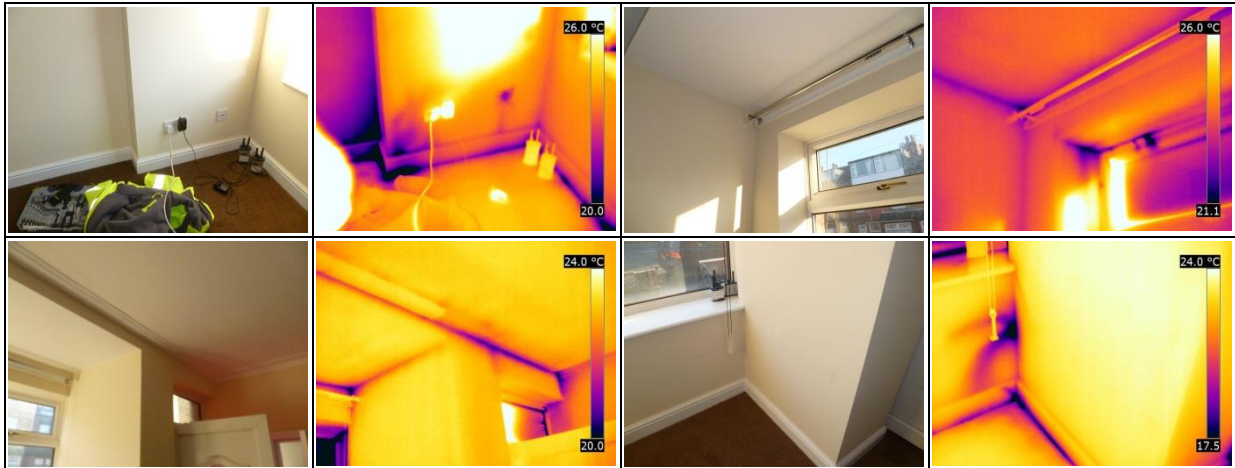
Lounge

Some air leakage was observed at more awkward junctions with the ground floor, but previously observed leakage through the floor itself and at the rear wall had been effectively eliminated. Air leakage around the internal wall insulation into the void behind the plasterboard was detected at a number of locations around the bay, with some direct infiltration at the TV socket and at the window head/frame junction.

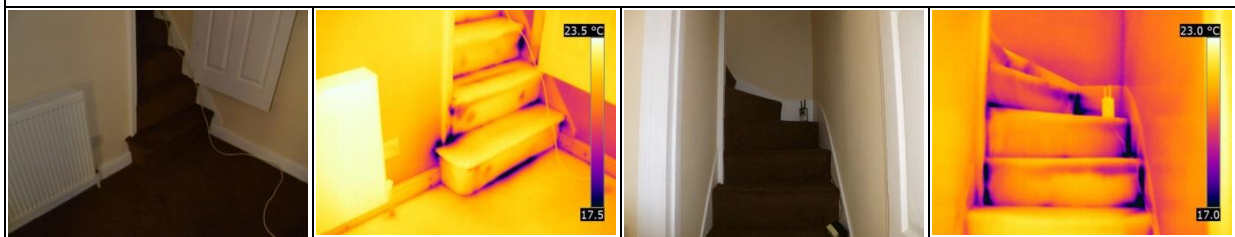
Stairs/1st Floor Landing

Air movement was observed, presumably entering from the cellar beneath.

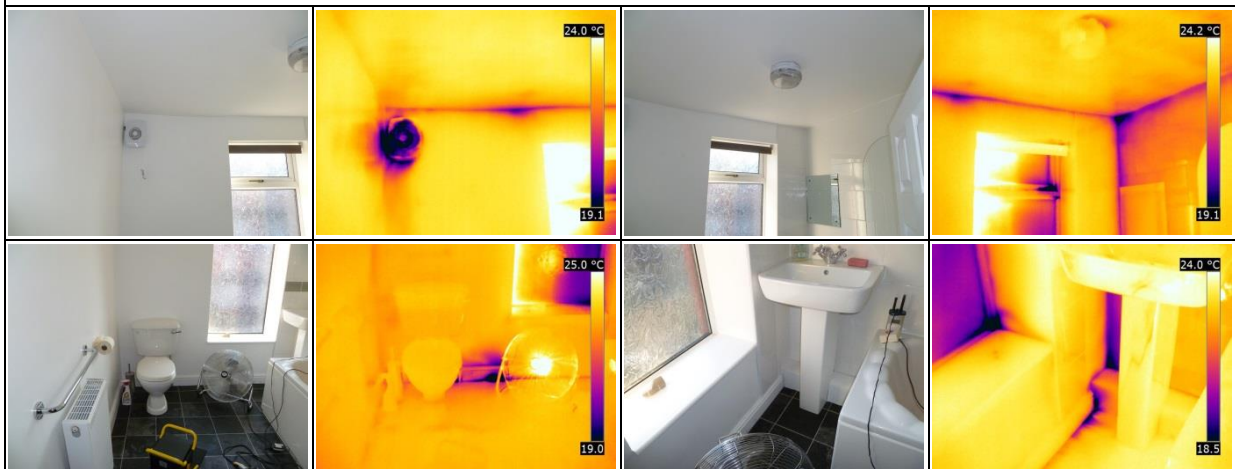
Bathroom

Air leakage was detected around the extractor fan and opening light of the window, and also at floor/external wall junction.

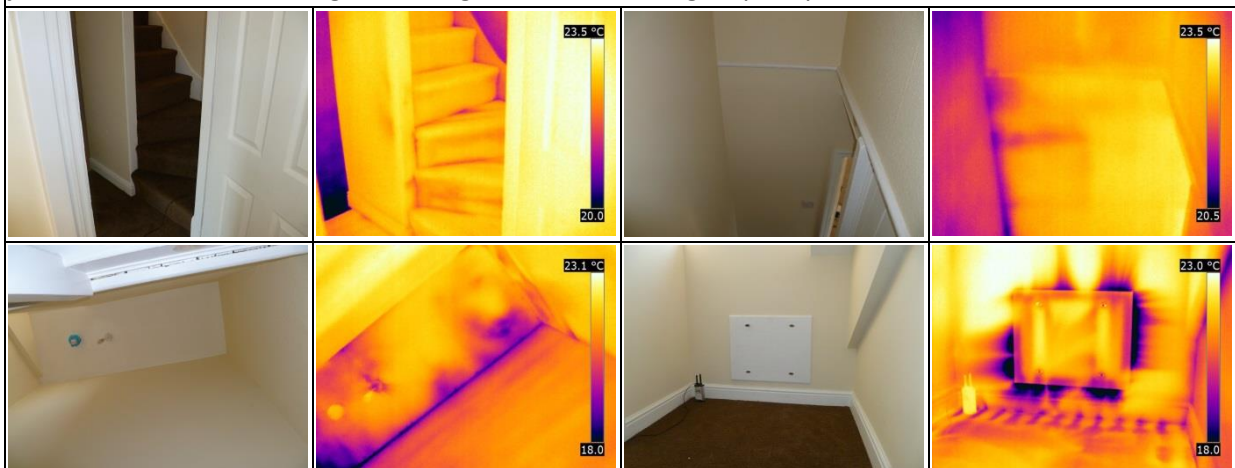
Stairs/2nd Floor Landing

Air movement was detected around the stairs (as in the lower stairs) but did not show up clearly under thermography as the infiltrating air was at a fairly ambient temperature. Some air leakage into the internal wall between the stairs and the 1st floor bedroom could be seen, and issues at the ceiling above the stairs were also made apparent. On the landing significant airflow could be seen around the access door to the roof void and between the floorboards directly adjacent to this up to the first floor joist. The airflow here was great enough to lift the landing carpet up off the floor.

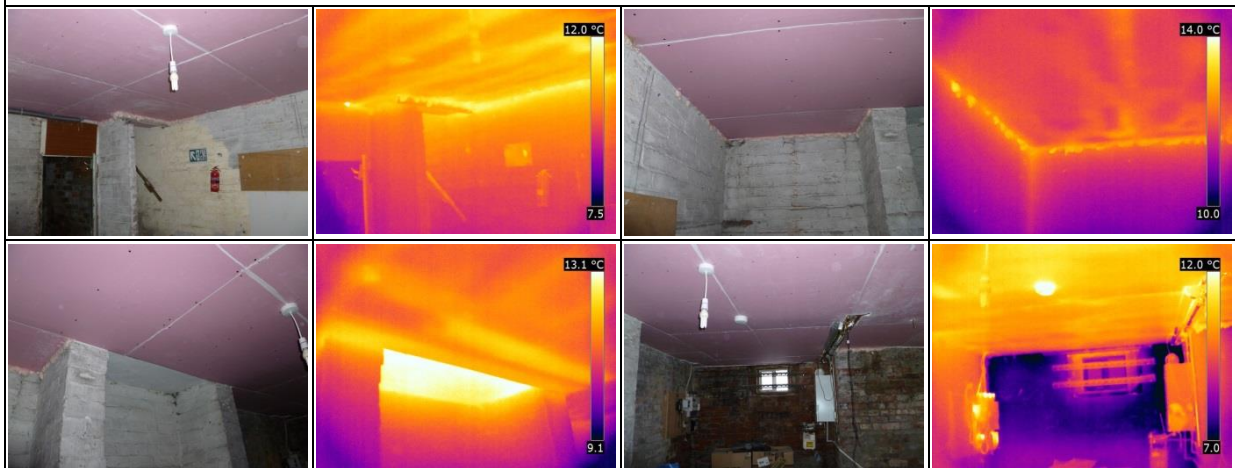
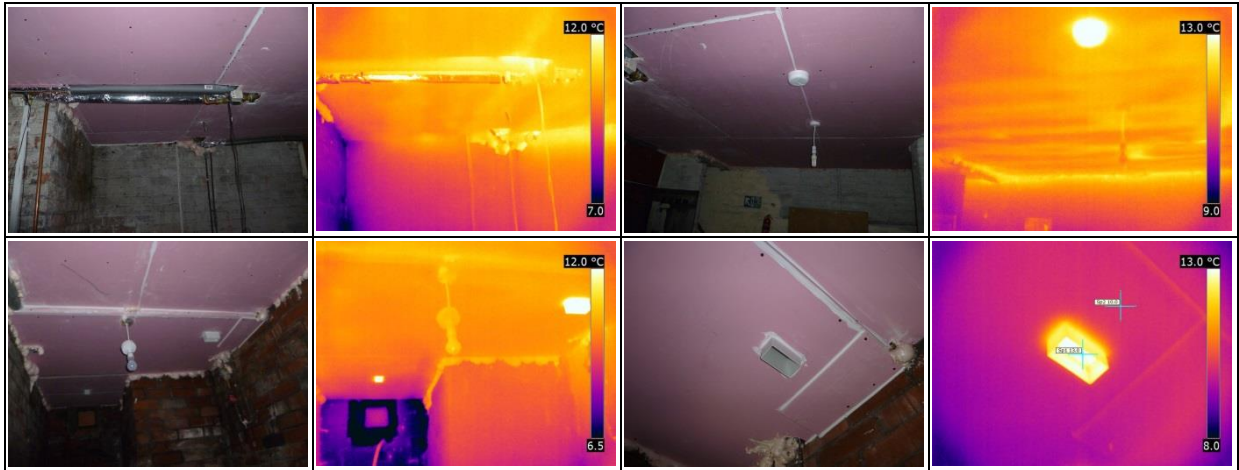
Cellar (under house pressurisation)

As no air leakage had been observed into the house through the ground floor into the lounge and kitchen, a brief investigation was undertaken under dwelling pressurisation to see if warmer air could be seen being blown out to the house into the cellar. No significant air movement was observed into the cellar around the perimeter or at service penetrations. A large thermal bridge was observed at the hearth, and warmed air entering the cellar through 2 ducts below the kitchen were the only noteworthy observations.

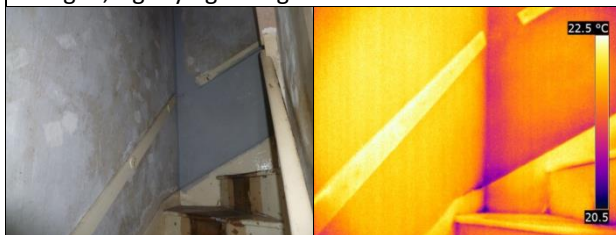
Ground Floor Stairs:

Only slight air leakage was detected through and around the stairs, this could be felt with the back of the hand better than observed on the thermal image so presumably the infiltrating air must have warmed by the time it emerged, signifying a longer or more convoluted infiltration path.

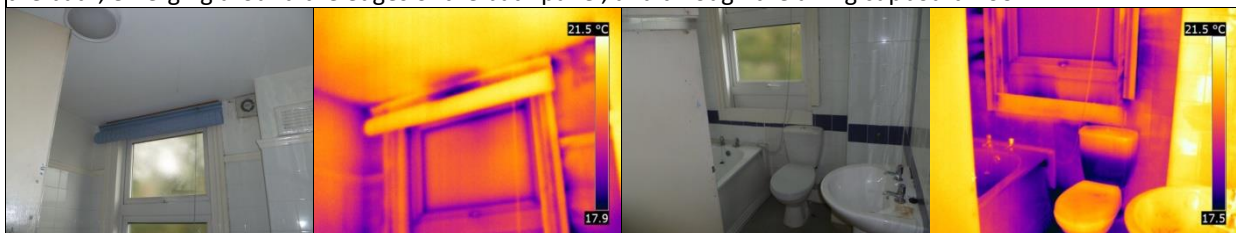
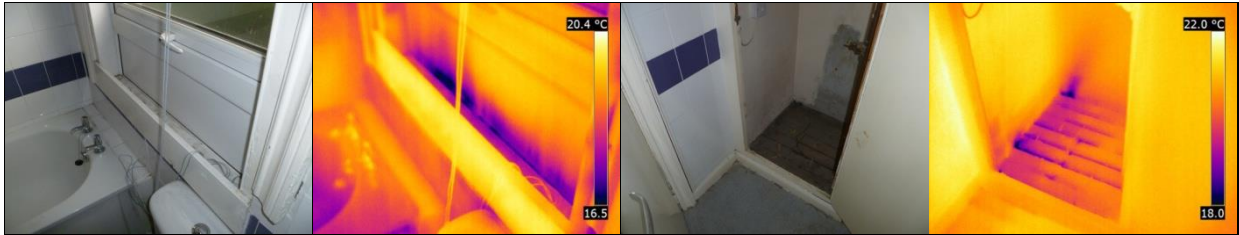
Bathroom:

Significant leakage was detected around the window, through the closed trickle vent, around the frame and around the modesty panel at the bottom of the window. Considerable infiltration was also seen from underneath the bath, emerging around the edges of the bath panel, and through the airing cupboard floor.

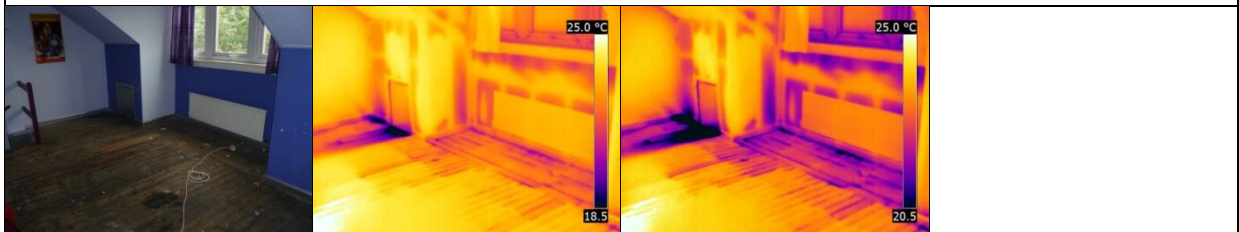
Top Floor Bedroom:

The main leakage paths were around the unsealed access door into the loft void to the left of the dormer and up through the floor (again this shows more clearly in the thermal images near the perimeter as the infiltrating air was coolest, but was detectable throughout the floor). Lesser infiltration was observed around the dormer window frame and sill and at a number of small gaps and cracks at junctions between walls and ceiling surfaces. In the sections of flat and sloping ceilings, knee walls and dormer cheeks, an indication to the level of insulation between the timber studs by using the surface temperature patterns to determine whether the studs allowed more or less heat to escape than the areas between them; although direct sun onto the sloping roof can cause confusion.

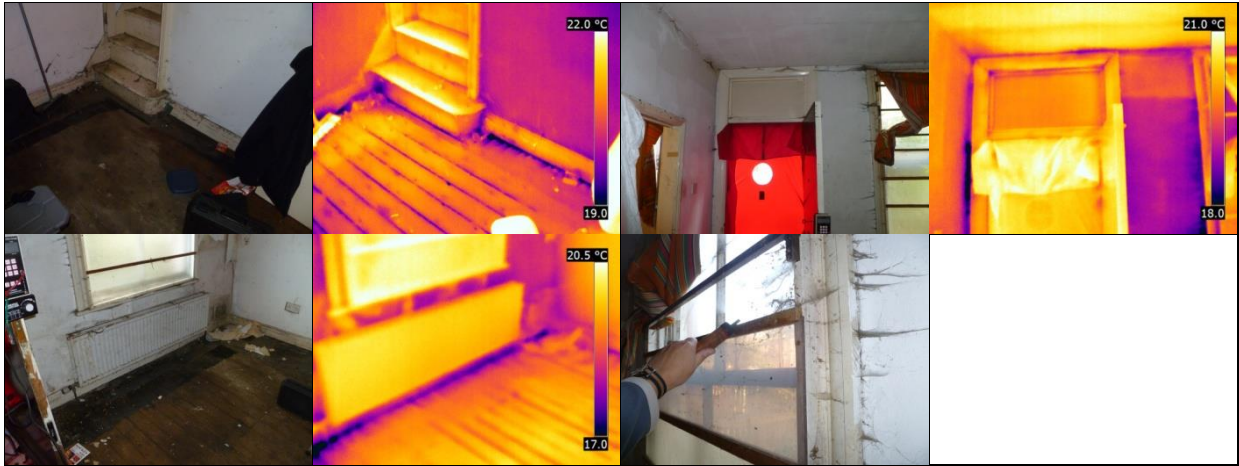
Lounge:

Airflow up through gaps between the floorboards was again present throughout the room and particularly at the floor/wall junctions. Leakage was detectable around most of the door and window frames, and daylight visible between the upper and lower sash.

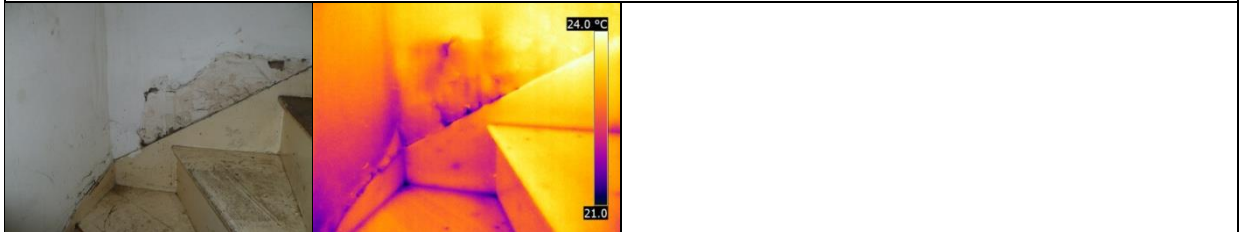
Ground Floor Stairs:

Again, only slight air leakage was detected through and around the stairs, although more air leakage was identified around the stringers on the rear and side party walls.

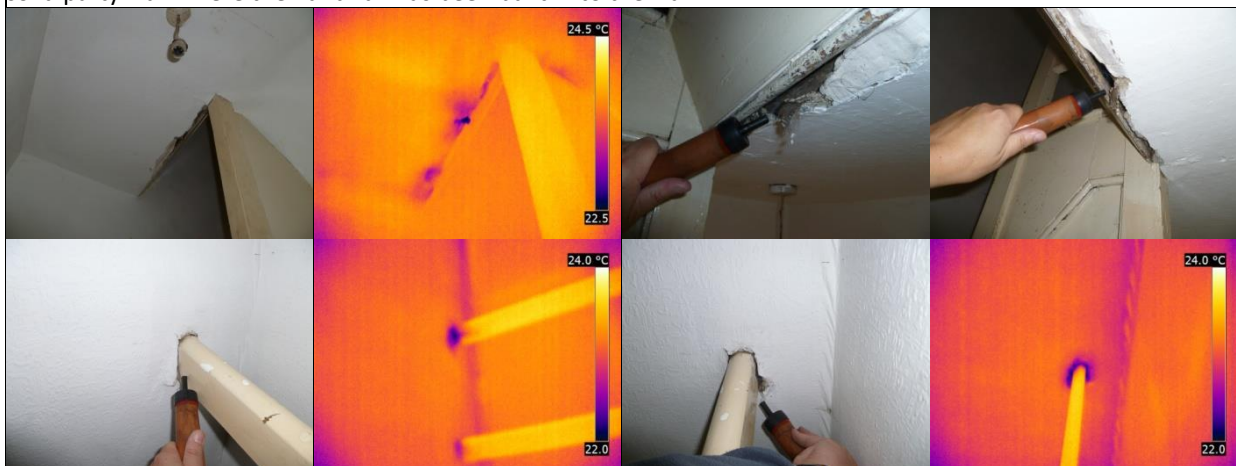
First Floors Stairs:

Infiltration was detected at gaps in the ceiling into the intermediate floor void, and also into the wet-plastered solid party wall where the hand rail has been built in to the wall.

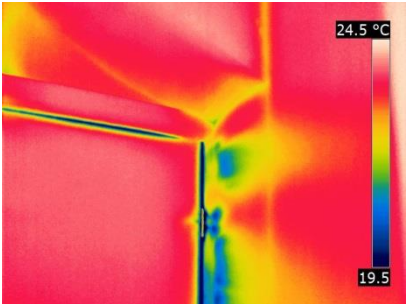
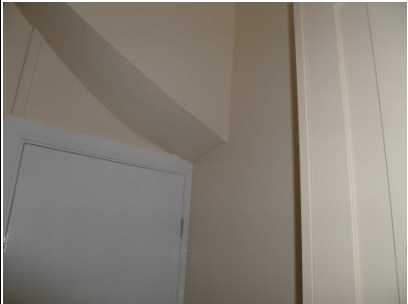
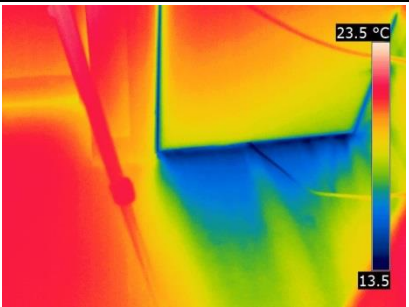
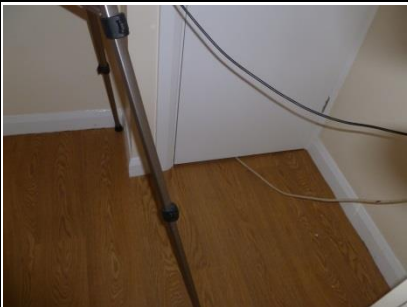
Under depressurisation	No induced pressure differential
<p>Kitchen</p> <p>The fact that the cellar door was a boundary between conditioned and unconditioned space had been recognised by insulating it, but it had not been made airtight with a 10 ~ 15 mm gap at the bottom and leakage around the remainder of it.</p> <p>Infiltration into the intermediate floor void from the party wall could be observed extending fully across the kitchen ceiling in places and emerging out of the downlighters.</p> <p>Air leakage around the ventilation unit was considerable, despite the unit being temporarily sealed for test purposes.</p> <p>Air leakage from behind the kitchen units was also significant, implying that the kitchen units had been installed before the walls, junctions and penetrations behind had been suitably sealed.</p>

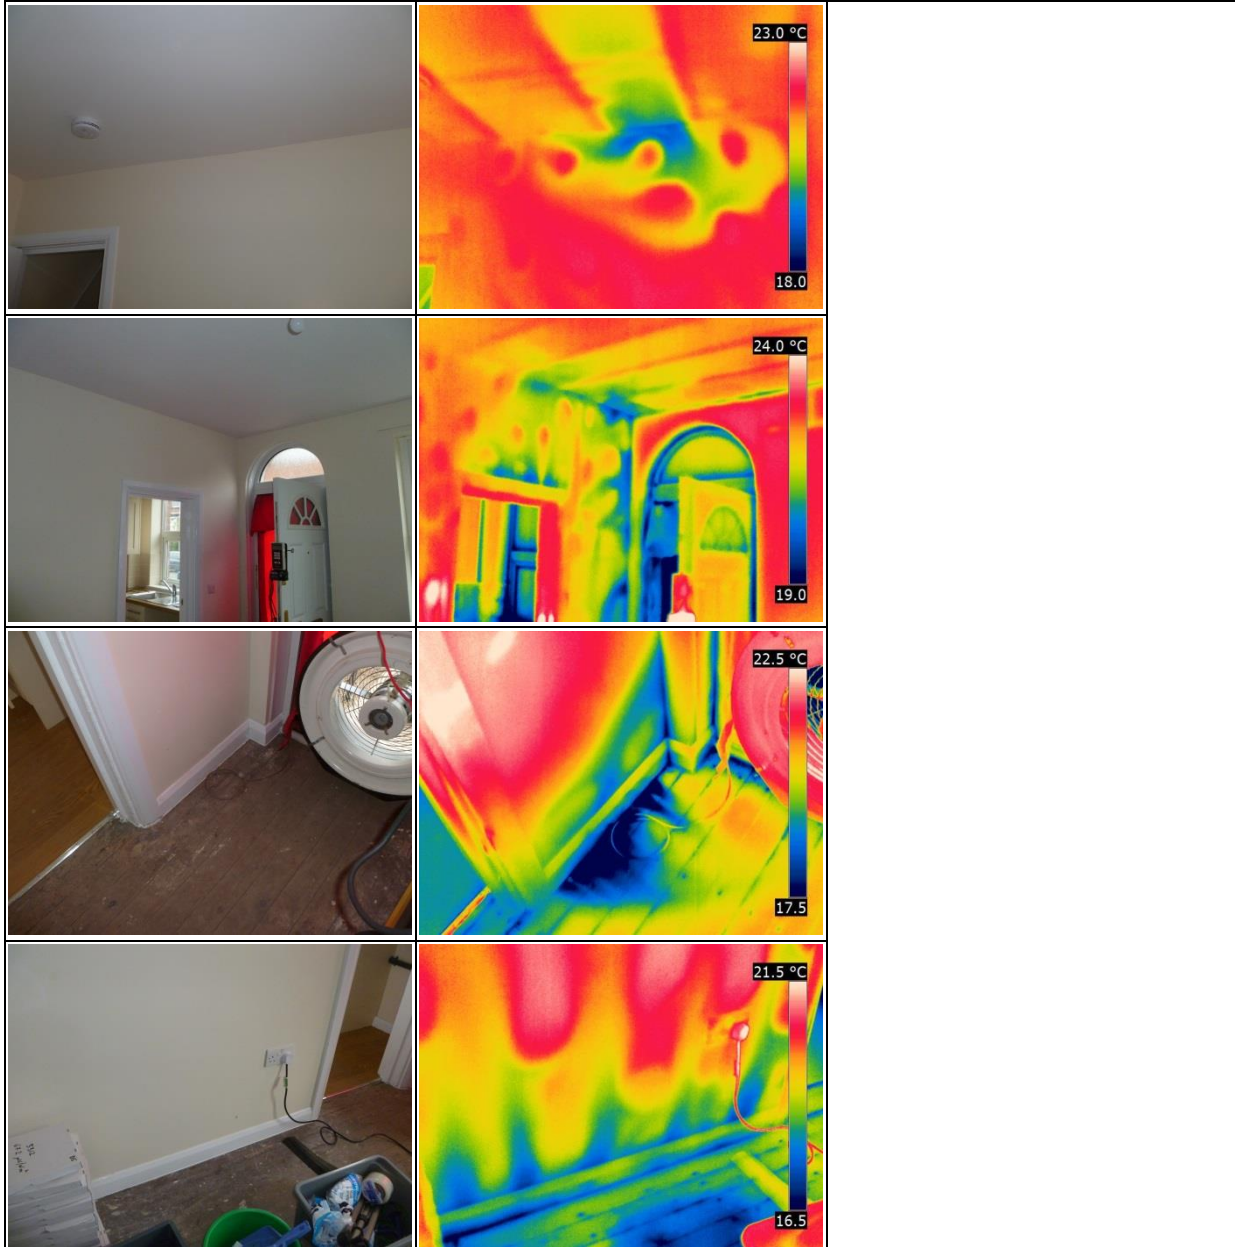
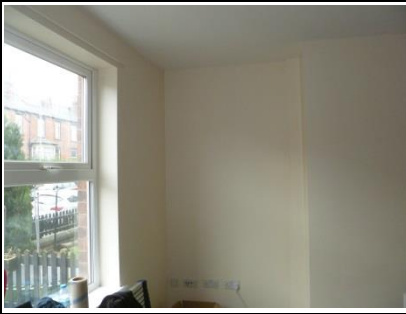
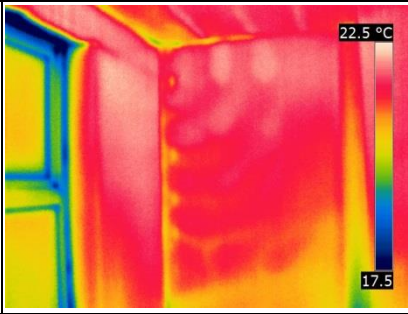
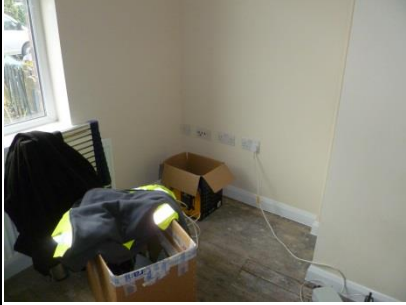
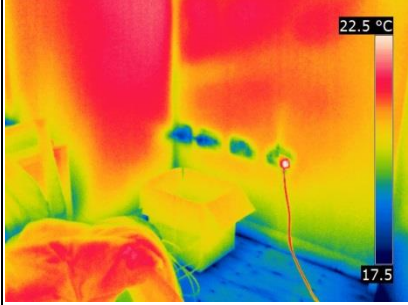
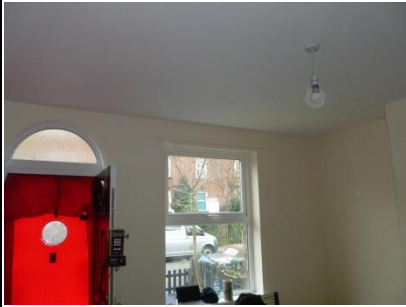
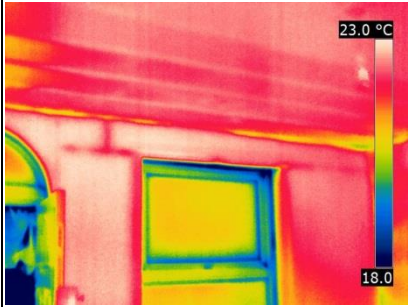
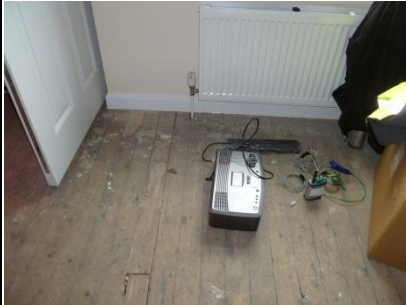
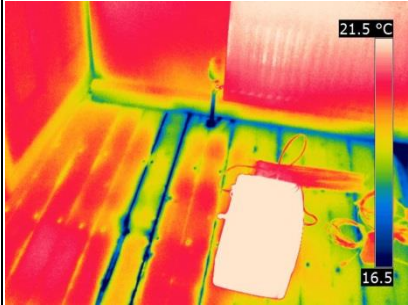
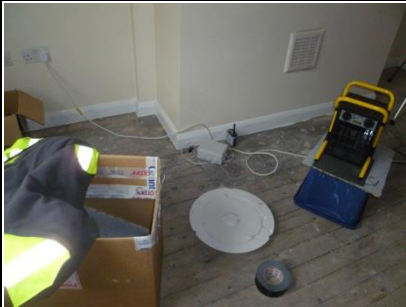
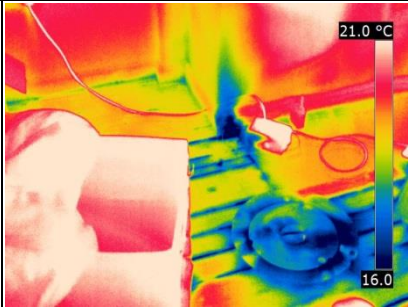
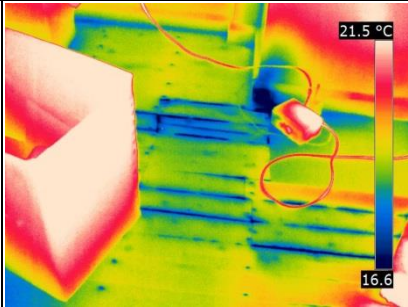
Lounge

The strip of coolest air observed across the kitchen ceiling from the party wall could be seen extending across the top of the partition wall into the intermediate floor void above the lounge and down into the void behind the plasterboard on the internal partition wall. At the junctions of this internal partition wall with the external wall and with the ground floor cooler air could also be observed entering the void behind the dry lining. A similar phenomenon could be seen on the opposing party

Some of the joints between insulation boards were visible under depressurisation, but temperature differences were slight, and air leakage around the window was drastically reduced from previous tests on this property.

As in tests 01 & 02, the most serious infiltration path was up through the timber ground floor, with cold, moist air being drawn in from the cellar. At the time of the test the air temperature and relative humidity in the lounge was 21.9 °C and 44.4%, compared to 13.7 °C and 83.0% in the cellar. The images captured under no induced pressure difference show that this air will be entering the habitable space under normal circumstances and could create comfort and moisture-related issues. It could also be easily distinguished where the floor had been insulated beneath the lounge and where it had not.

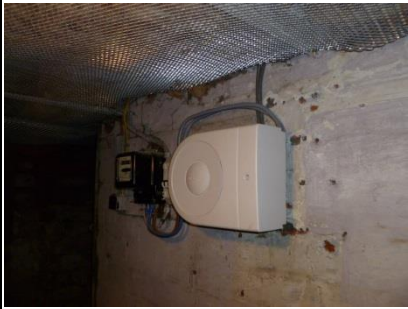
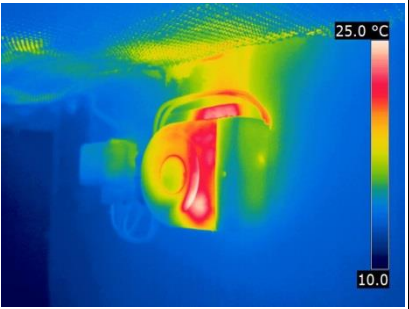
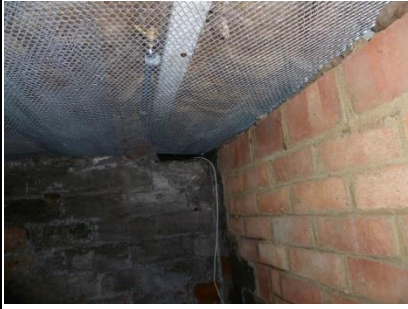
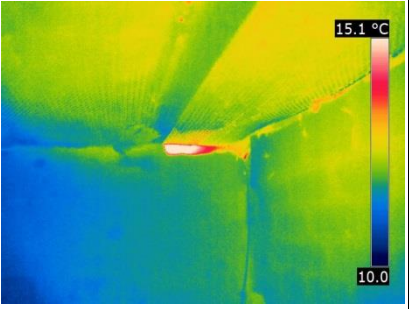
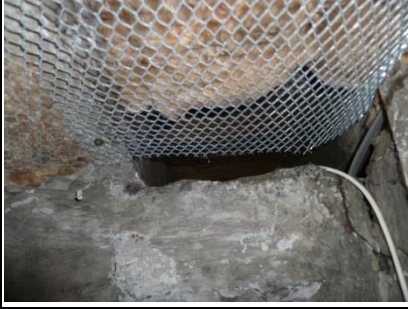
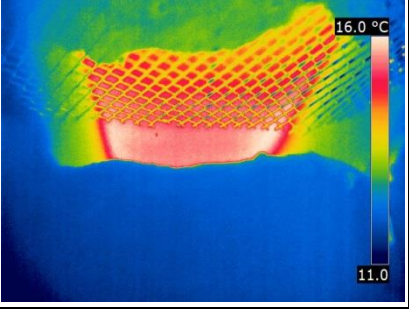
Cellar

No leakage detection was performed in the cellar but some observations were made using thermal imaging such as: the amount of heat being given off by the voltage optimisation unit (outside of the thermal envelope), the difference in temperature between areas of the lounge floor that had or had not been insulated, and the gap beneath the door to the kitchen.

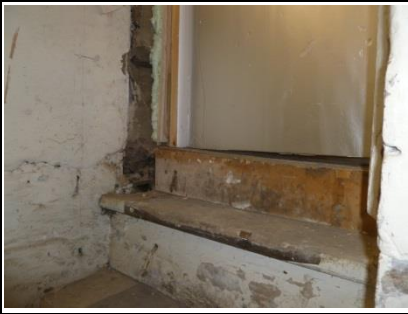
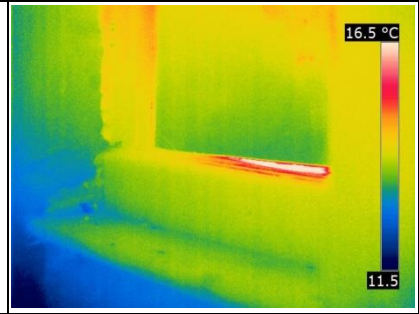
Ground to 1st Floor Stairs

Infiltration was observed under depressurisation at the steps which were exposed to the cellar stairway where they had been insulated beneath but had not been sealed. The surface temperatures of the stairs here actually appeared cooler than those below them due to the air movement.

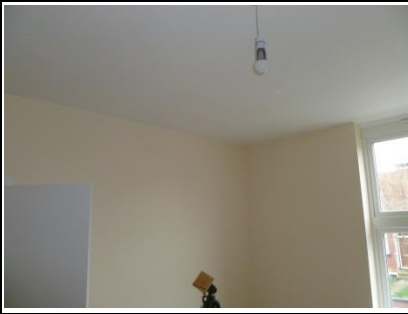
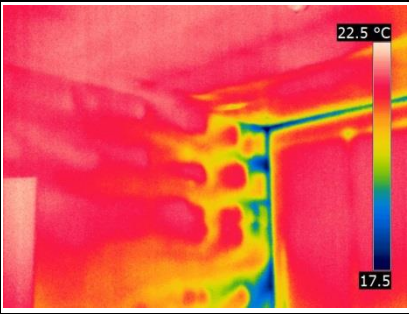
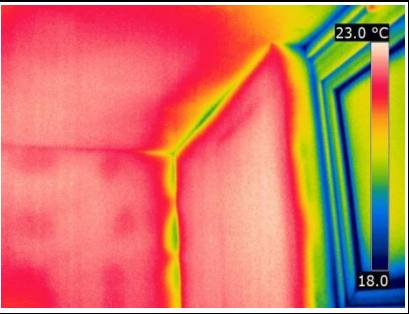
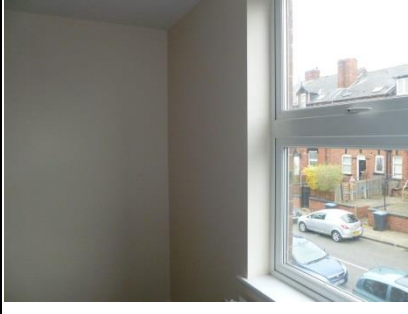
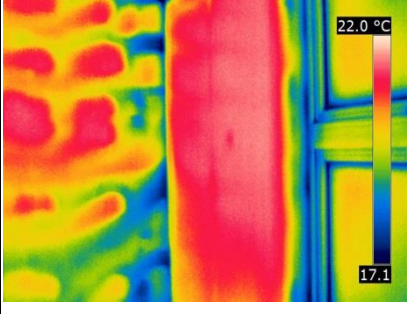
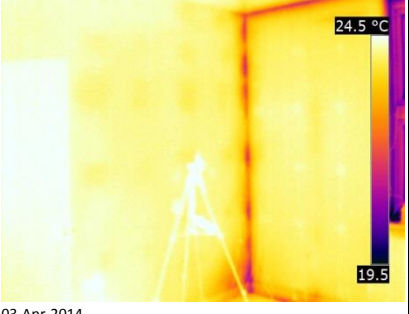
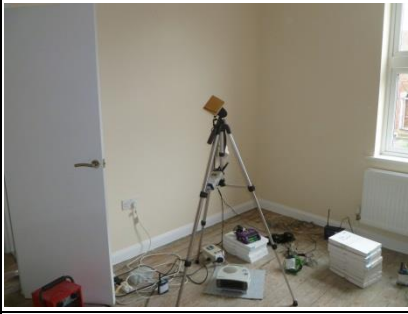
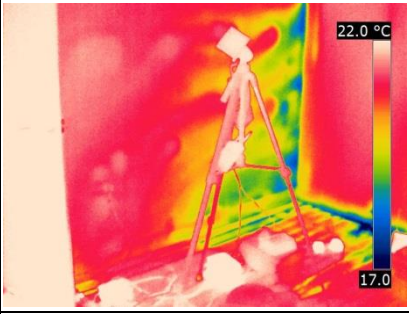
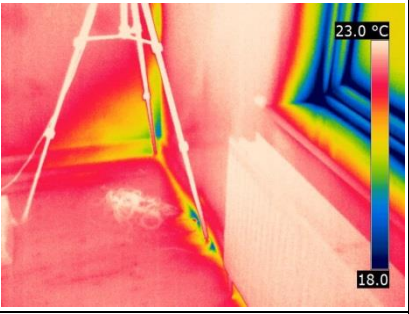
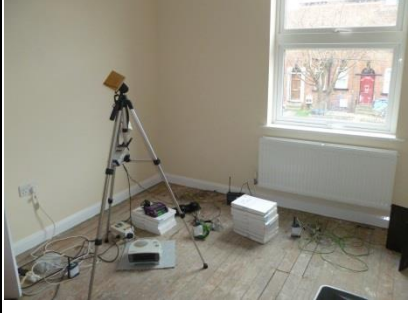
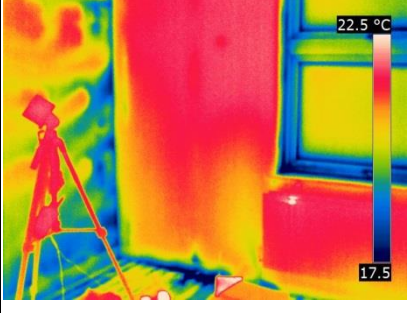
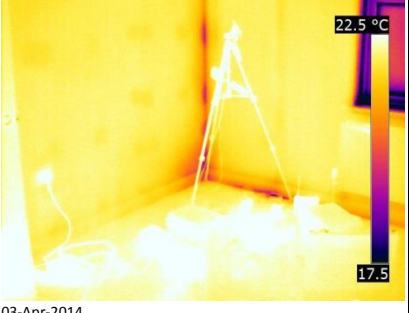
1st Floor Bedroom

The internal wall between the bathroom and bedroom had been dry lined and displayed infiltration entering the void behind the dry lining apparently originating from the external wall junction. The wet plaster finish that had formerly lined the external wall had been removed, and the wall had not been pointed or parged prior to the application of the insulated plasterboard, gaps at unfilled perpend and at the floor junction could be responsible for the infiltration observed here. Air movement between gaps in the insulation panels was minimal in all but one small section on the external wall and previously observed infiltration around the window had been dealt with very effectively, with only small amounts remaining around the trickle vent and at one end of the window sill.

It was possible to observe a cooler area of bedroom ceiling directly beneath the cold roof void above it, but markedly less than had been seen prior to renovation.

Some air leakage was also detected around the air brick on the chimney breast.

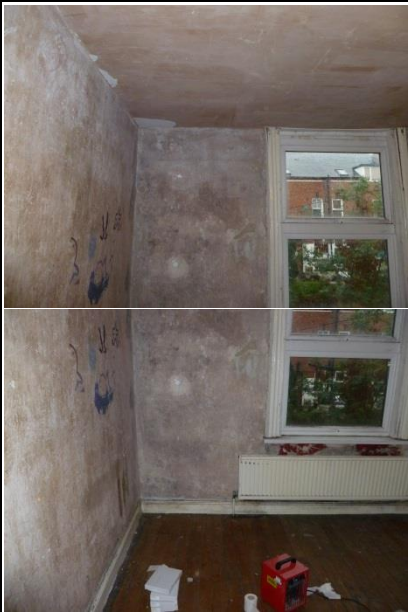
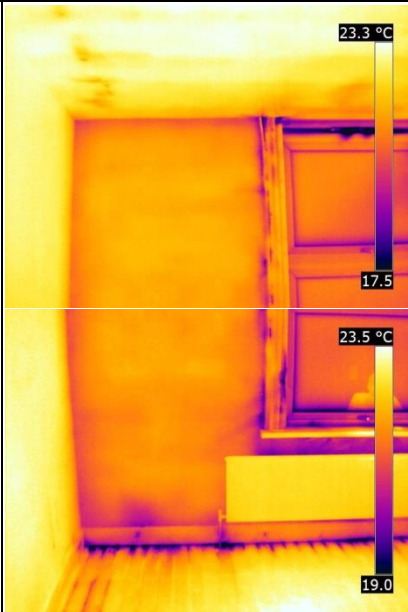
From depressurisation prior to renovation:
With the wet plastered walls the observed infiltration was limited to the floor wall junction and around the window frame.

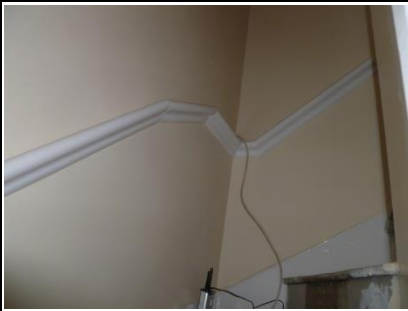
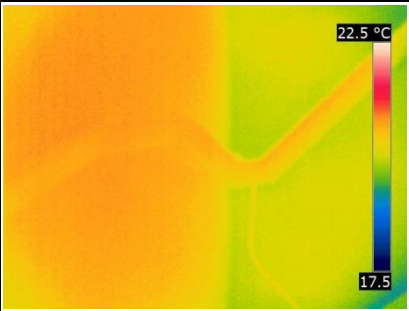
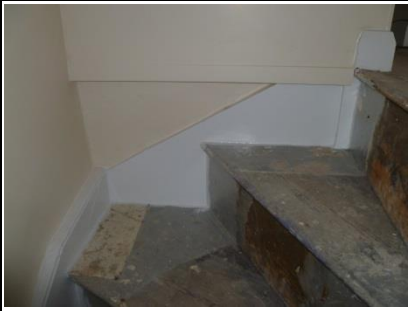
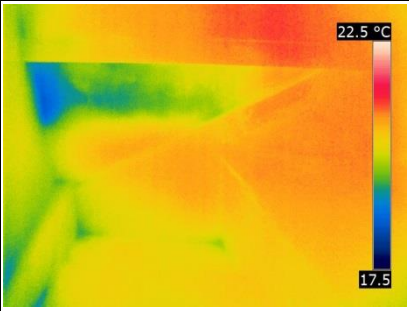
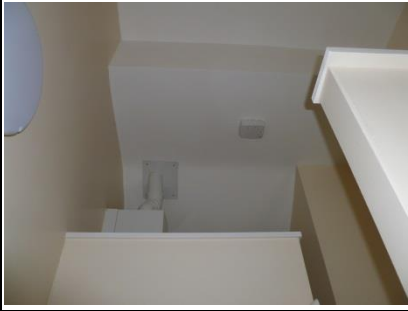
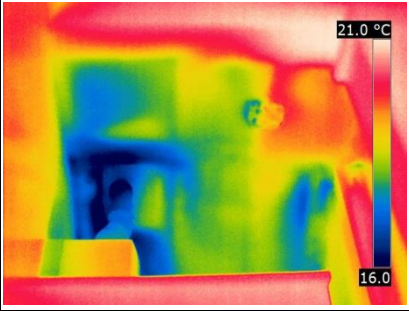
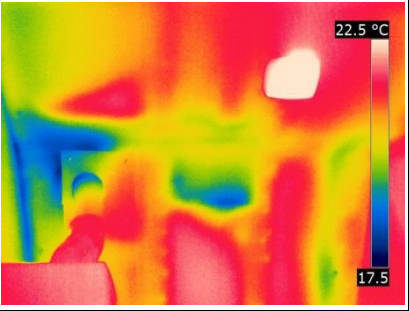
2nd Floor Stairs & Landing

On the stairs there was little to be observed with the variation in wall temperatures reflecting those from different neighbouring properties or distinguishing between internal or party elements. The landing ceiling showed heat loss at areas where the insulation was not ideally fitted around penetrations and more complex junctions intensified by air movement and infiltration around some penetrations. The access door to the roof space was not draught-stripped and performed particularly badly under depressurisation; however under normal conditions this would be an exfiltration area and with heated air leaving the conditioned space looks very different through thermography.

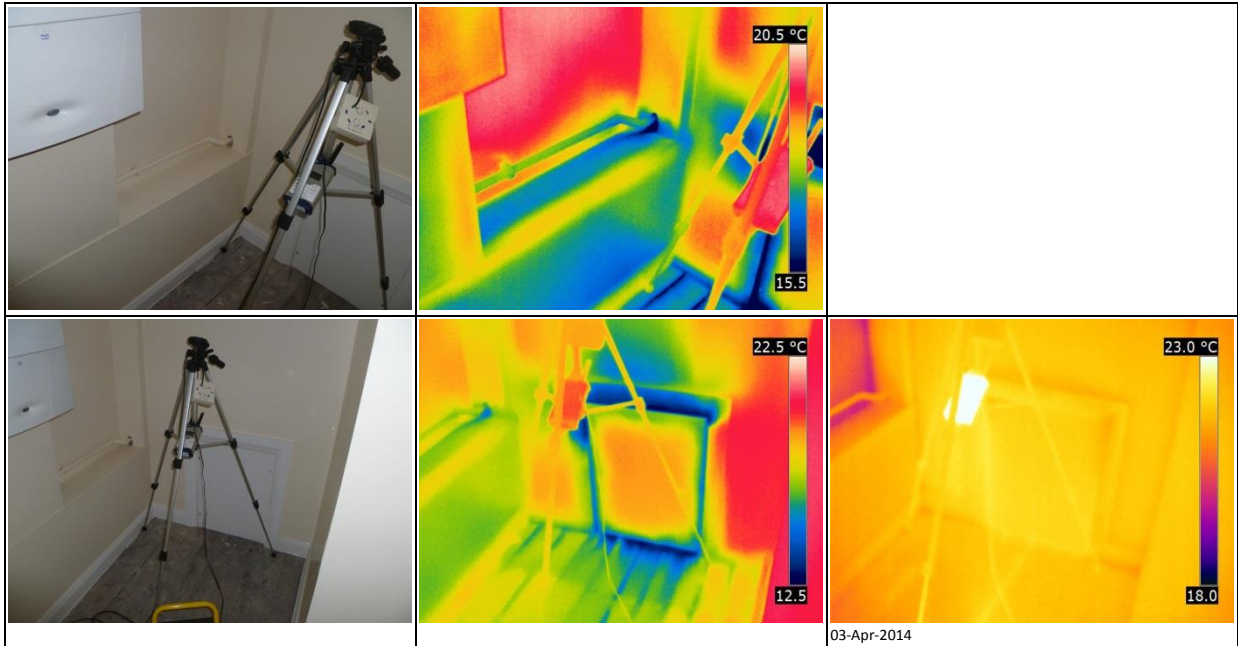
2nd Floor Bedroom

Air leakage up through the intermediate floor and through the window remained similar to that observed in the tests prior to renovation, but the rest of the room in roof structure had improved dramatically. The high visibility of the thermal bridging through the timber formwork indicating that there is effective insulation between.

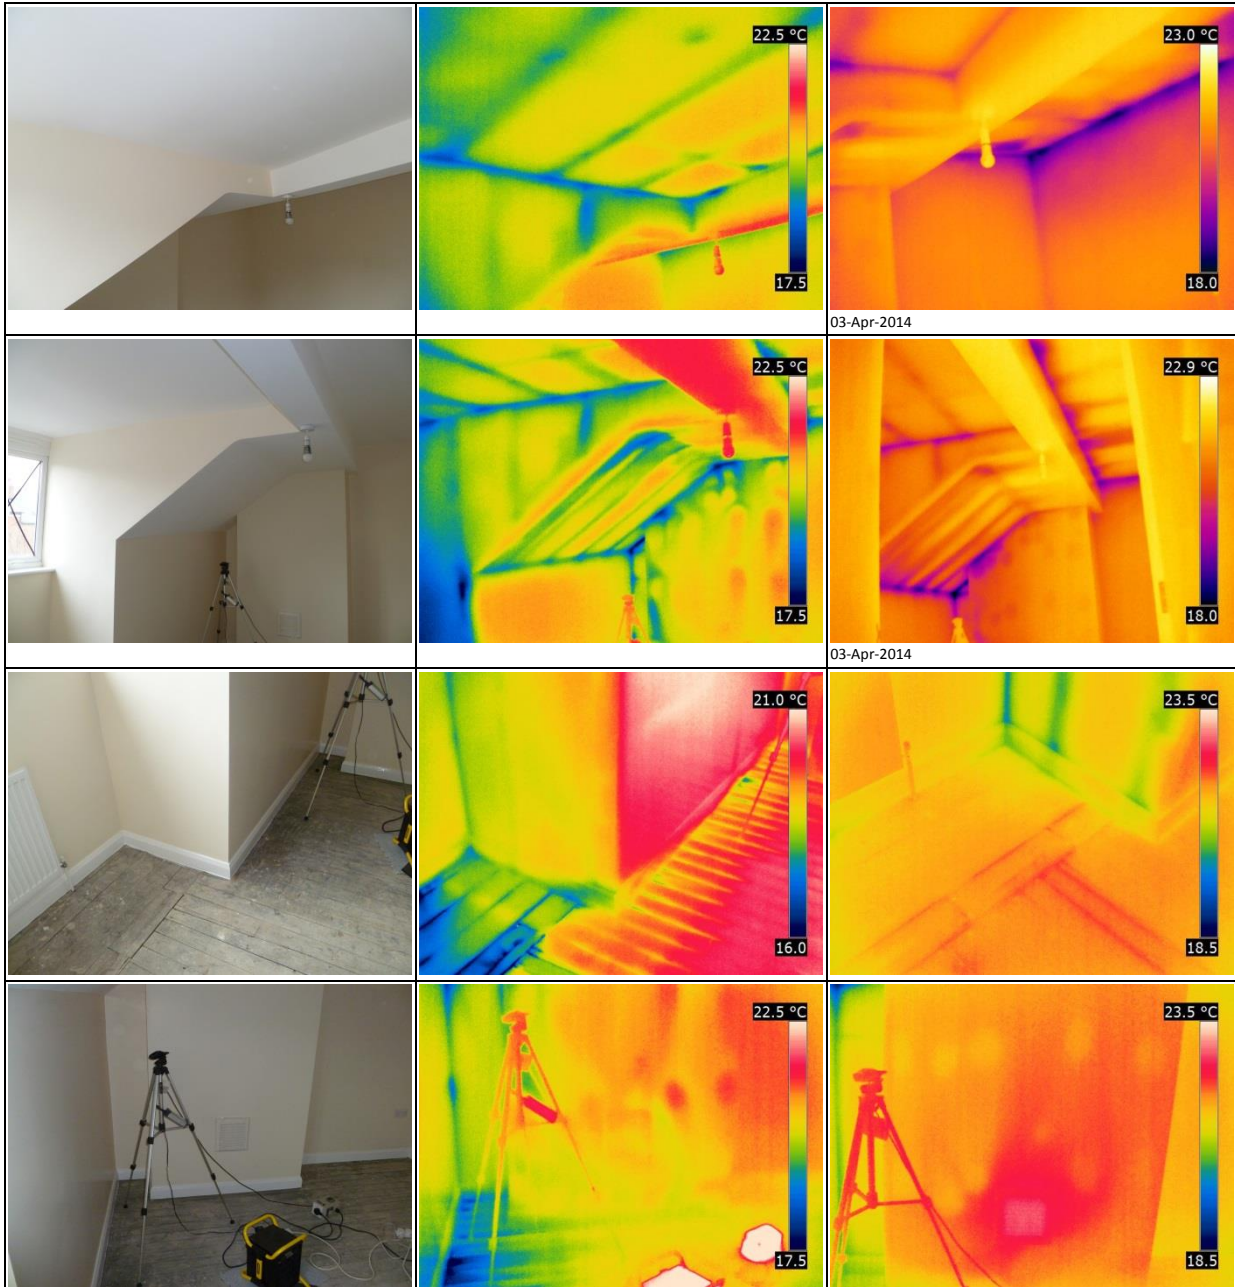
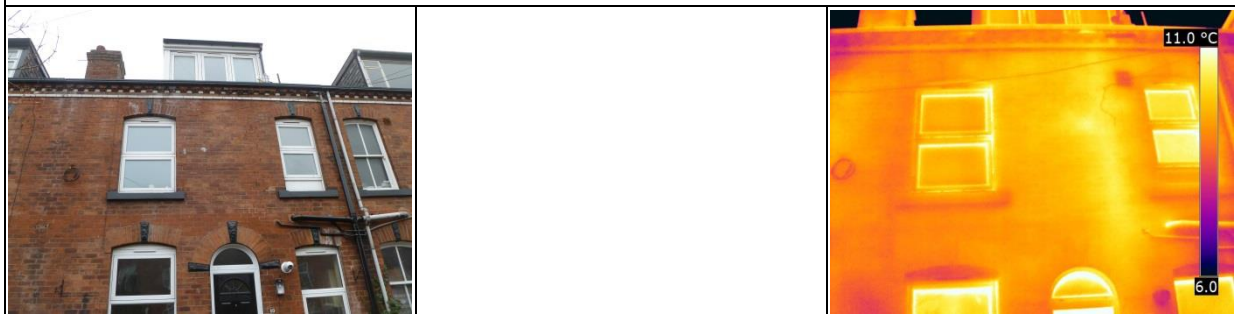
External

The junction of the internal wall between the 1st floor bedroom and bathroom with the external wall shows up quite significantly on thermal images captures from outside the dwelling. With no thermal break between the internal and external wall and the junction in the bathroom intermittently exposed to high humidity levels with no mechanical extraction, the risk of condensation and/or mould growth might want to be evaluated.

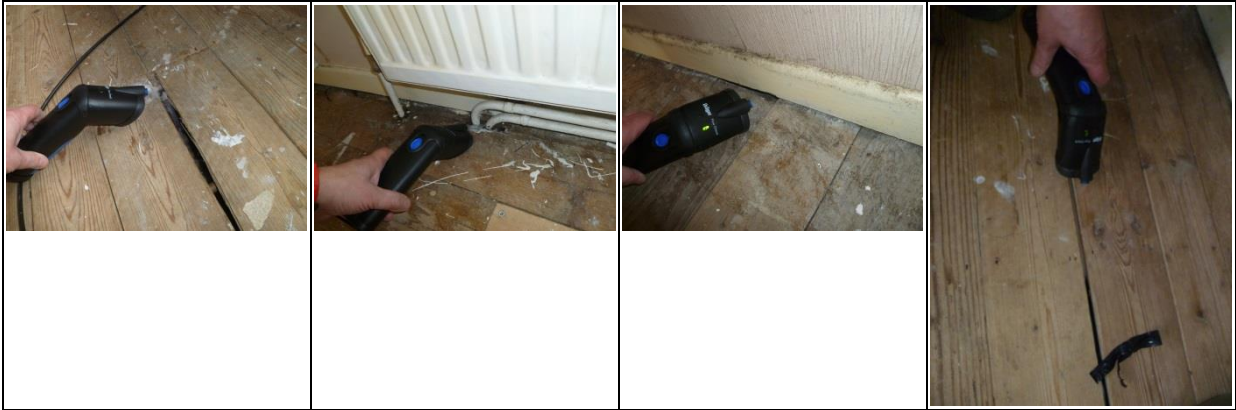
Intermediate Floor

Air leakage was rife through numerous gaps between floorboard throughout the dwelling and at all junctions of the floor with external and party walls.

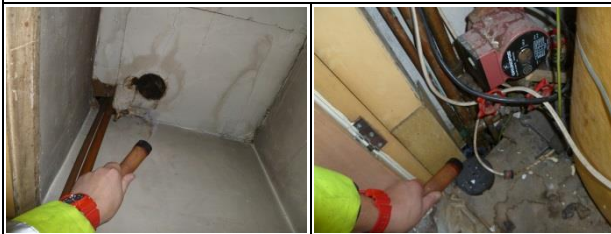
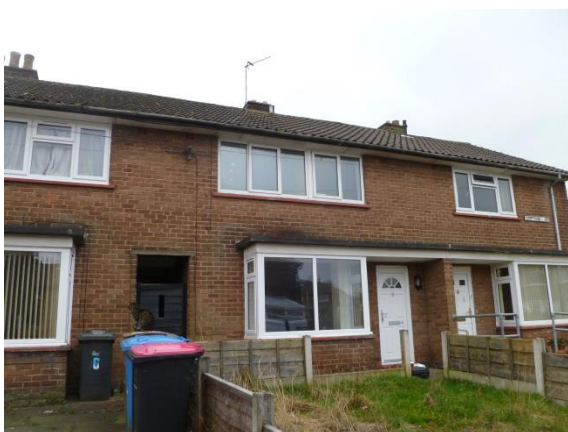
Cylinder Cupboard

Air movement into both the loft space and intermediate floor was particularly severe here, with large openings into both permitting substantial air flow.

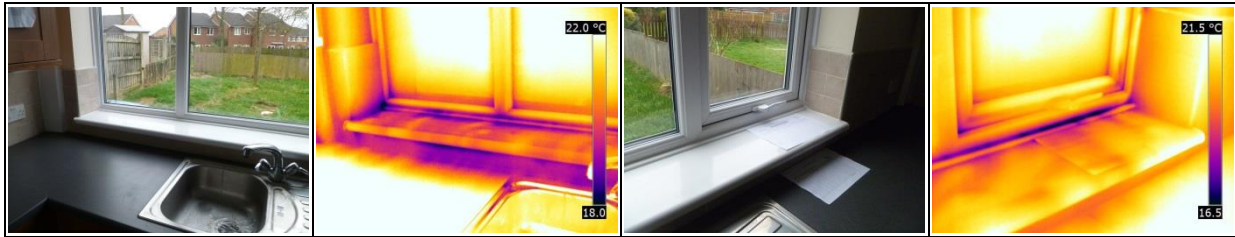
<p>Kitchen As in the lounge, there was very little detectable air movement aside from that around openings and service penetrations. Air leakage was detected behind the kitchen units on the external wall, although the exact paths were obscured by the units, and around the intermittent extract fan. Additional air leakage was observed at the external wall where the boxing for services beneath the bathroom met the wall; air emerging from here was significantly warmer than the air entering around the window, indicating a more complex or convoluted leakage path. The most severe leakage was observed around the window, particularly around the closed trickle vent but also at the frame/sill junction and underneath the sill.</p>

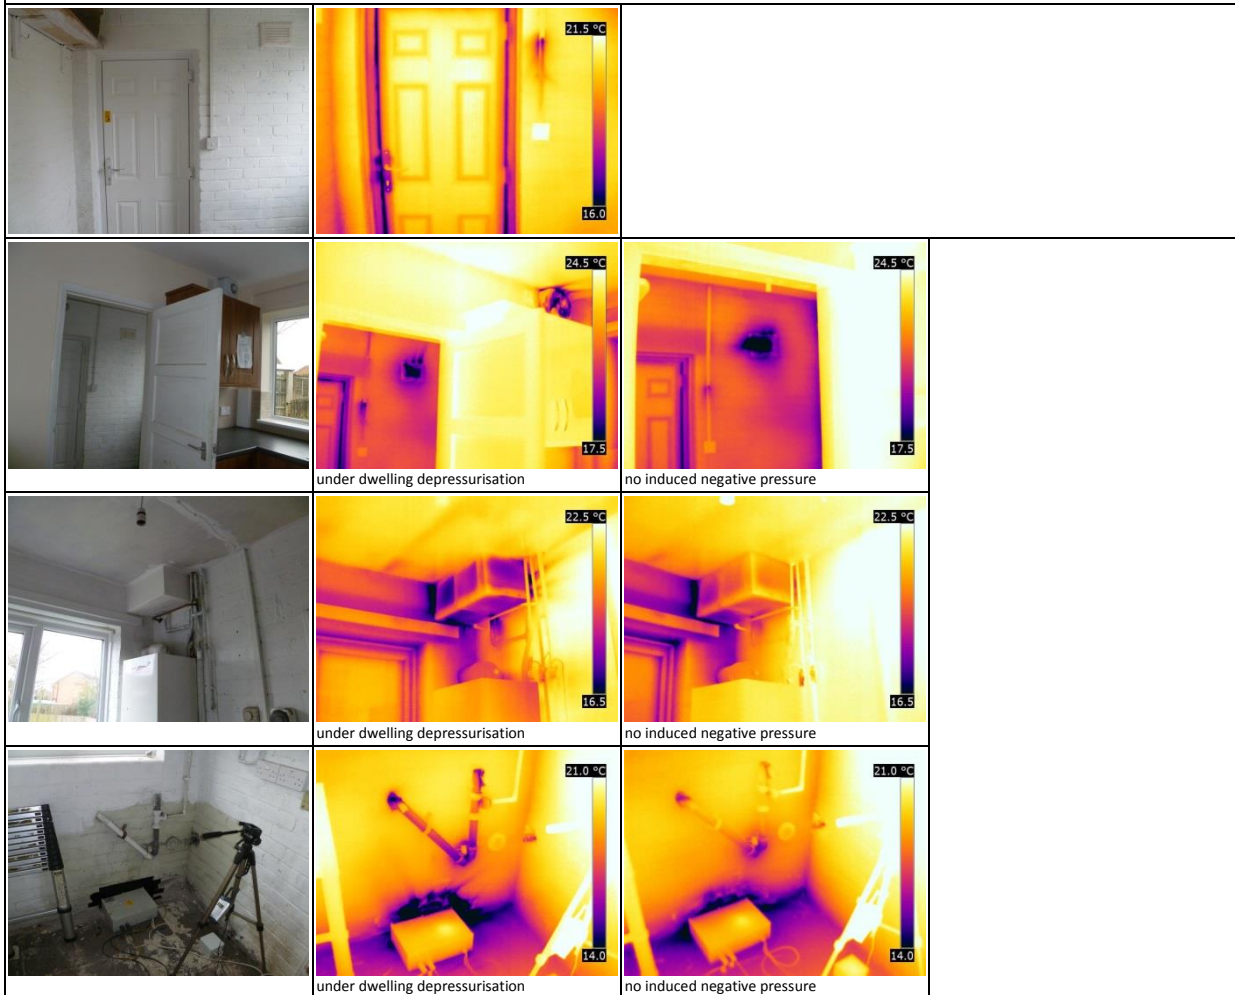
Utility/Boiler Room

Infiltration here was again limited to around openings and service penetrations. The door was draught-stripped and performed well apart from the area where no draught-stripping was applied around the lock. Other notable areas of air flow were observed at exposed and boxed-in penetrations, and at the base of the external wall where the temporary sealing of a wall vent (for test purposes) did not adhere adequately to the damp wall allowing additional infiltration.

Comparison of thermal images under depressurisation and under no artificially-induced negative pressure (using the same temperature range) is used to help to avoid misinterpretation of which observations are due to air leakage and which are due to other effects. As the ground floor is naturally an infiltration zone some air ingress will occur here under normal conditions.

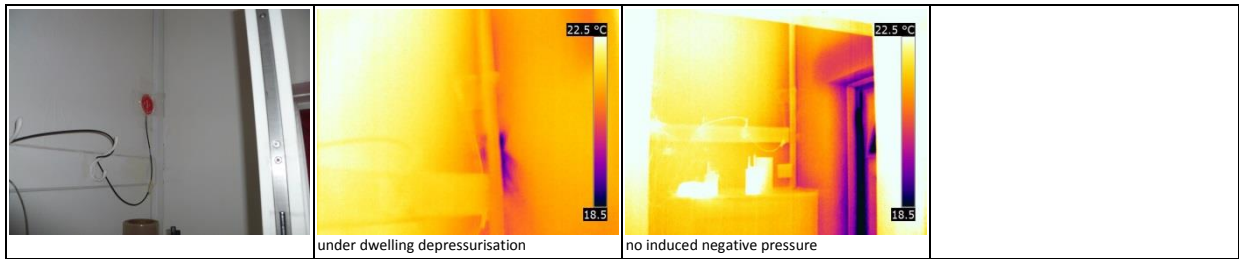
Hall & Stairs

There appeared to be significant infiltration at the meter cupboards, although due to the close proximity to the blower door it was not possible to determine the actual air paths, and apart from a small area at the party/external wall junction there was no other air leakage detected at any junctions or around the lower part of the stairs.
