Appendix B. Air tightness test reports

Air tightness test field reports

LEEDS
METROPOLITAN
UNIVERSITY
Leeds Sustainability Institute

Dwelling C-01, before and after retrofit

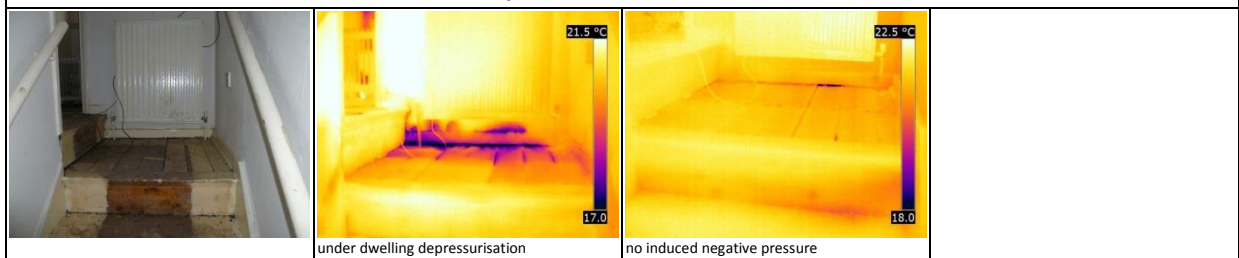
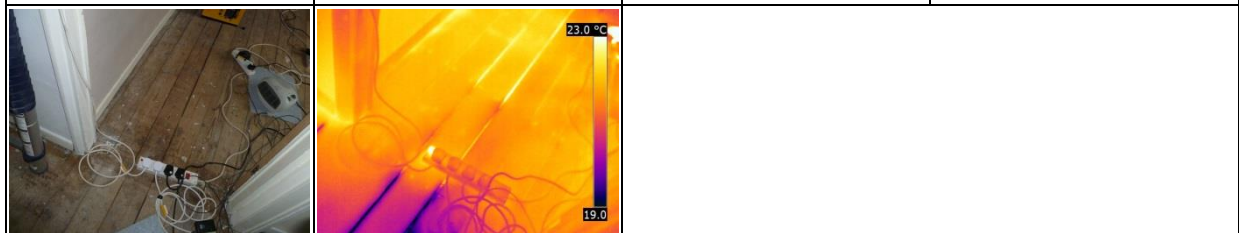
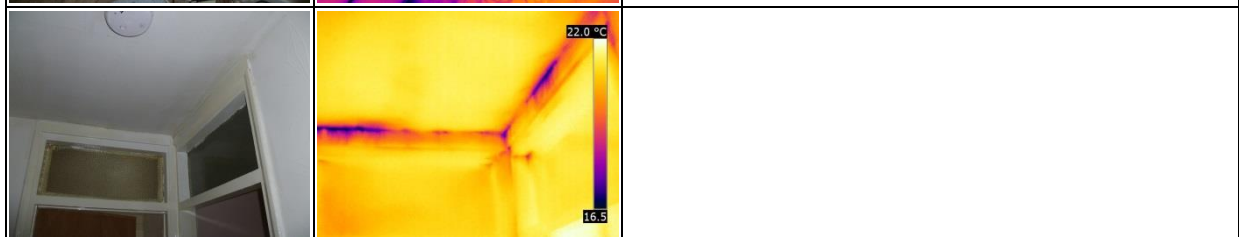
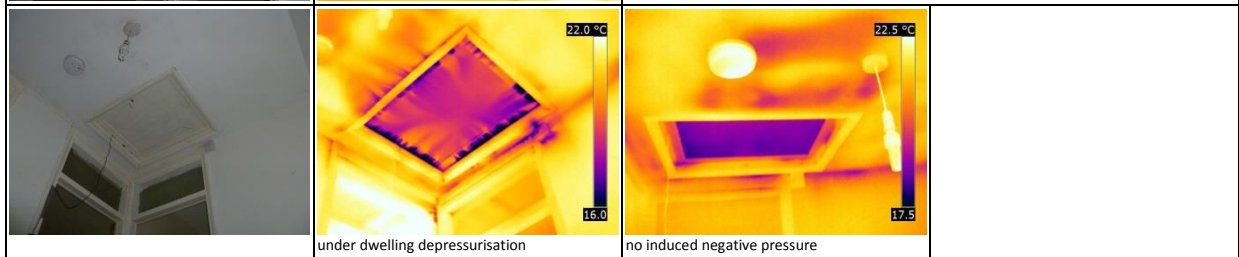
Landing

As in the previous pressurisation test, significant air movement was detected at the junction of the stairs with the intermediate floor. Air was detected emerging from the intermediate floor throughout the dwelling, the doorway between the landing and bedroom 2 reveals air surfacing at a range of temperatures (from cooler in the landing to warmer in the bedroom) indicating how complex some of the air movement throughout the dwelling can be.

Also, under depressurisation, air could be detected being drawn in from the loftspace at junctions of the ceiling and partition walls, and around the loft hatch. This was not observable under no induced depressurisation as the loft boundary is an exfiltration zone under normal conditions and any air movement would be from the habitable space into the loft.

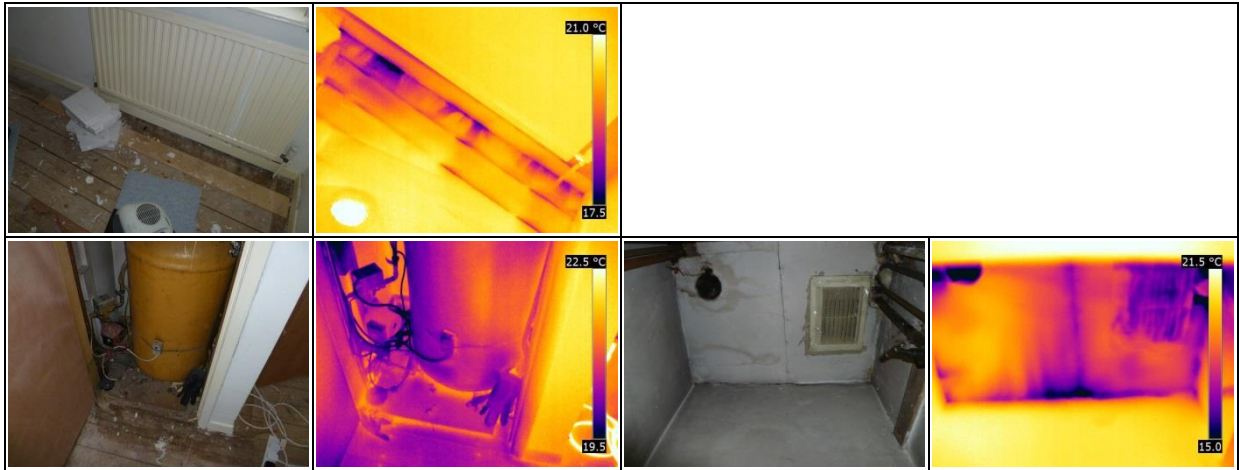
There was considerable air movement in the cylinder cupboard, with gaps in both the cupboard ceiling and floor allowing large amounts of air exchange with the conditioned space.

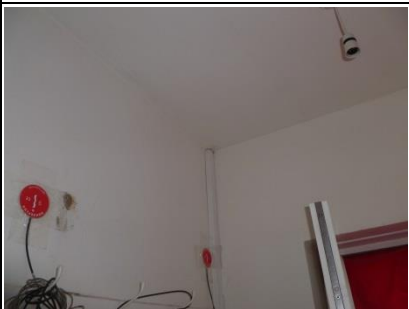
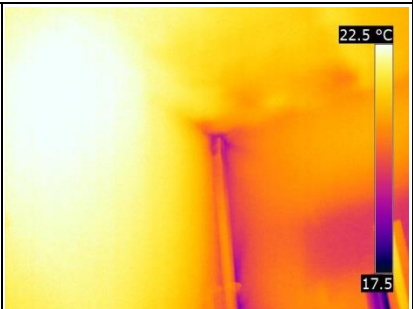
17-Mar-2014 (test 03)	25-Mar-2014 (test 04)
Hall Similar leakage paths were observed to those identified in previous tests, although infiltration around the gas and electric meter cupboards may have reduced slightly as previously there appeared to be too much turbulence to capture reasonable thermal images, whereas now this was possible.

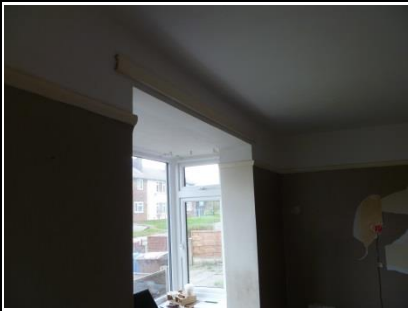
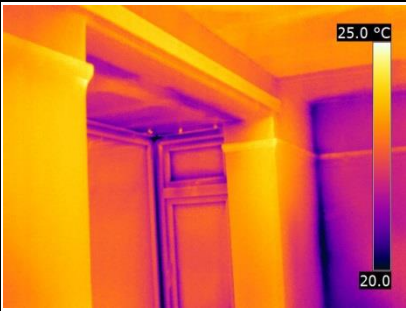
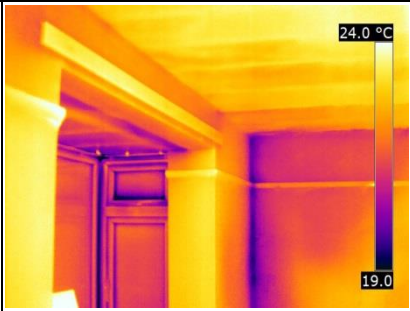
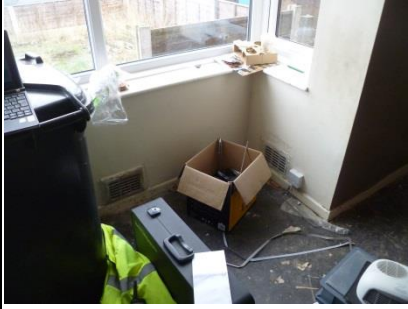
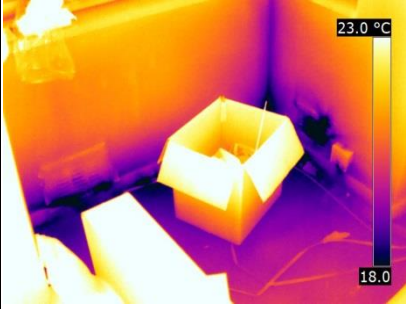
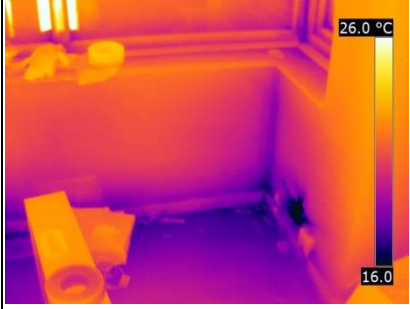
Lounge

Again, there was no significant change in detected leakage paths to those identified in previous tests. With the steady increase in ΔT with each test some areas of lesser leakage were now more clearly detectable through thermal imaging, such as small gaps around the bay window and the compartmentalisation of the intermediate floor void.

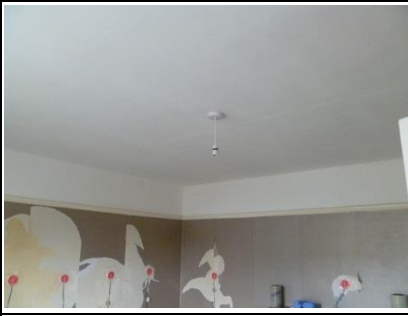
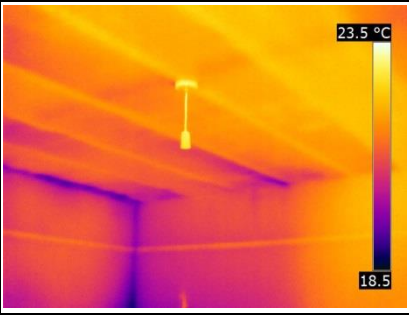
Kitchen & Utility Room

Once again, the detected leakage paths remained very similar to those identified in previous tests, and the increase in ΔT enhancing thermographic leakage detection.

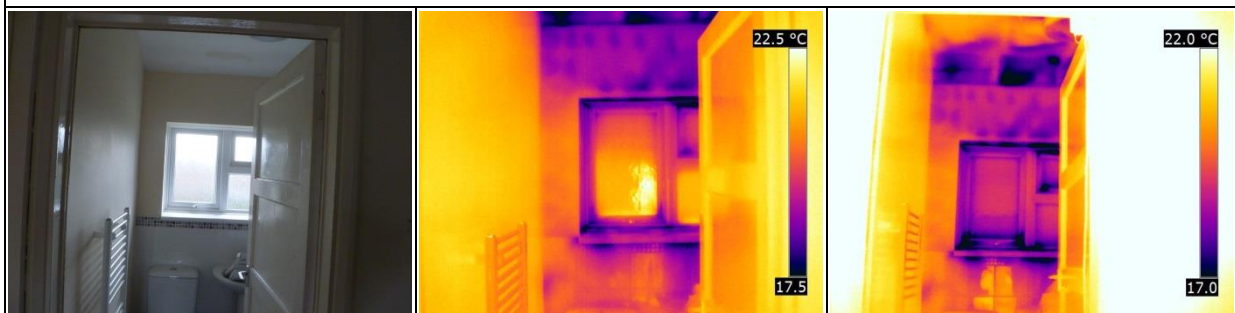
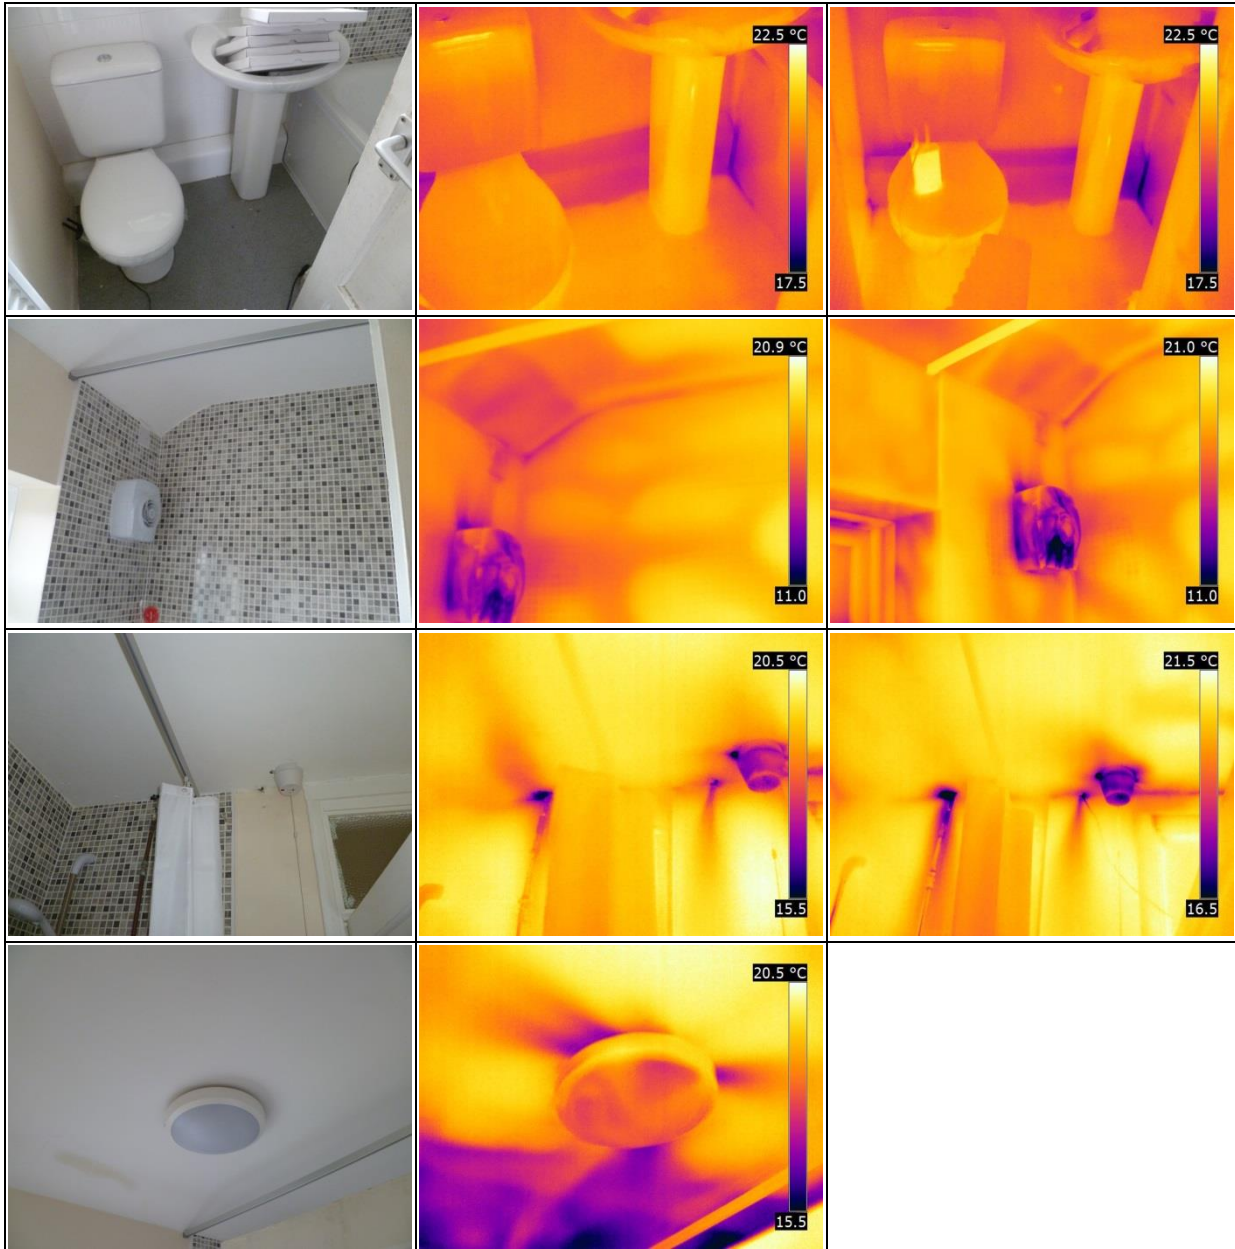
Bathroom

As previously noted, the detected infiltration paths remained similar to those identified in previous tests.

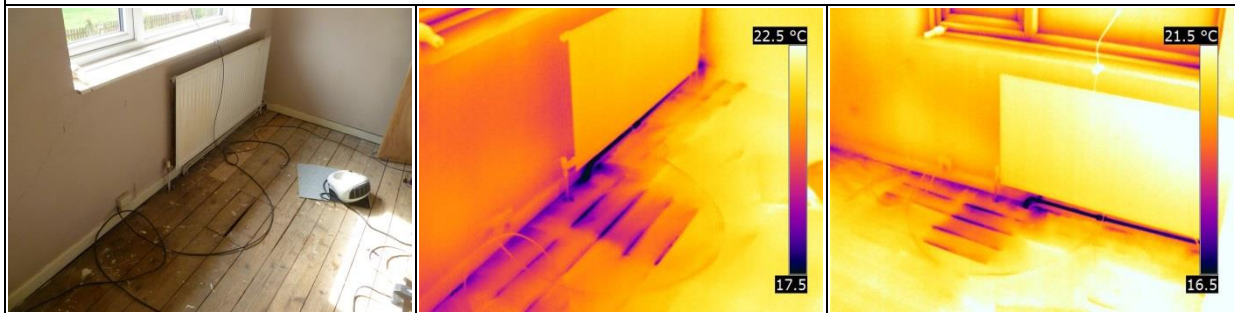
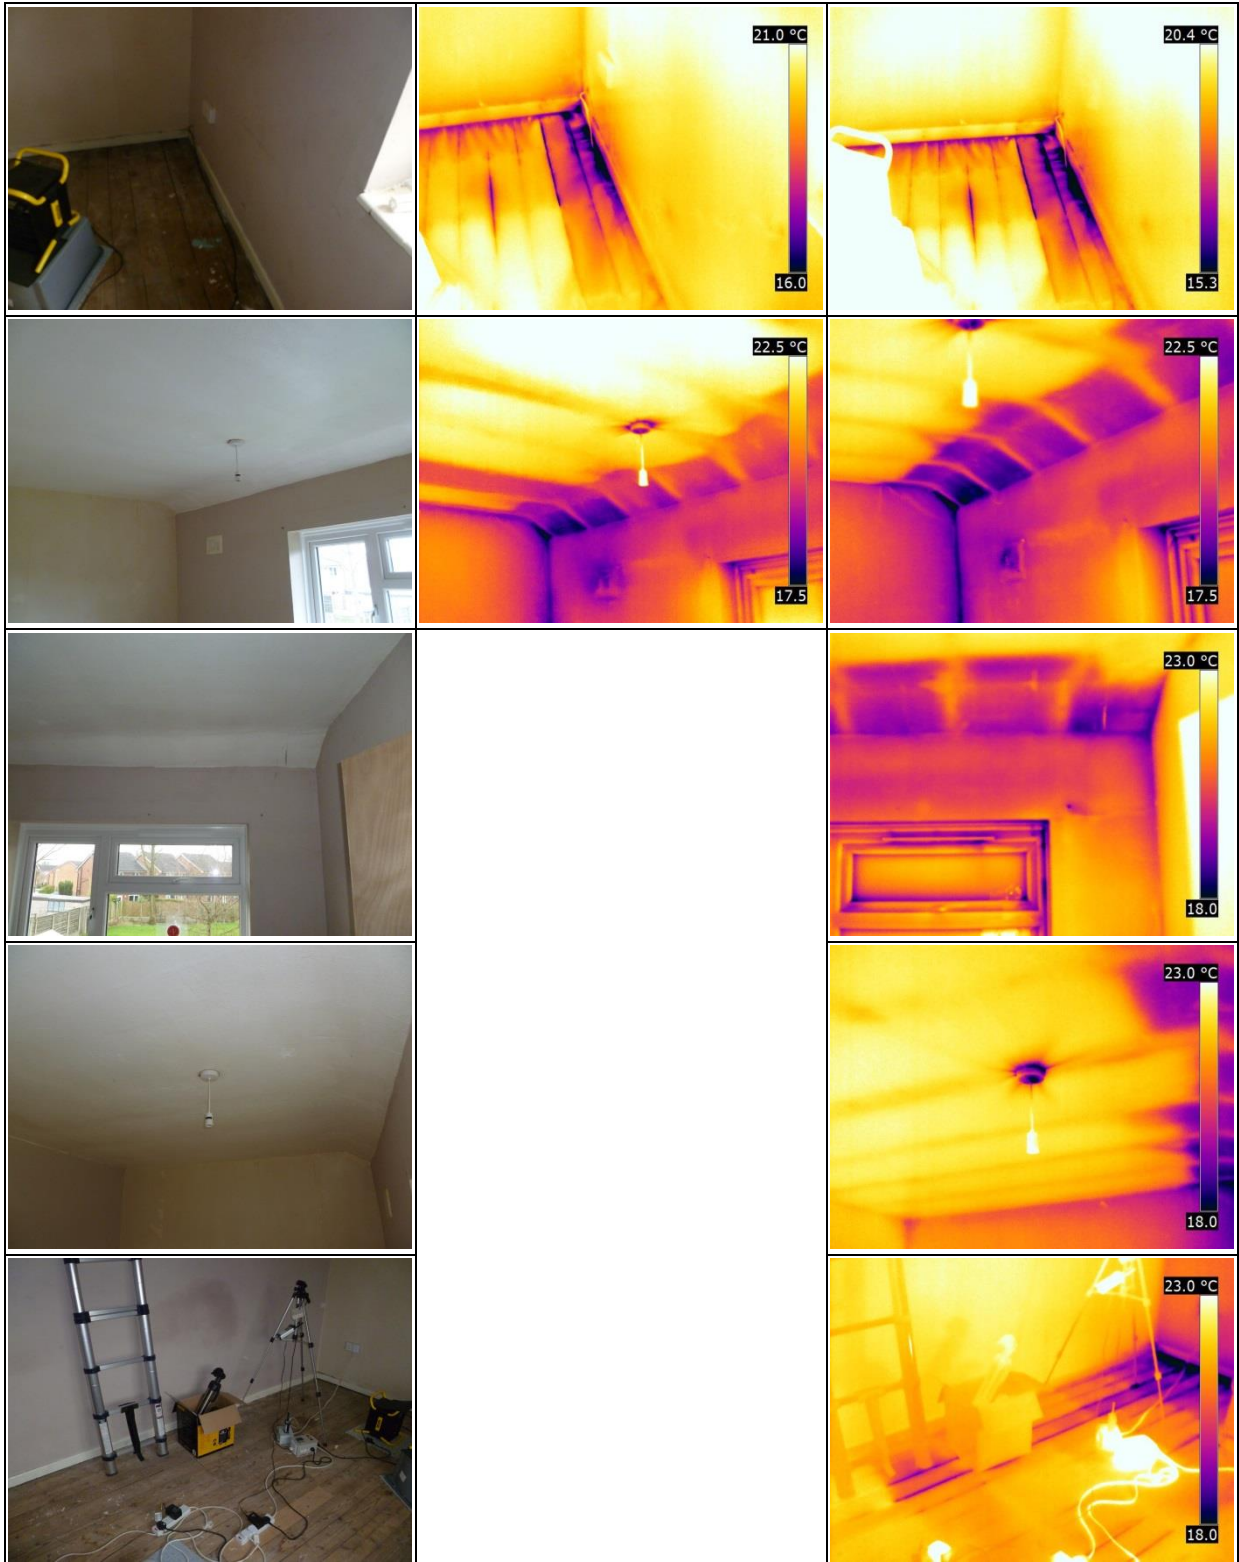
Bedroom 2 (Rear)

Air leakage paths were unchanged from previous tests. The upgrade of the loft insulation between test 03 and test 04 is shown by the more even ceiling temperatures; however, air leakage around the central light fixing appeared to be unaffected.

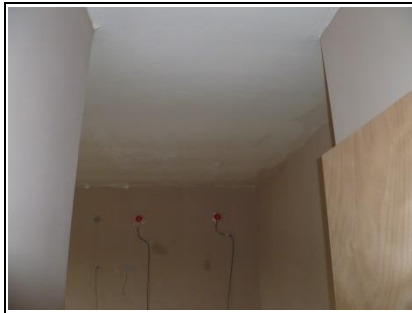
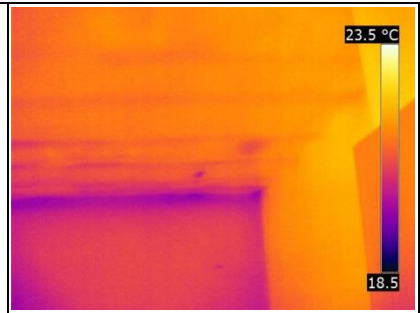
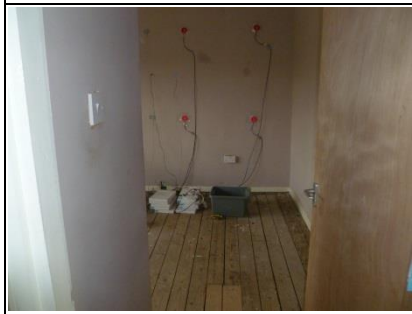
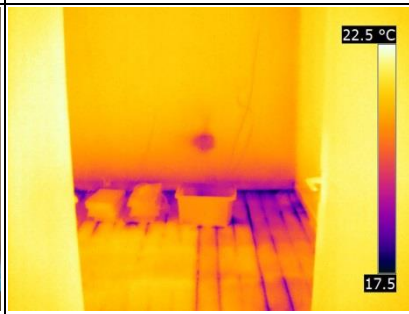
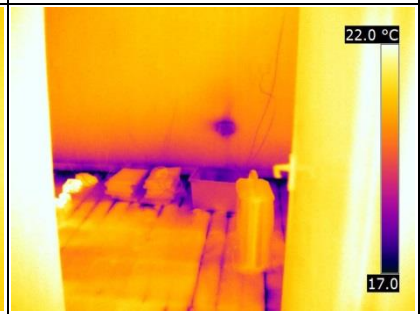
Bedroom 1

As in bedroom 2, the upgrade of the loft insulation between the 2 tests is shown by the more even ceiling temperatures. The electrical pattress box on this unfilled party wall still shows infiltration of cold air, unlike those on the filled party wall which now show warmer air emerging. Otherwise, the only differences observed between these tests (and previous ones) was due to the increased ΔT .

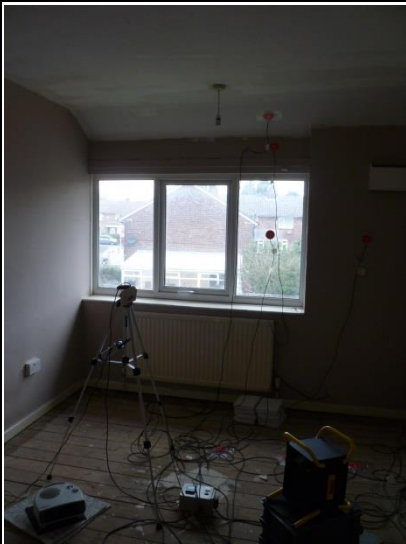
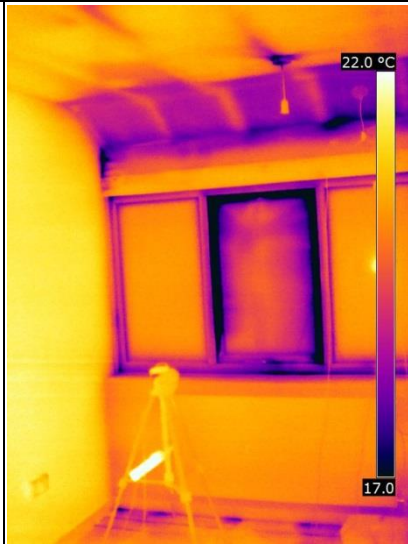
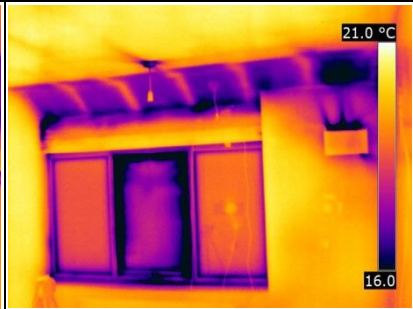
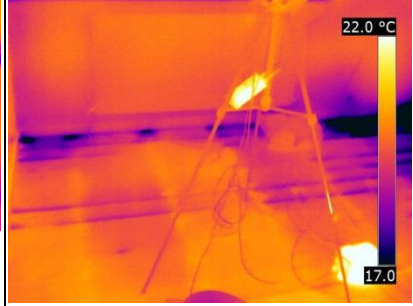
Bedroom 3

As in the other bedrooms the loft upgrade is shown by more even ceiling temperatures, and other differences observed between tests due to the increased ΔT for the latter test. The electrical pattrass box on the party wall and the floor/wall junction beneath it show infiltration of warm air emerging from the filled party wall cavity; previously (without the party wall cavity filled) infiltration here had been detected as cooler air.

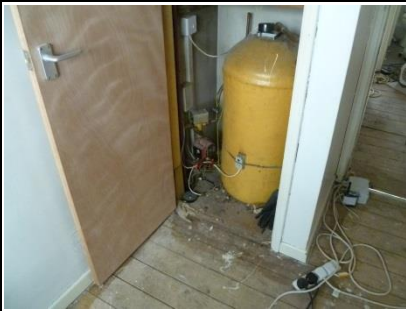
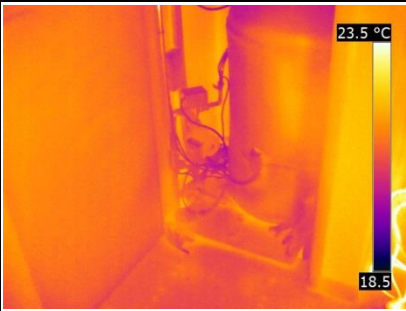
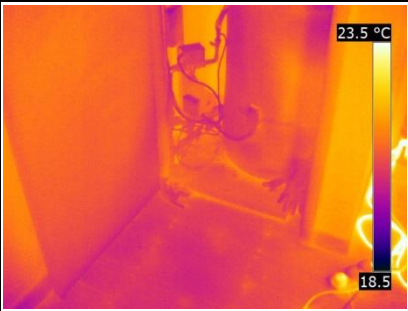
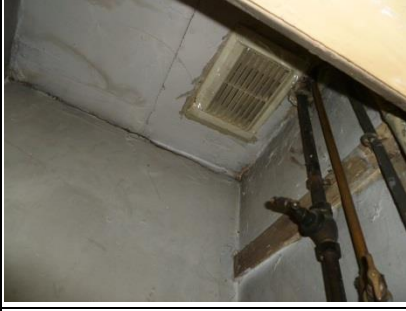
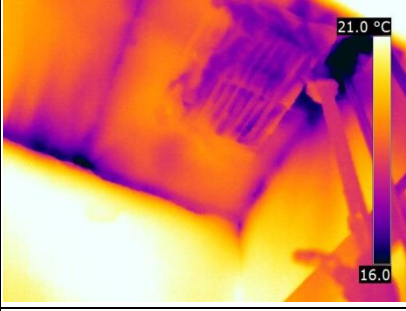
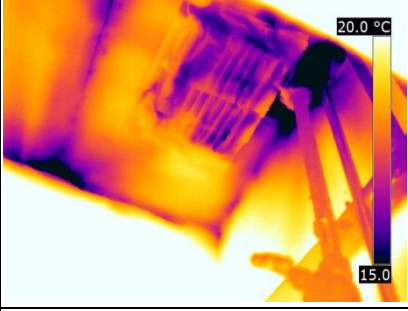
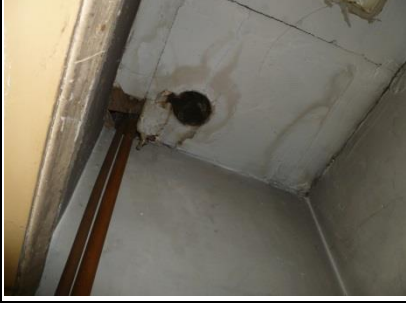
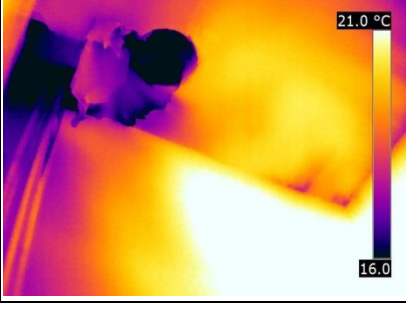
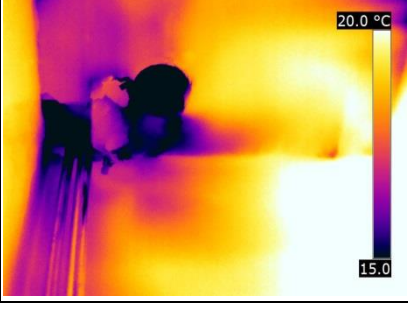
Cylinder Cupboard

There was no noticeable change in air leakage patterns in the cylinder cupboard between these tests and the previous one.

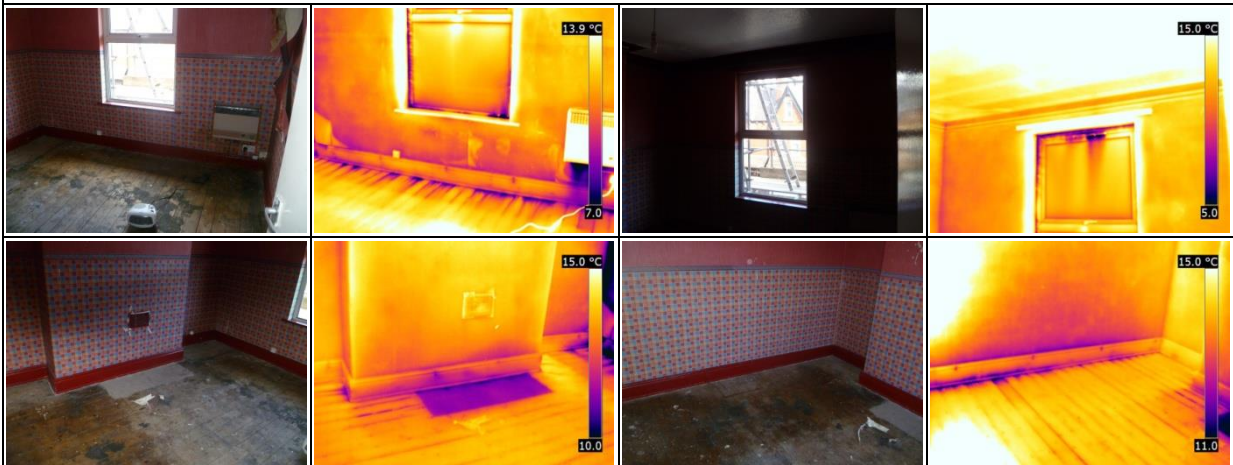
Bedroom 1

As previously observed, leakage at the trickle vent, window and intermediate floor perimeter. It was possible to see discrete temperature changes between joists across the intermediate floor void as the distance from the external wall increased. Air was also observed entering through the floor around the chimney breast and at the base of the partition wall backing on to Bedroom 2, although at significantly higher temperatures than the direct leakage from outside.

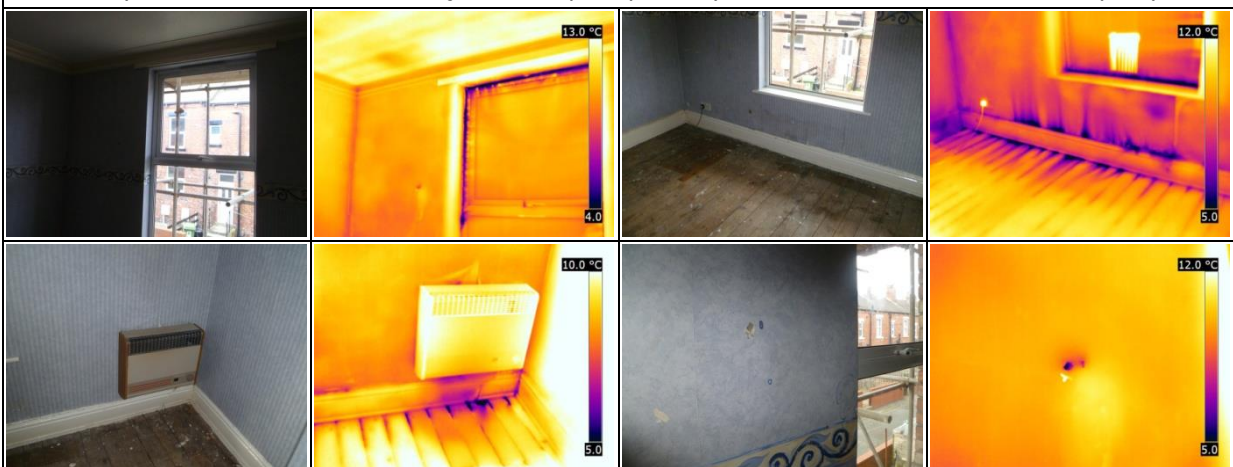
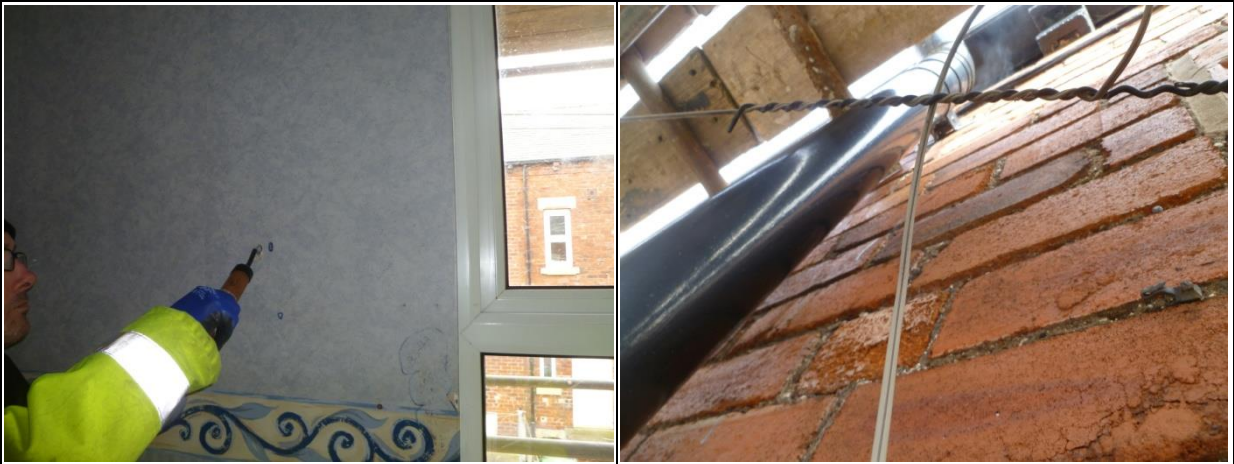
Bedroom 2

Air leakage was once again detected around the window and again at the floor perimeter. Here the infiltration at the external wall junction with the floor was even more apparent than in Bedroom 1, and the stratification of floor temperature moving away from the external wall more clearly defined. A penetration into the wall to the left of the window showed external air being drawn into the bedroom from outside, as this penetration was not completely through the wall it was investigated further to attempt to determine the air path. Under dwelling pressurisation smoke could be observed going into the hole in the wall but not emerging externally until it reached the eaves; confirming that the infiltration at this penetration was coming from the "cavity" inside the solid external wall. A cavity which may link the whole external façade and quite possibly connect to a similar one in the party wall.

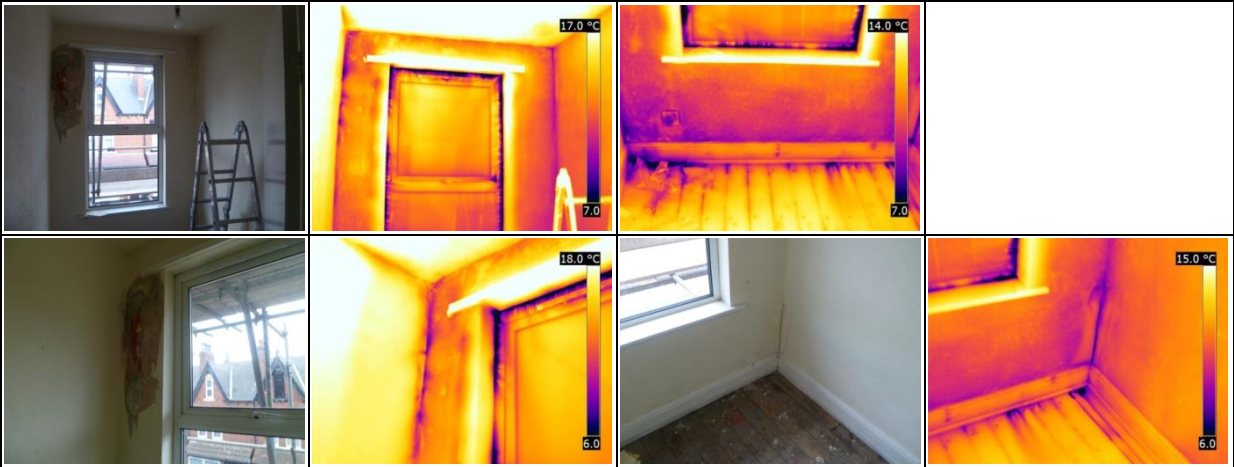
Bedroom 3

Infiltration around the window and intermediate floor, as mentioned previously.

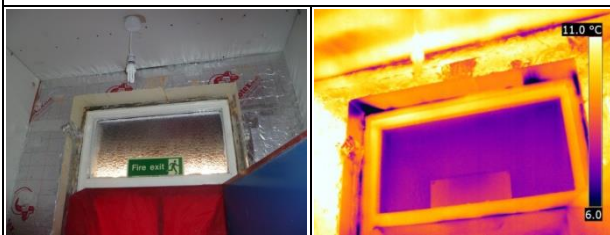
Hall

Leakage at the unfinished opening, coming from gaps around the as yet unsealed junction between the frame and the external wall.

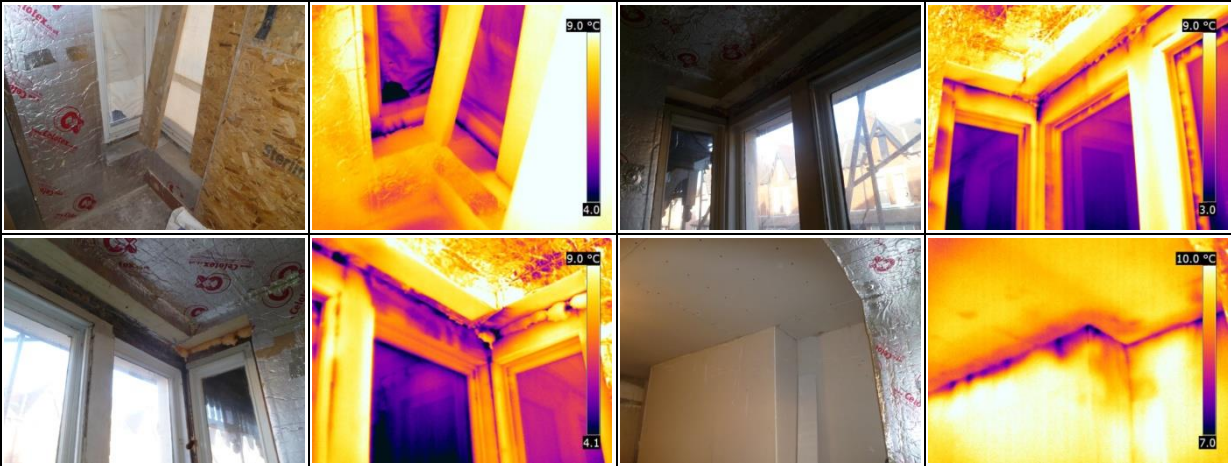
Lounge

Air leakage detected around the bay window and around the wall insulation at external/internal wall junctions, at the wall/floor junctions and around the bay roof. The penetration through the insulation appeared well-sealed with no detectable air movement. Some air leakage was also observed at the intermediate floor junction with the party wall.

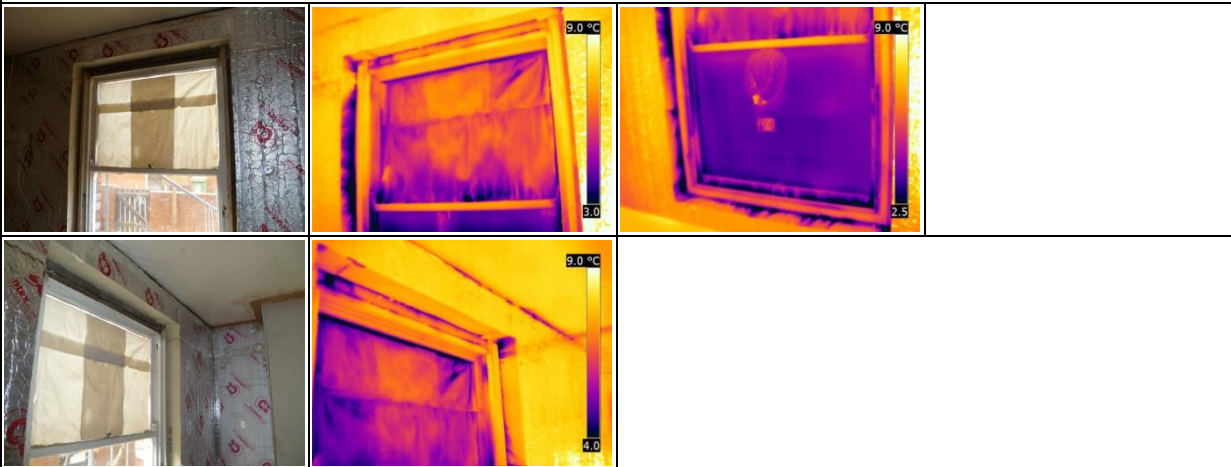
Kitchen

Infiltration detected around and through the window as seen in the lounge.

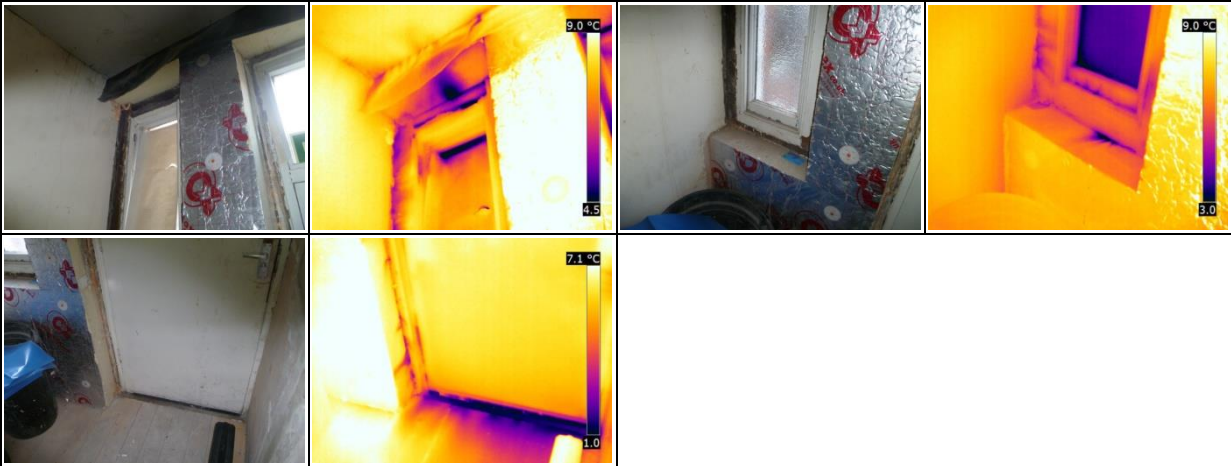
Rear Lobby

As previously observed, plus considerable air movement around the back door.

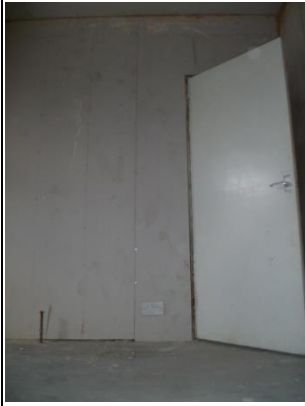
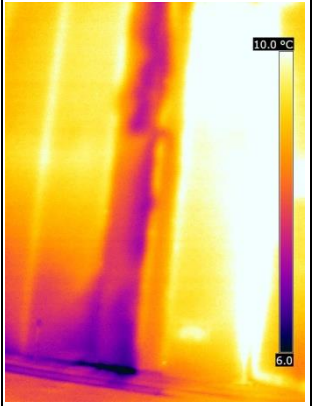
Bedroom 1

Infiltration was observed as previously, at the window and around the external wall insulation. Substantial infiltrating air was being drawn in along and into the internal wall backing onto bedroom 3, which was open to the attic, and up through gaps between the floorboards running parallel to this partition wall. Some air movement was also observed at the ceiling junction with the partition wall backing onto bedroom 2.

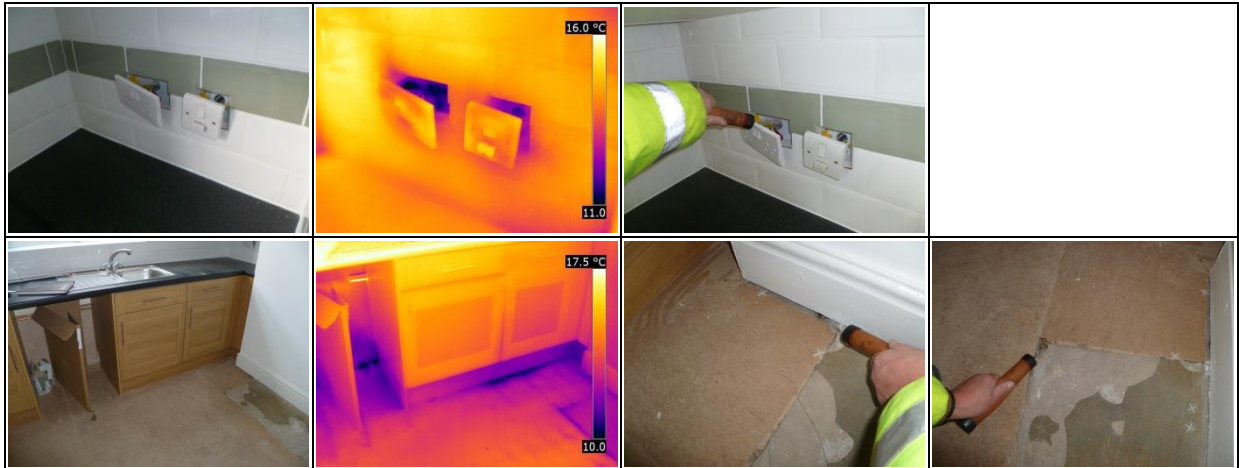
Kitchen

Infiltration was again observed around the window, particularly between the trickle vent and the window frame. The penetration for the extraction fan was temporarily sealed for the test, but still allowed significant air movement into the void behind the plasterboard directly from outside, hopefully this will reduce markedly once the device is installed and sealed around externally. Leakage was also detected around the wall-mounted patresses, from areas obscured by the kitchen units and at the floor/party wall junction around the chimney breast.

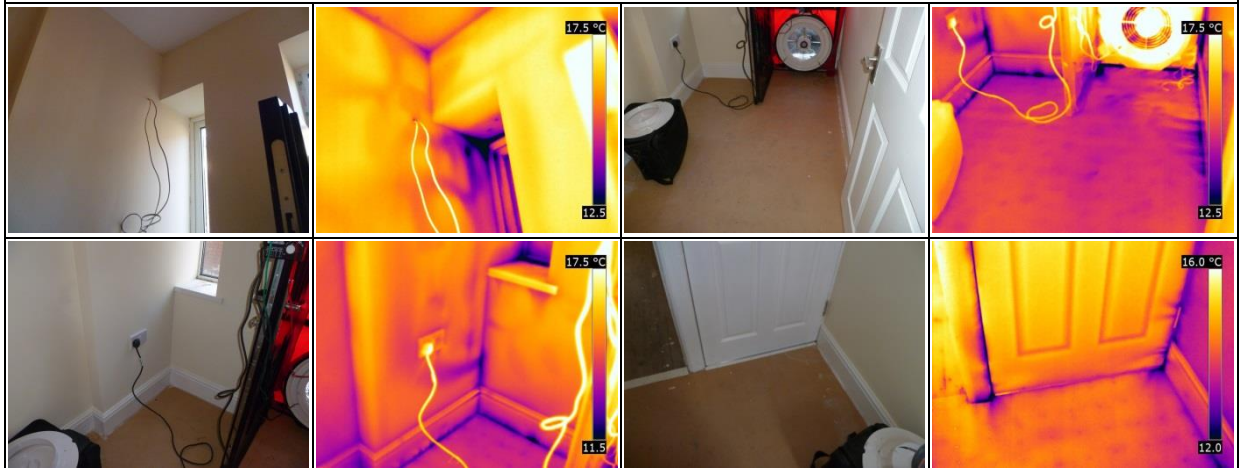
Rear Lobby

Air paths were detected around the window, this was not direct leakage into the room but from outside into the void behind the plasterboard. Air leakage was also seen at the room perimeter, around the floor covering, and around the cellar door.

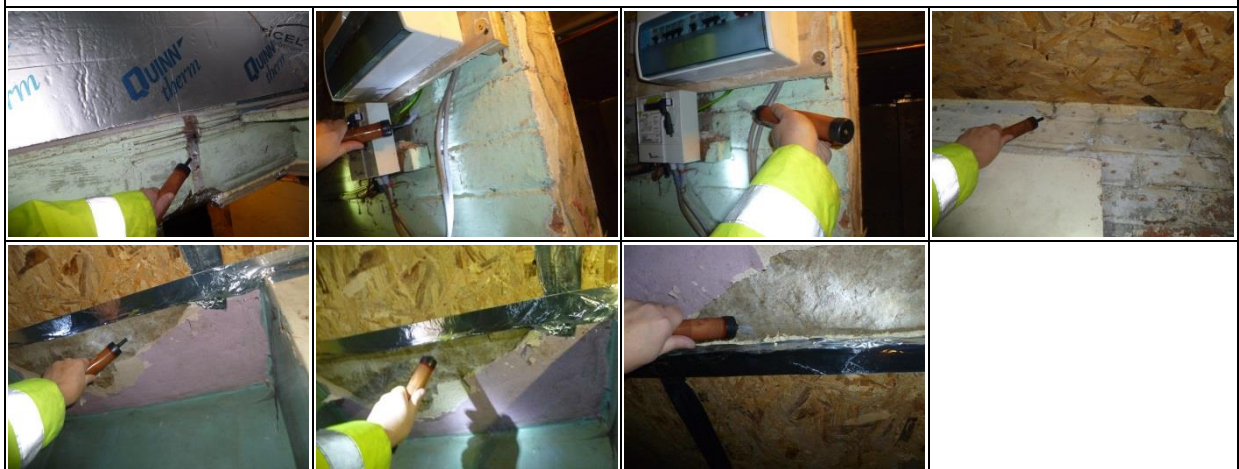
Cellar

Some leakage detection was performed in the cellar under dwelling depressurisation, using smoke to identify where air from the cellar was entering the property. Generally the cellar ceiling was well sealed with air entering the floor void from a few gaps in the seals and from behind the consumer unit.

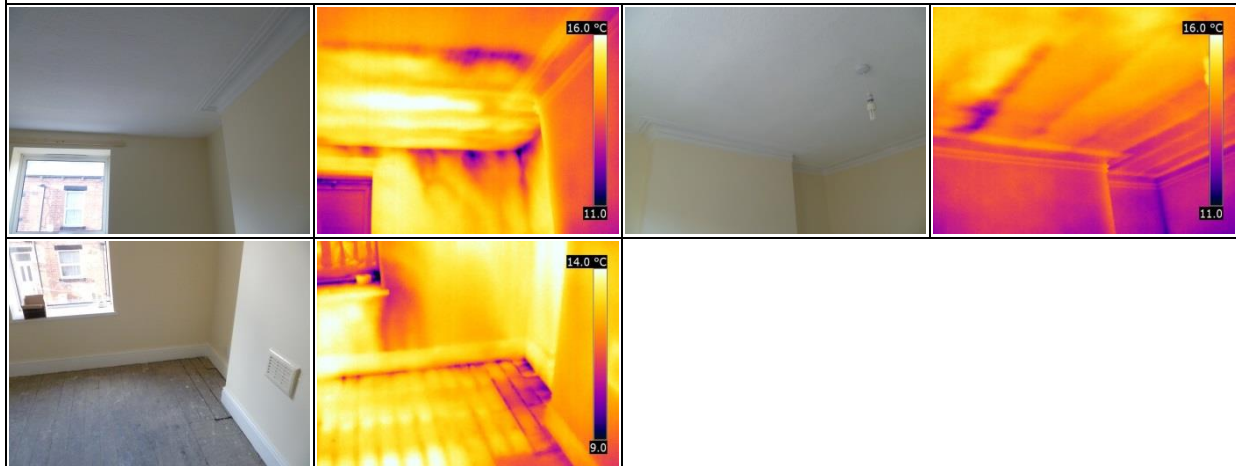
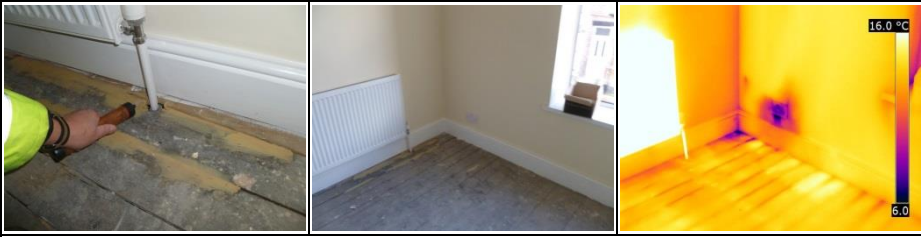
Bedroom 2

The infiltration at the external wall junctions with the floor and ceiling were still apparent, although not appearing quite as serious as in either the bathroom or bedroom 1. However, the infiltration through the electrical socket on the external wall was particularly cold.

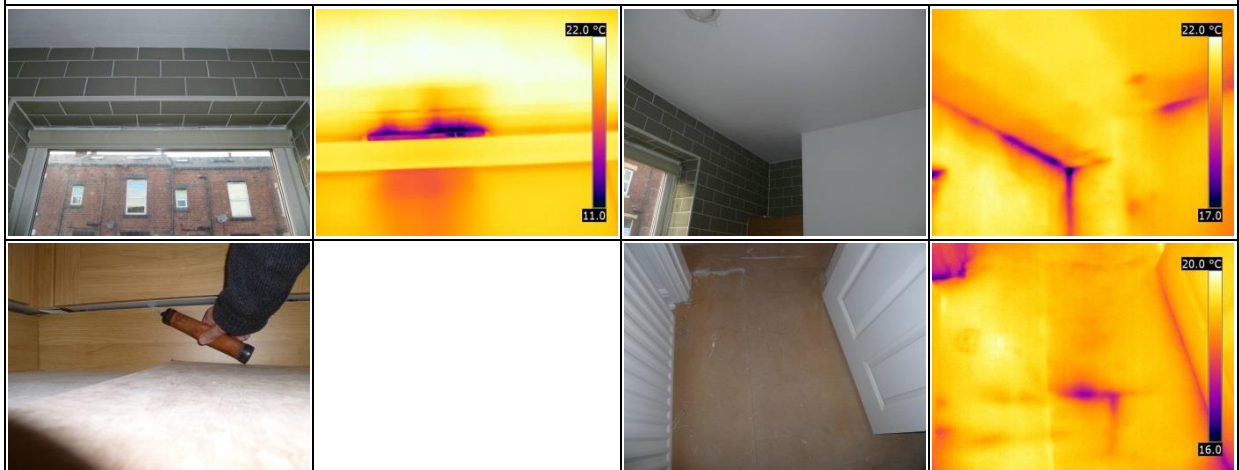
Kitchen

Infiltration detected around the trickle vent and somewhere behind the kitchen units. There were indications of air movement at the external wall junction with the intermediate floor and through the ground floor beneath the floor covering, but this was again comparatively minor compared to previous observations and No.16.

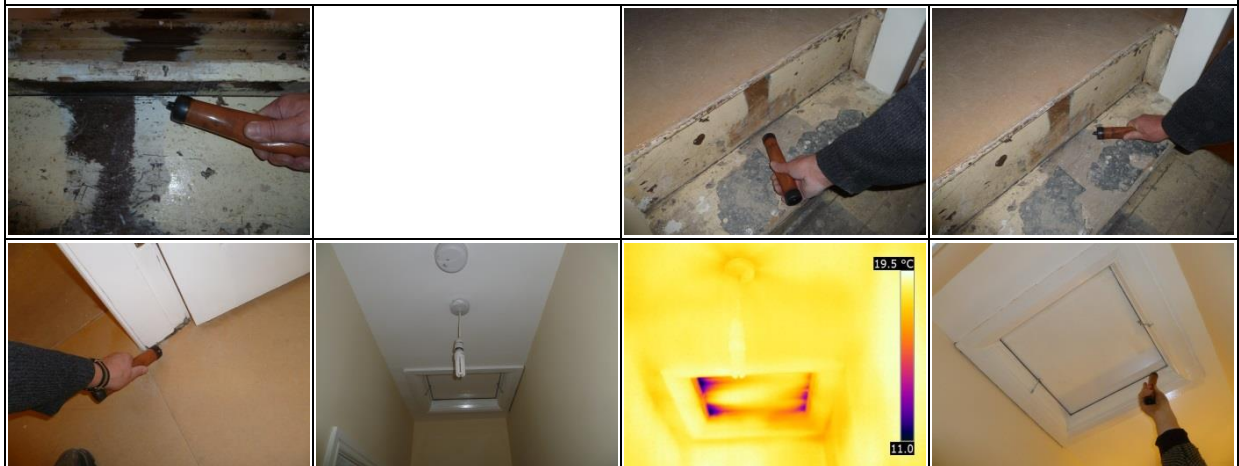
Stairs/Landing

Some air leakage was observed through small gaps in the stairs, this was greatest at the junction of the stairs and the intermediate floor. As in the next door property leakage was observed around the loft hatch, possibly to the same extent but in this dwelling it was perceived as worse because the rest of the building was much more airtight. Air leakage was also observed into the intermediate floor voids at the floor perimeter.

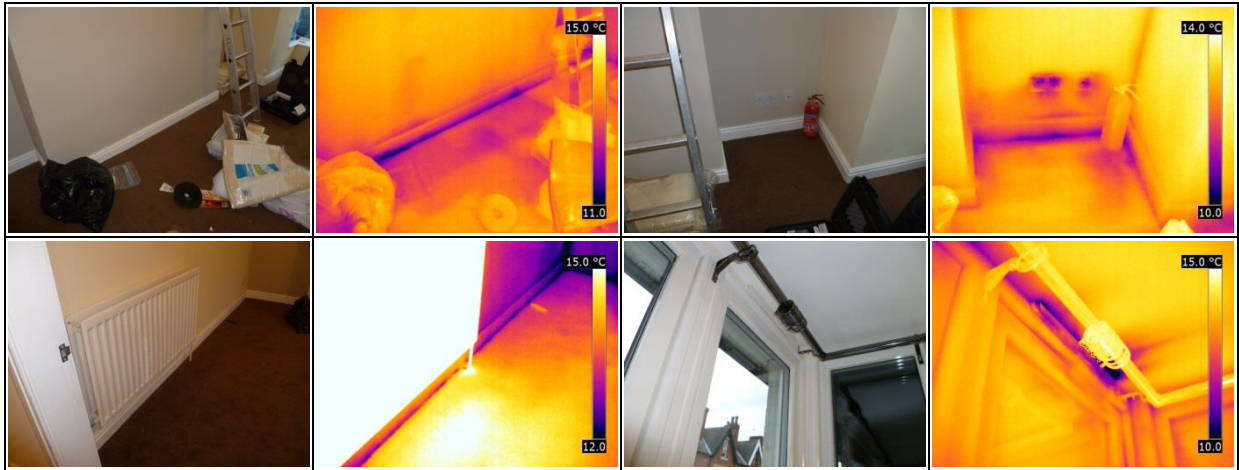
Lounge Air leakage was reduced at the floor perimeter, both on the internal wall adjacent to the kitchen and on the party wall at the chimney breast and beneath the electrical socket at the side of the bay. Air leakage was significantly reduced at the trickle vents.

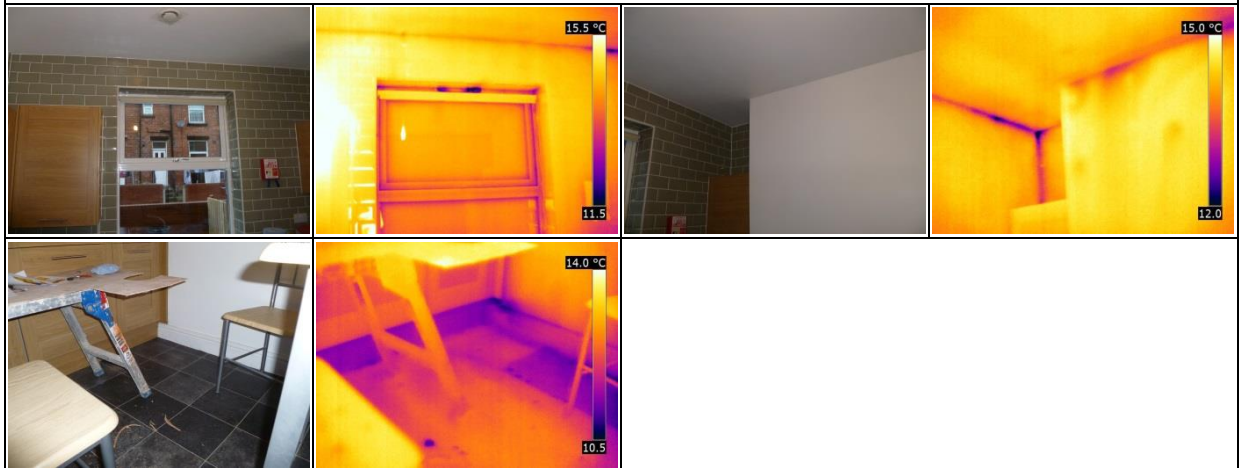
Kitchen

Infiltration at the trickle vent was again significantly reduced. Air leakage remained from the void behind the kitchen units and to a lesser extent around the ceiling perimeter on both external and party walls.

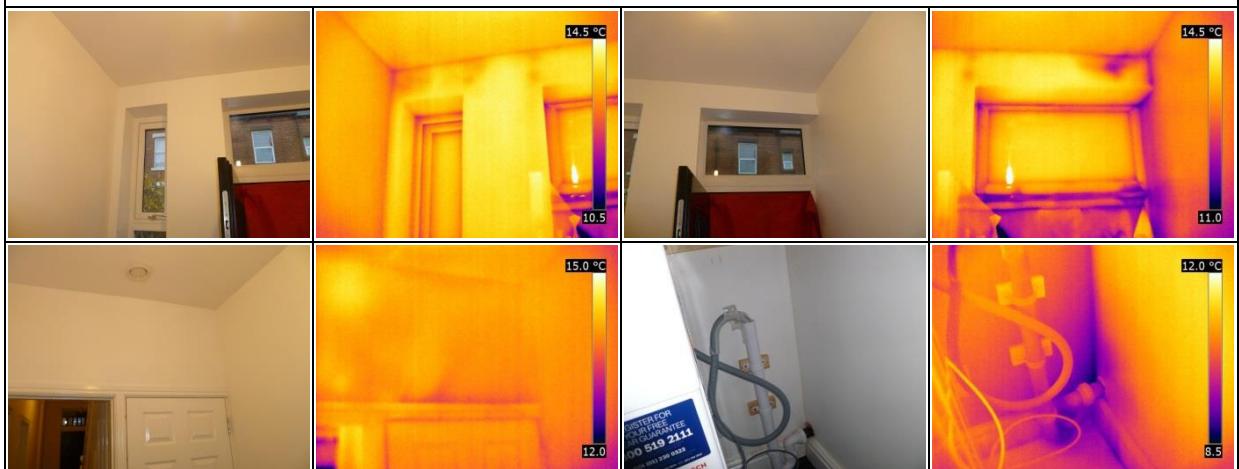
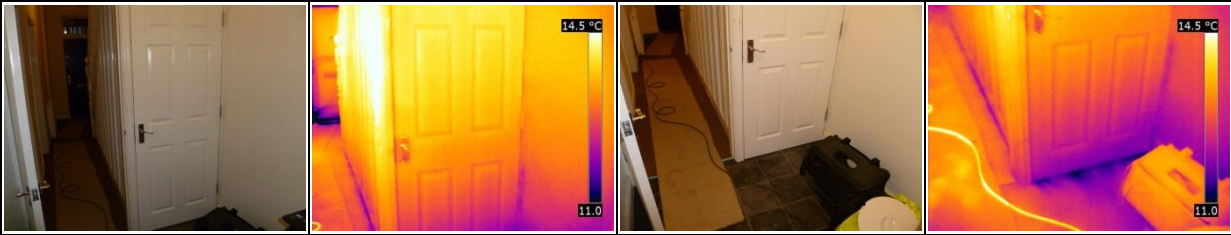
Rear Lobby / Utility

As previously observed there was minor air leakage at the external wall junction. Air movement around the cellar door was reduced, with airflow through and around the handle effectively eliminated. Some air movement was also detected around the waste penetration for the washing machine.

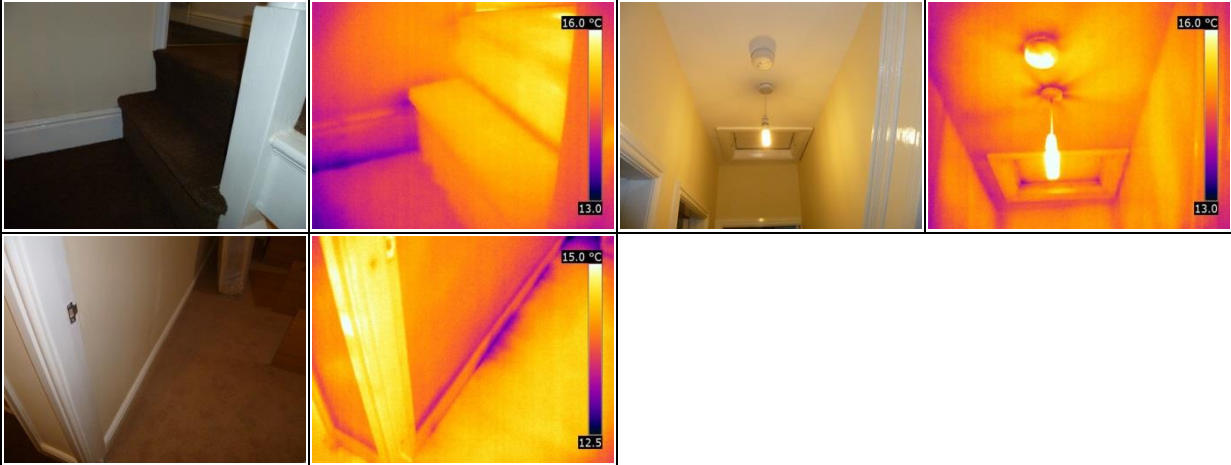
Stairs/Landing

Air leakage at the stairs appeared to be limited to the edges of the 2 steps at the intermediate floor junction. Leakage around the loft hatch had been reduced substantially. Air leakage was still observed at the intermediate floor perimeter.
