Appendix B. Air tightness test reports

Air tightness test field reports

LEEDS
METROPOLITAN
UNIVERSITY
Leeds Sustainability Institute

Dwelling C-01, before and after retrofit

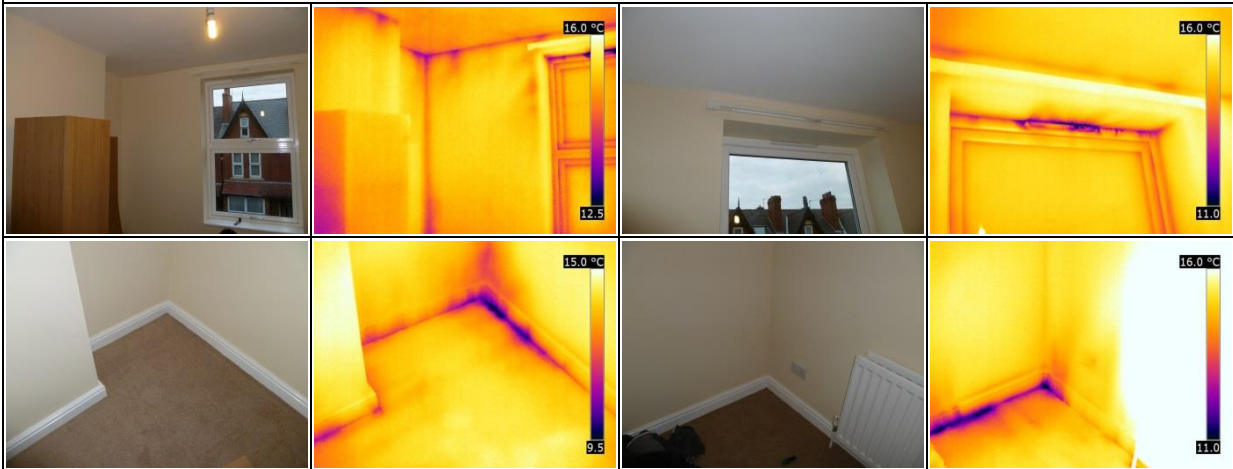
Bedroom 1

Infiltration at the junction of the external wall and intermediate floor was still detected, with air entering the property at a temperature actually cooler than the external air temperature and the infiltration at the trickle vent.

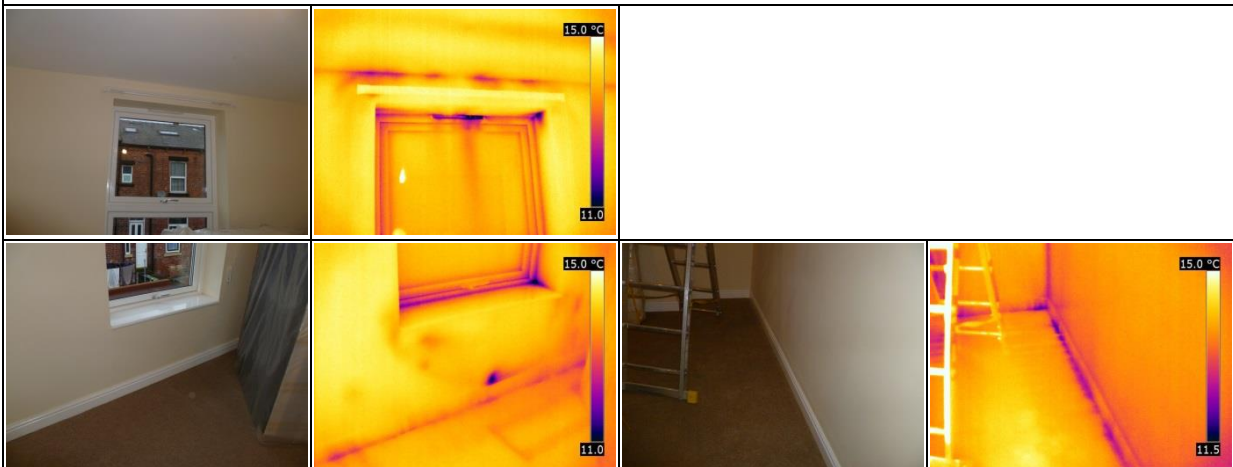
Bedroom 2

Air movement previously detected at the floor perimeters and at the trickle vent had been reduced, but still remained at the number of spots on the external wall.

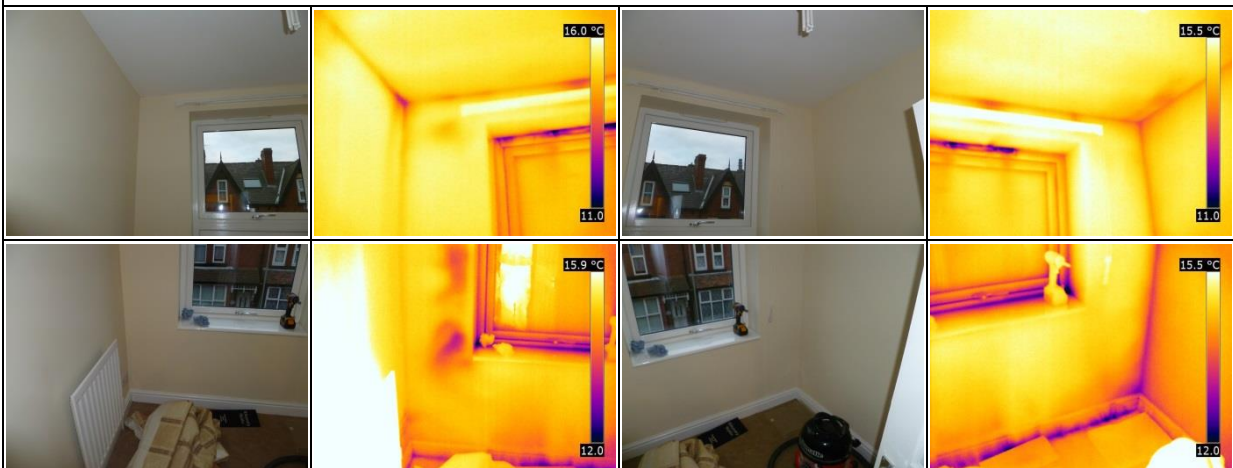
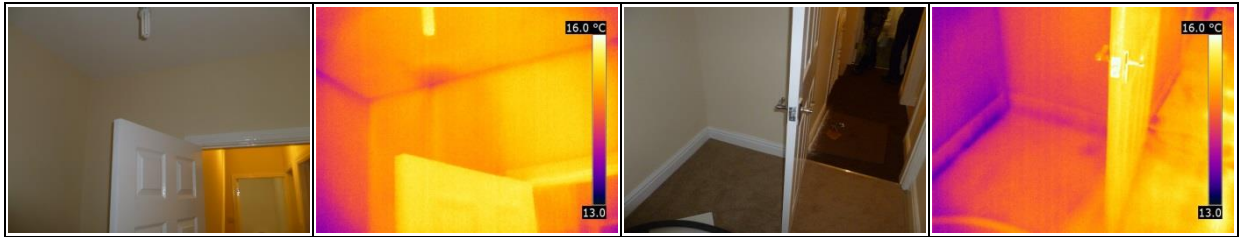
Bedroom 3

Air leakage around the window and at the external wall junction with the intermediate floor still detectable. Leakage around the trickle vent was again significantly reduced. The internal wall adjacent to the void above the stairs again showed cooler areas.

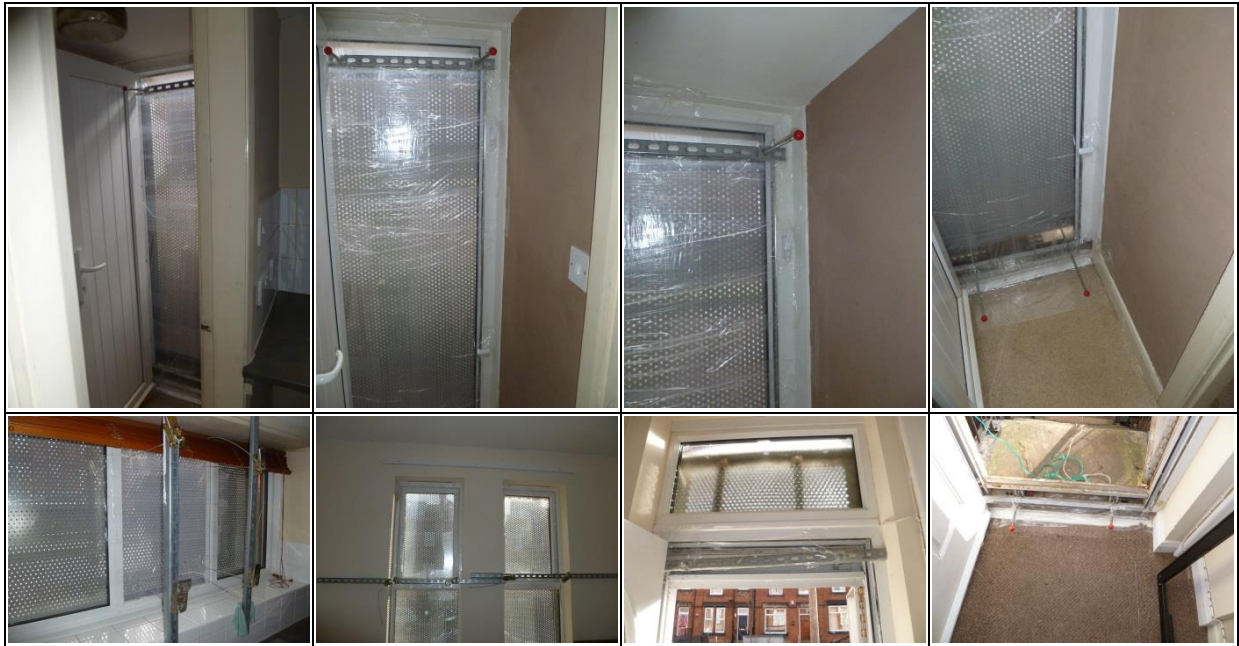
The fixings for the temporary security screens on the basement and ground floor meant that substantial additional sealing was necessary for the pressurisation test to be conducted. The basement door required fully sealing, as did the centre light of the basement kitchen window which had been purposefully removed. The lounge windows were taped and sealed around where penetrations prevented them closing and the front door required additional sealing at the top and bottom to allow an airtight seal to be made around the blower door frame.

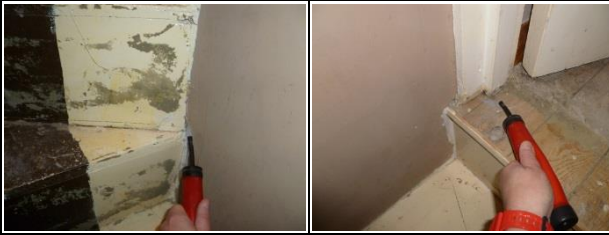
Hall and Basement Stairs

Some air movement was observed both through and around the cellar stairs, through visible cracks and gaps.

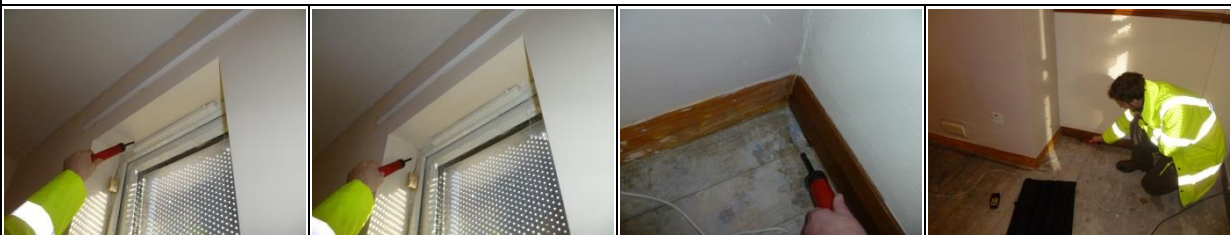
Ground Floor Living Room

As in the basement, air leakage was observed around and through the trickle vent, and to a lesser extent around some gaps around the window frames. The lounge floor generally performed well, but in the small number of places where there were gaps air movement was detected, this was most severe at the room perimeter and corners in particular.

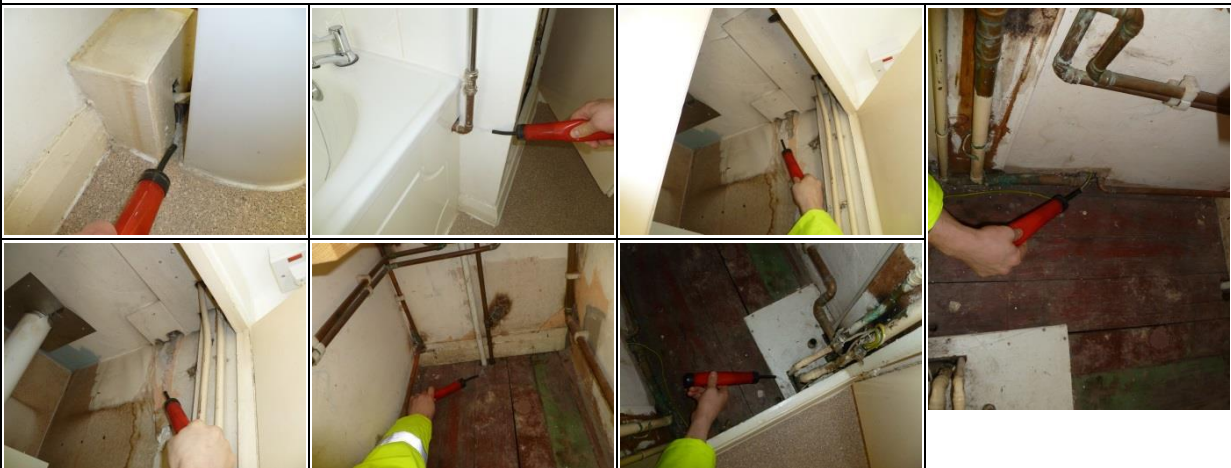
First Floor Bathroom

Significant air movement into the boxed in service void behind the pedestal was detected, and also into the void beneath the bath. Although sealant had been applied to the perimeters of these, less attention had been made to the service penetrations into them.

In the airing cupboard there had been little attention paid to penetrations into either intermediate floor, and sizeable air leakage into both the cupboard floor and ceiling was observed.

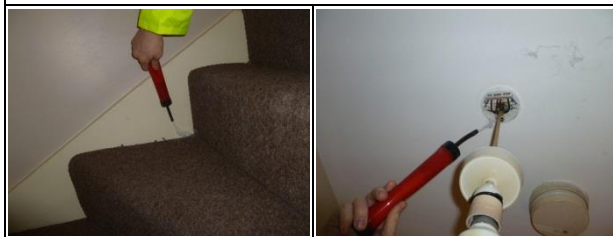
Upper Floor Stairs and Landings

Leakage was again detected around the stairs and through electrical penetrations into the intermediate floor voids.

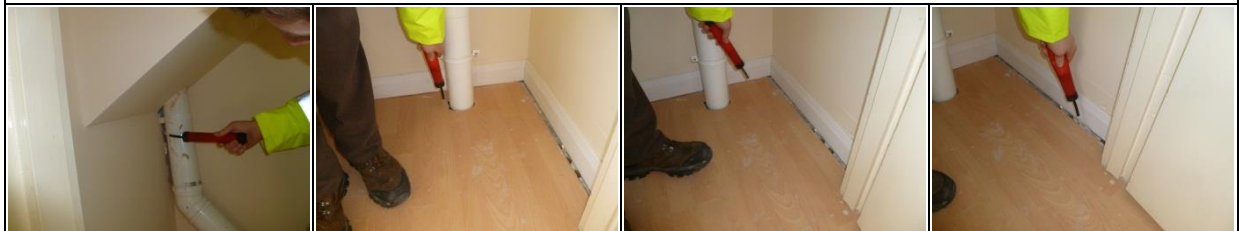
Second Floor Bedroom

In the bedroom cupboard unfinished detailing around penetrations and junctions permitted significant airflow.

The access hatch to the cold roof void at the front of the property leaked both around the hatch and between the hatch and door, the electrical penetration through the same knee wall also performed quite badly. The floor covering prevented air movement through the floor, but leakage at the floor perimeter was prevalent, particularly at the knee wall junction.

Air leakage at the window was only observed around the trickle vent and at the penetration under the window sill. Leakage into the loft space was only observed around the lighting penetration and the loft door, which did not seat properly into the hatch.

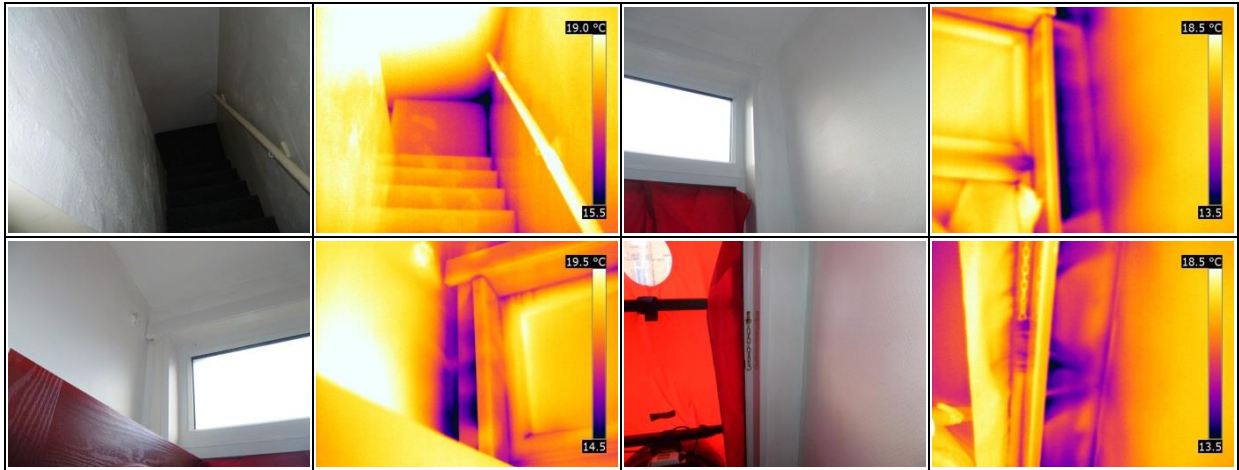
Cooler air appeared to be drawn into the lower landing of the cellar stairs.

Around the front door and window, the architrave was not sealed to the wall and significant infiltration observed.

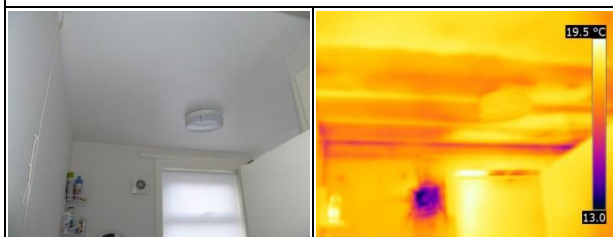
First Floor Bathroom

Infiltration was again observed into the intermediate floor void, and at the intermittent extract fan and trickle vent.

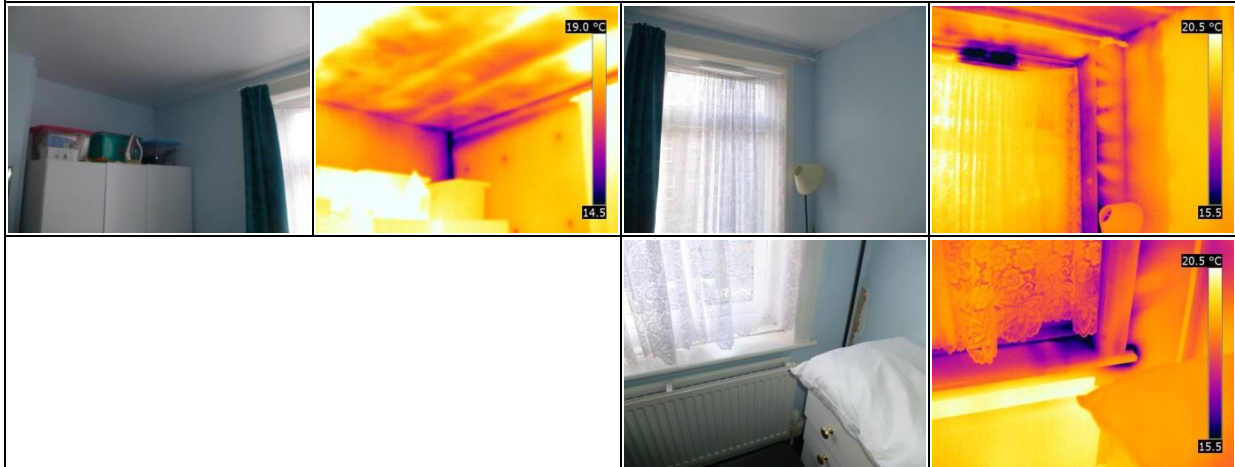
First Floor Bedroom

As observed previously around the property, infiltration was detected at the party wall junction with the external wall around the IWI and at the window trickle vent, architrave and frame perimeter.

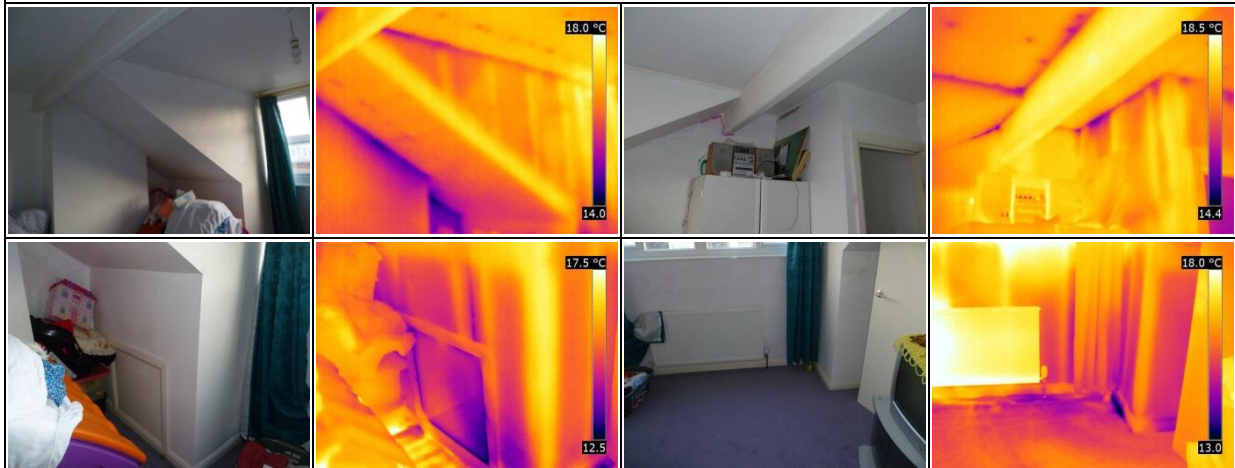
Second Floor Bedroom

Cooler air could be detected being drawn down from the loft space into partition wall voids, around the access hatch to the cold roof at the front of the house and at the floor perimeter.

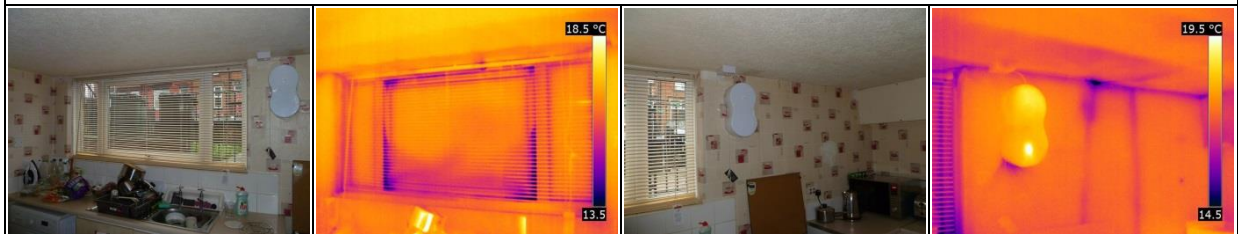
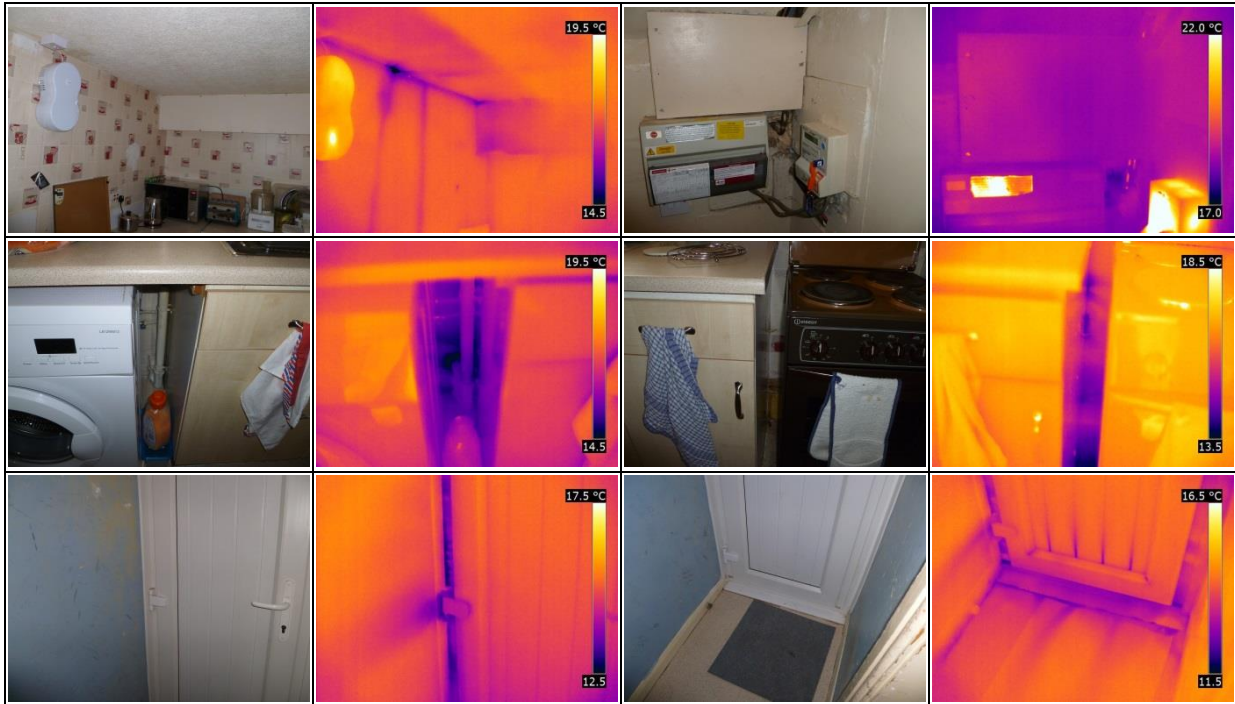
The central opening light of the kitchen window had been replaced, following the removal of the security screen, but air movement was detected around its perimeter even when fully closed. Cool vertical stripes were visible under depressurisation on the external wall where air was being drawn down through the chased-in electrical services. Some compartmentalisation of the ceiling void was visible, where the section between the external wall and nearest joist was noticeably cooler than between the next 2 joists, presumably due to infiltration. This could also be observed on the boxing leading to consumer unit on the basement stairs, air leakage was detected through the unit although it had warmed significantly by the time it emerged.

Additional air infiltration was detected at junctions and penetrations behind the kitchen units and appliances, and around the door and frame in the basement lobby.

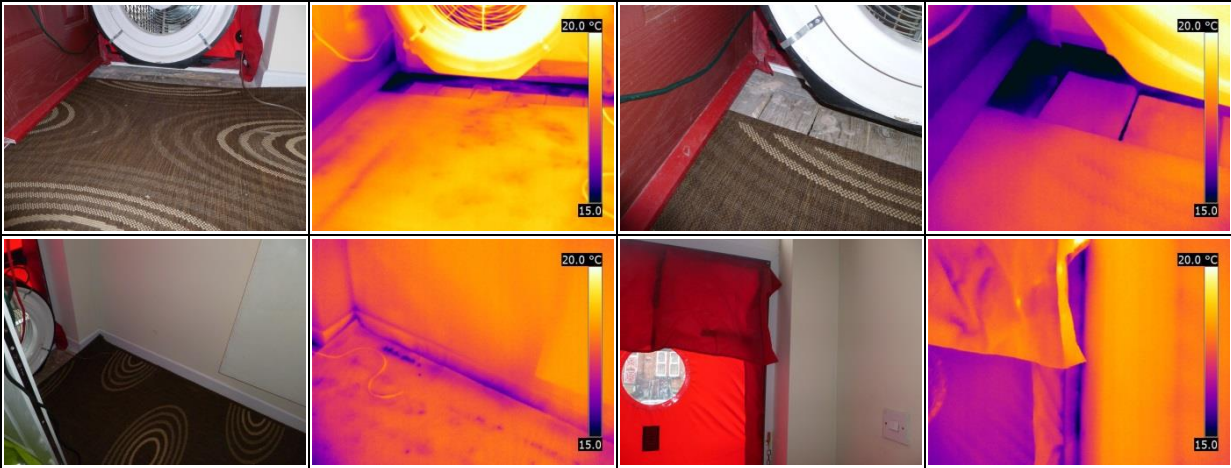
Hall & Stairs

Significant air movement was detected at the threshold, at the floor/party wall junction and through the timber floor; this was visible through the hall carpet. Air movement was also observed around the door frame.

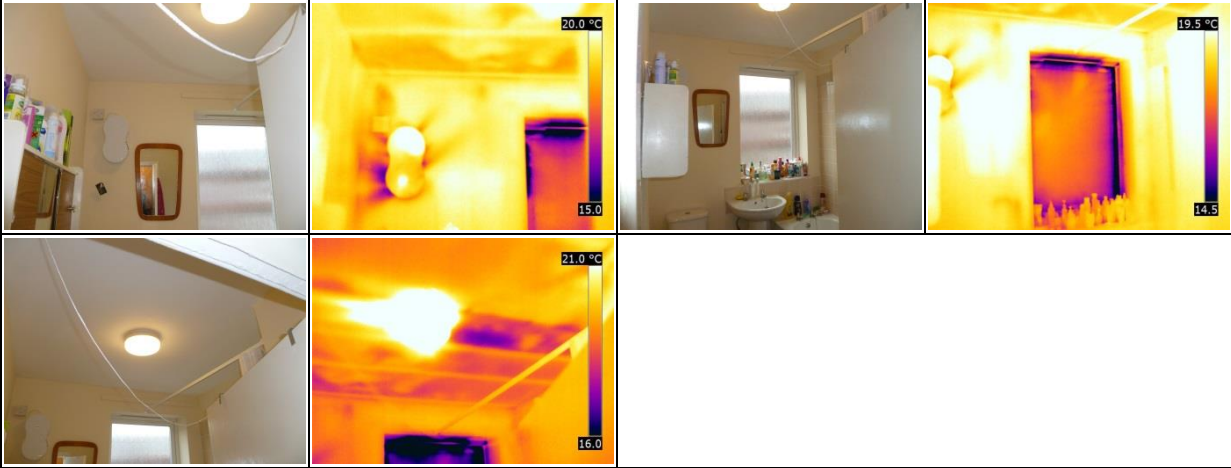
Bathroom

The most apparent infiltration paths were around the ventilation unit, which had been temporarily sealed for the test, and at the window, through the closed trickle vent and around the casement. Air leakage into the intermediate floor void was again observed, this was most clearly seen below the area of cold roof space.

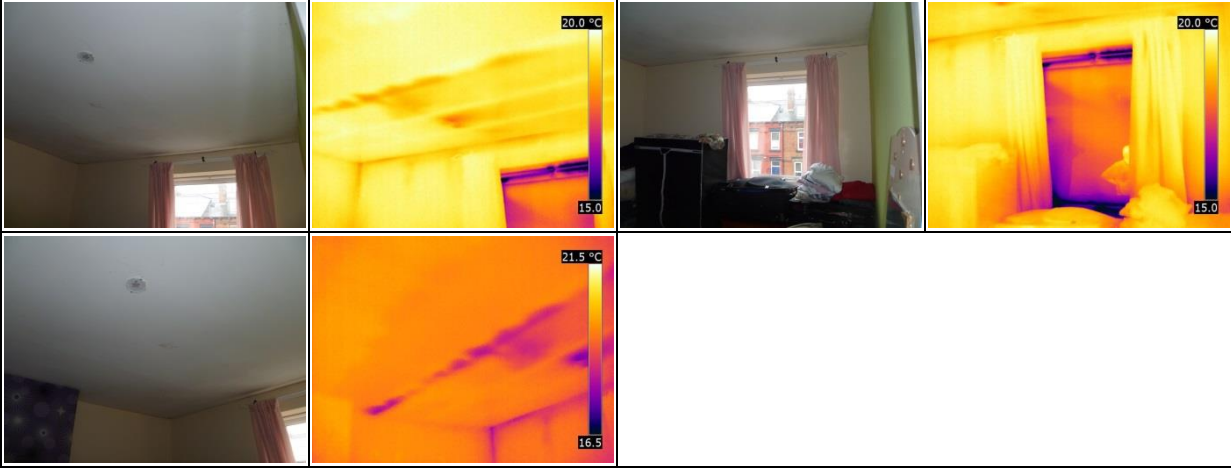
1st Floor Bedroom

As in the bathroom, air movement into the intermediate floor void could be clearly observed under thermal imaging. Again, infiltration around the window was highly obvious. Air movement up through the floor was not possible to view with the thermal camera due to the occupant's belongings, but there was some lifting of the carpet under dwelling depressurisation although the emerging air was at or near room temperature so did not show up under thermography.

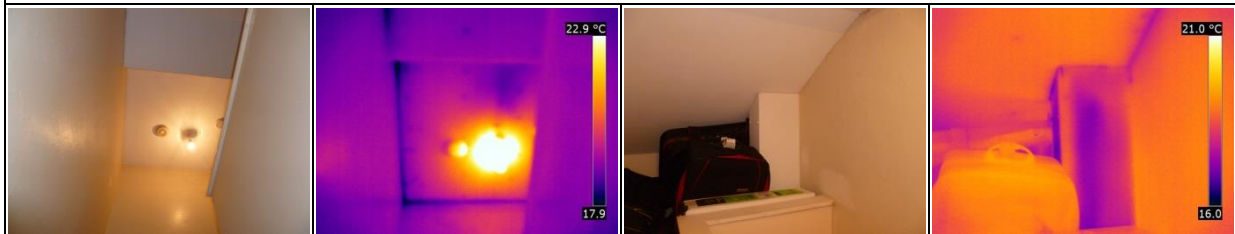
Landing & Stairs

The door to the roof void at the front of the dwelling was not accessible at the time of the test to check for airtightness as it was obscured by the occupant's belongings. Any issues at the ceiling were also impossible to detect due to the heat emitted from the landing light. Indirect leakage into the service riser on the landing was clearly visible.

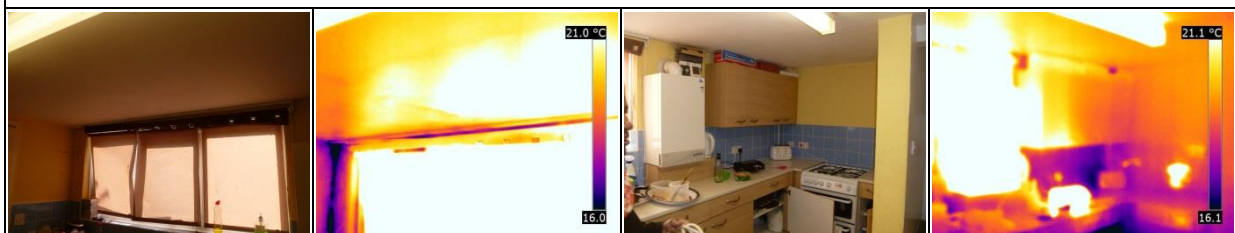
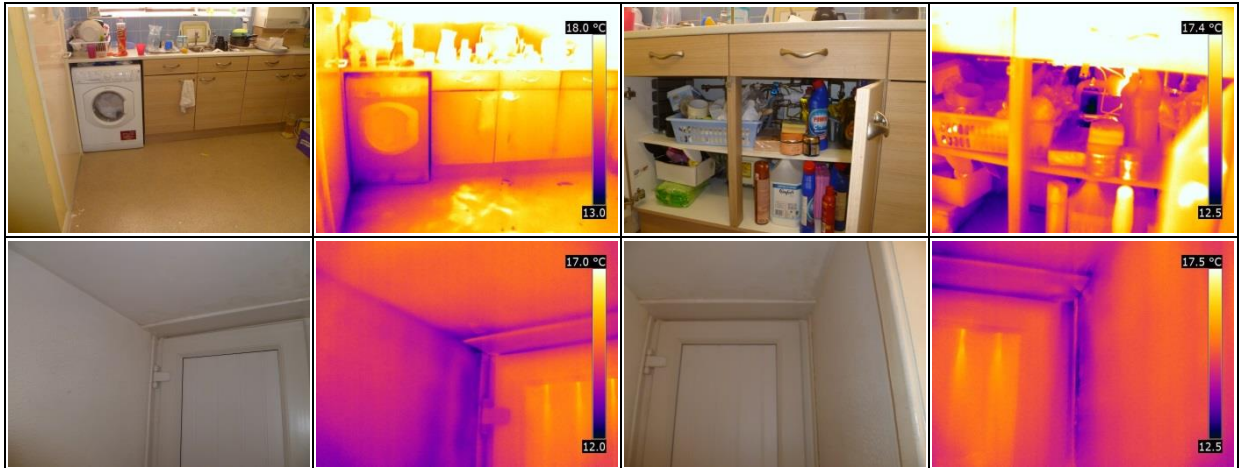
Basement

There was little change from the leakage detection performed for the previous test, with air leakage detected around the trickle vents, behind the kitchen units, around external wall penetrations and around the lobby door and frame.

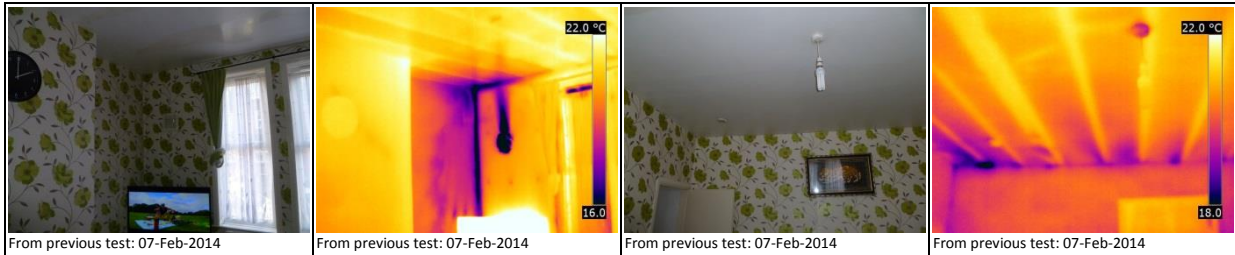
Air leakage was again detected at the window, at the trickle vents and sill, although there was a reduction in leakage around the window frames.

On both the external and party walls air movement was detected around the IWI boards, but leakage previously observed around the vent in the external wall appeared to have been eliminated.

Other areas of infiltration included the floor perimeter and the vent on the chimney breast.

On the rear party wall, cooler air previously seen being drawn into the intermediate floor void around the built in joists had reduced significantly.

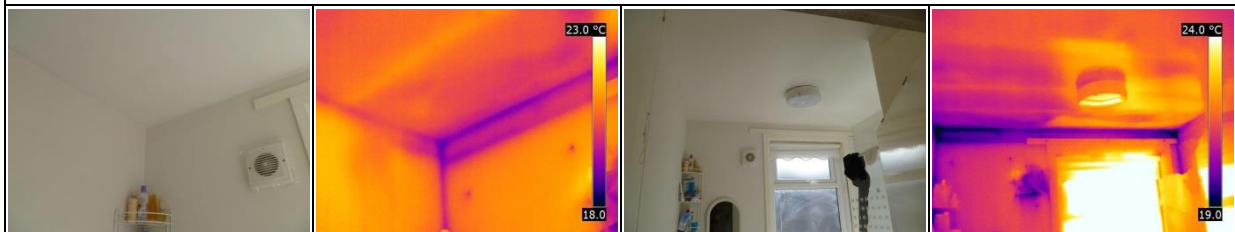
Infiltration was again observed into the intermediate floor void, and at the intermittent extract fan and trickle vent.

Air emerging from around the bath panel and from the airing cupboard was similar in quantity of flow but at very different temperatures, the air coming out from around the airing cupboard had warmed to near room temperature whereas that escaping from around the bath panel was substantially cooler.

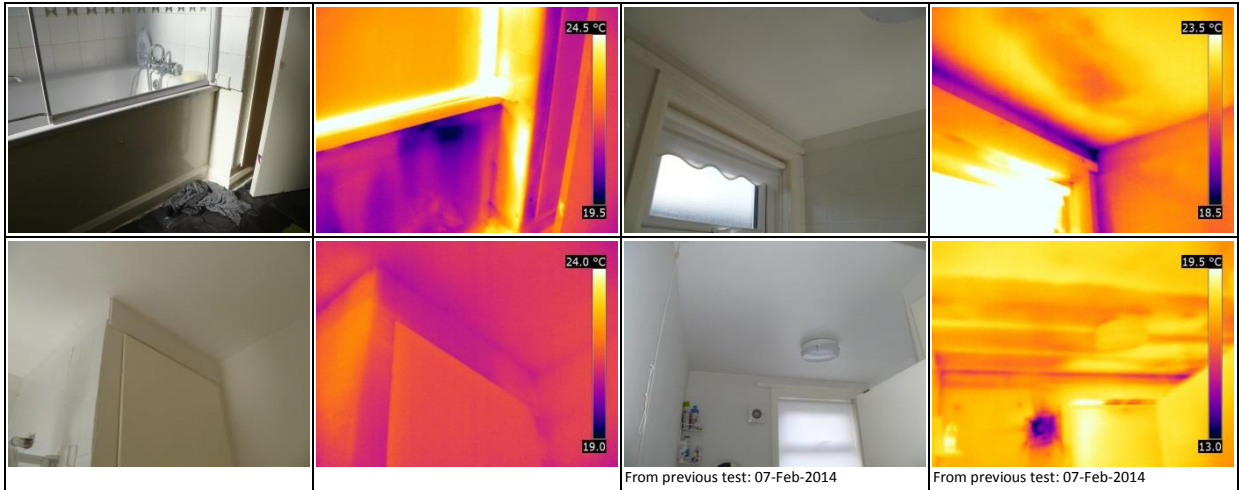
1st Floor Bedroom

Air leakage previously detected at the window architrave and frame perimeter appeared to have been reduced, although intense sunlight made this impossible to confirm with thermal imaging.

Some air movement around the IWI panels could be detected, although this also showed an improvement from the previous test.

Some air was detected coming in through the floor as the carpet was lifting under depressurisation, but this was at room temperature so did not show up through thermal imaging.

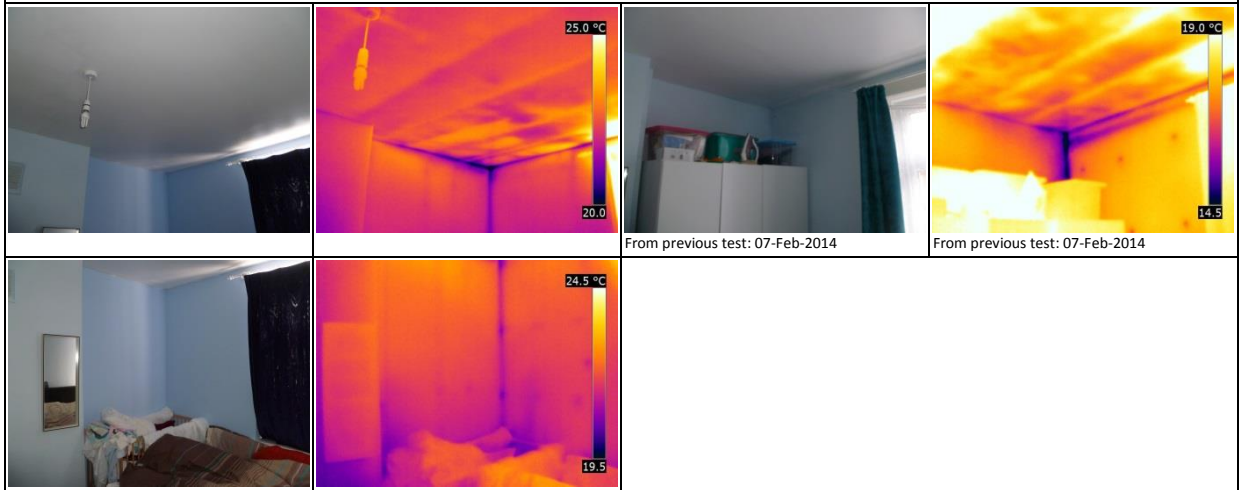
Stairs & Landing

Air could be felt leaking in around the stairs to the 2nd floor, but this was emerging at room temperature.

The ceiling above the stairs showed some cooler and warmer areas but no obvious signs of air being drawn in under depressurisation.

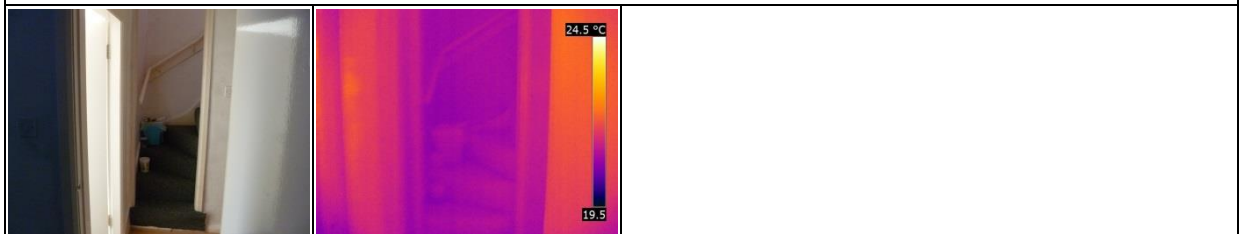
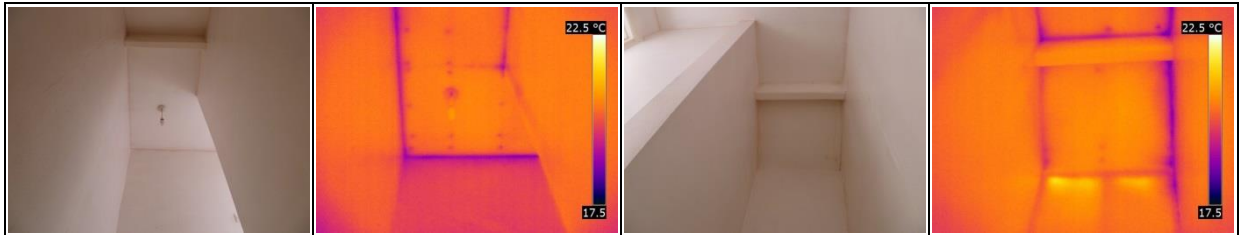
2nd Floor Bedroom

Cooler air had previously been detected being drawn down from the loft space into partition wall voids, around the access hatch to the cold roof at the front of the house and at the floor perimeter, this was all still apparent even though some (most noticeably around the access hatch) had been reduced.

Air leakage through the intermediate floor actually appeared to be worse than previously observed; with the carpet lifting throughout the room, especially where there were holes in the floor, and joints between floorboards visible through the carpet. Along the rear wall junction with the floor the air emerging was still cool enough to show clearly in the thermal images.

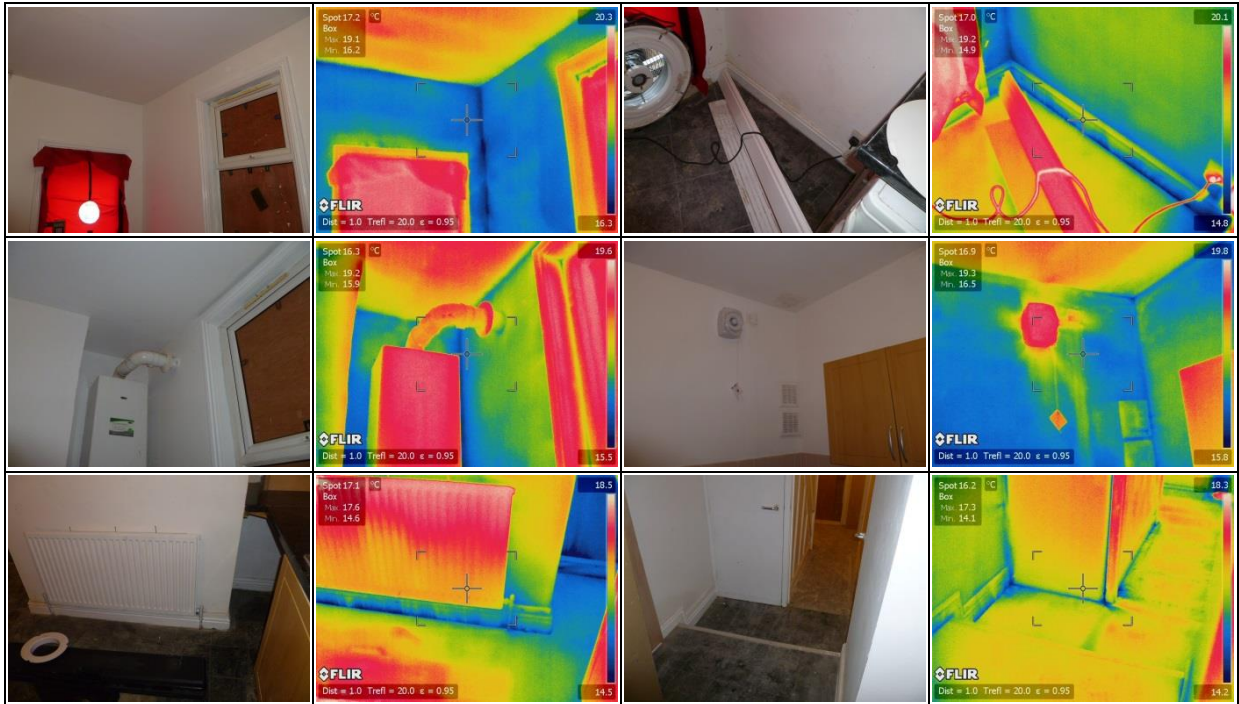
Hall

No infiltration was observed at the junction of the intermediate floor where IWI had been installed apart from around the unfinished boxing to the right of the door. It was unclear where this air was entering the boxing, although as air entering the hall from the top of the boxing was warmer than at the bottom it suggests that it too was being drawn up from beneath the ground floor.

The ground floor perimeter appeared to be far more problematic, with noticeable infiltration at all floor/wall junctions and at the base of the stairs.

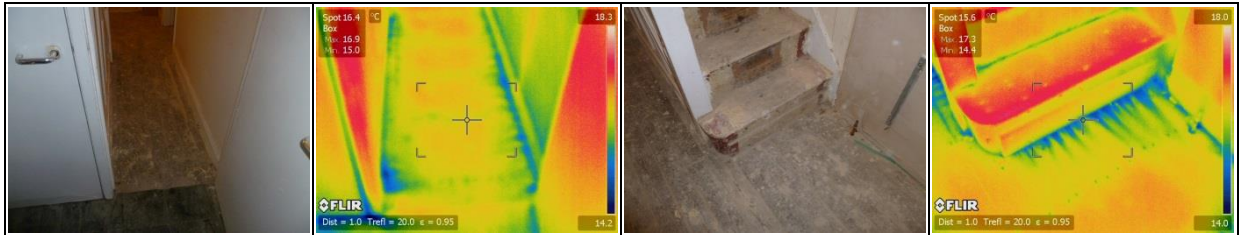
Lounge

Again, around the IWI on the front of the house the junctions with the intermediate floor performed well, junctions with the ground floor not so well.

The external gable wall performed particularly badly around the chimney breast, with air emerging from the floor wall junction obviously cooler than air being drawn in around the gas fire itself. The rest of the gable wall displayed less air movement at the floor junction, comparable to that seen at the base of the two internal walls in the lounge.

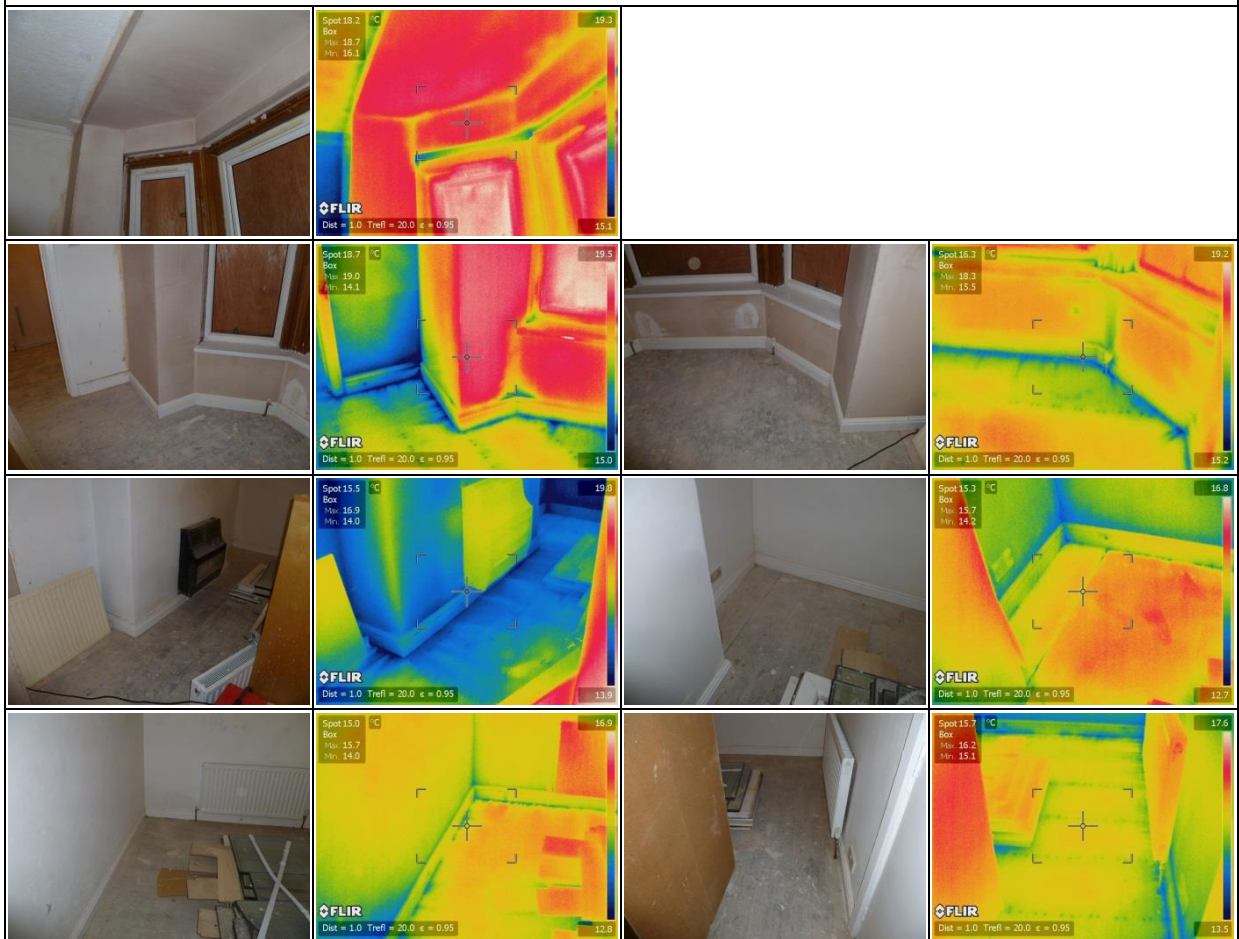
First Floor

Air leakage around the front wall and IWI was not detectable using the thermal camera due in part to the lack of internal/external temperature differential (as can be seen by the temperature of the infiltration around the window), but also because there was very little airflow. Air emerging at the party wall and externally insulated wall junctions with the intermediate floor was both more prolific and cooler at point of emergence.

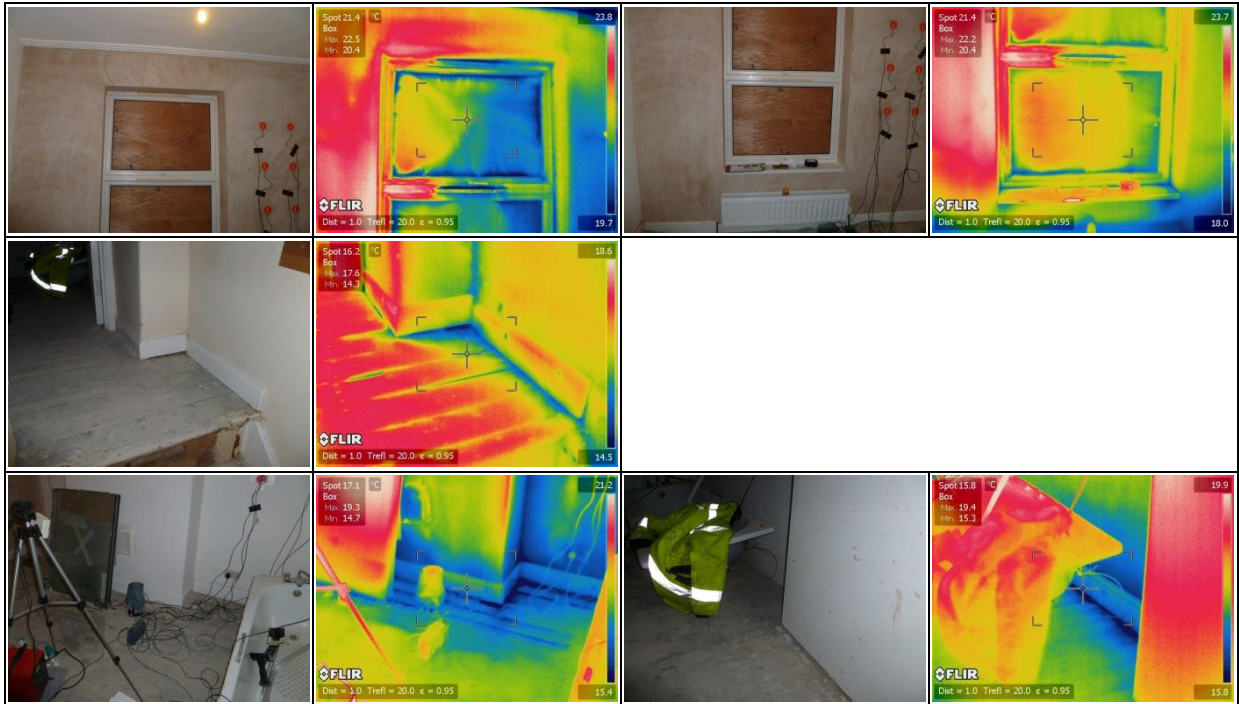
Second Floor

Air movement was detected around the ventilation unit, although barely visible with the thermal camera due to the lack of temperature differential. However, visible holes around the ceiling penetrations for the landing light and smoke alarms did not display and air leakage.

Leakage was also detected at the floor wall junctions at the knee wall on the front of the dwelling and around the chimney breast on the gable wall but to a much lesser degree on the rear wall.

No air leakage was detected at the sloping ceilings and its junctions, the dormer also appeared to perform well with only a small amount of air movement around the light fixing in the dormer roof.

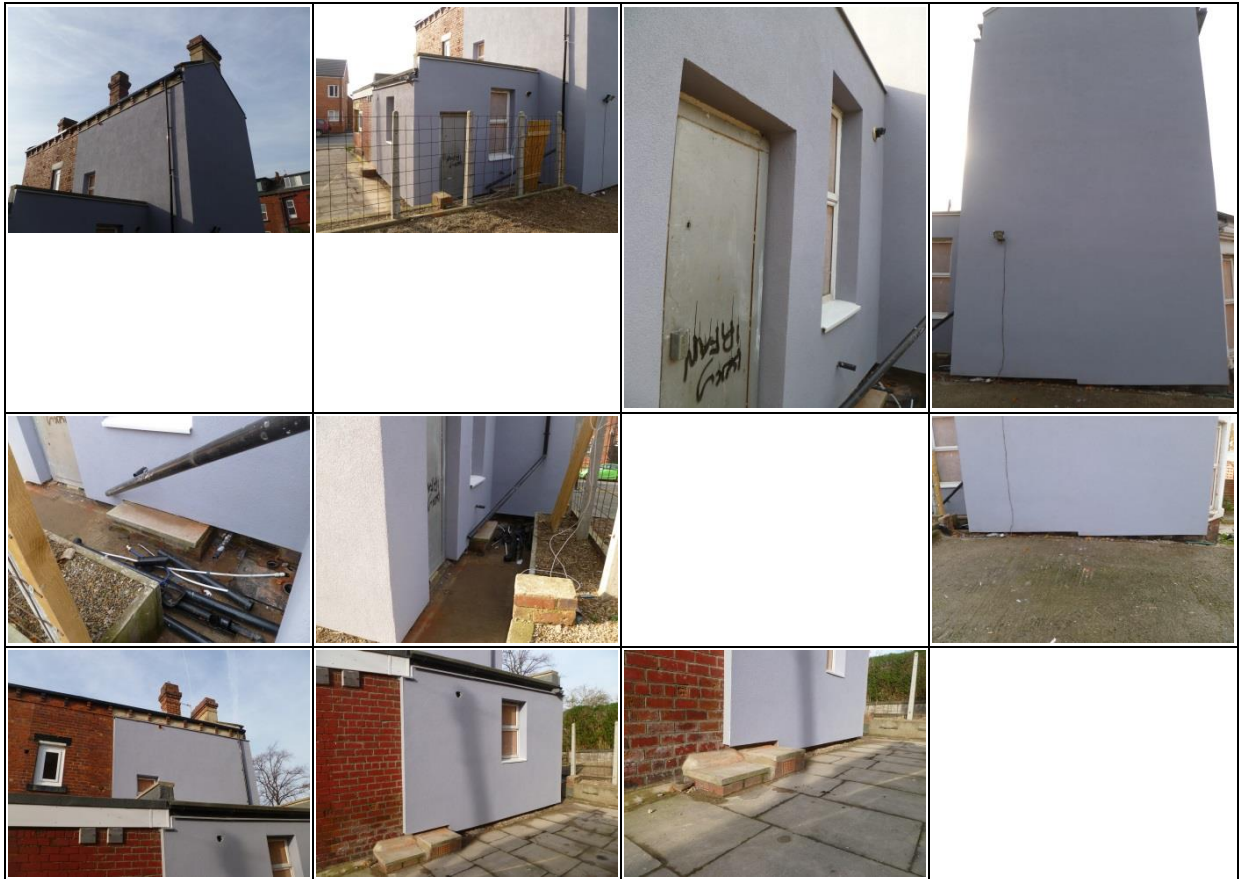
Gaps between wall and EW1?

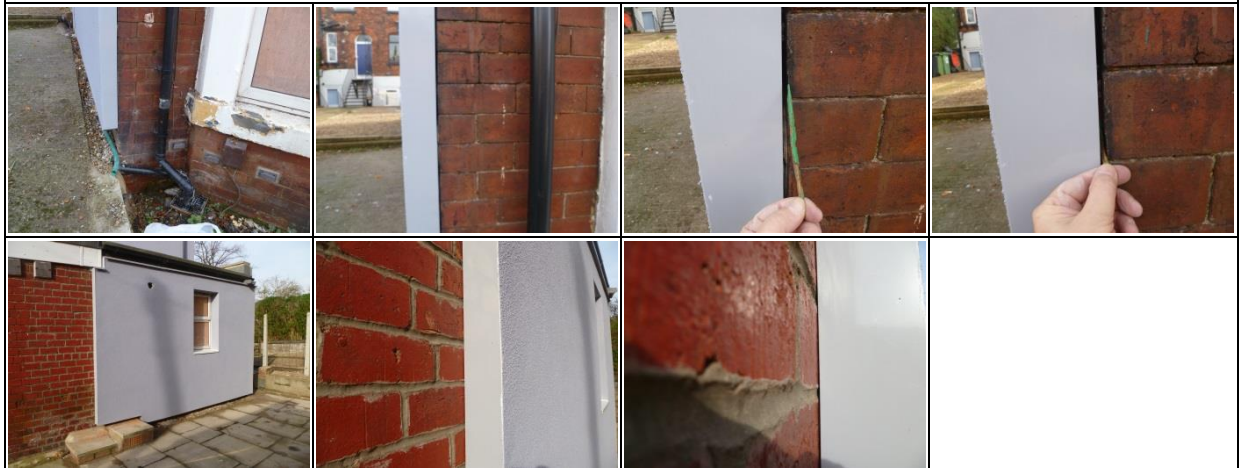
EPS wall beads leaking out of wall vents at rear of building?

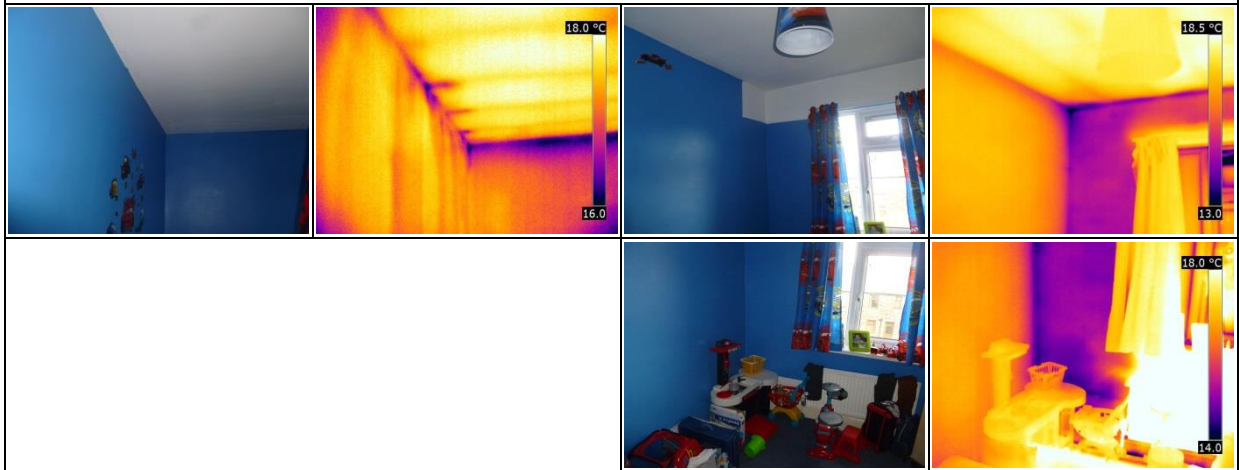
Rear Bedroom
 Some cooler air could be observed being drawn down into the internal partition wall between the bedrooms although this was minor compared to other leakage paths observed, and surface temperatures were well above those observed on the external wall.

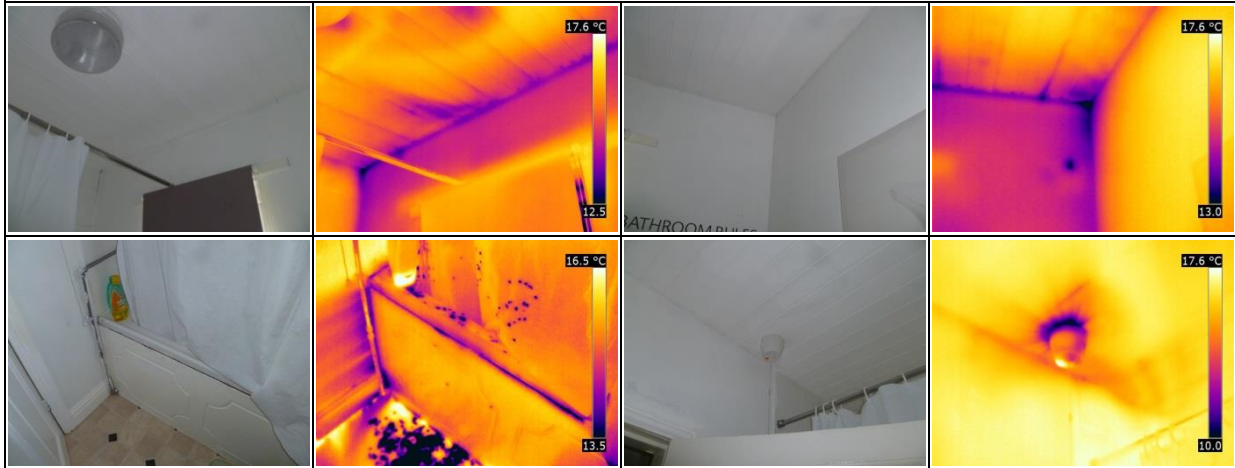
Bathroom

There were signs of either missing insulation or air being drawn in under the insulation at the rear eaves above the bathroom; this was not air entering the habitable space. Infiltration into the living space was rife around the bath panel, although it is unclear whether this was up from the intermediate floor void or from around unsealed service penetrations. Air movement was also detected from the loft void around the bathroom light switch.

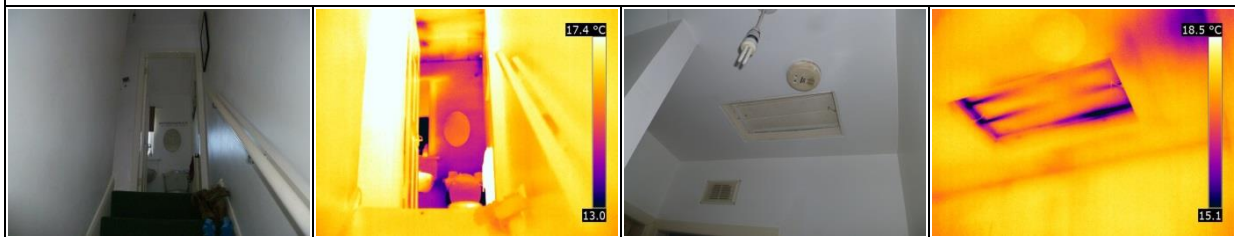
Landing

The landing had no external walls and displayed little signs of air movement apart from some infiltration between the loft door and hatch.
