Appendix B. Air tightness test reports

Air tightness test field reports

LEEDS
METROPOLITAN
UNIVERSITY
Leeds Sustainability Institute

Dwelling C-01, before and after retrofit

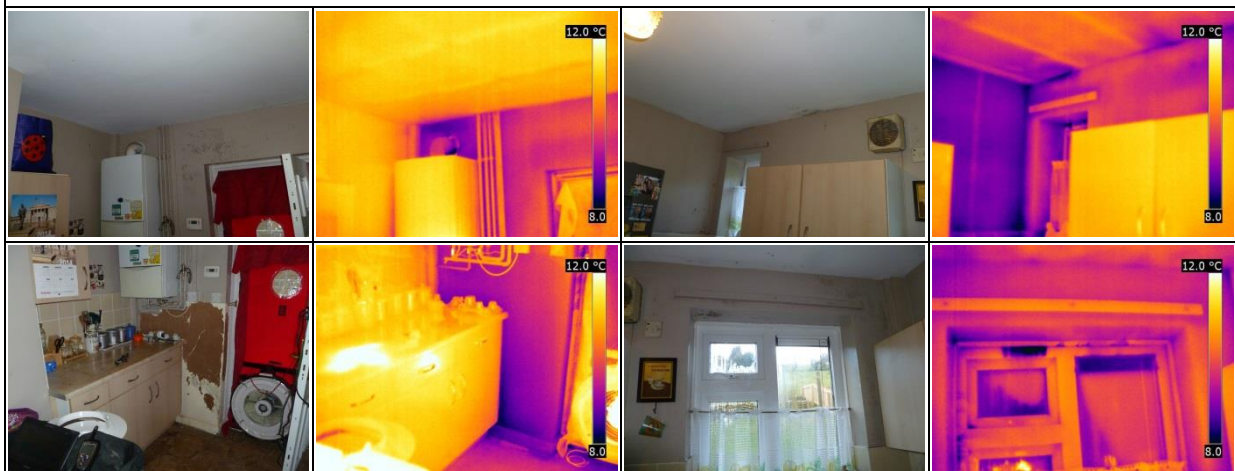
The external wall adjacent to the rear door appeared to display particularly low surface temperatures, although there was some dampness associated with it which will have suppressed IR emittance causing slightly lower readings on the thermal image these near-external temperatures are still a cause for concern.

Air could be seen being drawn into the intermediate floor void, causing areas which were cooler than the rear external wall so would be the first places where condensation would form – particularly as the occupants did not use the intermittence extraction fan and this was where they used their kettle. There was also some air leakage around the kitchen window frame and at the trickle vent.

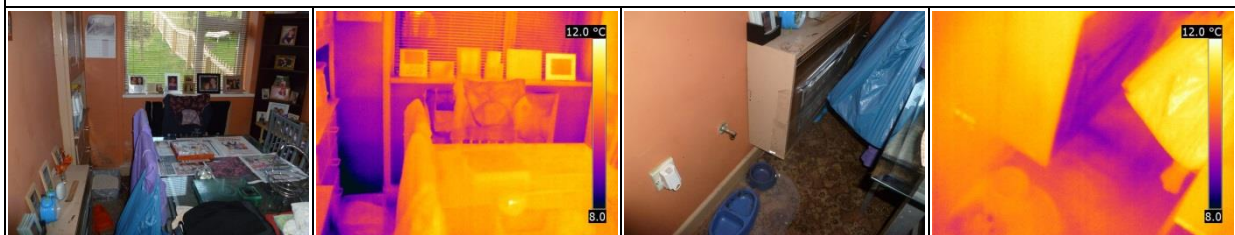
Dining Room

The ground floor junction with the external wall appeared very cold. Air was observed being drawn in through and underneath an unused gas fire.

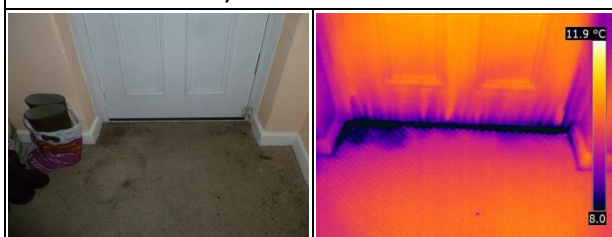
Hall & Stairs

Significant air leakage was detected at the front door threshold, the rest of the door and the stairs showed little if any air movement.

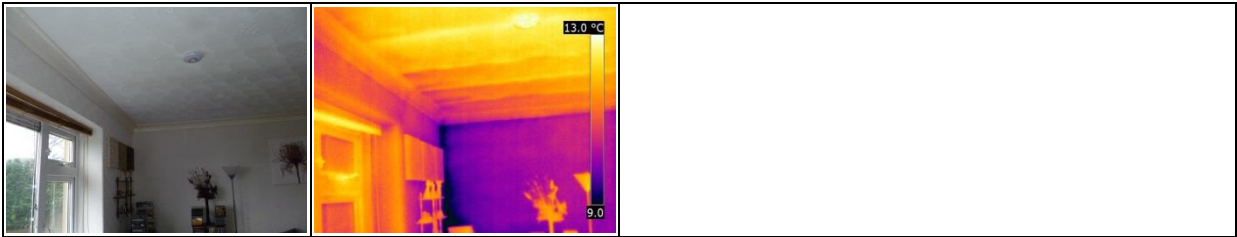
Living Room

As at the rear of the property, air was drawn into the intermediate floor void, shown here as cooler areas between the floor joists with the coolest sections nearest to the gable wall.

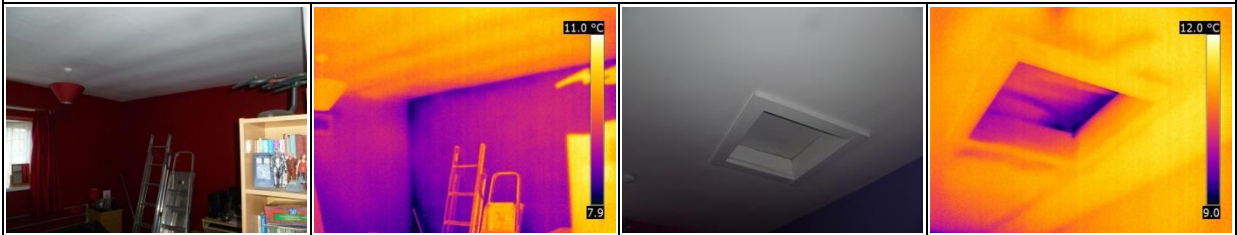
Front Bedrooms

As expected, both external walls display a significantly cooler temperature than the ceiling, which displays a good even temperature with no obvious gaps in the loft insulation even at the eaves or the often missed section between the end joist and the wall. As in the previous property, there was air movement between the loft door and hatch.

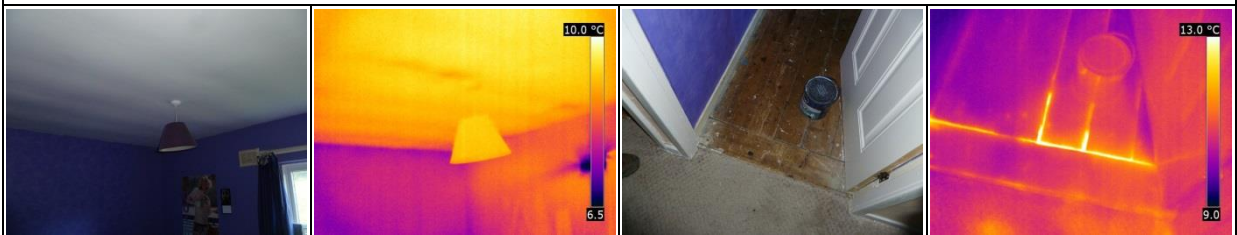
Rear Bedroom

As in the front bedrooms the loft insulation appeared to be evenly laid and the external and gable walls substantially cooler. This bedroom had no fitted carpet and substantial air movement was detected coming into the room from between the floorboards; this was at a temperature not much lower than the room temperature throughout most of the room, but where heating/DHW pipes ran through the floor void this showed up in the thermal images as warmer air emanating from the intermediate floor void.

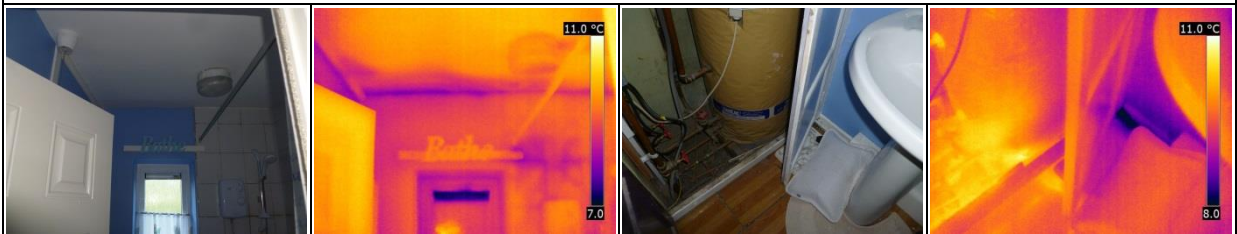
Bathroom & WC

In the bathroom there were signs of cooler areas at the eaves, it was not possible to determine whether this was due to air movement around the insulation or missing/thin insulation. Substantial air movement was detected coming up from the intermediate floor void through the numerous gaps in the cylinder cupboard floor, and cold air emerging at the external wall junction with the bathroom floor at the room perimeter.

In the WC there was also some air movement around the trickle vent and window, but the eaves issue observed in the adjacent bathroom were not immediately obvious.

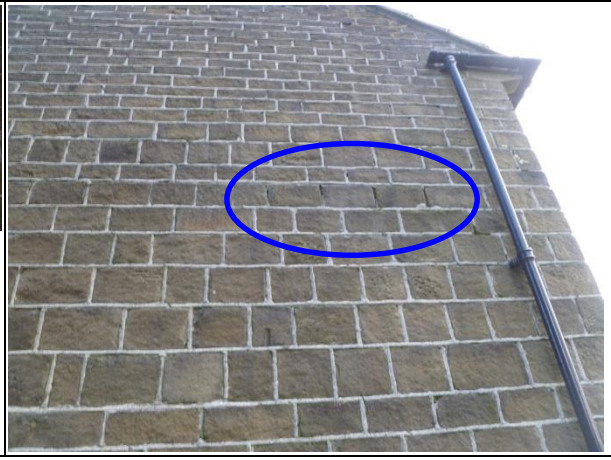
External Observations

Numerous external vents and airbricks were observed in the outer leaf stonework which did not correspond to internally visible ventilation. These may aid airflow into the external wall cavity and result in greater windwashing of the structure, assisted by the exposed location. Unfilled perpend in the external wall may also contribute to over-ventilation of the external wall cavity. If gaps around the built-in intermediate floor joists connect the floor void directly to this cavity it may explain some of the leakage observed in this (and the previous) dwelling.

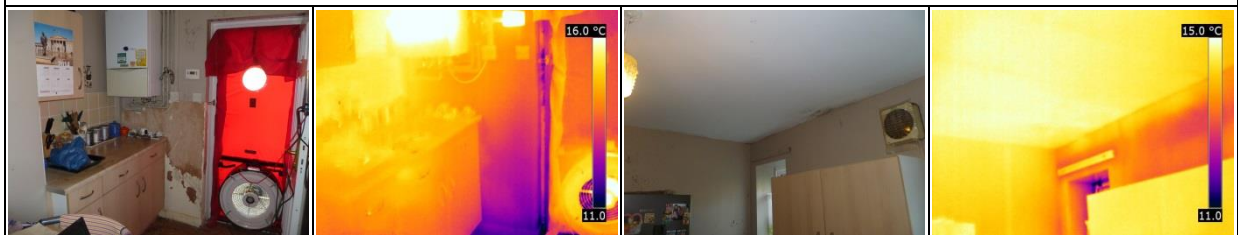
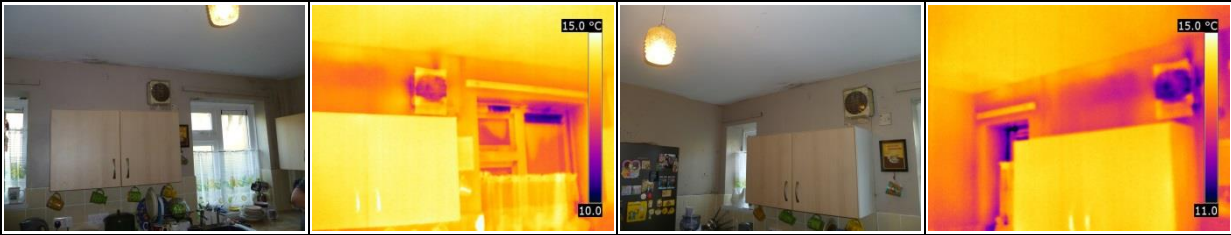
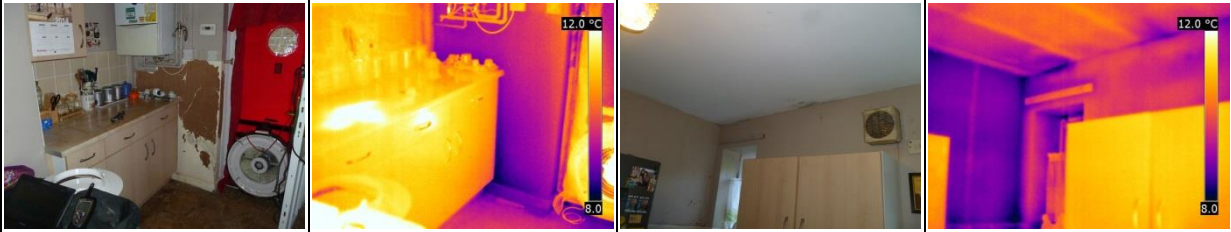
The dampness associated with external wall adjacent to the rear door appeared to have diminished somewhat since the previous test; the greater increase over external temperatures observed at the wall surface here are due in part to the reduction in moisture level at the wall surface even though the internal relative humidity was actually higher for the re-test.

The temperatures of the internal surfaces of the external walls appeared significantly higher than was observed in the previous test, although the external temperature was only 1.2°C higher for the re-test and the central heating was not operating for either test. Some thermal bridges had also become more obvious due to the increased performance of the plane elements around them, such as the lintel of the blocked-up window on the rear wall.

Air that was previously seen being drawn into the intermediate floor void now appeared to have been effectively eliminated.

The previously observed air leakage around the window frames, extract fan and trickle vents remained unchanged between both tests.

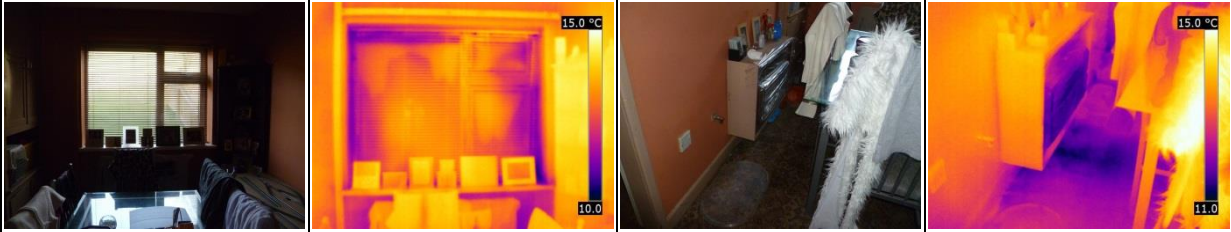
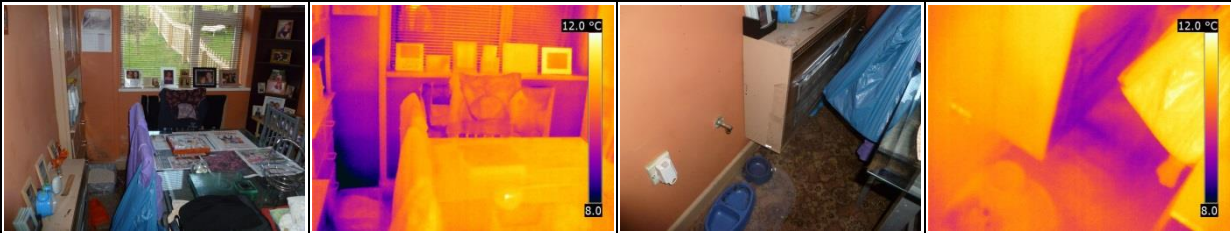
Air leakage in the Dining Room showed no change, with cooler air still observed being drawn in through and underneath an unused gas fire.

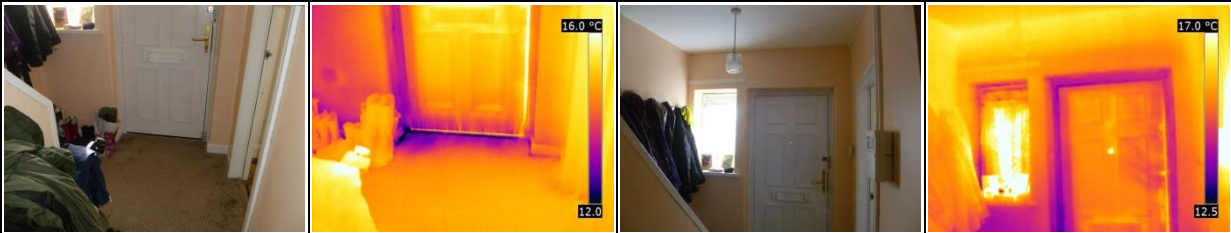
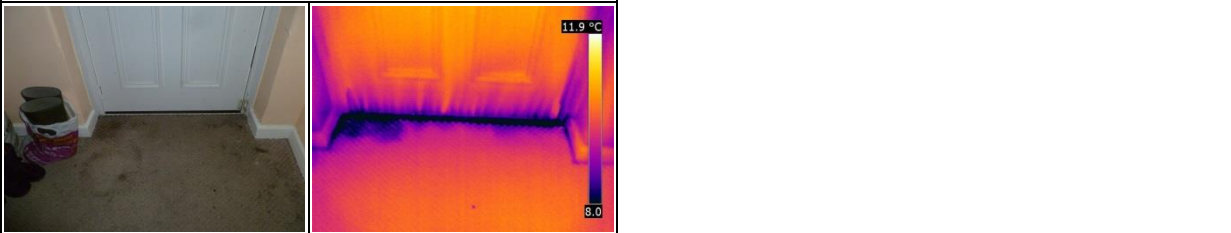
Hall & Stairs

Again, there was no significant change in the air leakage in the Hall. The most significant infiltration was again detected at the front door threshold.

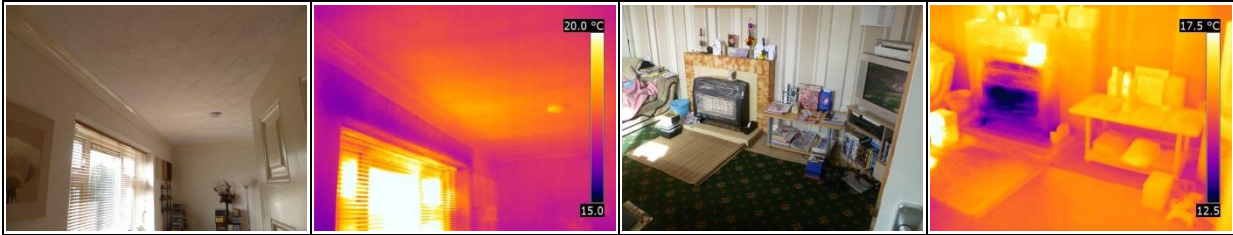
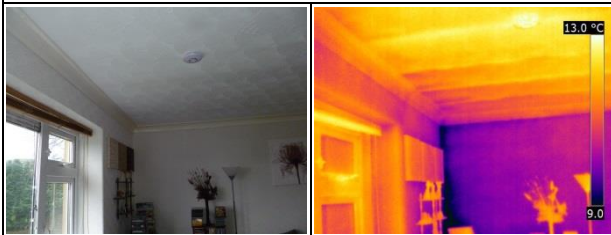
Living Room

As at the rear of the property, air observed previously being drawn into the intermediate floor void from the external wall cavity appeared to have been effectively eliminated and the surface temperature of the external walls was noticeably higher than previously observed. Air leakage through and around the temporarily sealed gas fire remained.

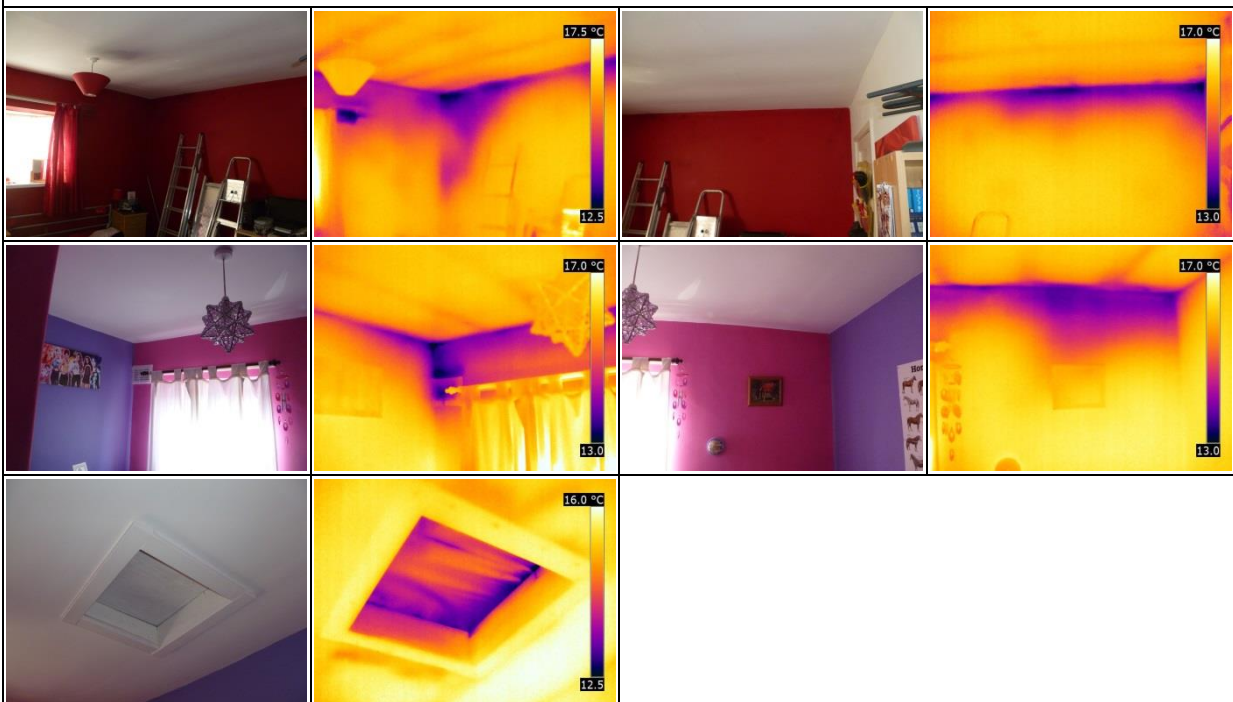
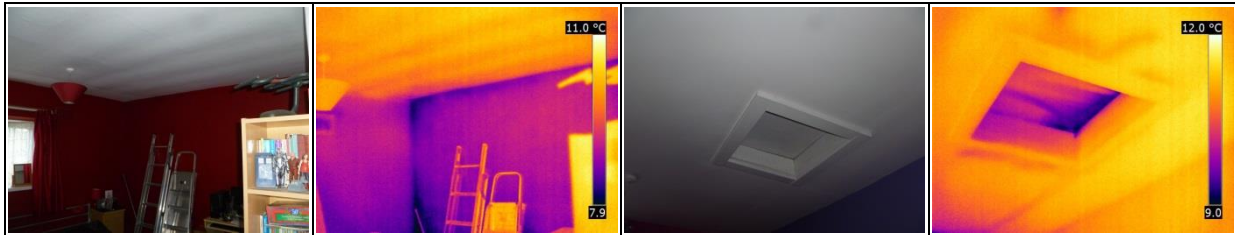
Front Bedrooms

At the previous test both external walls display a significantly cooler temperature than the insulated ceiling, now all three elements were relatively isothermal and thermal bridging was now apparent as the plane element thermal transmission has been considerably reduced.

The SouthWest top corner of the gable wall displays an extended cooler area. It is unclear whether this is due to the insulation not filling right up into the junction or whether the cooler area is due to higher moisture (hence, greater thermal transmittance) compared to the areas around it, possibly due to ingress or residual moisture.

There air movement between the loft door and hatch was unchanged.

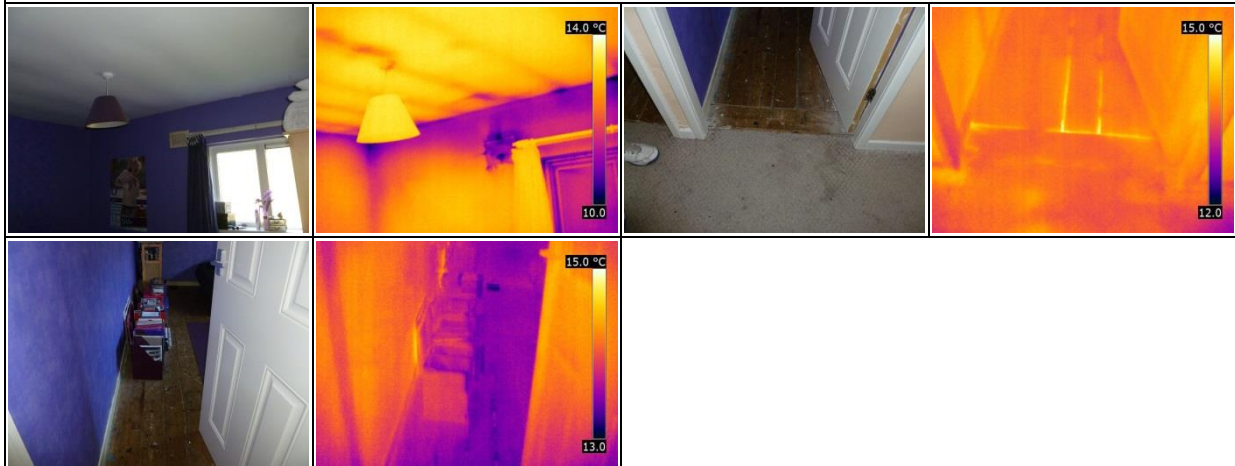
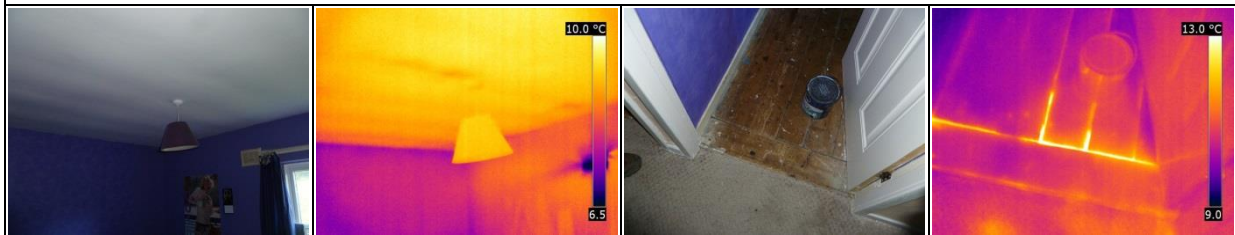
Rear Bedroom

As in the front bedrooms, the inner surfaces of the external walls were now at the same temperature as the insulated ceiling and thermal bridging at the junction had become increasingly distinguishable. Air leakage around the window and vent were similar to the previous pressurisation test although infiltration up through gaps between the floorboards appeared noticeably reduced.

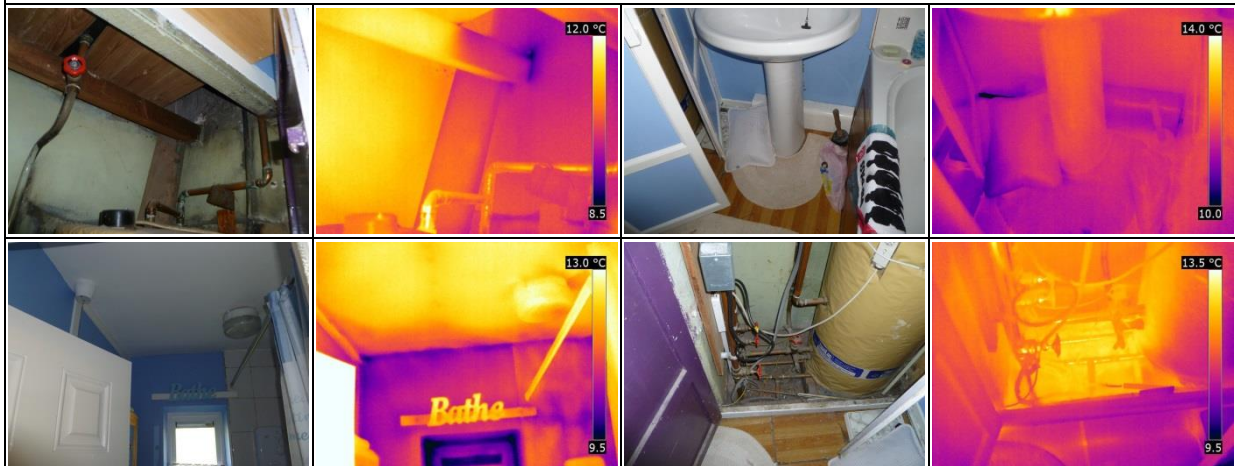
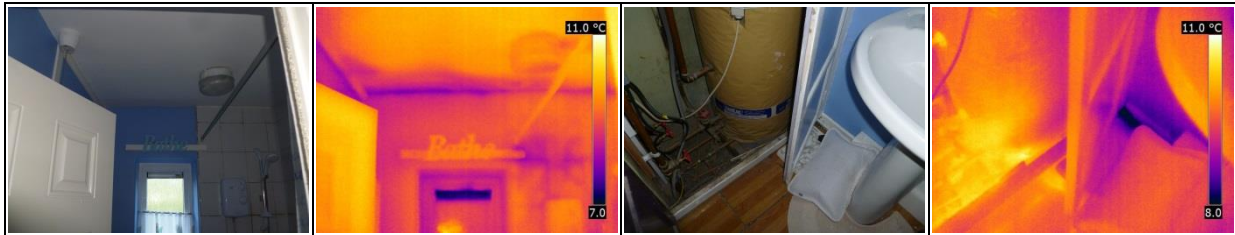
Bathroom & WC

In the bathroom the most prominent change between the two tests was the reduced infiltration up through the floor in the cylinder cupboard; where infiltration was now detected being drawn down from the loft. It is assumed that the air leakage from the loft was overlooked previously due to it being masked by the severity of the air coming up from the intermediate floor.

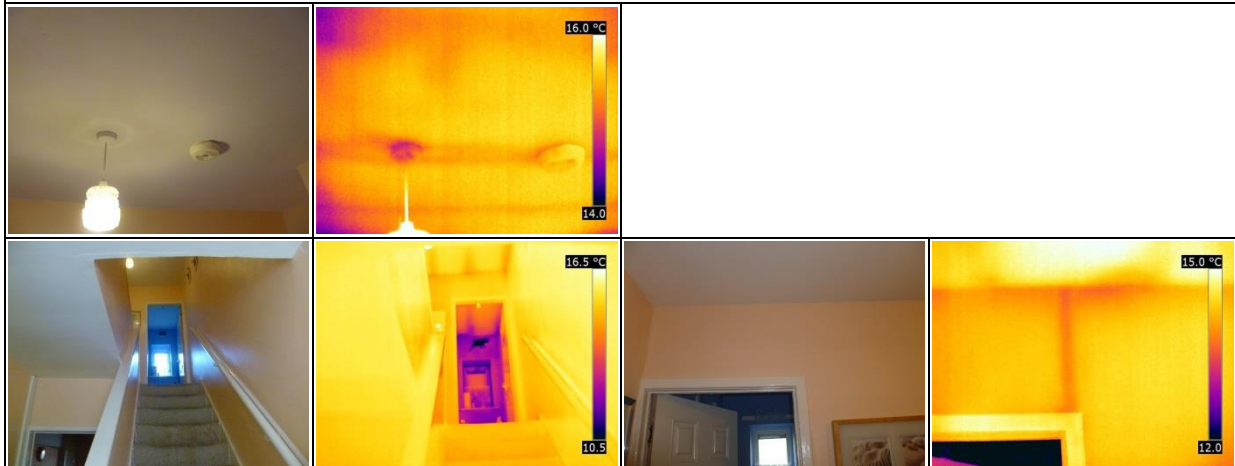
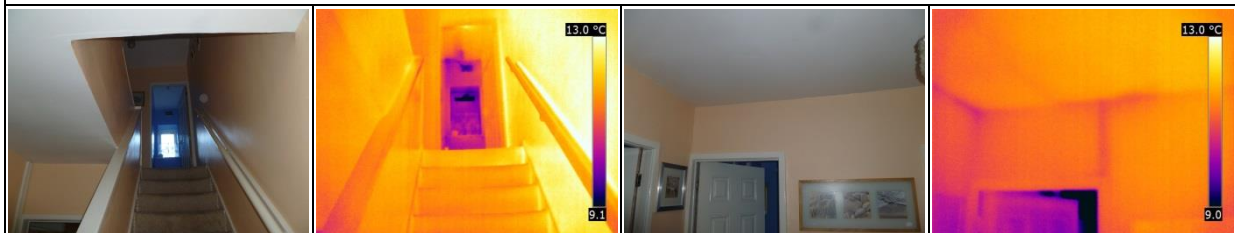
Landing

The small amount of air movement previously detected around electrical penetrations from the loft space remained unchanged between the two tests.

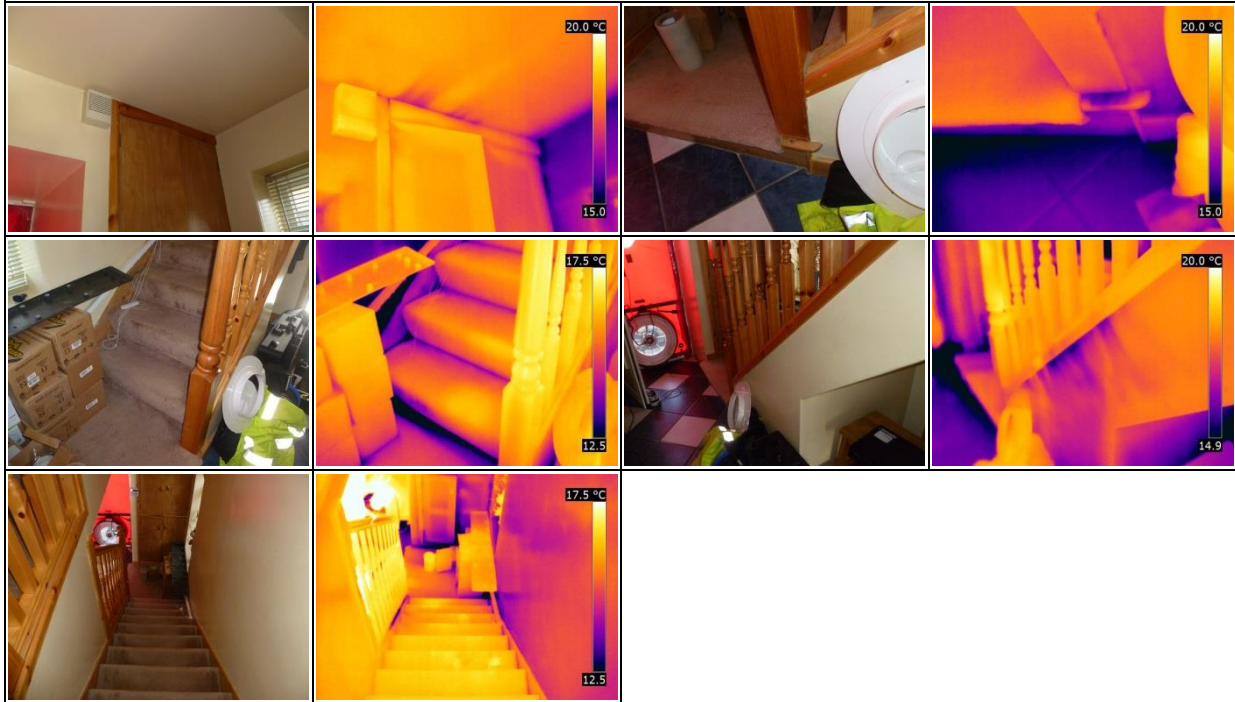
Hall and Stairs

Even with a small internal/external ΔT cooler air could be observed entering the living space from around the lower few steps of the staircase and the cupboard on the external corner at the bottom of the stairs. Air leakage through the stairs appeared limited to where there was a void beneath the staircase, but came through junctions with all other elements and joints within the staircase itself.

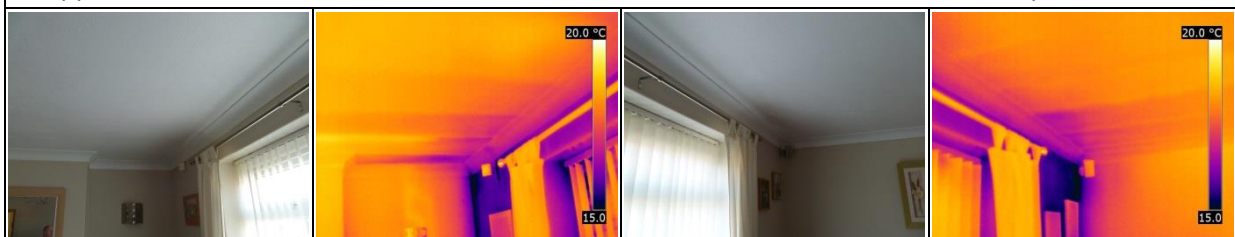
Lounge

The external wall appeared significantly colder than the internal partition wall and party wall. Cooler air appeared to be drawn into the intermediate floor void from the external wall cavity.

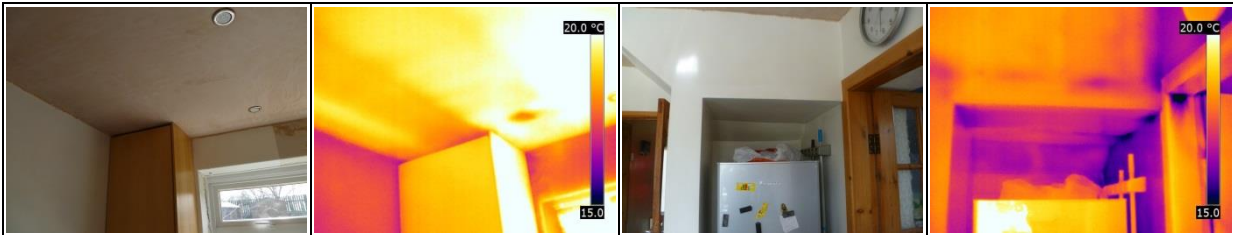
The cavity wall between the kitchen and side extension was noticeably cooler than the other internal walls, although not quite as cold as the external walls.

Behind the refrigerator the internal wall showed signs of cooler air being drawn into it, even though the heat dissipator from the back of the appliance would have been expected to make this area warmer.

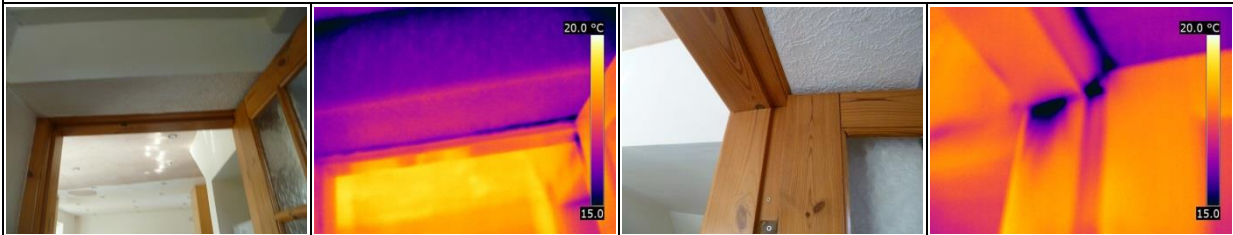
Side Extension

Infiltration was observed around the door frame between the kitchen and side extension, possibly coming from the cavity within the wall.

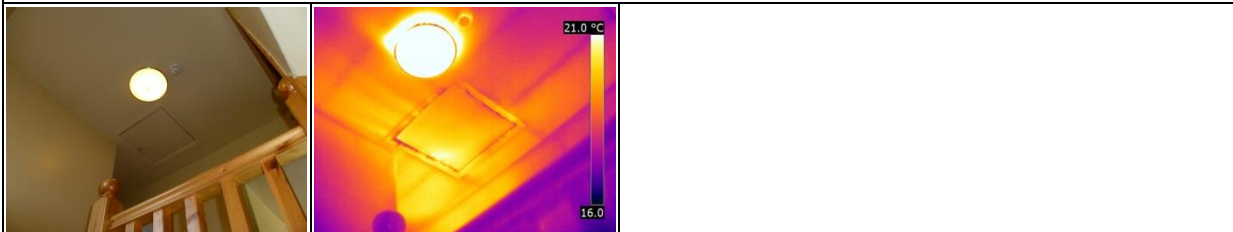
Landing

Air was observed being drawn in from the loft around the lofthatch.

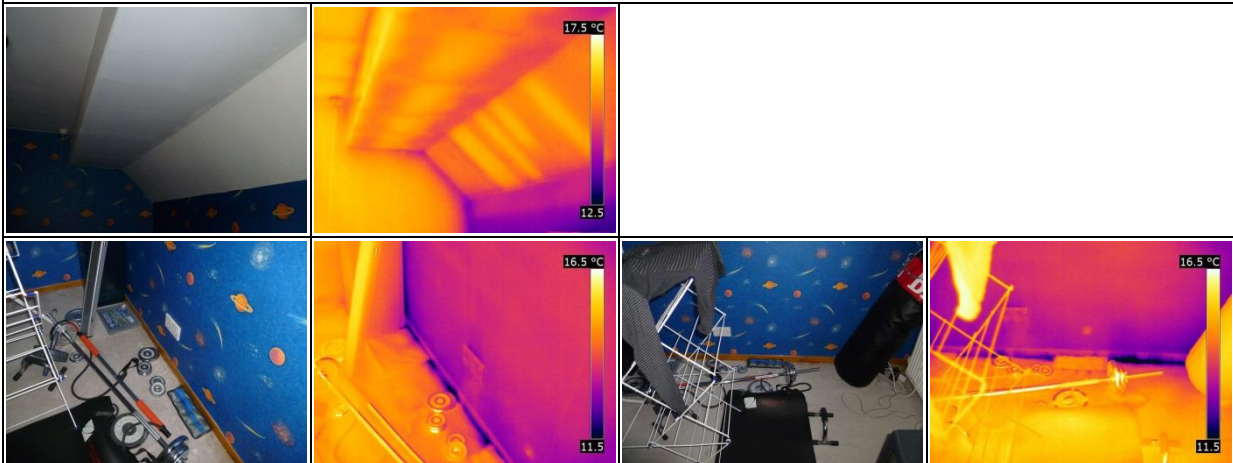
Bedroom 3 (Front/Gable Wall)

The coldest air detected entering the dwelling was from the roof void adjacent to this bedroom, particularly at the junction of the floor and the knee wall. Usually in ceilings cooler joists indicate insulation is present between them, warmer joists imply no insulation; at the dropped soffit and sloping ceiling here, the timbers are cooler in some places and warmer in others. It is unclear whether this is due to air movement or other effects such as being only partially or inconsistently insulated.

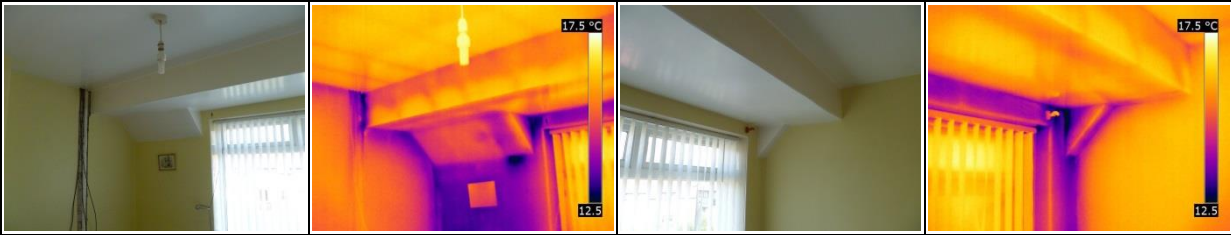
Bedroom 1 (Front/Party Wall)

Again there are unexplained effects at the dropped soffit and sloping ceiling as observed in Bedroom 3. Also, there are very much cooler areas around the small dormer cheeks near the window head. Infiltration was detected at the unsealed chased out cables on the party wall.

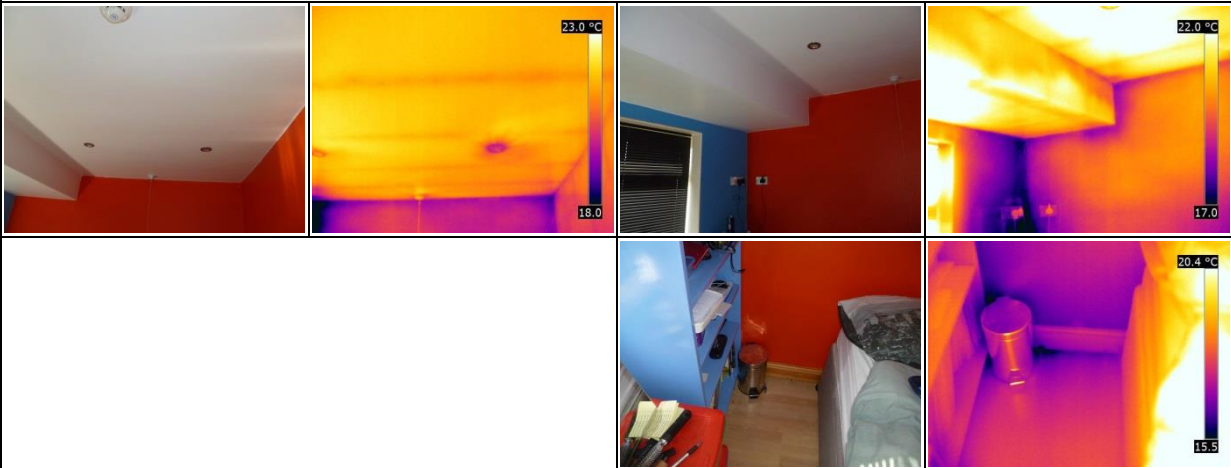
Bedroom 2 (Rear/Party Wall)

Varying amounts of infiltration was observed around the recessed lights and again there was something happening at the dropped soffit with it displaying a range of surface temperatures which cannot all be attributable to solar gain/reflection. Significantly cooler areas were observed at the party wall junction with the external wall than were observed in the rest of the room; it is unclear whether this is just a transient effect (with solar gain heating the rest of the room first and stagnant cold air remaining here) or whether it is due to some other influence.

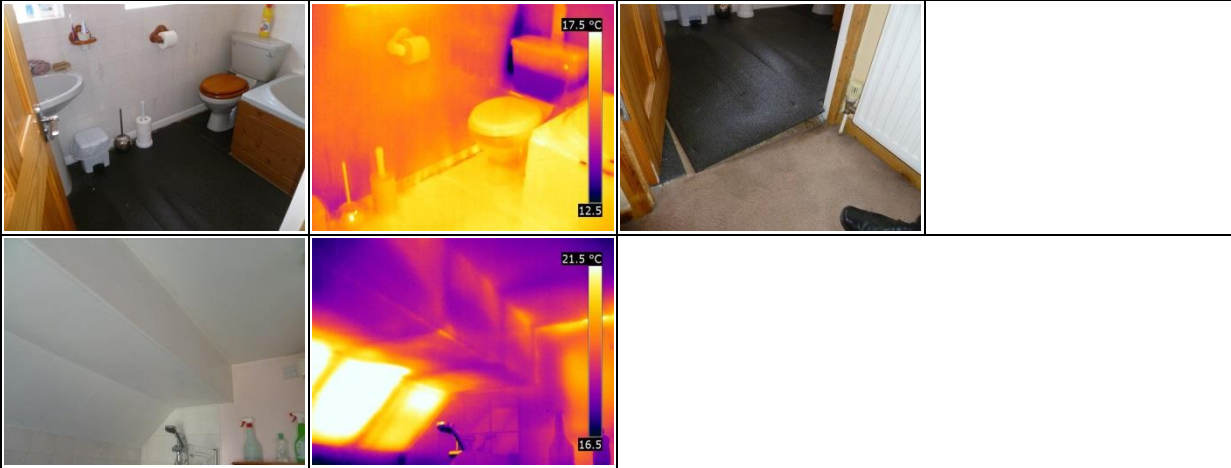
Bathroom

Air infiltration through the intermediate floor was enough to lift the floor covering, but the emerging air was not cool enough to show on a thermal image. Direct sunlight on the SouthEast facing roof shows up in the thermal image as warmer areas of possibly un-insulated areas of sloping ceiling; here the dropped soffit displays opposing thermal gradients to those seen on the front and rear of the house which have received either no or significantly less direct solar insolation over the period prior to the pressurisation test.

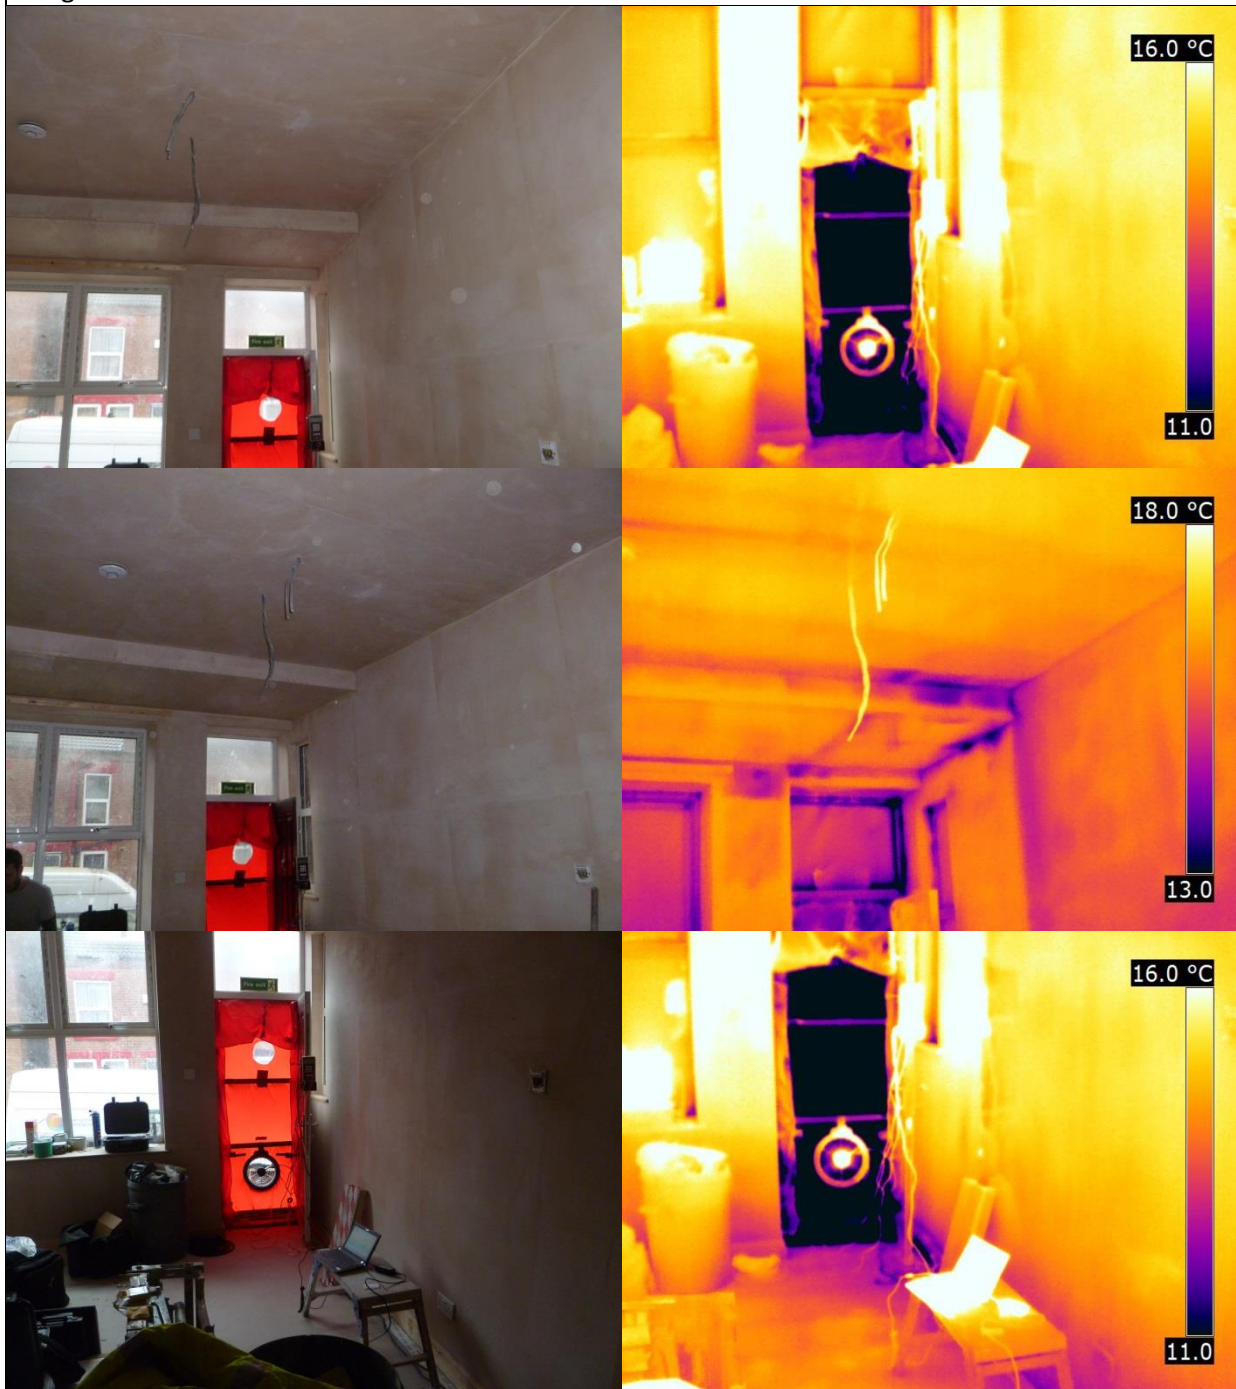
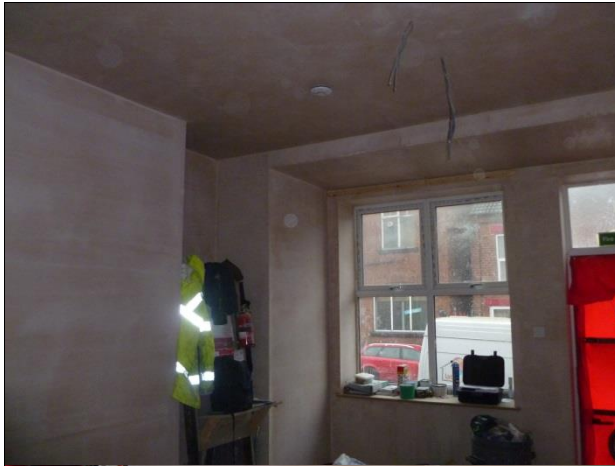
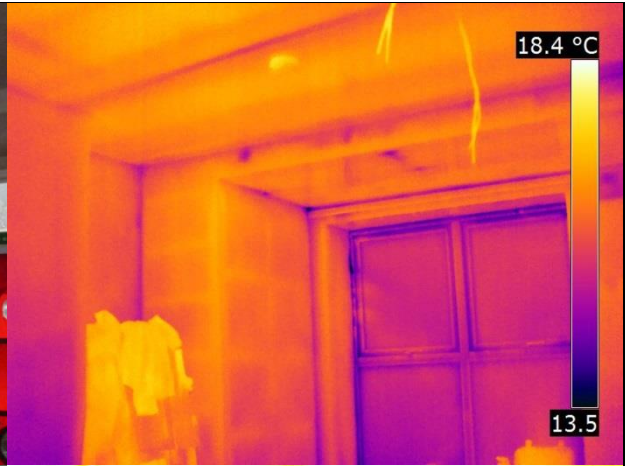
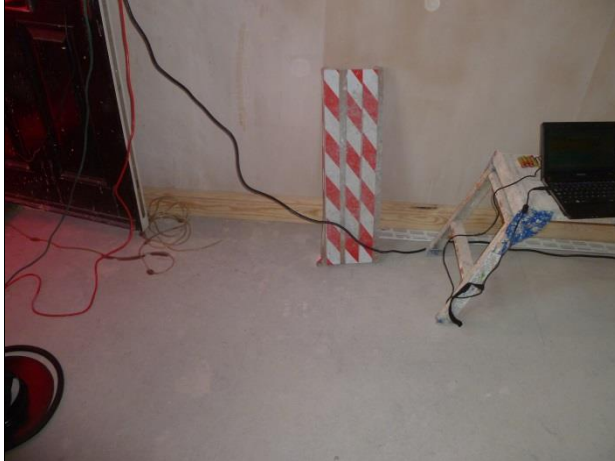
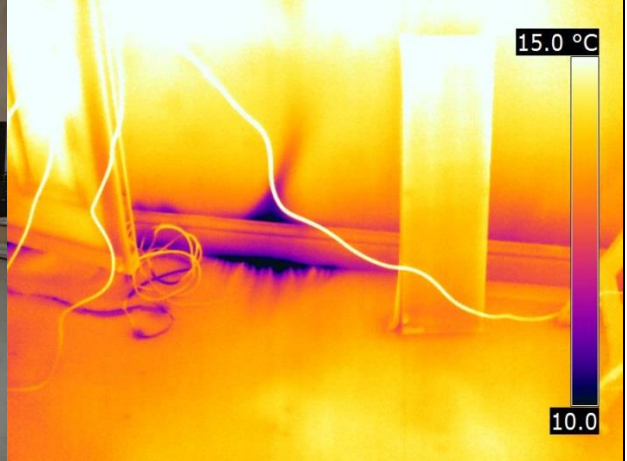
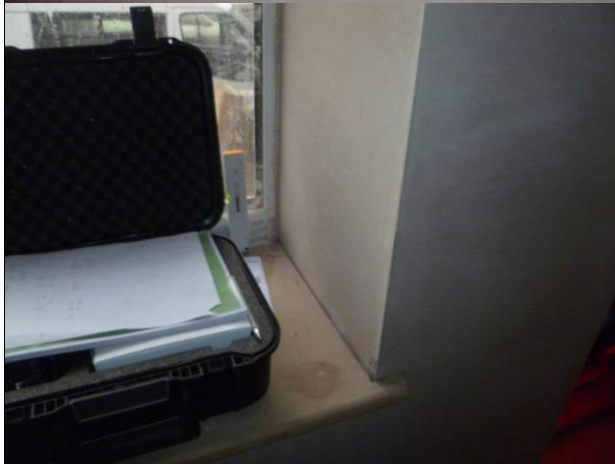
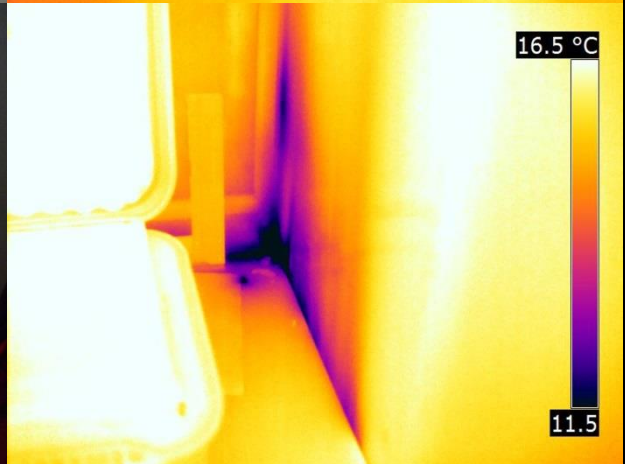
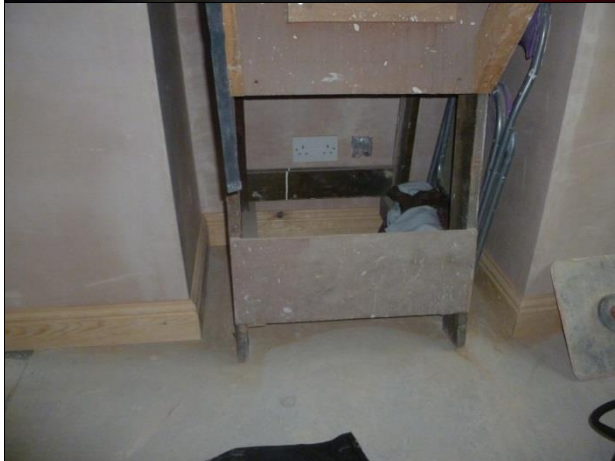
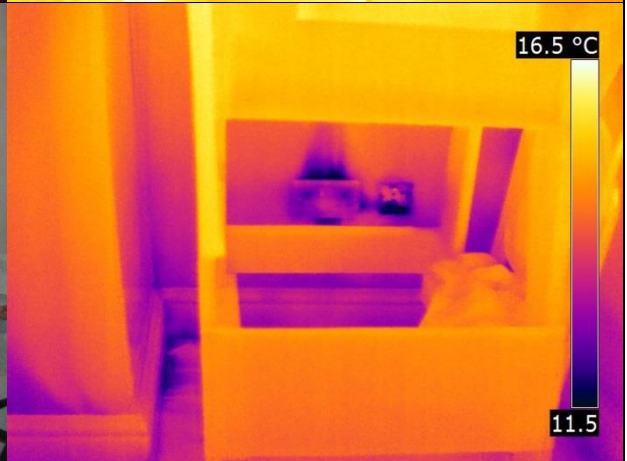
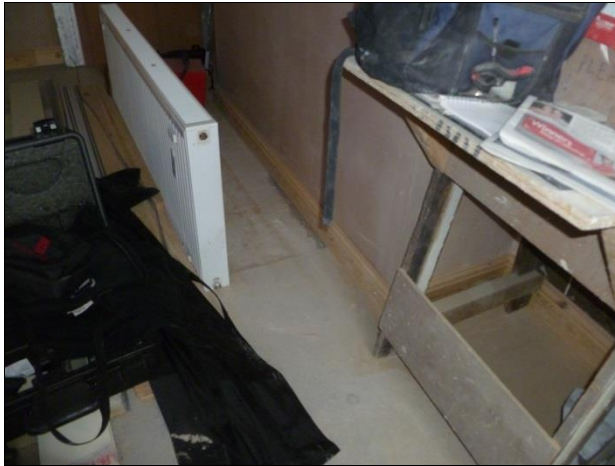
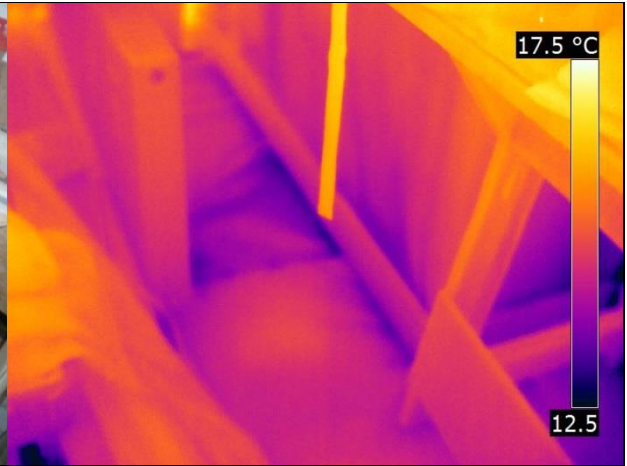
Living Room:

Significant air leakage was detected both around the temporary glazing panels and the trickle ventilators, there was also infiltration detected at the sill/frame corner junction.

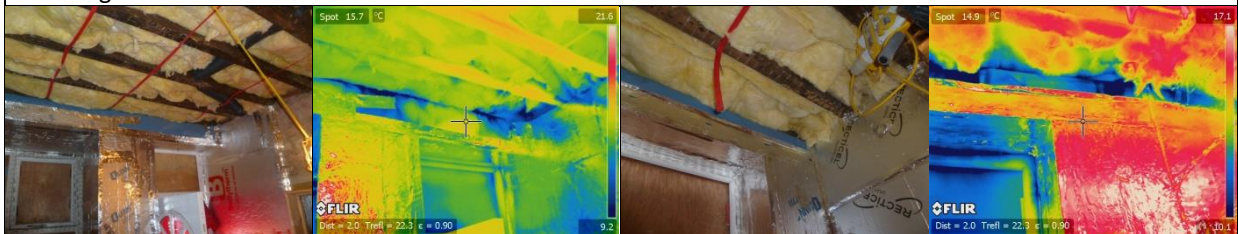
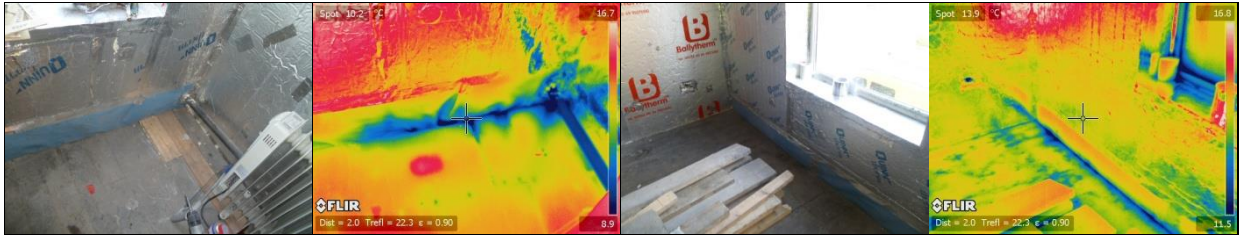
Bay Roof/Intermediate Floor Perimeter:

Air leakage around the membrane.

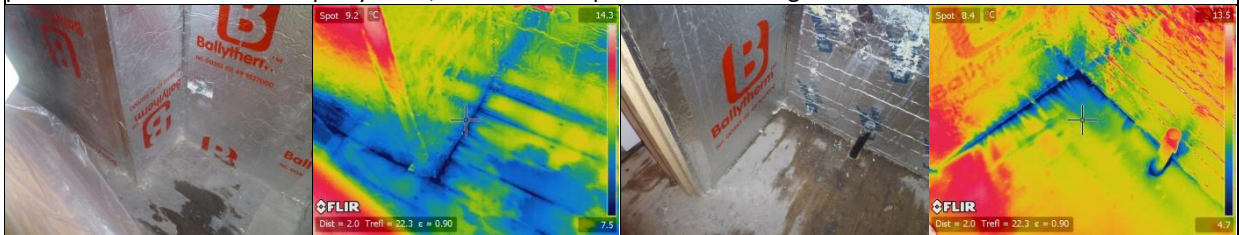
Timber Ground Floor:

Air leakage was detected both through gaps between the floor boards and at the floor perimeter in a number of places on both external and party walls, and around a penetration through the floor.

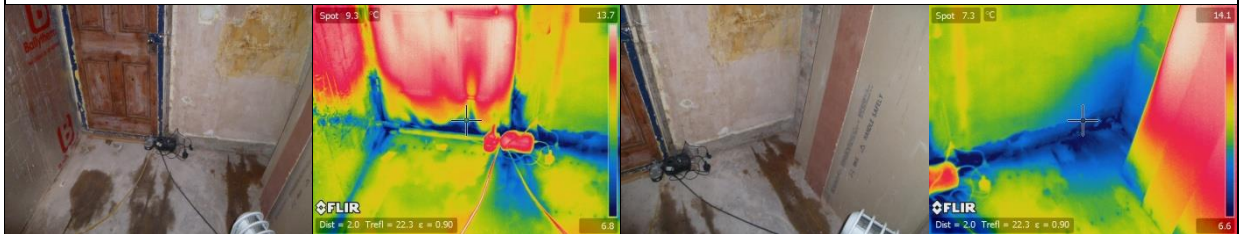
Cellar :

Leakage around the cellar door, which was temporarily sealed (albeit fairly ineffectually), and around the kitchen floor.

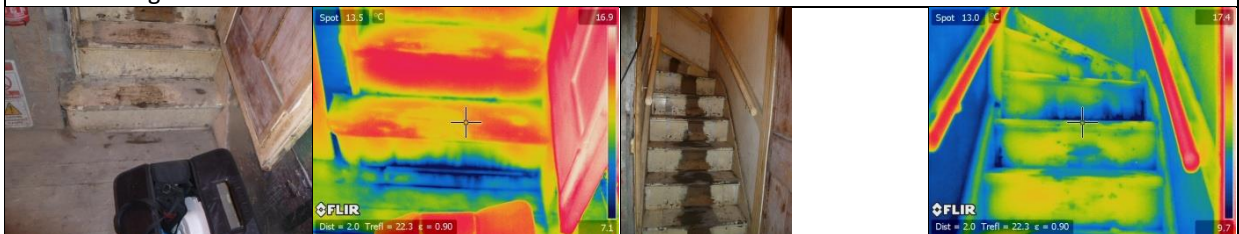
Stairs:

Infiltration observed at a number of points on the stairs, this was most obvious on the ground floor stairs where the infiltrating air was coolest.

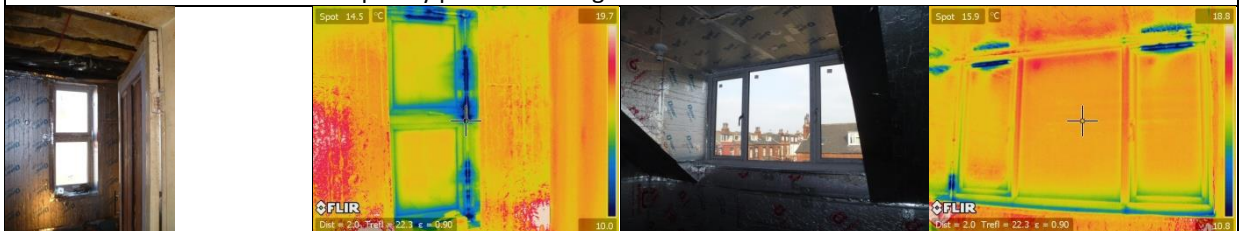
Upper Floors Windows:

Trickle vents again and some areas of leakage around the frames, no leakage between the glazing panels and frames as observed with the temporary panels on the ground floor.

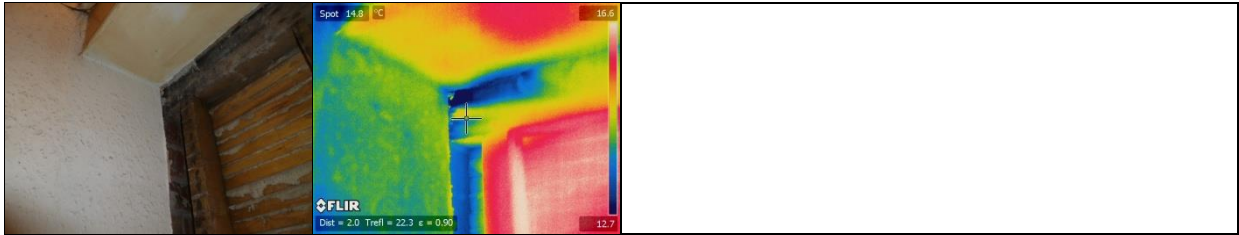
Party Elements:

Some leakage from through party walls was visible using thermography, but in most instances the temperature of the incoming air was not significantly cooler enough for leakage detection through thermography even though there was substantial infiltration.

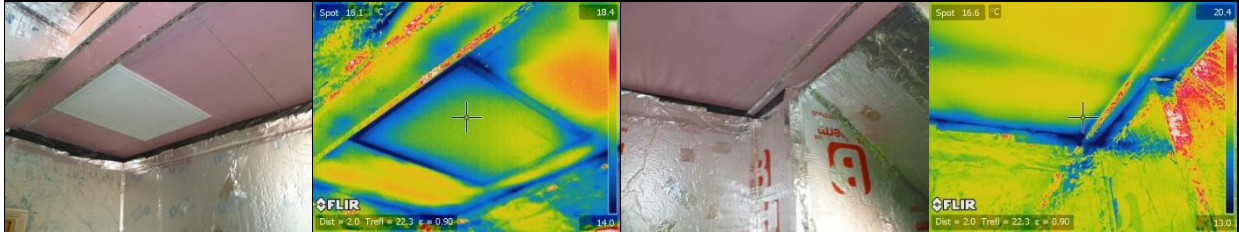
Top Floor Ceiling:
Through proprietary loft hatch and at some patches at ceiling/wall junctions.

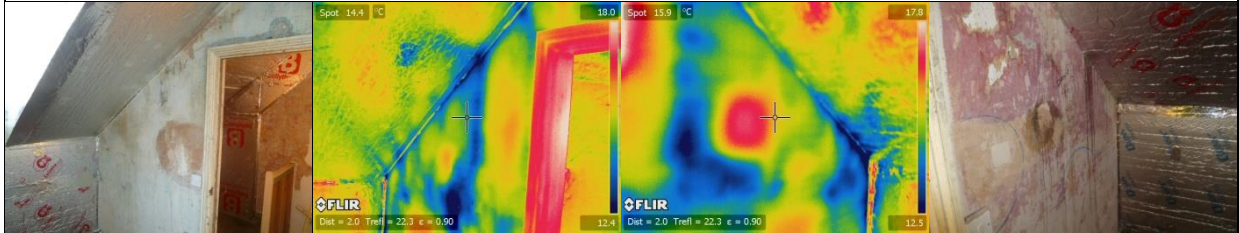
Top Floor Partition Wall:
Cooler air observed being drawn down into the internal wall cavity
