Appendix B. Air tightness test reports

Air tightness test field reports

LEEDS
METROPOLITAN
UNIVERSITY
Leeds Sustainability Institute

Dwelling C-01, before and after retrofit

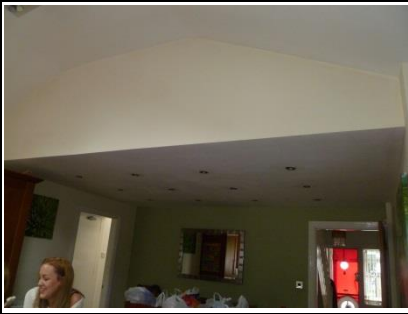
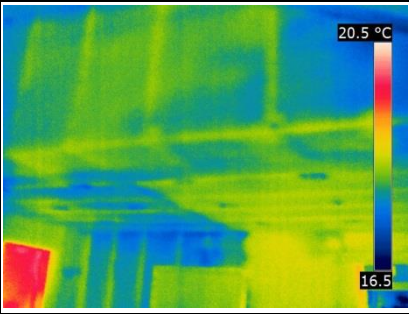
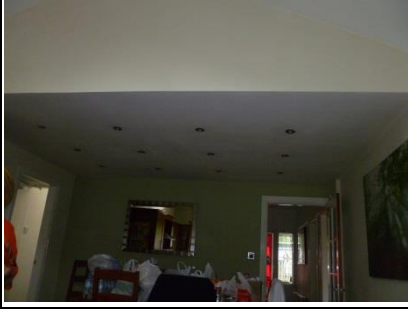
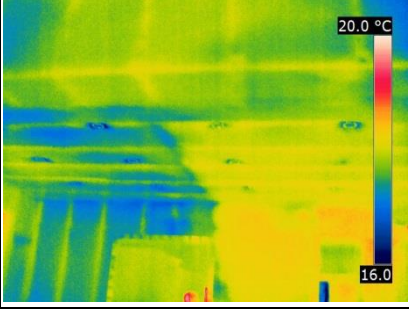
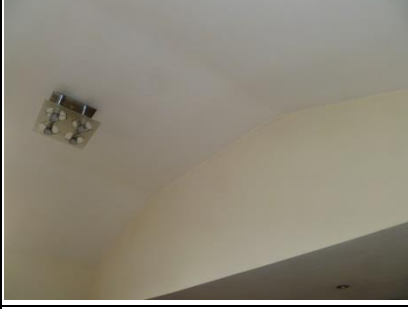
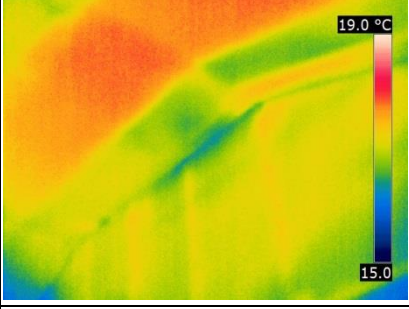
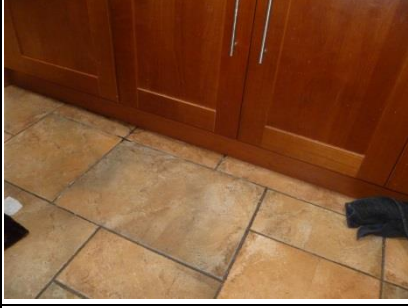
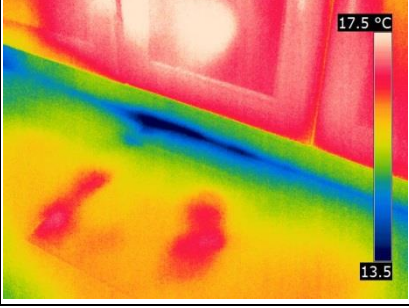
Under depressurisation

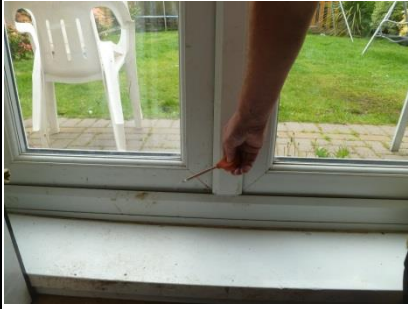
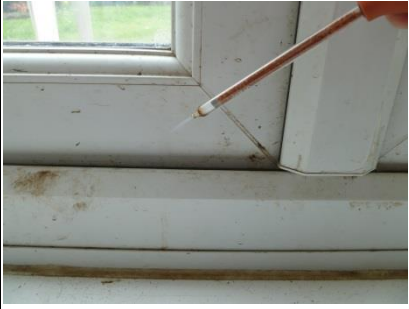
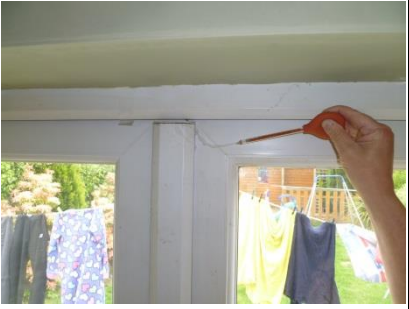
Under pressurisation

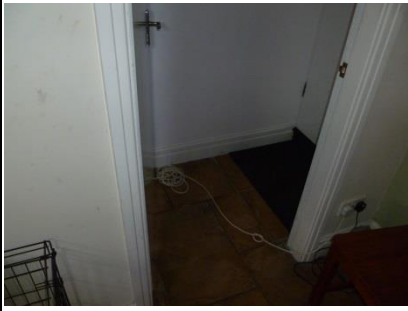
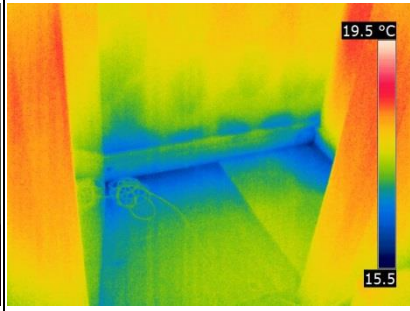
Ground Floor Side Extension

Prior to test

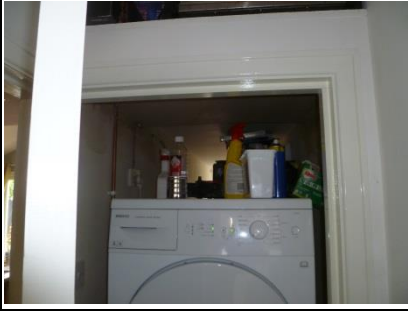
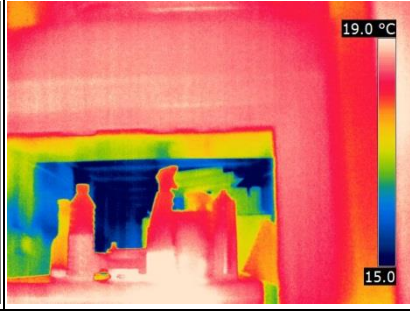
Under depressurisation

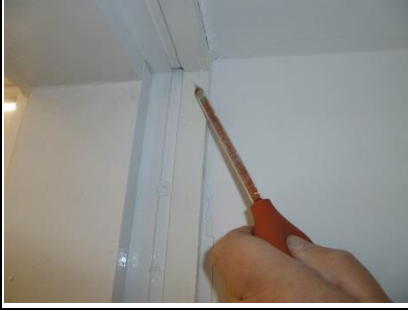
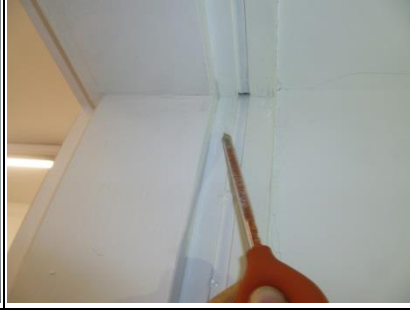
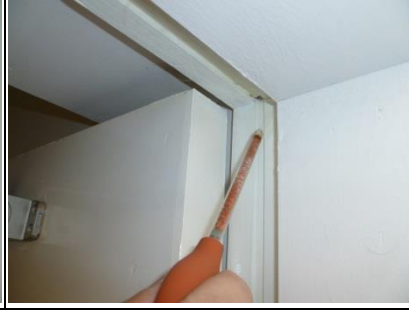
Under pressurisation

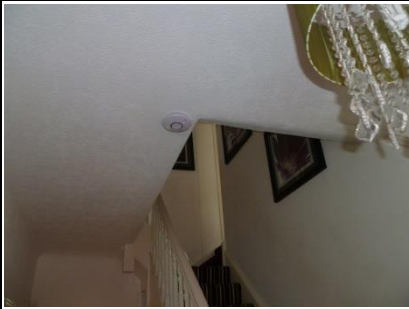
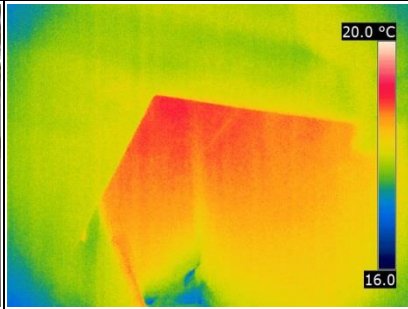
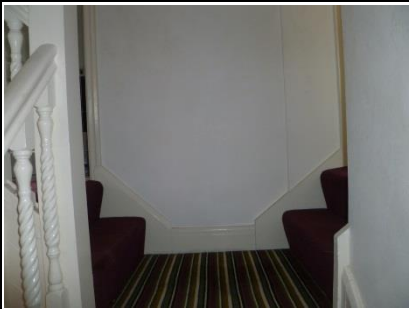
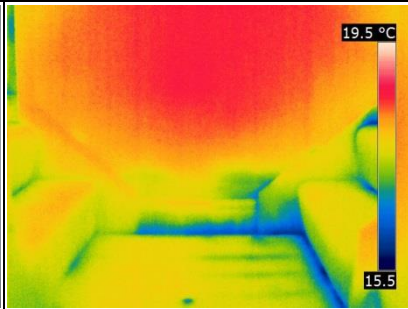
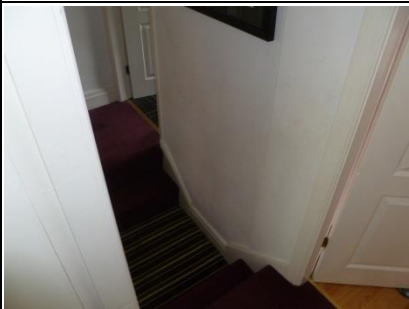
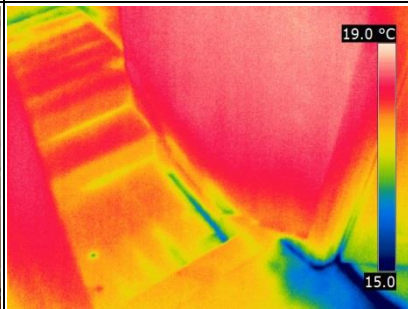
1st Floor Landing

Under depressurisation

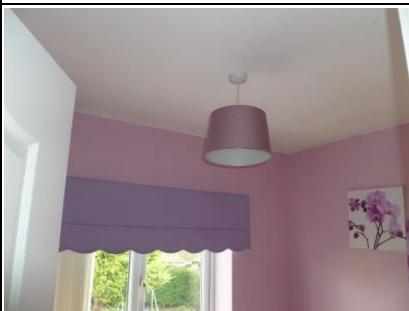
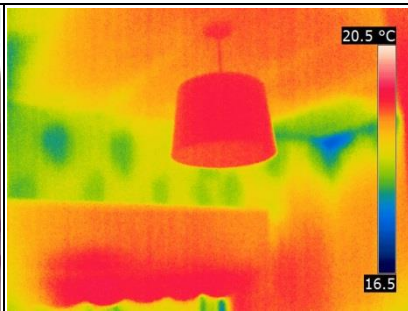
Rear Bedroom (Gable Wall)

Prior to test

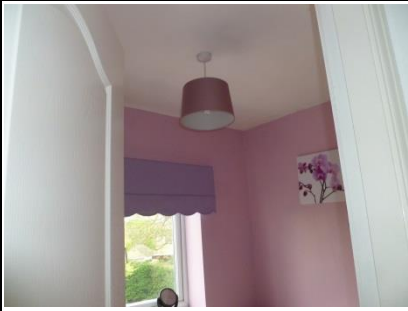
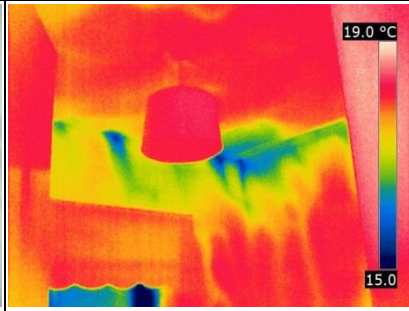
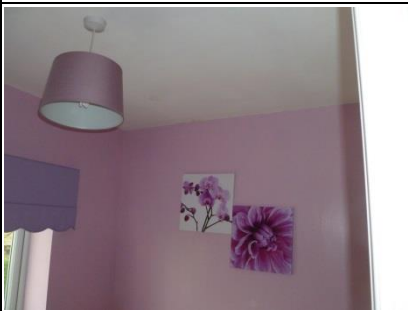
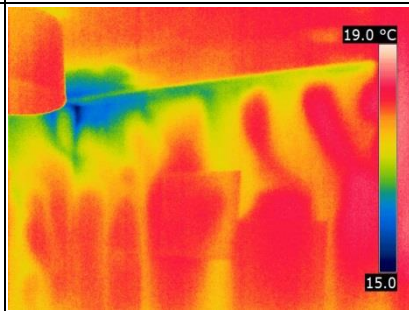
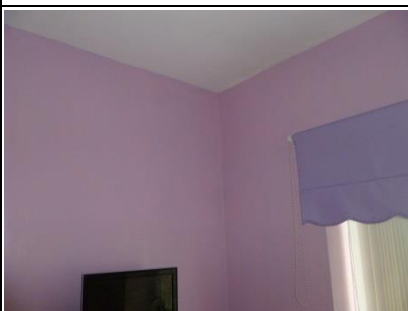
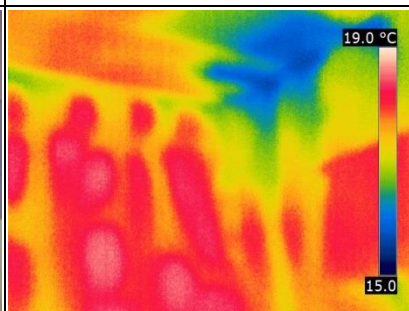
Under depressurisation

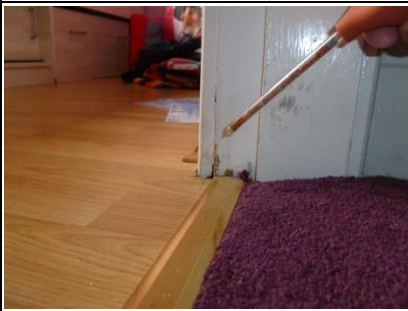
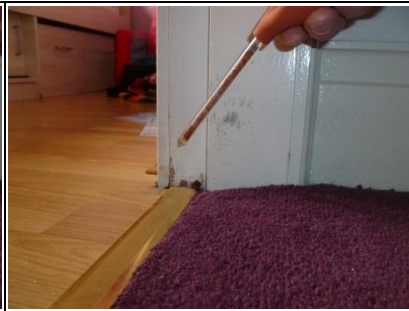
Under pressurisation

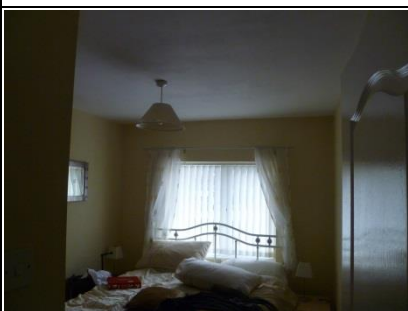
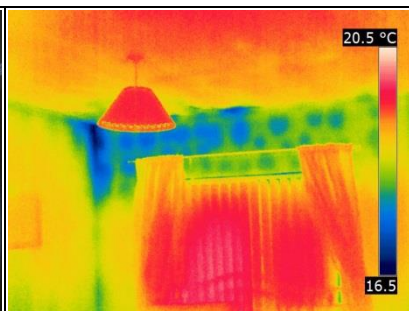
Front Bedroom (Gable Wall)

Prior to test

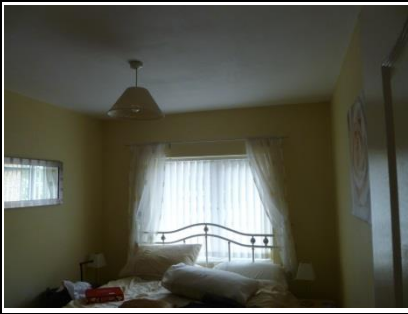
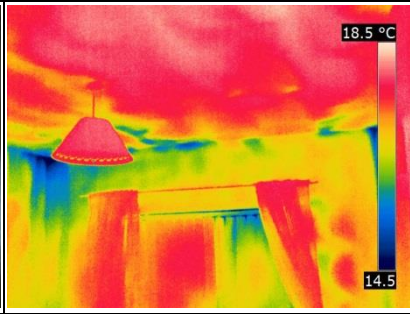
Under depressurisation

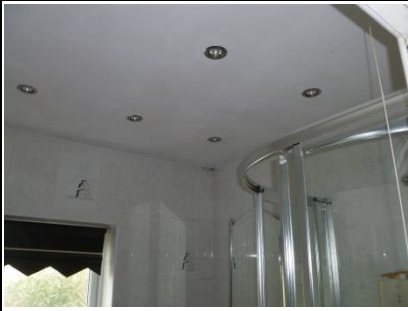
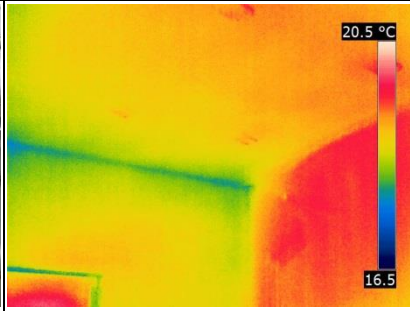
Bathroom

Prior to test

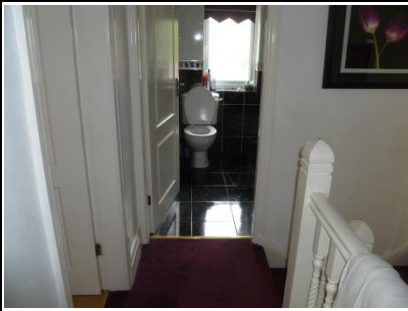
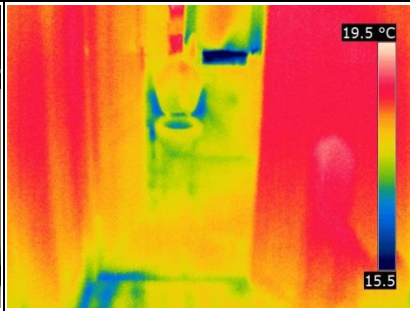
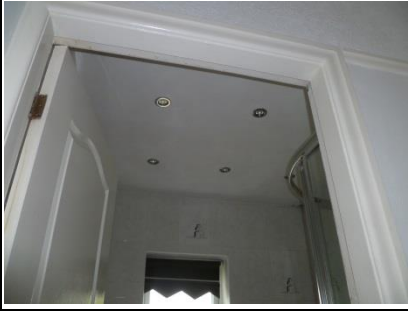
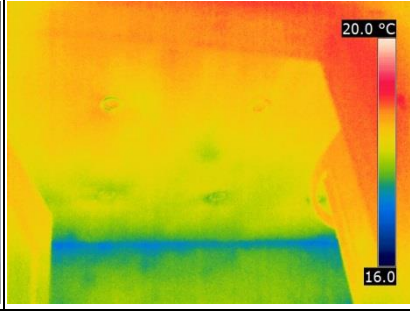
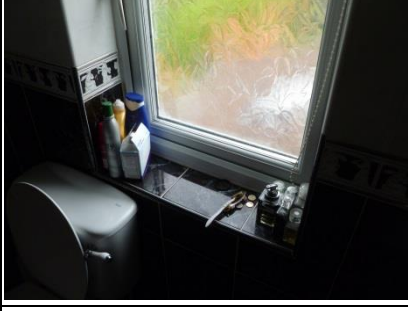
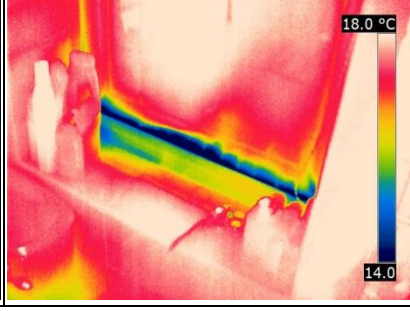
Under depressurisation

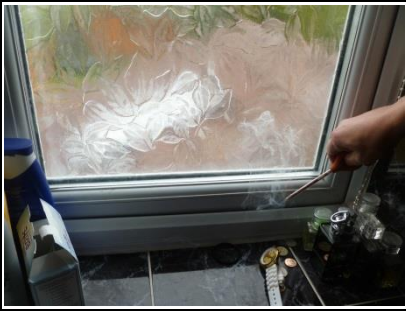
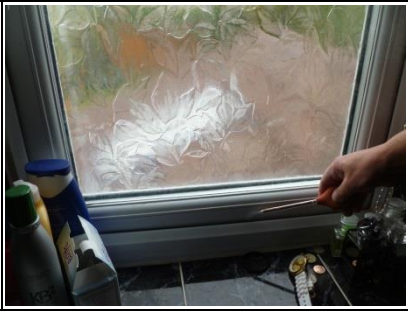
Under Pressurisation

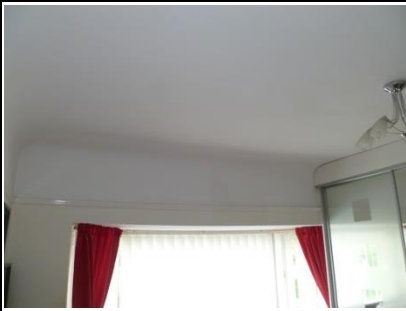
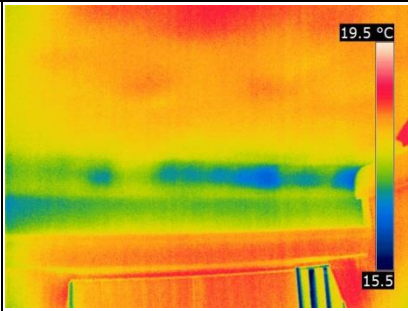
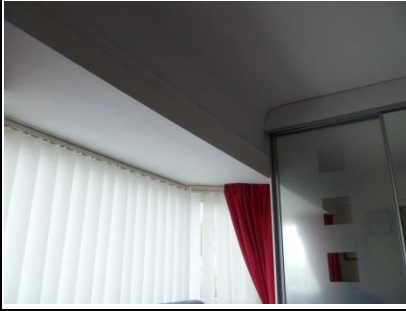
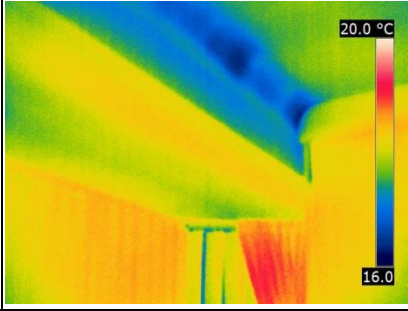
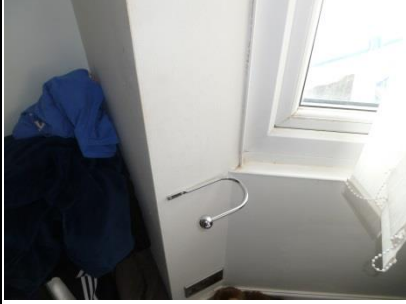
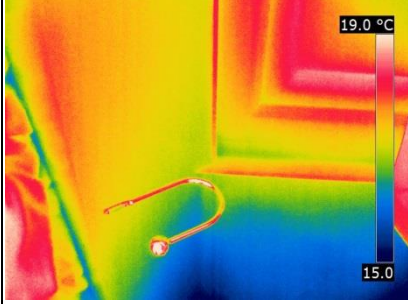
Front Bedroom (Party Wall)

Prior to test

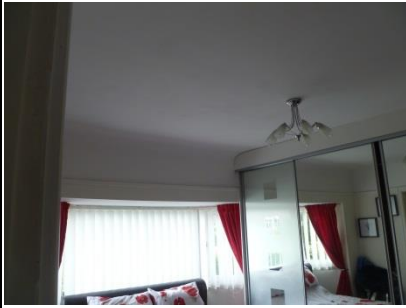
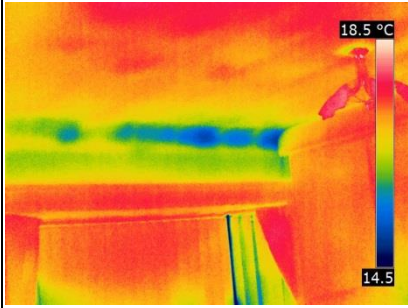
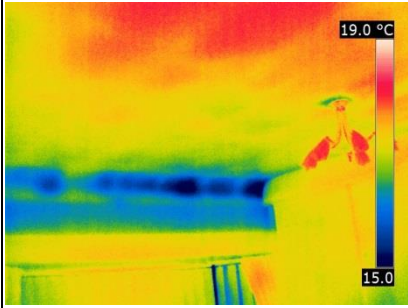
Under depressurisation

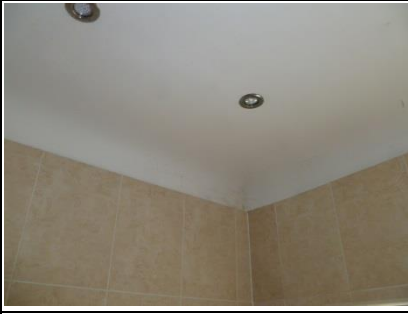
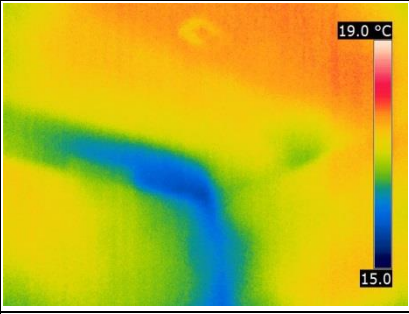
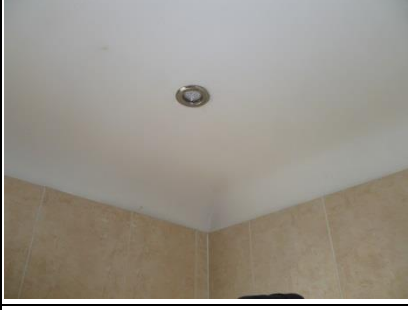
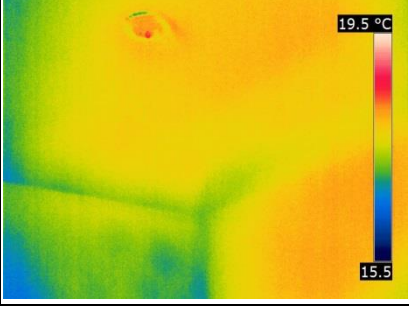
En suite

Prior to test

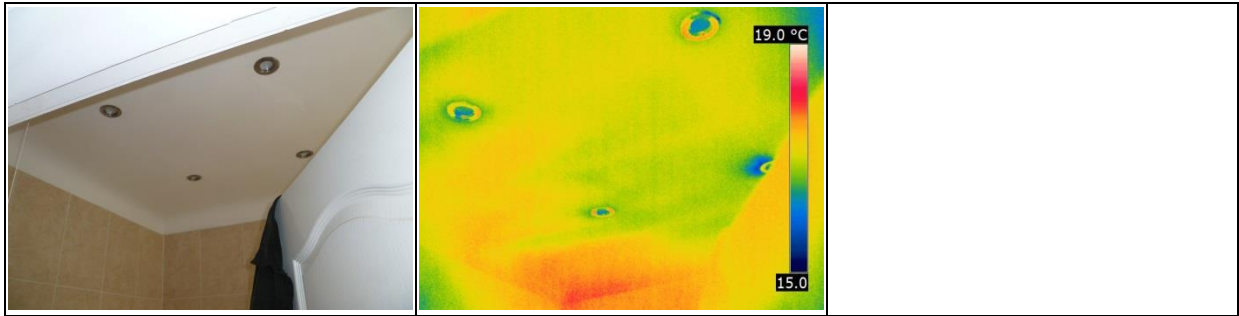
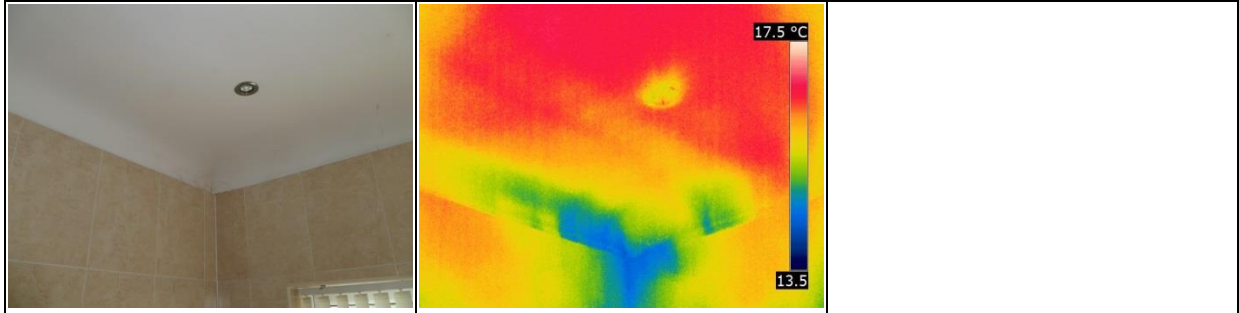
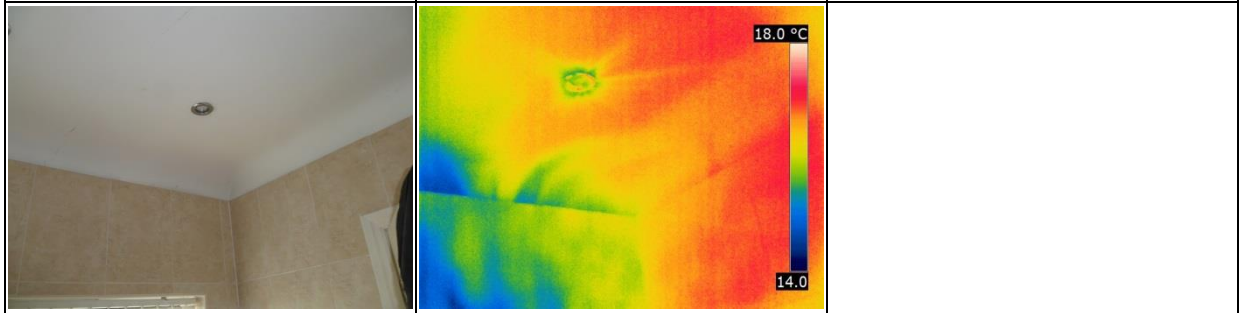
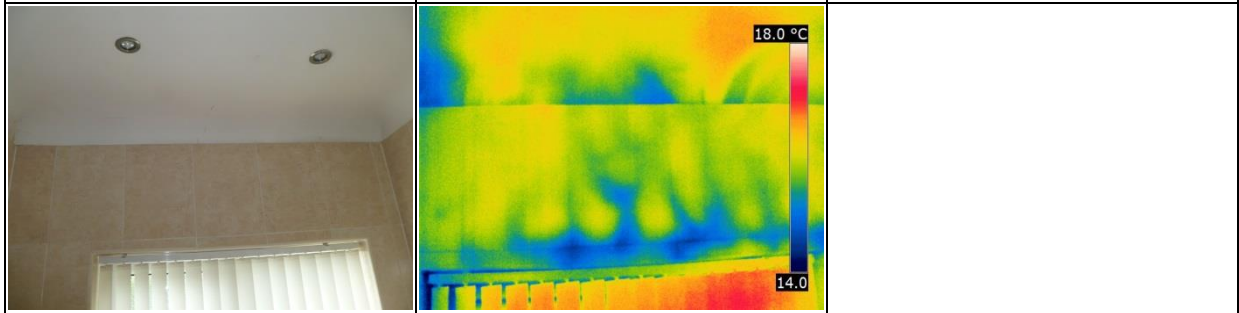
Under depressurisation

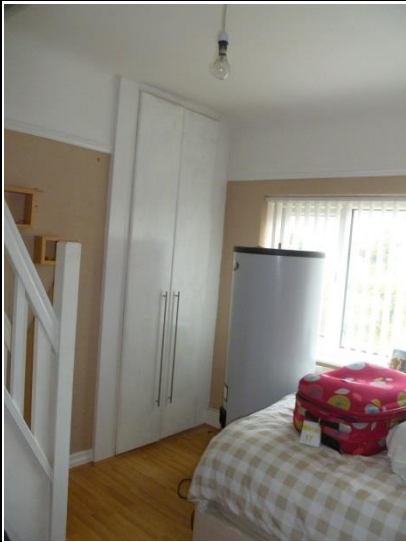
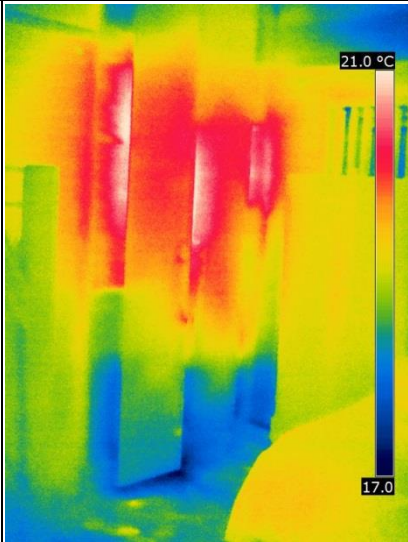
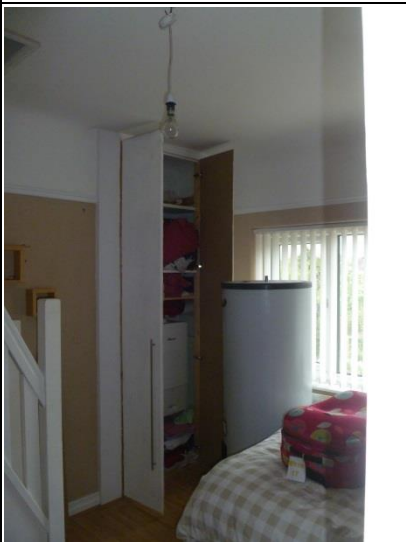
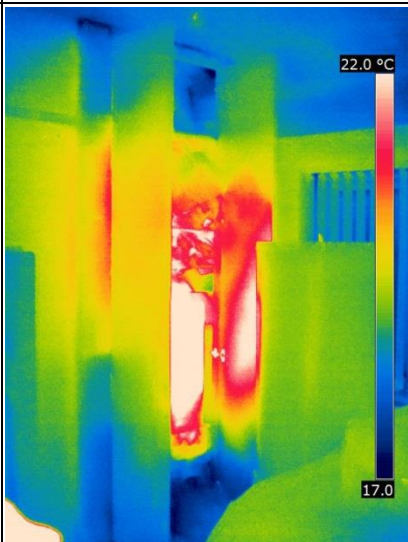
Under pressurisation

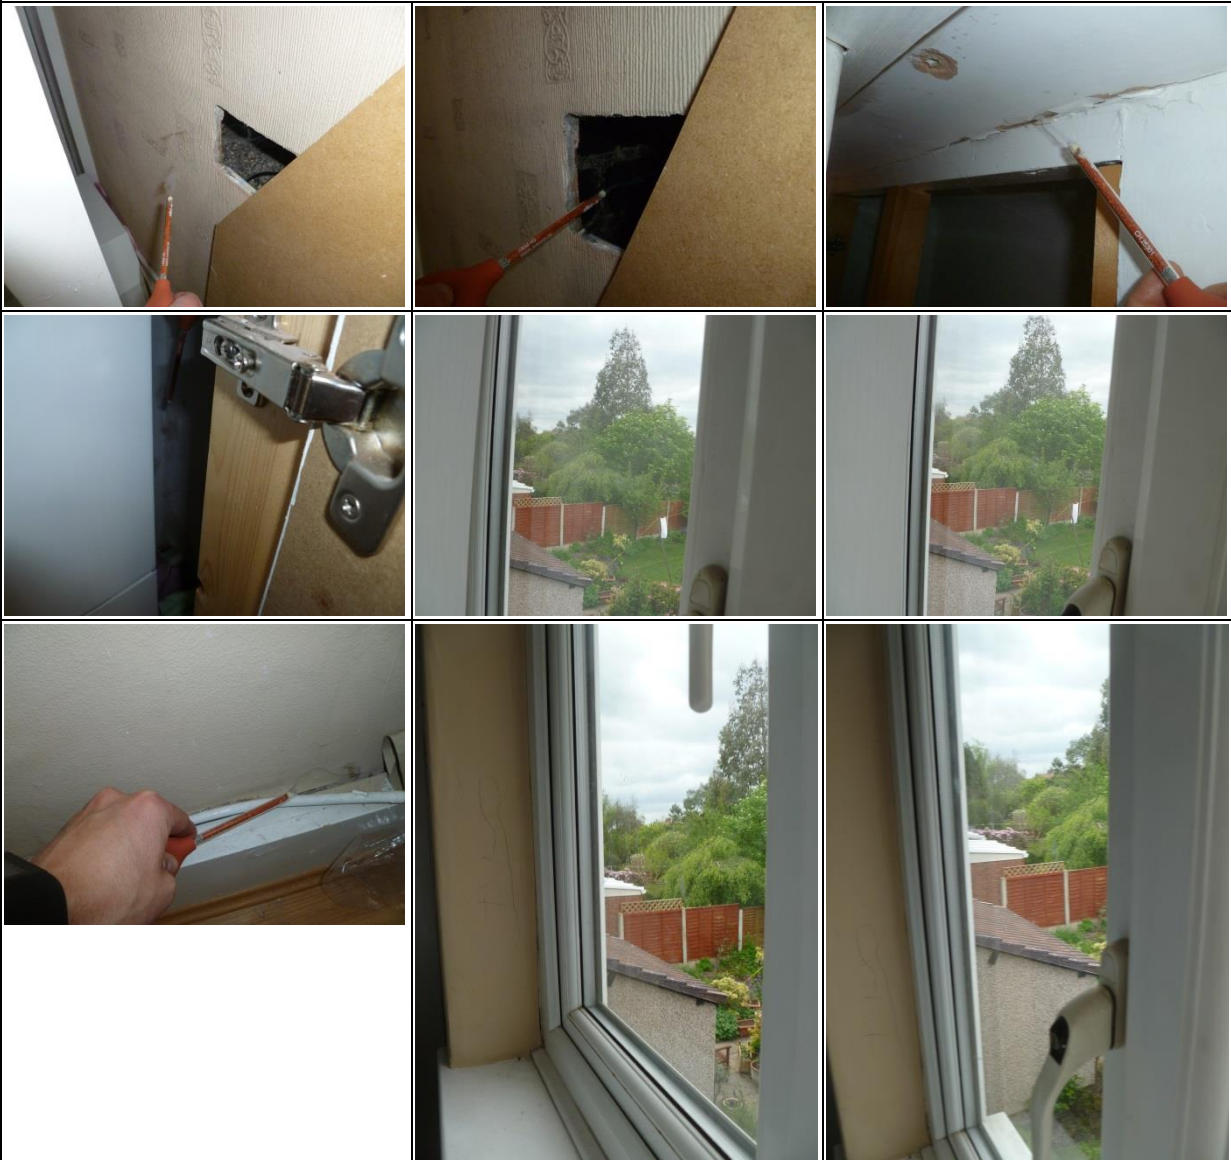
2nd Floor Bedroom

Prior to test

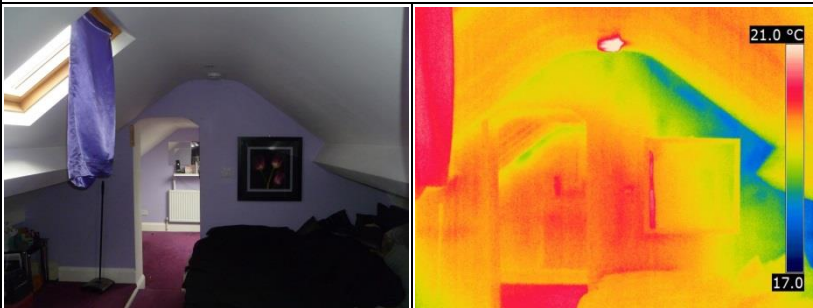
Under depressurisation

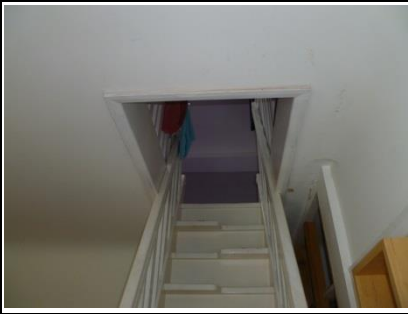
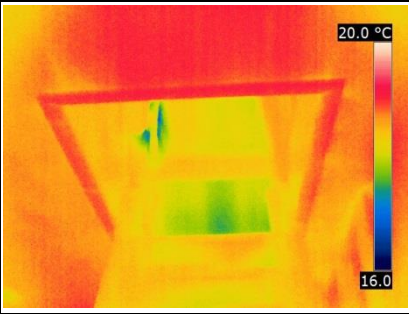
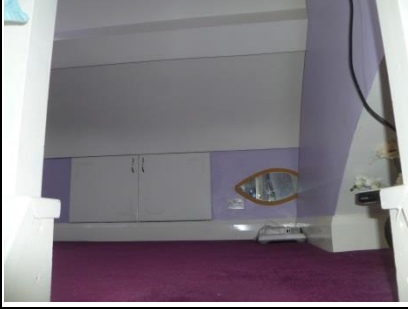
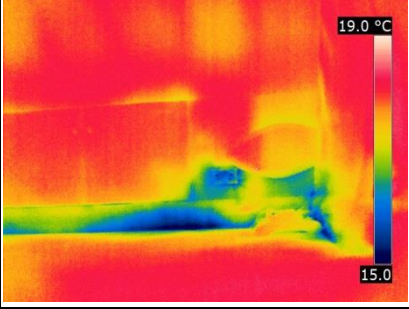
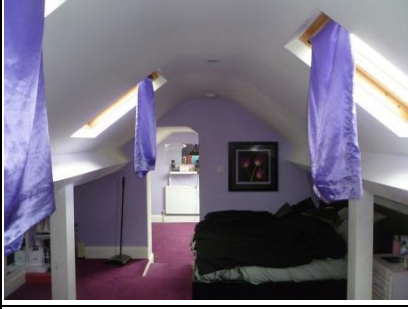
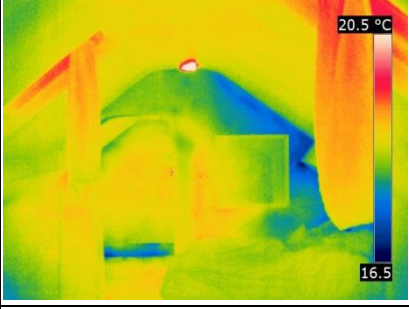
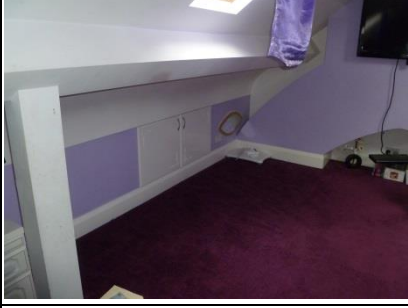
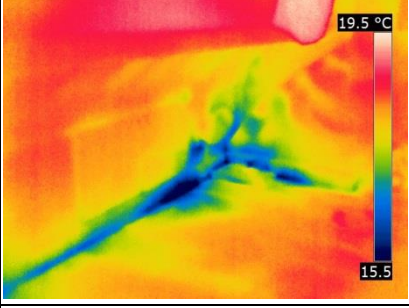
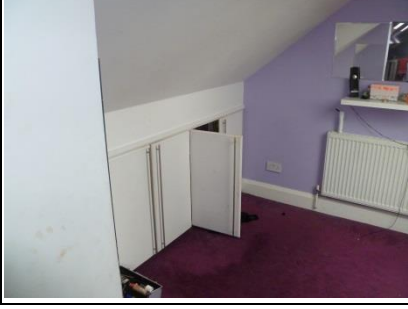
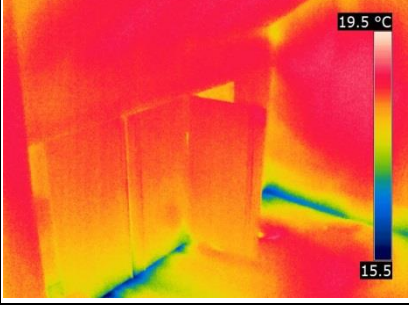
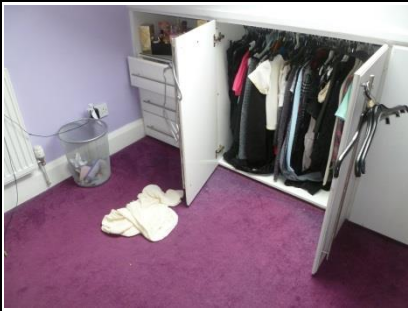
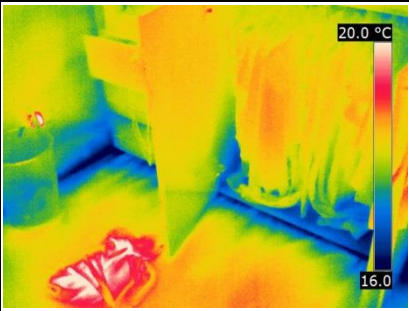
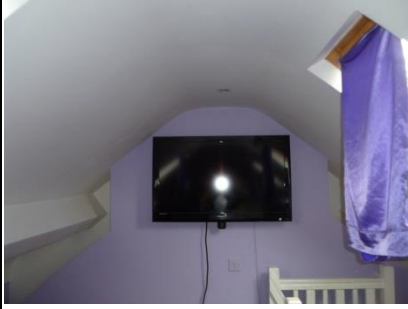
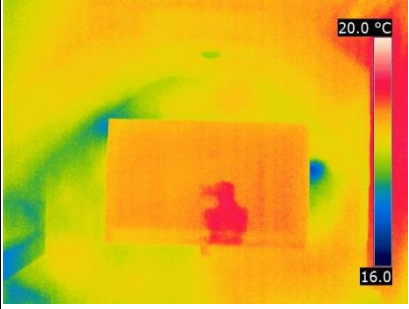
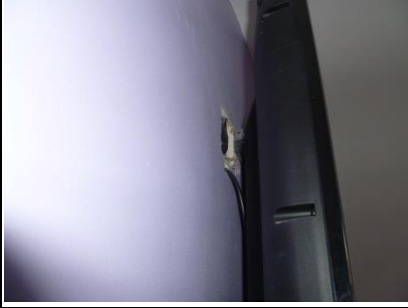
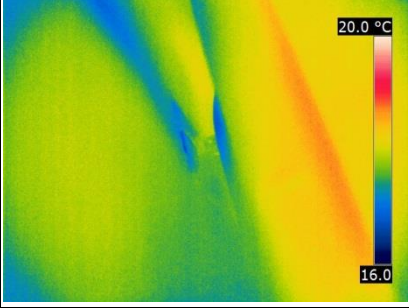
The airtightness of the dwelling had increased since the previous test, although not by a significant amount. The leakage detection displayed very similar air leakage paths to those previously identified under both pressurisation and depressurisation.

Leakage detection was performed at -50 Pa for thermal imaging under depressurisation and +50 Pa for smoke detection under pressurisation. Thermal images captured prior to the test were done so under natural conditions, under no induced pressure; where the ground floor was an infiltration zone (with external air entering the dwelling) and the attic an exfiltration zone (internal air exiting the dwelling).

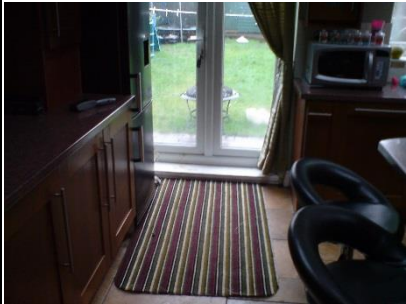
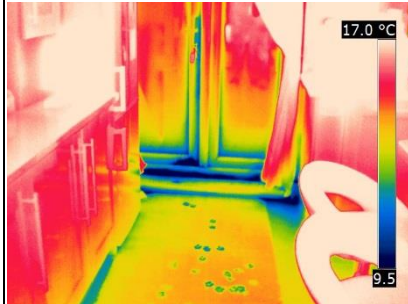
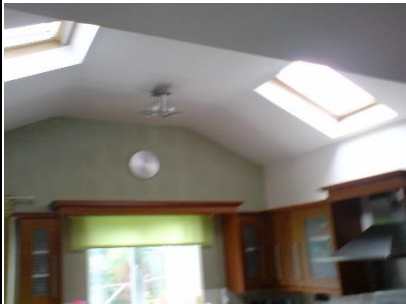
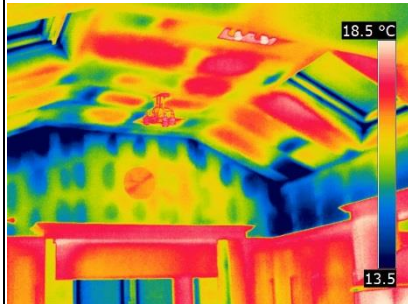
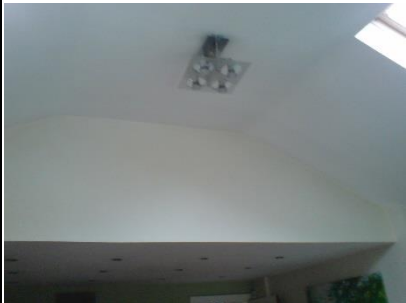
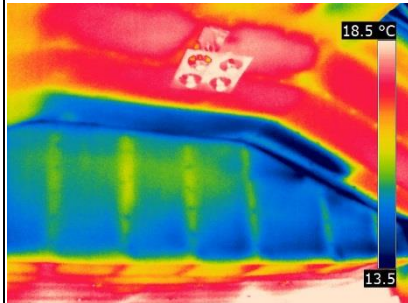
Prior to test

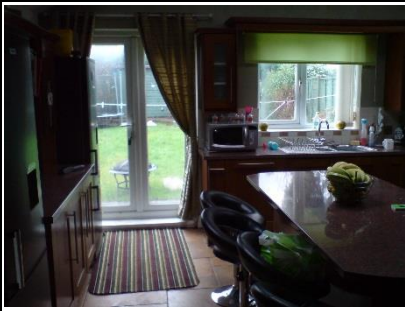
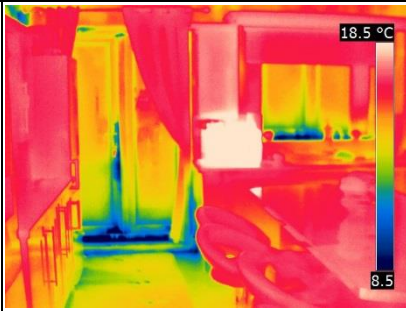
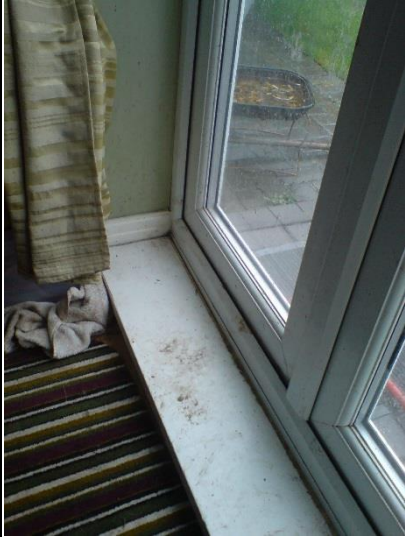
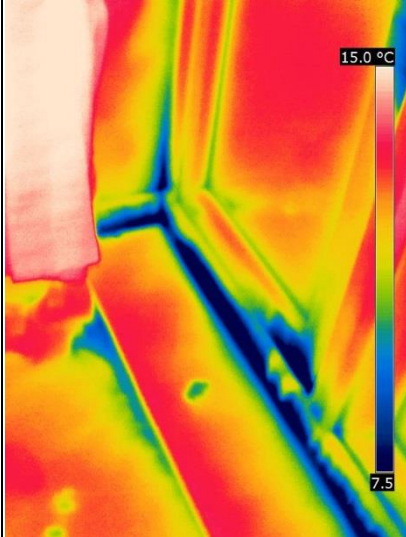
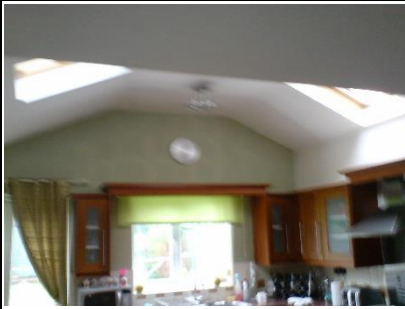
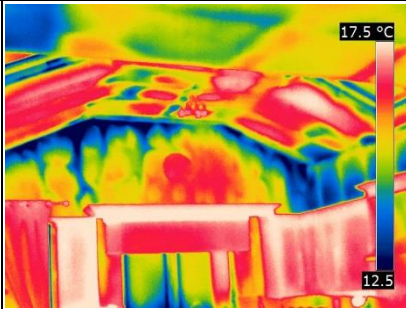
Under depressurisation

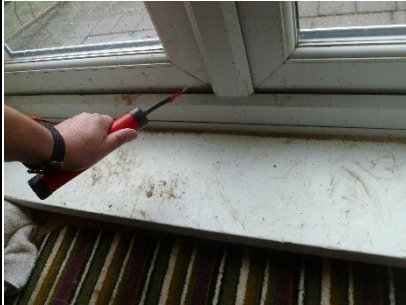
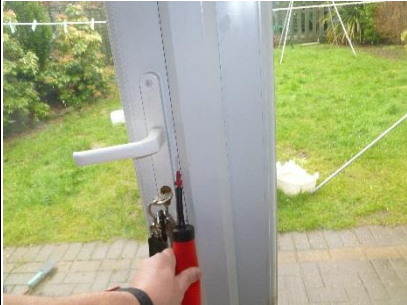
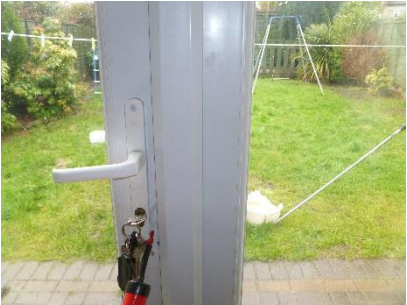
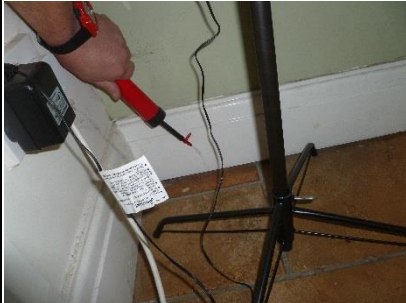
Under pressurisation

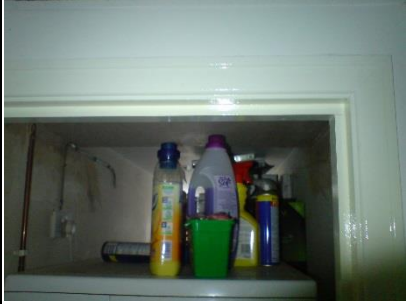
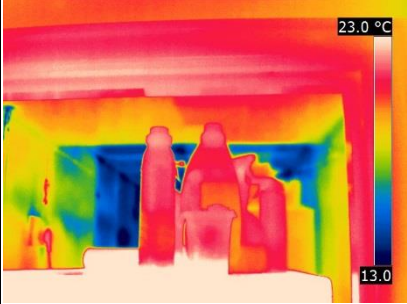
Ground Floor Side Extension

Under depressurisation

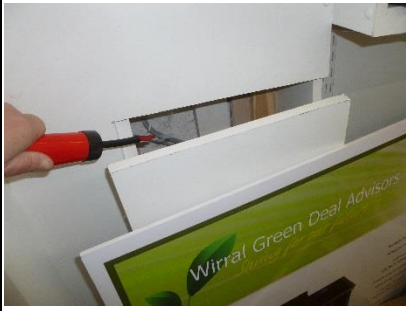
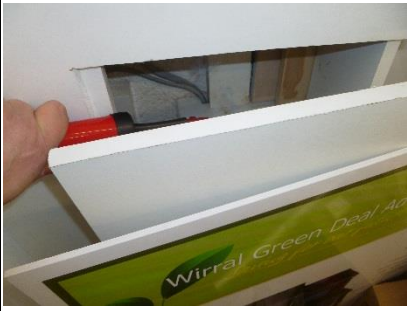
1st Floor Landing

Under pressurisation

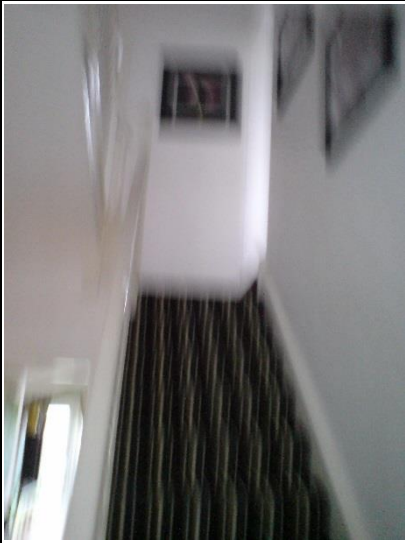
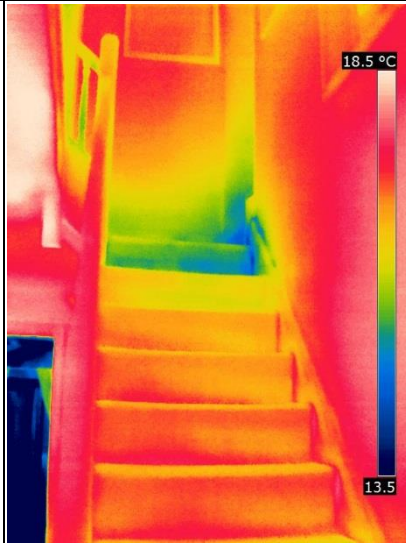
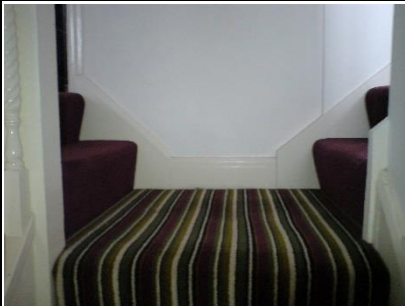
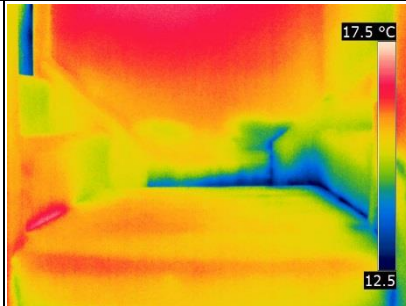
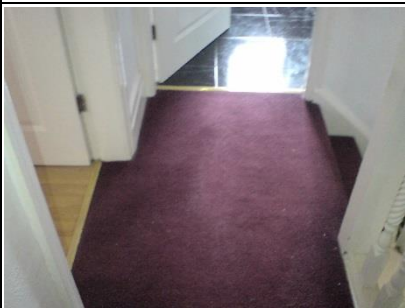
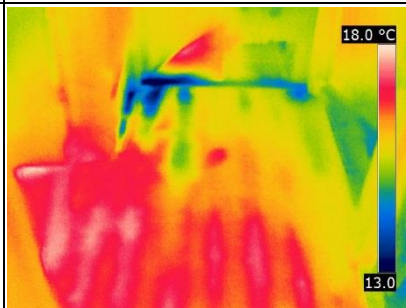
Under depressurisation

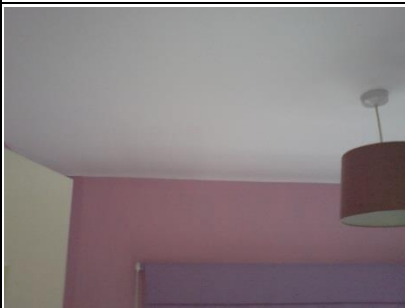
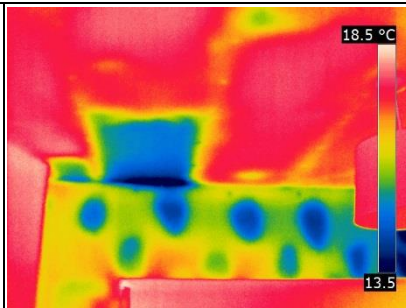
Rear Bedroom (Gable Wall)

Prior to test

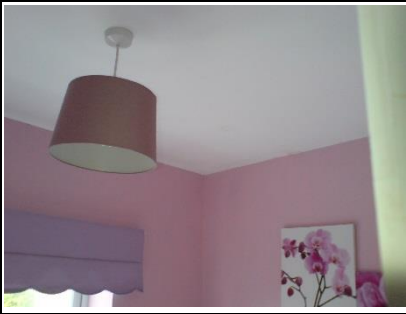
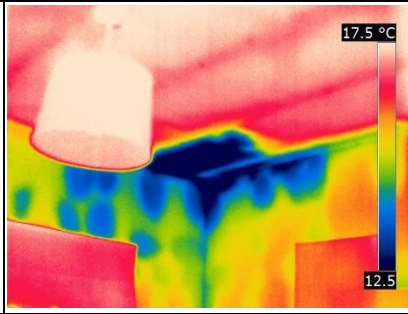
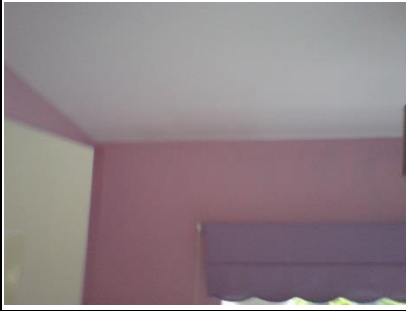
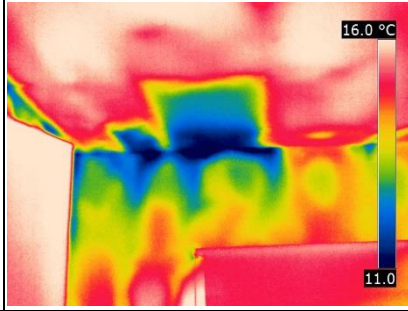
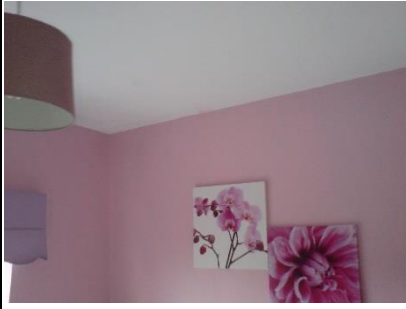
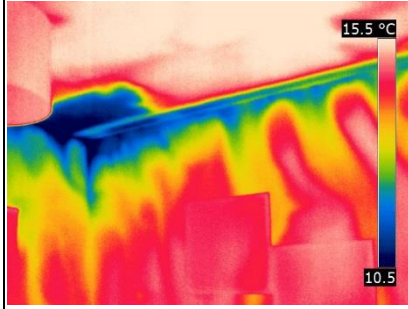
Under depressurisation

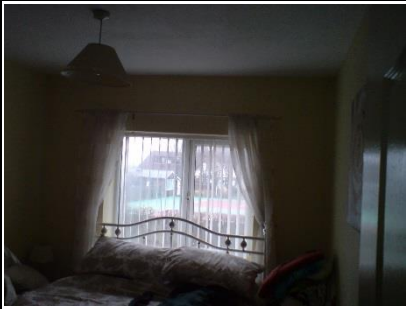
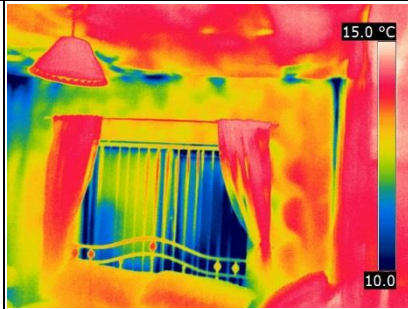
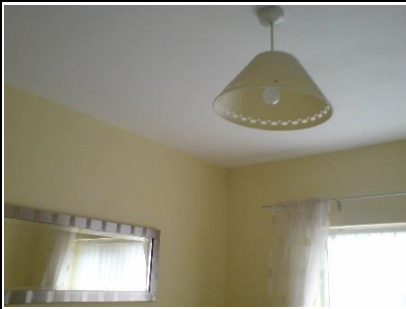
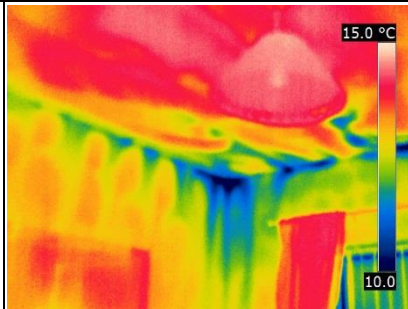
Front Bedroom (Gable Wall)

Under depressurisation

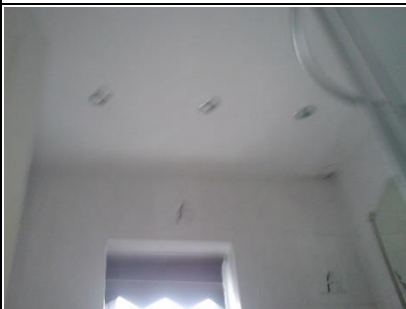
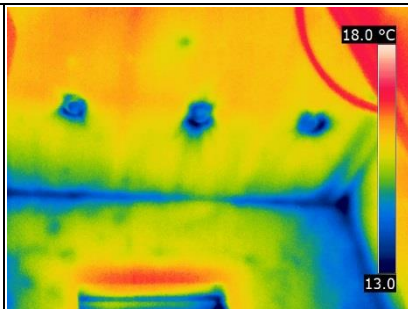
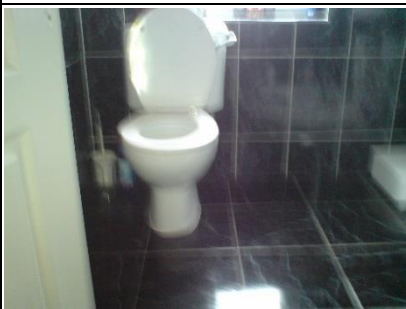
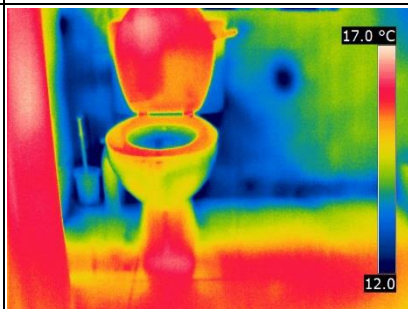
Bathroom

Under depressurisation

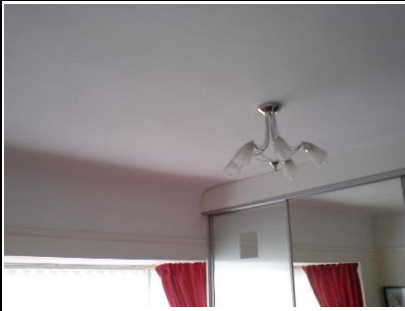
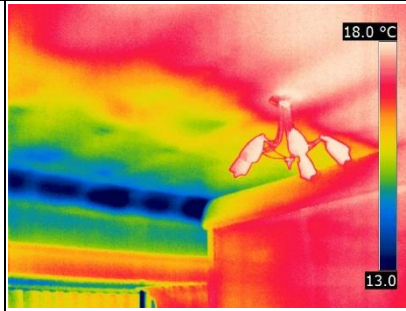
Front Bedroom (Party Wall)

Prior to test

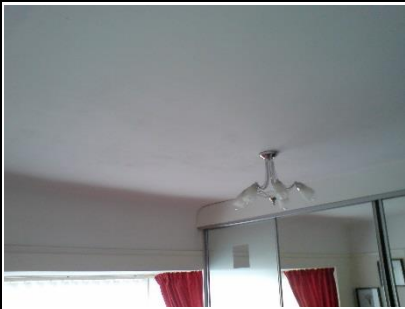
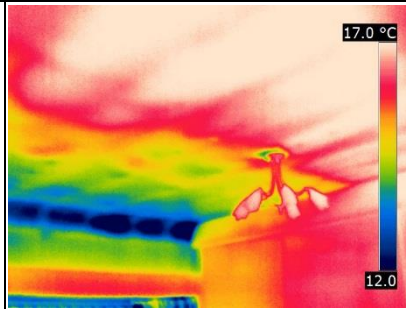
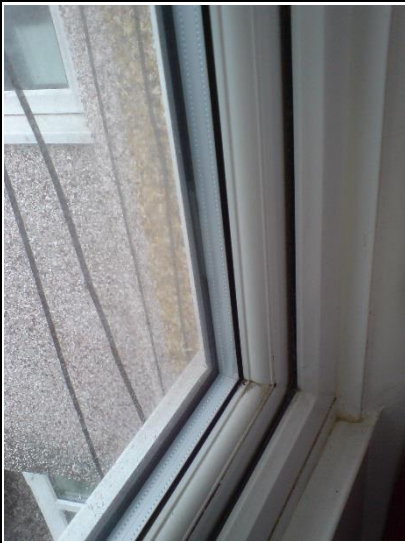
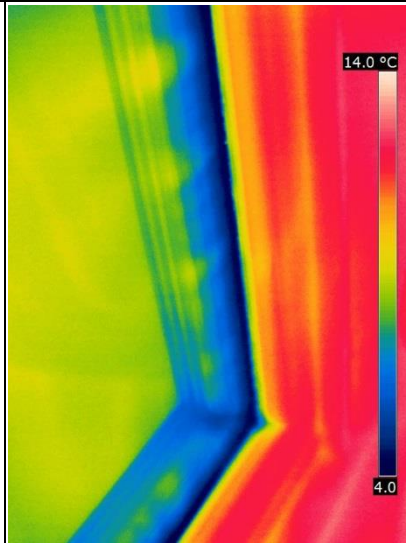
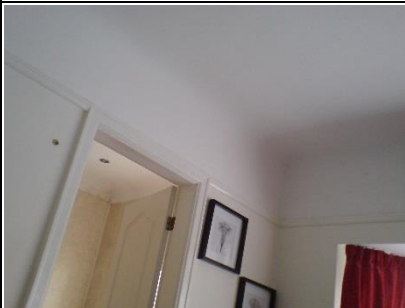
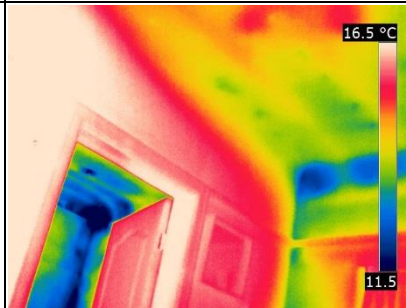
Under depressurisation

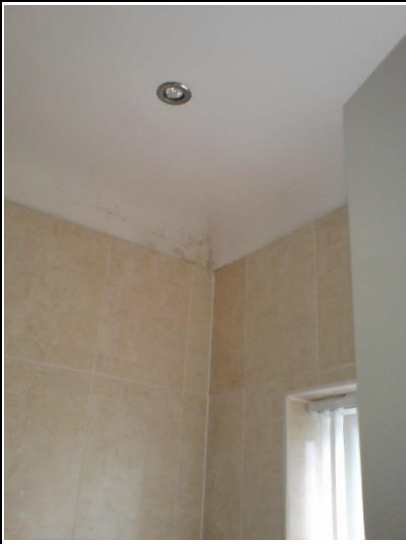
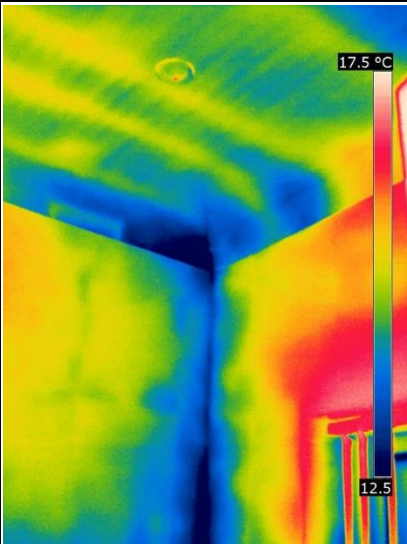
En suite

Prior to test

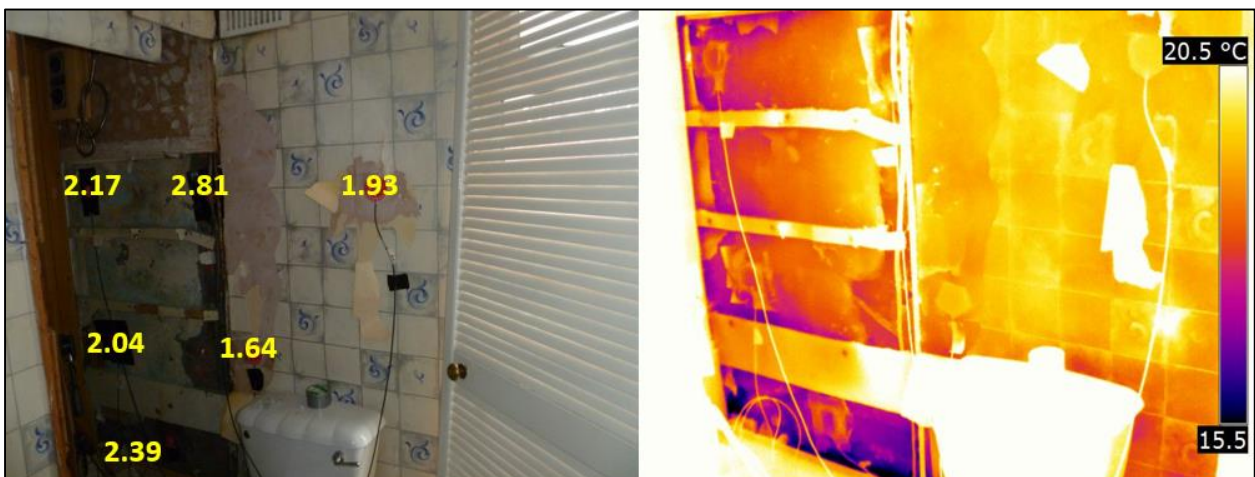
Figure 4: Annotated image and thermogram showing the pre-retrofit external wall U-value measurements. The thermogram in Figure 4 reveals a high level of thermal inconsistency across the pre-retrofit external wall, which is reflected in the large range of *in situ* U-value measurements (1.64 – 2.81 W/m²K). The

The pre-retrofit external wall U-value of 2.08 W/m²K is in reasonable agreement with the RdSAP assumed U-value of 2.10 W/m²K.
