Appendix B. Air tightness test reports

Air tightness test field reports

LEEDS
METROPOLITAN
UNIVERSITY
Leeds Sustainability Institute

Dwelling C-01, before and after retrofit

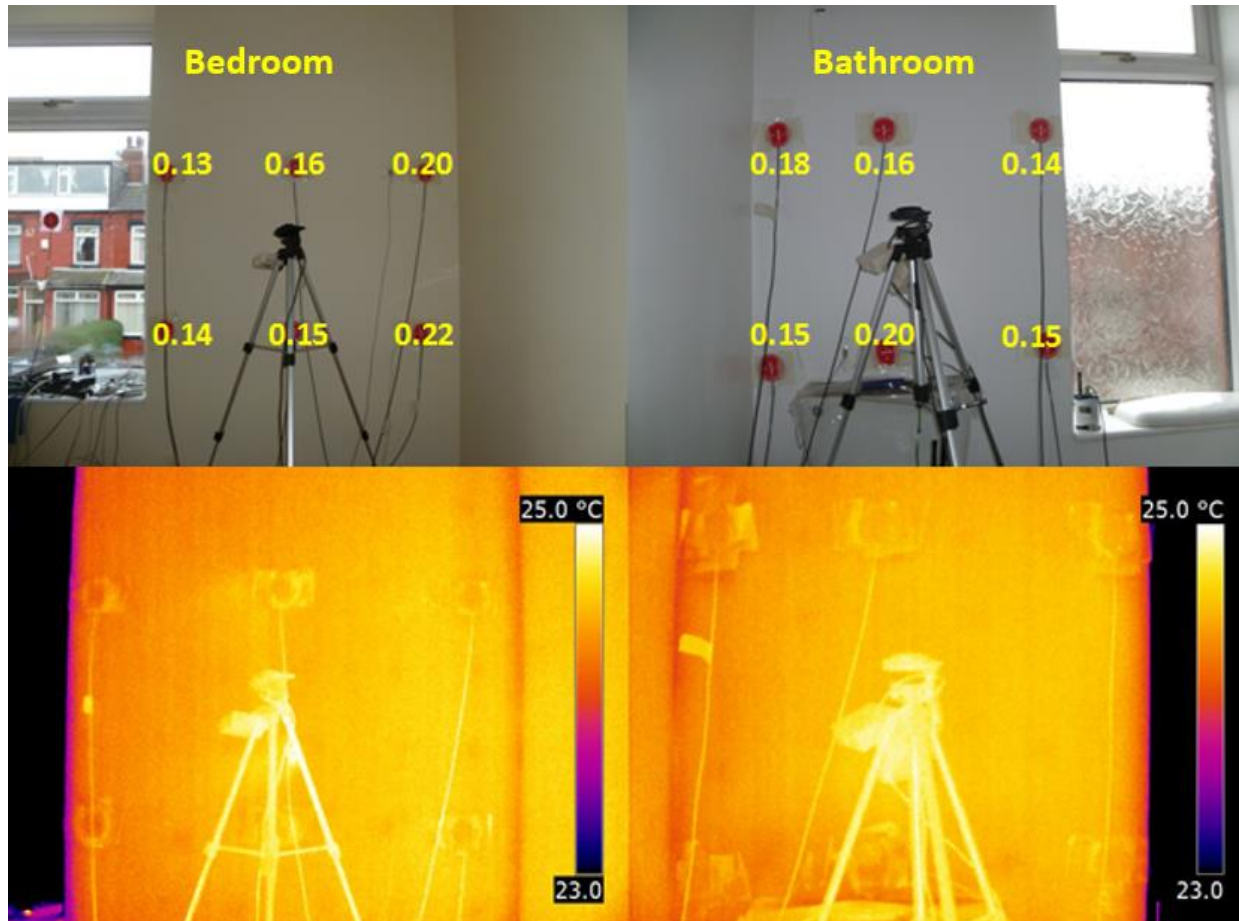
Figure 5: Annotated images and thermograms showing the post-retrofit external wall U-value measurements

The U-values measured close to the reveals are not considered representative of the majority of the external wall locations as they are affected by non-perpendicular heat flow at the jambs.

The thermograms in Figure 5 suggests a very high level of thermal consistency across the measured wall; though the distribution of *in situ* U-values measured seen in Figure 6 shows this not to be the case.

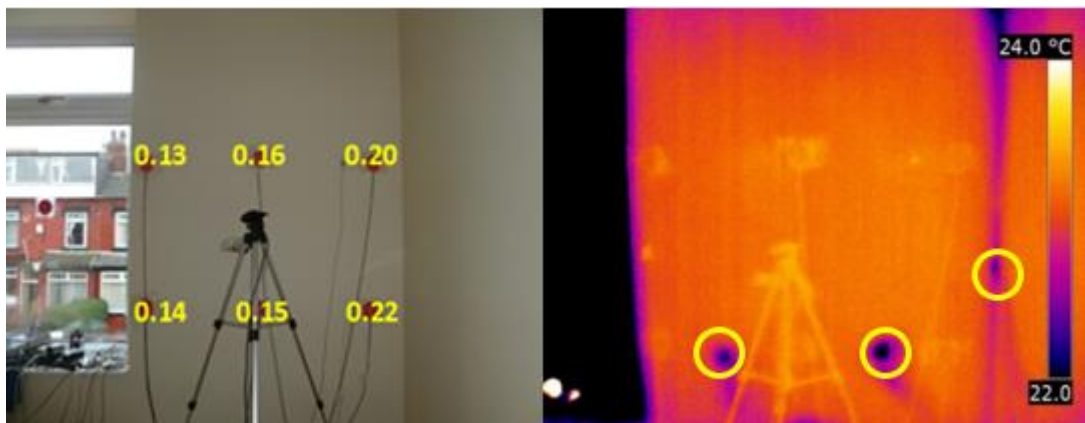
Figure 7 reveals that the location at which the greatest *in situ* U-value was measured is close to a point of air infiltration which was observed when the test house was being artificially depressurised. The movement of cool air around the insulation is a possible cause of the underperformance measured.

Figure 7: Proximity of the greatest post-retrofit external wall *in situ* U-value to air infiltration points observed using thermography during building depressurisation (locations circled)

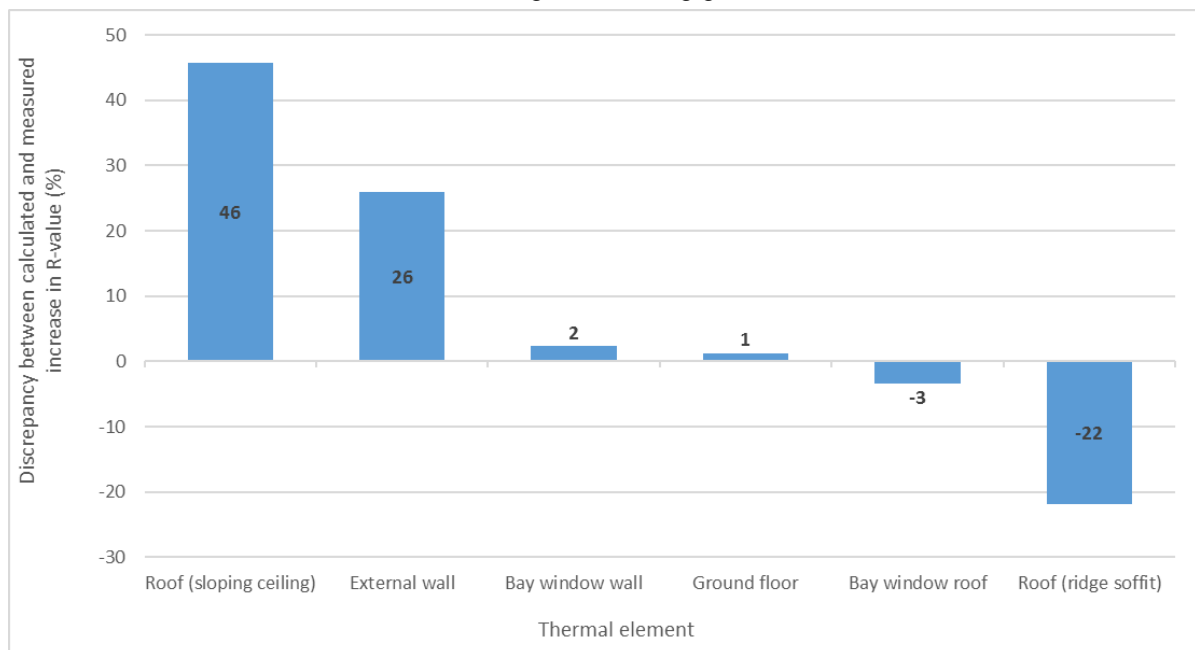
Figure 8 shows that other than the external wall, the thermal element to measure a significant underperformance was the sloping ceiling section of the roof (46%). The reason for this and the measured increase in R-value of the roof at ridge level being greater than that calculated is not known.

Figure 8: Percentage discrepancy between the calculated and measured increase in R-value of the test house's thermal elements

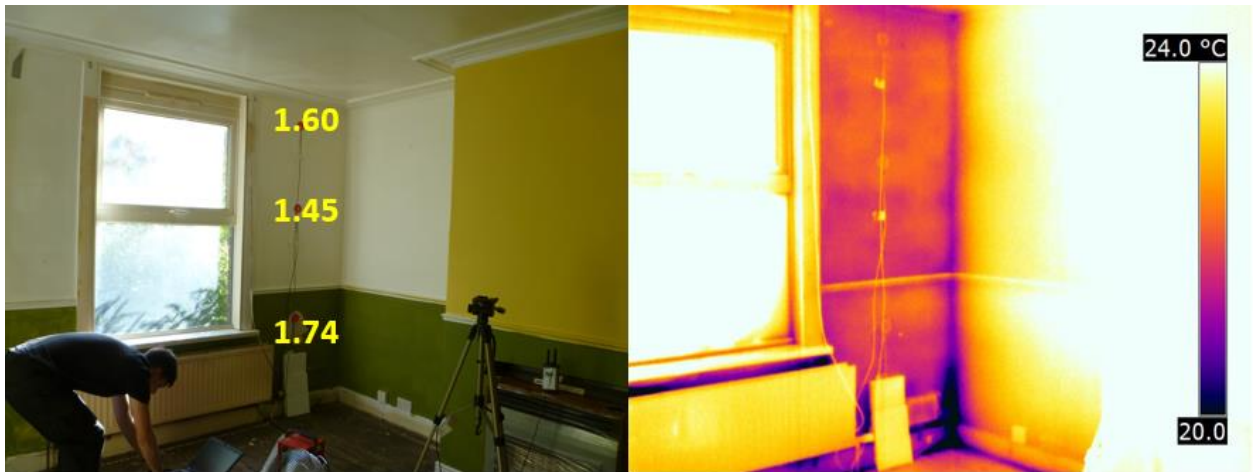
Figure 3: Annotated image and thermogram showing the ground floor pre-retrofit external wall U-value measurements

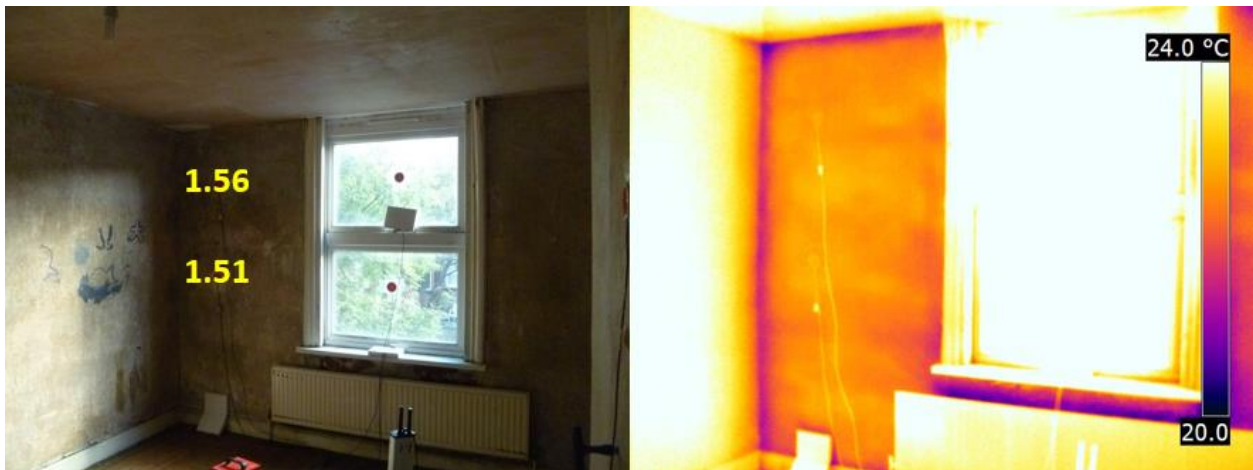
Figure 4: Annotated image and thermogram showing the first floor pre-retrofit external wall U-value measurements

The mean pre-retrofit external wall U-value of 1.57 W/m²K is substantially lower than the RdSAP assumed U-value of 2.10 W/m²K.

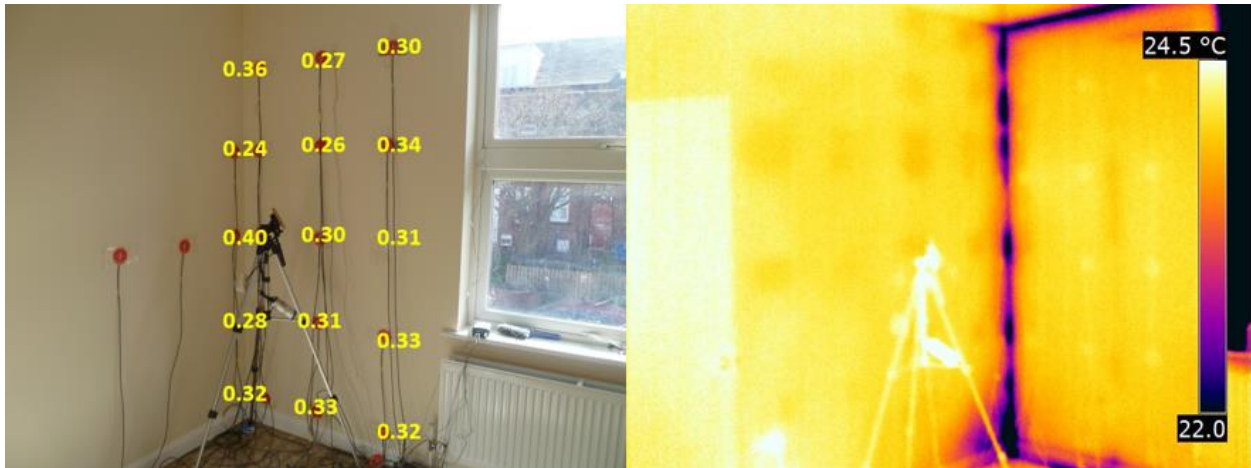
Figure 6: Annotated image and thermogram showing the post-retrofit external wall U-value measurements

The mean of post-retrofit external wall *in situ* U-value measurements is 0.31 W/m²K.

The thermogram in Figure 6 shows a high level of thermal consistency across the measurement area post-retrofit, which was also observed pre-retrofit (Figure 4). Figure 7 shows the post-retrofit external wall *in situ* U-values to be normally distributed. A Shapiro-Wilks test also suggested that the sample is normally distributed (p=0.953). The distribution suggests that the mean external wall *in situ* U-value of 0.31 W/m²K is representative of the measurement area.

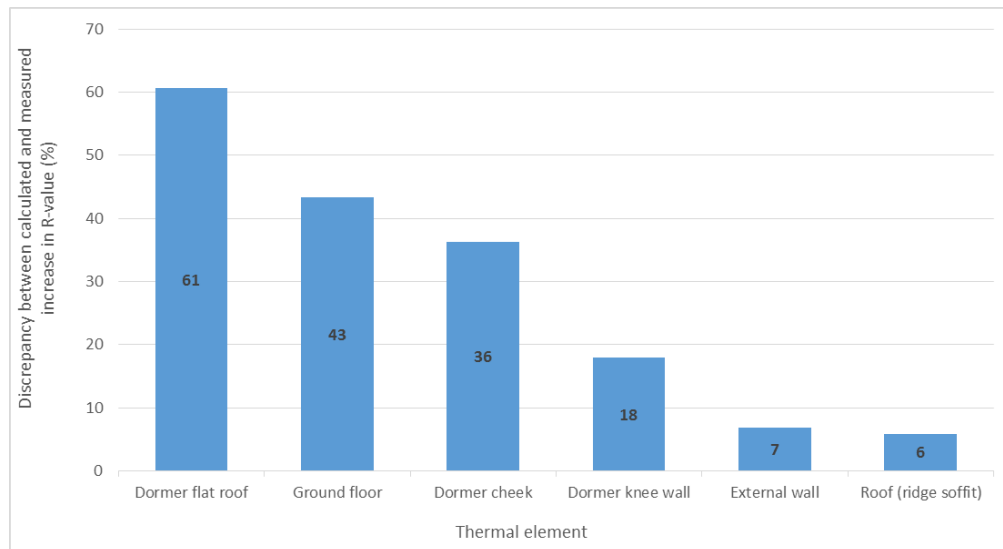
Figure 8: Percentage discrepancy between the calculated and measured increase in R-value of the test house's thermal elements

Figure 8 shows that the only thermal elements retrofitted, where comparable measurements were undertaken pre- and post-retrofit, that did not measure a statistically significant performance gap were the external wall and the roof ridge soffit.

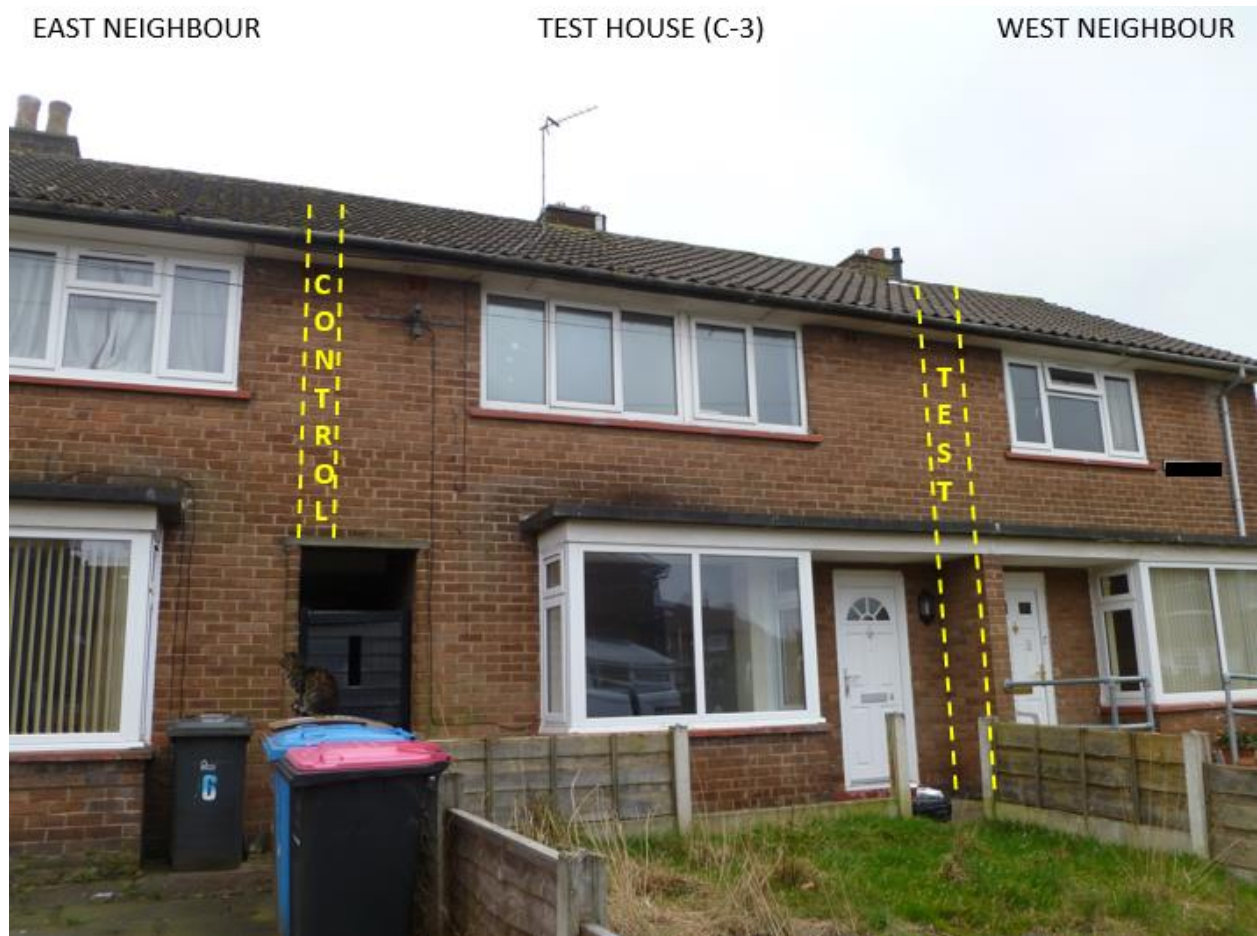
Figure 2: Image of the front of the test house illustrating the location and designation of the party walls

One of the party walls was designated as a control so that any measured change in thermal performance could be ascribed to the retrofit interventions rather than any change in external environmental conditions. Thus, the control wall remained unchanged throughout the test programme. Figure 2 illustrates the identifier of each party wall.

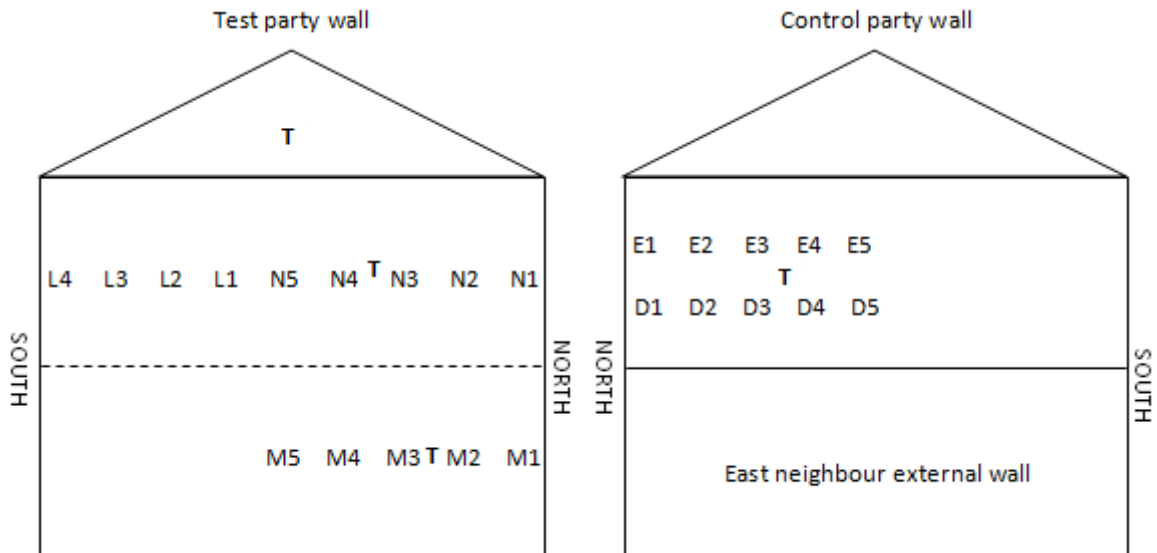
Figure 5 illustrates the location and identifier of the HFPs on the test and control party walls. The internal arrangement of the test house and presence of kitchen units prevented HFP positioning across the entire party wall at ground floor level.

Figure 5: Schematic of HFP locations and identifiers on the party walls of the test house (T denotes location of party wall surface and cavity air temperature measurements)

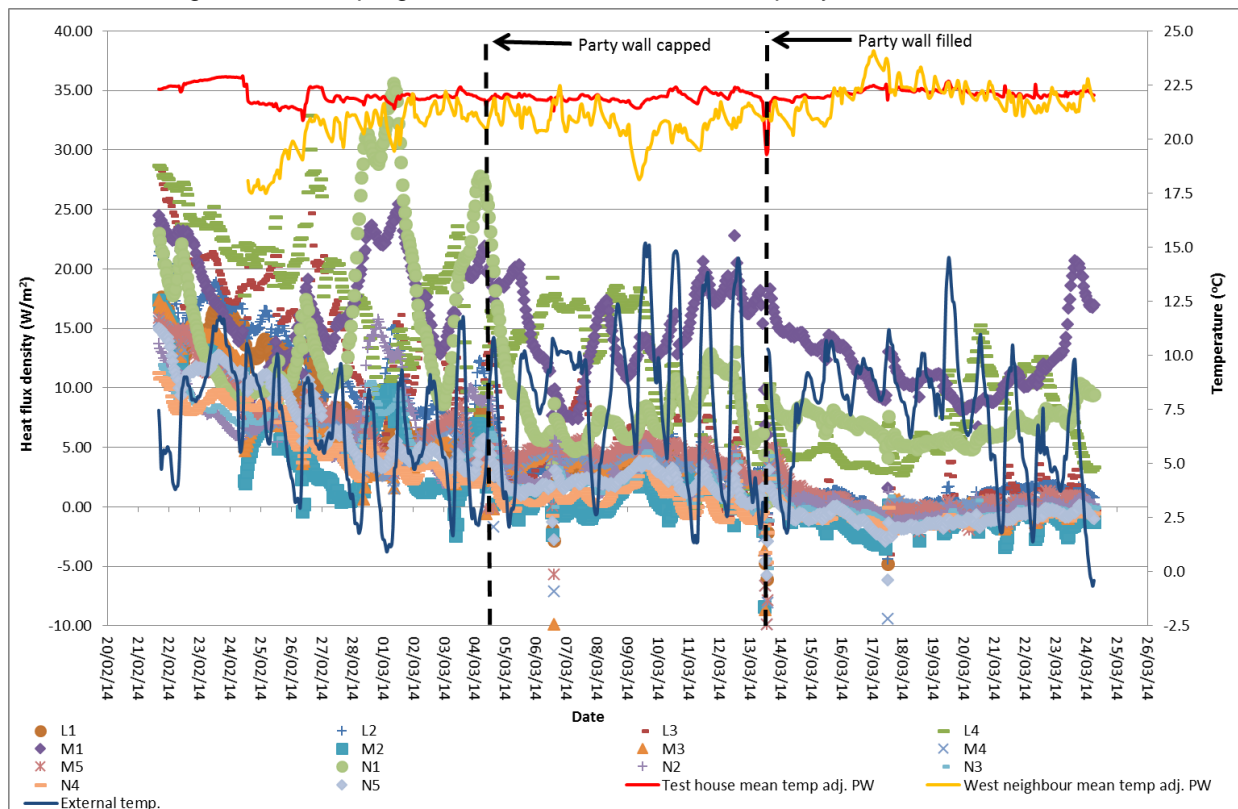
Figure 6: Measured heat fluxes and air temperatures relating to the test wall

The thermal connection between the test house and west neighbour was evident during all test stages when changes in the ΔT between dwellings resulted in a change to the heat flow measured. This was most evident in the capped test stage around 09/03/14 when the air temperature in the west neighbour dropped in relation to the test house, which resulted in a measured increase in heat flow into the test wall. During the filled test stage the west neighbour air temperature rose in relation to the test house around 17/03/14, this resulted in negative heat flow being measured, which signifies heat flow into the test house.

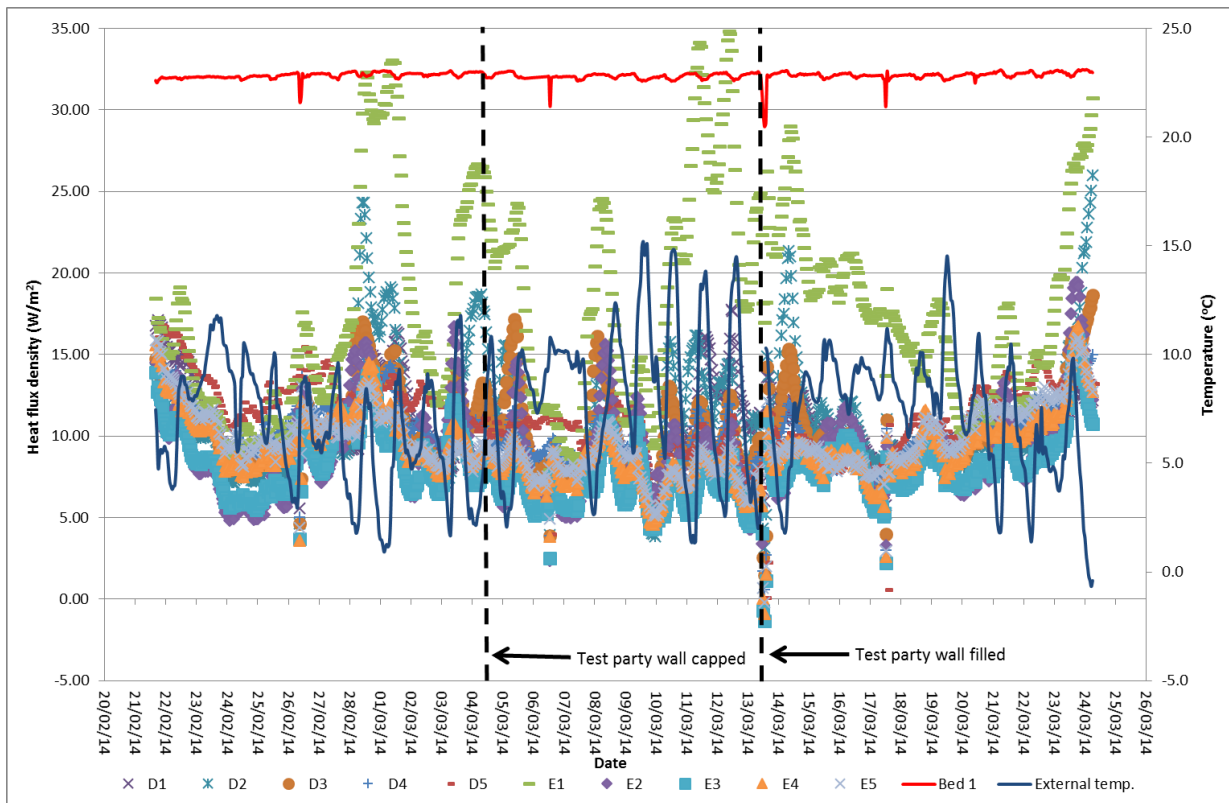
Figure 7: Measured heat fluxes and air temperatures relating to the control wall

As with the test wall, the highest rates of heat flow through the control wall were measured by HFPs at the junction with the external wall (D1, E1). These locations again showed the greatest response to change in external environmental conditions, most notably E1.

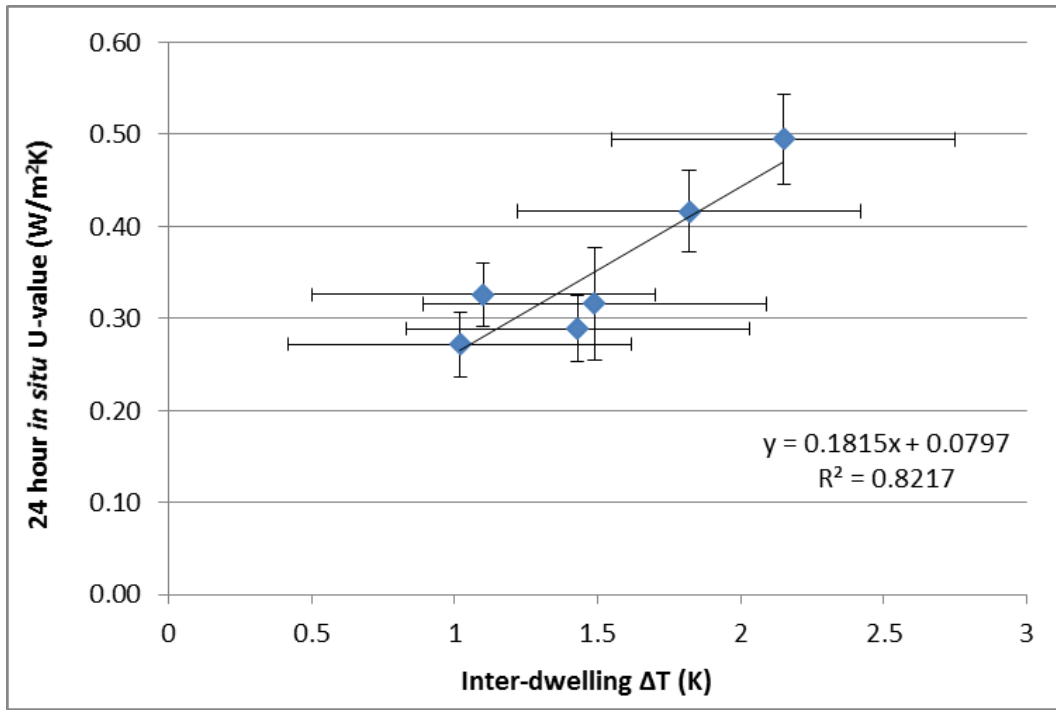
Figure 9: Inter-dwelling ΔT vs. unfilled test wall 24 hour *in situ* U-values

It can be seen in Figure 9 that there is a reasonably strong relationship between the inter-dwelling ΔT and 24 hour U-values. The 24 hour U-value stabilises around 0.30 W/m²K once the ΔT drops below 1.5 K on 28/02/14. Therefore only measured data from 28/02/14 onwards will be used to calculate the unfilled test wall *in situ* U-value. The uncertainty associated with the temperature measurements mean that it is not prudent to use the intercept value of 0.08 W/m²K as the unfilled test wall *in situ* U-value.

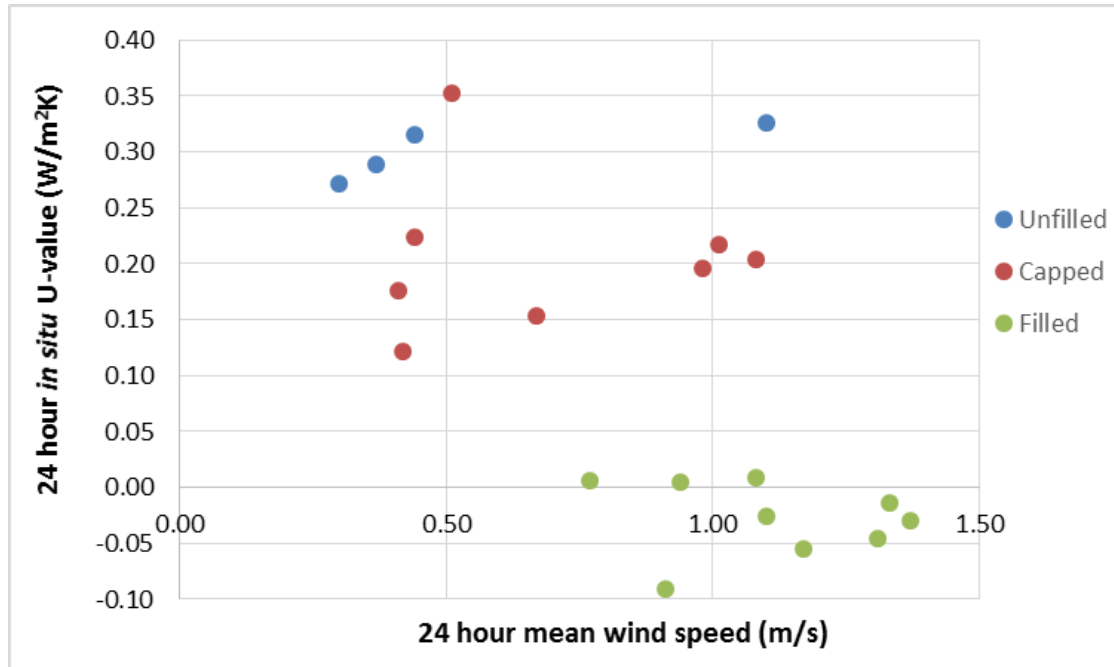
Figure 10: 24 hour mean wind speed vs. test wall 24 hour *in situ* U-values during each test stage

From Figure 10 it is evident that there is a reasonably strong positive correlation ($R^2 = 0.64$) between the 24 hour U-values measured and the mean wind speed during the same 24 hour period during the unfilled test stage. There appears to be no relationship evident following the initial intervention. This could suggest that sealing the test cavity reduced the susceptibility of the test wall to wind driven heat loss. However, the limited number and poor spread of data points mean that no firm conclusions can be drawn as to the effect of wind on the heat loss of the test wall using this analysis technique.

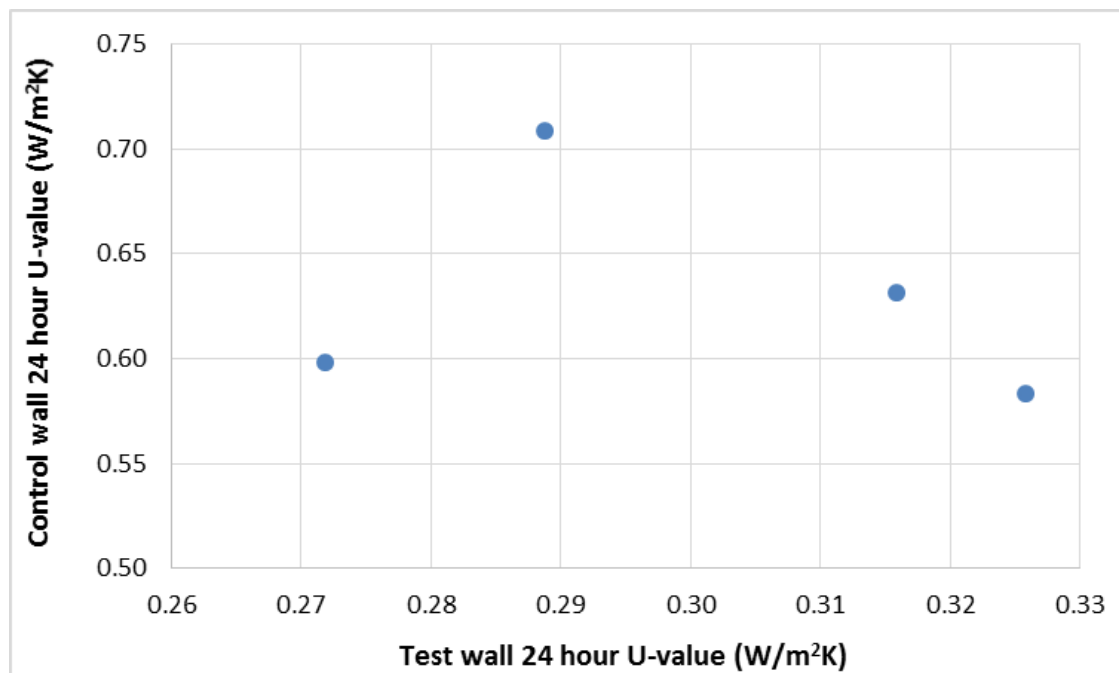
Figure 12: Test wall vs. control wall 24 hour *in situ* U-values during the unfilled test stage

Figure 12 shows there to be no correlation between the test wall and control wall 24 hour *in situ* U-values measured during the unfilled test stage. This shows that that the test and control walls react differently to changes in external environmental conditions over each 24 hour period. The absence of any relationship could also be a symptom of differing heating regimes in each neighbour. The differing reaction of the walls is not surprising given that the control wall: base is suspended in the external environment at first floor height; is a different height, most likely adjoins a neighbour with a variable heating pattern. The difference in behaviour precludes a direct statistical comparison between the two walls in the following test stages.

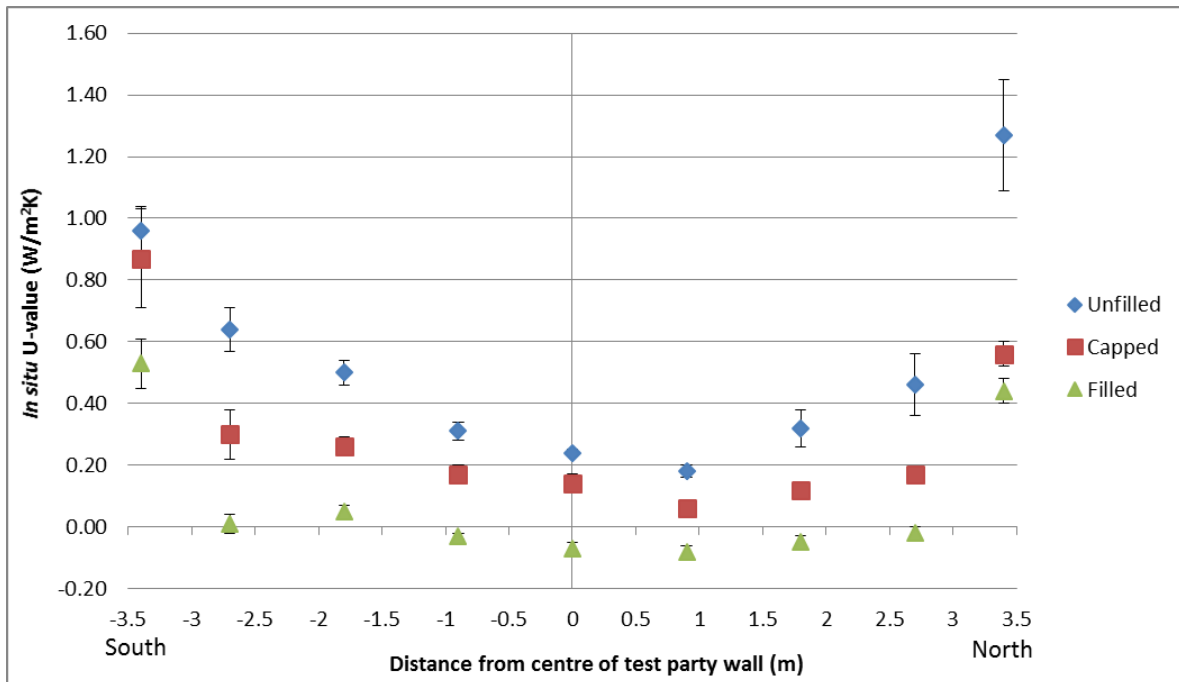
Figure 16: First floor test wall *in situ* U-values during each test stage in relation to location

Figure 16 shows how each successive intervention increases the consistency of the U-values measured across the test wall. The reduction in edge effects is most prominent at the measurement locations 700 mm from the junctions with the external walls. Heat loss across the test wall in the unfilled test stage could be described as asymmetric, with greater heat loss measured at the south of the dwelling (excluding extremities). However, each intervention resulted in the heat loss across the party wall becoming more symmetrical. The negative U-values measured in the filled test stage are thought to be caused by periods of overheating and the presence of heaters close to the party wall in the west neighbour.

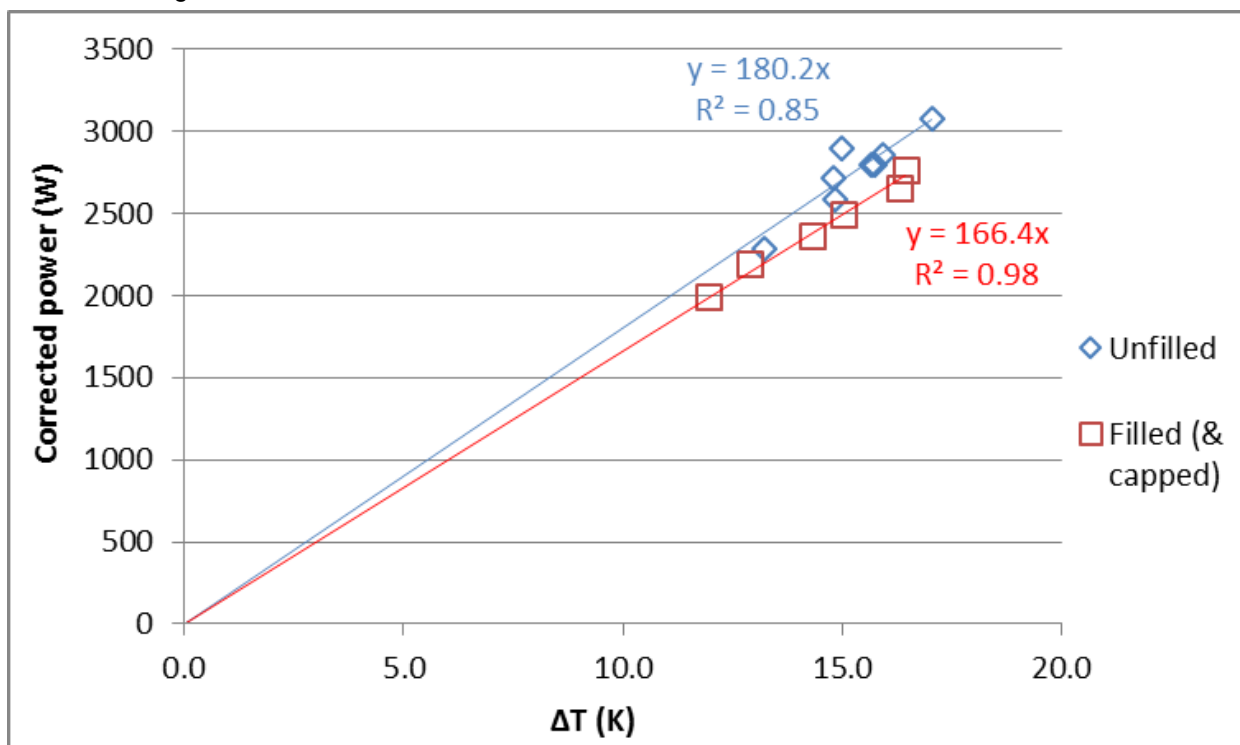
Figure 18: Linear regression HLC estimates for the test house during the unfilled and filled test stages. From Figure 18 it can be seen that the reduction in HLC following the capping and filling of the party wall was 13.8 W/K. The reduction in HLC measured can include both change to the fabric and ventilation heat losses. To isolate the change in fabric heat loss resulting from the filling and capping of the party wall, the change in background ventilation rate must be ascertained.

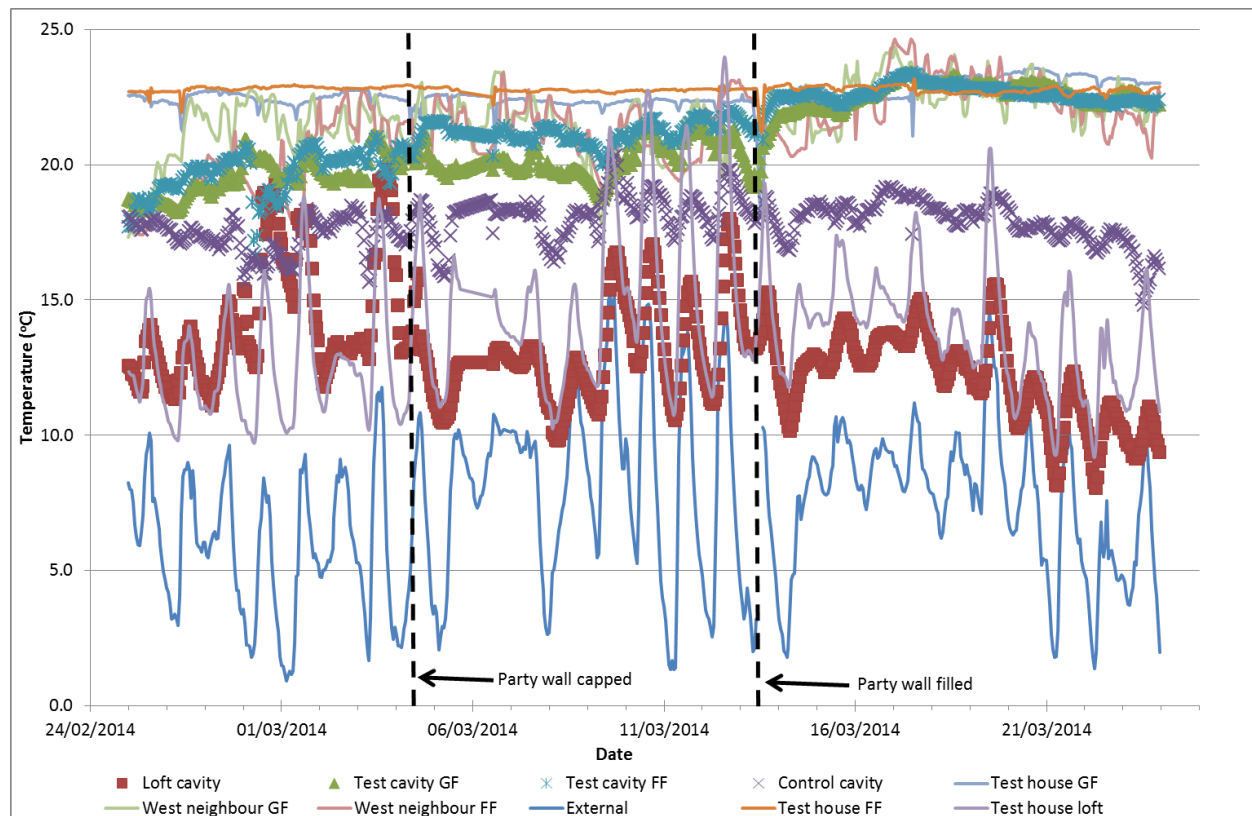
Figure 20: Hourly mean measurements of air temperatures adjacent to the test party wall and within the control and test party wall cavities

The test cavity temperature measured on the ground floor and first floor level became warmer following each intervention to the test wall. During the first two stages the ground floor cavity temperature was lower than that of the first floor; this could indicate stratification within the cavity, or the drawing in of cooler air at the base of the cavity. When the test wall was filled, the party wall cavity temperature became more consistent and was close to that of the surrounding air temperatures within the test house and west neighbour.

The air temperature of the test cavity at loft height was greater than the loft space during the unfilled test stage. It is thought that the elevated temperature in the cavity was caused by warm air rising within the test wall cavity; this suggests the presence of thermal bypass during this period. Following capping of test cavity, the loft cavity air temperature was predominately below that of the loft space. This behaviour suggests that the flow of warm air from below the roof insulation line was ceased following the capping of the test wall cavity.

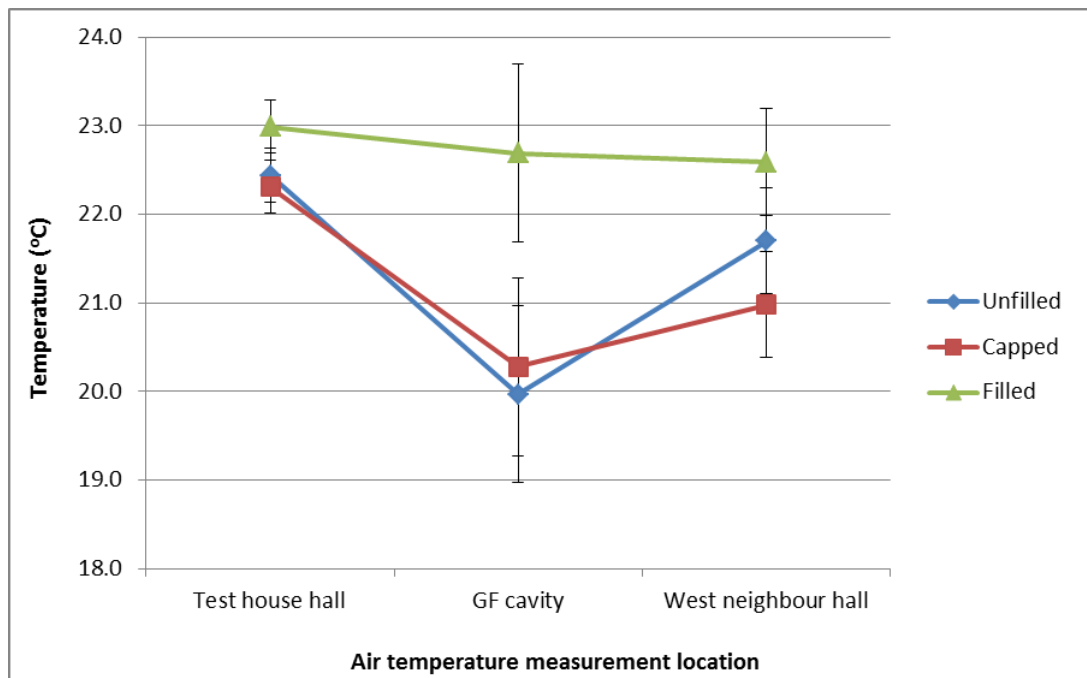
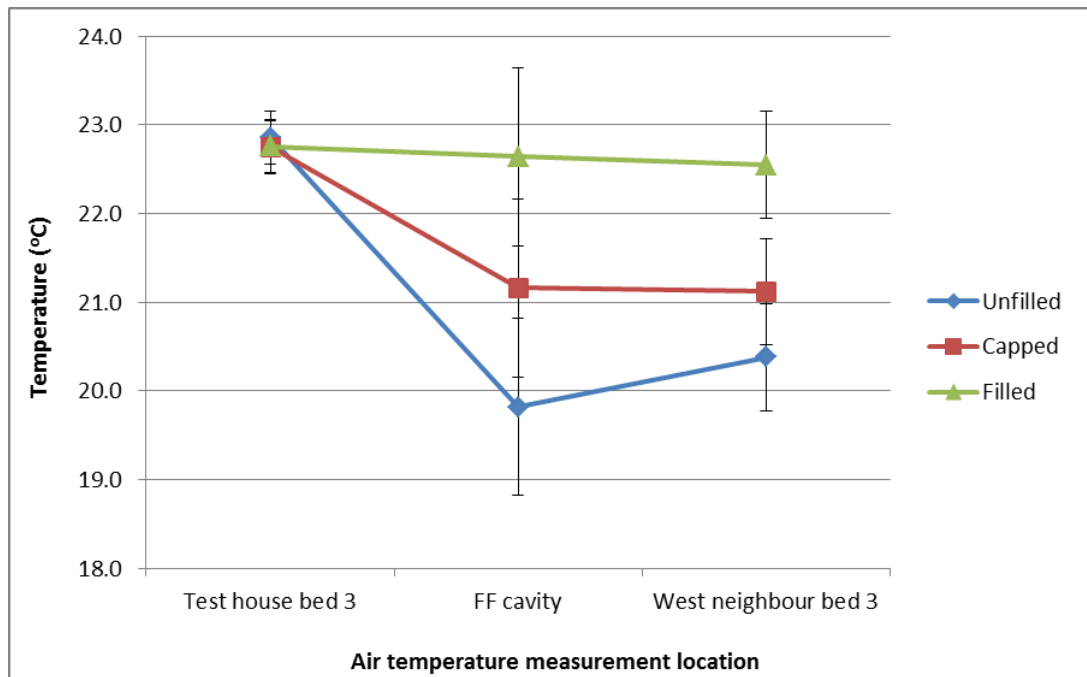
Figure 21: Air temperature measured within, and adjacent to, the test wall on the ground floor

Figure 22: Air temperature measured within, and adjacent to, the test wall on the first floor

The cavity temperatures measured were lower than the habitable spaces either side of the test wall during the unfilled test stage. This indicates cooling of the cavity either through the escape of heat or the infiltration of cold air. The temperature gradient of the capped test wall suggests the cooling mechanism was reduced, but not eliminated, by this intervention.

Following filling of the party wall, the temperature gradient is close to a straight line which indicates that indicates conduction of heat between dwellings, rather than to the external environment. The elimination of the thermal bypass means that the retrofitted party wall can be considered to have a U-value of zero.

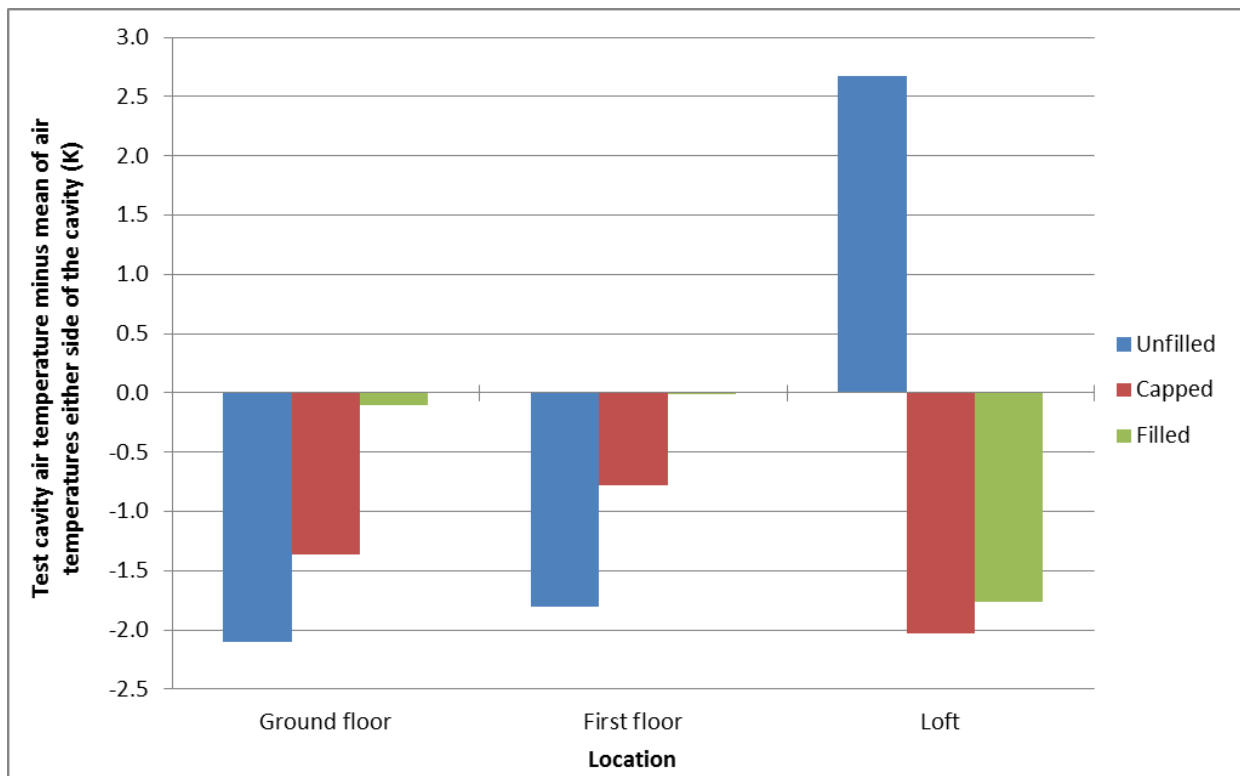
Figure 23: ΔT between air temperatures in test wall cavity and mean air temperature of internal spaces adjacent to the cavity in test house and west neighbour during each test phase⁵

The test wall cavity was cooler than the habitable spaces either side of it during the first two tests indicating the presence of a heat loss mechanism which was only eliminated after the test wall was fully filled.

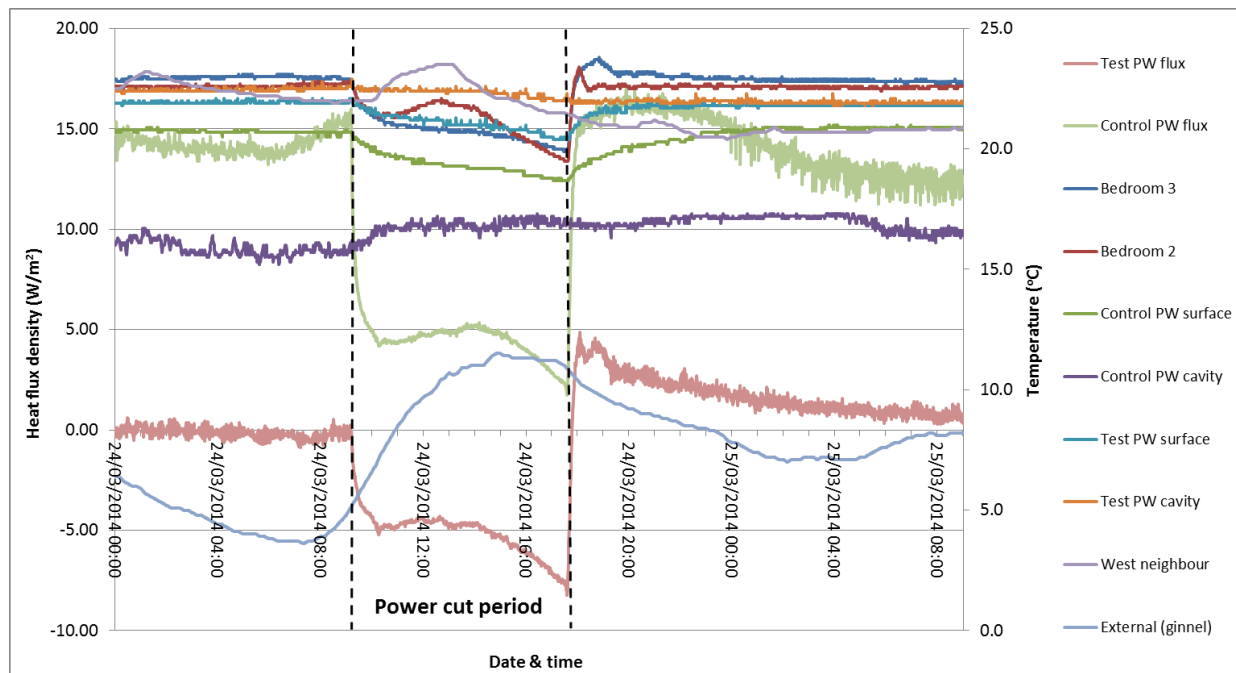
Figure 24: Heat fluxes and associated temperature measurements in the period around the power cut. Prior to the power cut, the surface temperature of the test party wall was below that of the air temperature of bedroom 3. Following the power cut, the surface temperature of the party wall reduced less rapidly than the air temperature, and after a period of approximately half an hour in duration, the air temperature had dropped to below that of the party wall surface, this continued for the remainder of the power cut period. The temperature within the filled party wall cavity remained greater than the air temperature throughout the entire power cut. Heat flow measured on the test party wall throughout this period was negative (into the building), which signifies the release of stored heat back into the bedroom 3.

The surface and cavity air temperatures of the control party wall remained lower than the air temperature of bedroom 2 throughout the entire period of the power cut. The heat flow measured on the control party wall remained positive (out of the building) throughout the entire period; though the rate of heat flow into the control party wall slowed as the ΔT between bedroom 2 and the empty cavity reduced.

It must be noted that some of the heat flow measured into bedroom 3 from the test party wall could have also been a result of inter-dwelling heat transfer. Further investigation is required to disaggregate from the measured heat flow the contribution of stored heat release and inter-dwelling heat transfer.

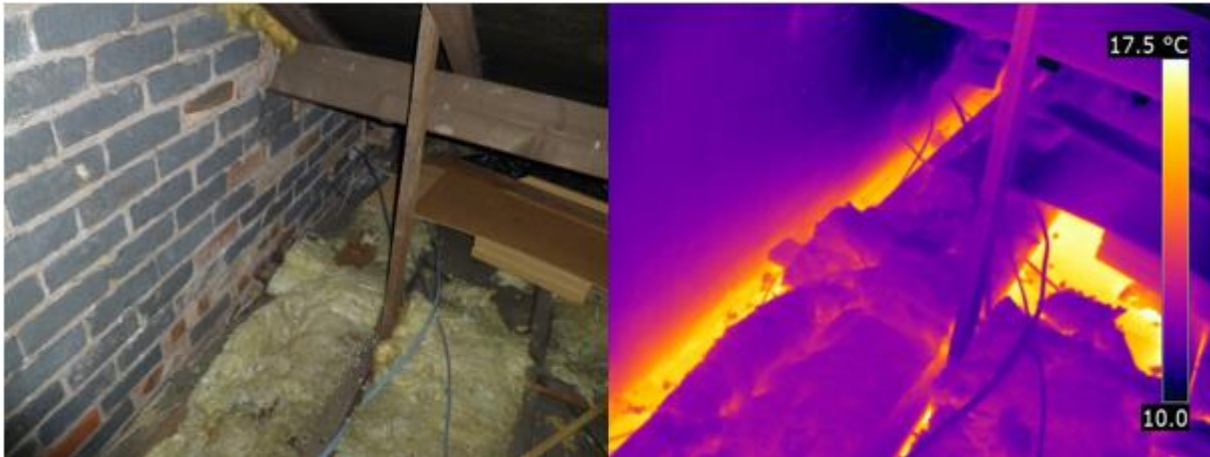
Figure A1 shows the inconsistency with the placement of the pre-retrofit loft insulation in the test house loft above bedroom 3. It is evident in Figure A1 that the greatest heat loss observed in the thermogram corresponds with missing insulation between the second pairing of ceiling joists from the party wall.

Figure A1: Image and thermogram of the loft space above bedroom 3 prior to retrofit showing poorly fitted and missing roof insulation

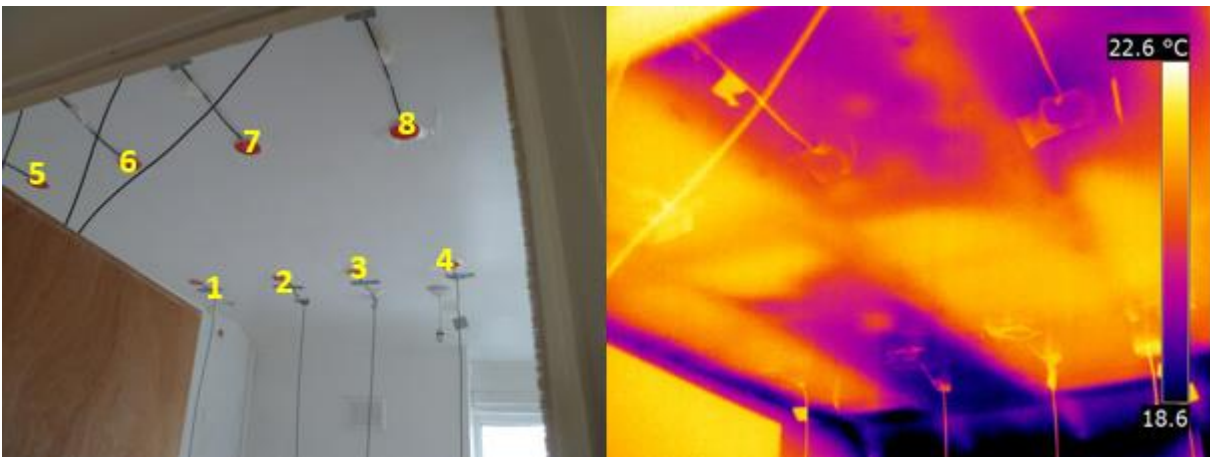
Figure A2 shows how the areas of missing insulation in the loft space seen in Figure A1 correspond with the cold areas of ceiling in bedroom 3. The thermal inconsistencies evident in the thermogram in Figure A2 are typical of what was observed across the first floor ceiling of the test house pre- retrofit.

Figure A2: Image and thermogram of the ceiling in bedroom 3 prior to retrofit. Numbers 1-8 are the roof HFP identifiers.

There are two distinct bands of pre-retrofit U-value measurements evident in Figure A6. The highest U-values measured correspond to the HFPs at the locations of greatest heat loss seen in Figure A2.

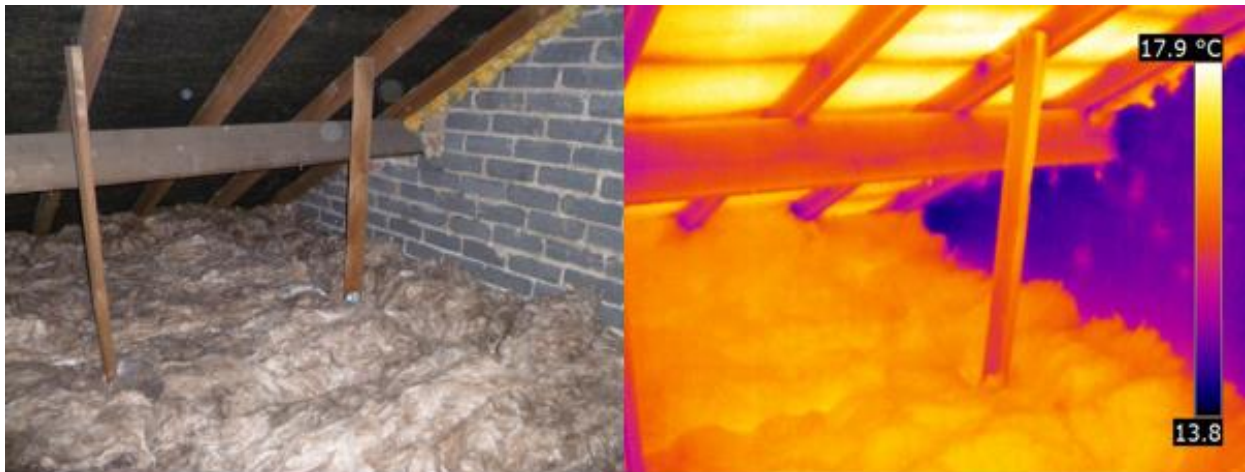
It can be seen in Figure A3 that the retrofit loft insulation was correctly installed resulting in a higher level of thermal consistency.

Figure A3: Image and thermogram of the loft space with the retrofit loft insulation fitted

Following the main party wall investigation the existing (pre-retrofit) loft insulation was removed and replaced (retrofit) with 300 mm of glass mineral wool quilt ($\lambda = 0.044 \text{ W/mK}$). Measurements of thermal performance continued to be taken. All pre-retrofit values stated were measured during the filled test stage of the party wall investigation.
