Appendix B. Air tightness test reports

Air tightness test field reports

LEEDS
METROPOLITAN
UNIVERSITY
Leeds Sustainability Institute

Dwelling C-01, before and after retrofit

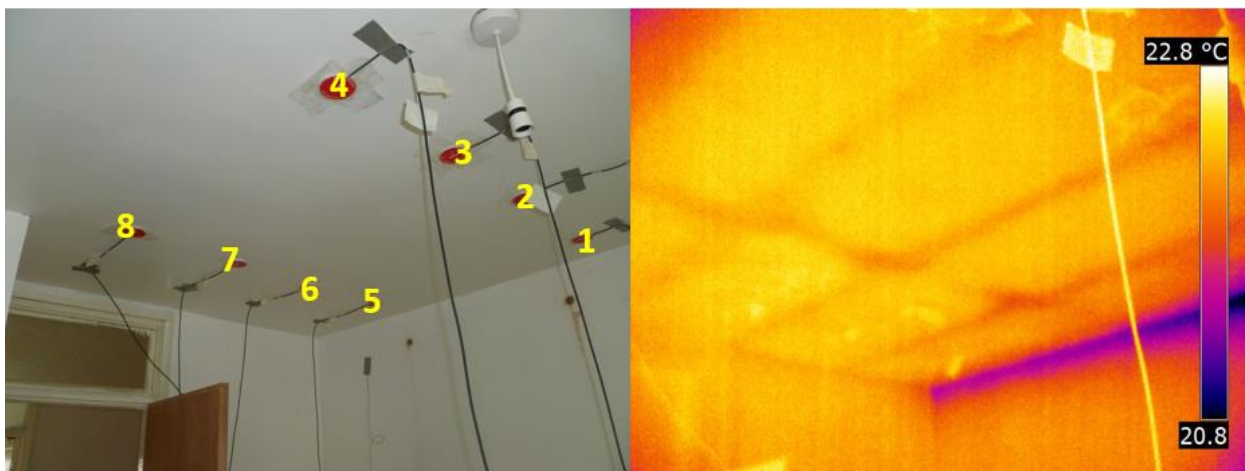
The 2 K temperature span in the thermogram of the ceiling in bedroom 3 seen in Figure A4 shows a high level of thermal consistency across the ceiling following the installation of the retrofit loft insulation.

Figure A4: Image and thermogram of the ceiling in bedroom 3 post-retrofit. Numbers 1-8 are the roof HFP identifiers.

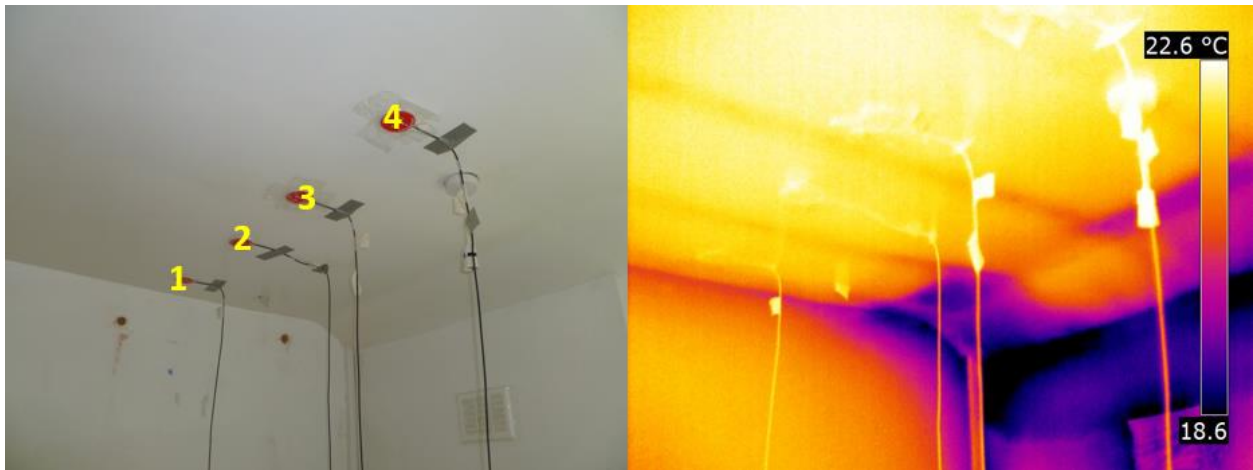
Figure A5 shows homogenous surface temperatures on the ceiling of bedroom 3 post-retrofit. This region that was previously characterised by a high level of thermal consistency, notably in the region of roof HFP2 (refer to Figure A2).

Figure A5: Image and thermogram of the ceiling in bedroom 3 post-retrofit. Numbers 1-4 are the roof HFP identifiers.

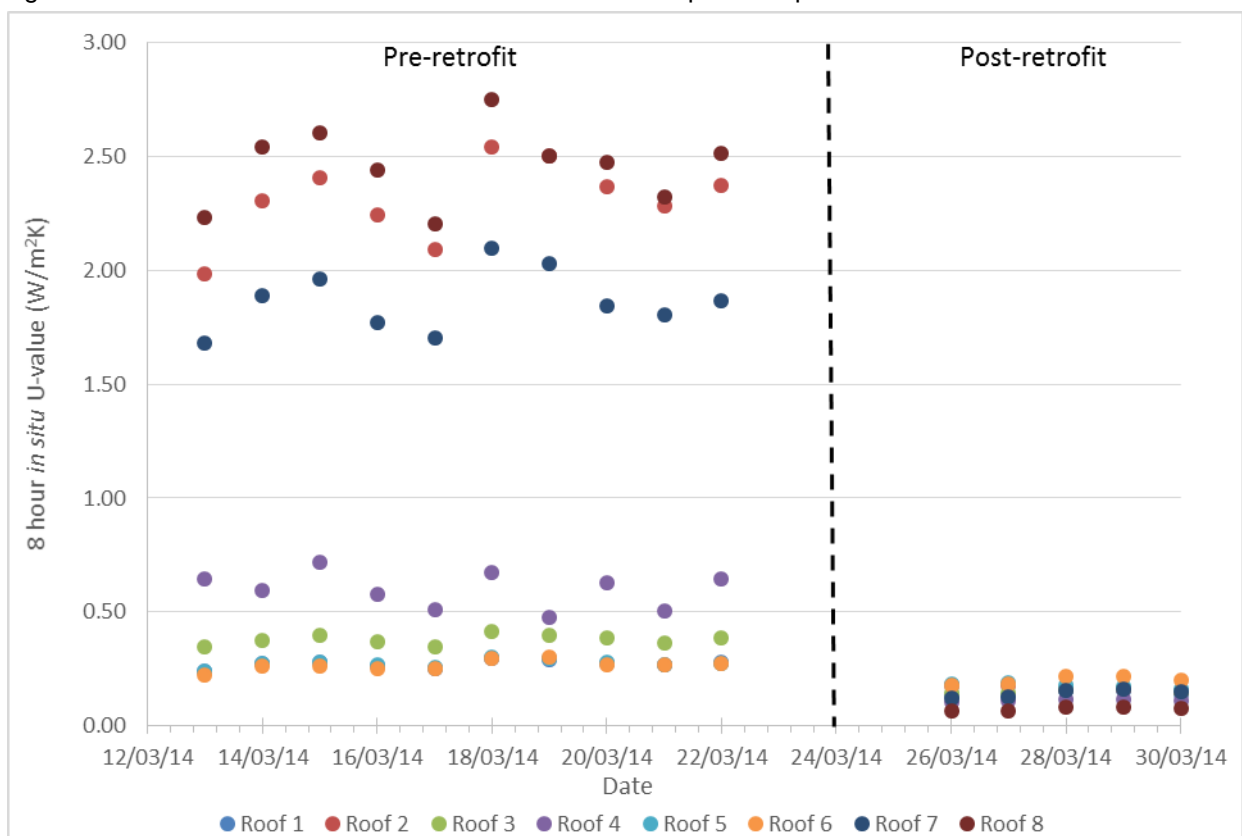
Figure A6: 8 hour *in situ* U-values measured pre- and post-retrofit for the test house roof

There are two distinct bands of pre-retrofit U-value measurements evident in Figure A6. The highest U-values measured correspond to the HFPs at the locations of greatest heat loss seen in Figure A2.

The HFP positioning on the pre-retrofit ceiling was not random in nature and the distribution of U-values measured pre-retrofit cannot be considered representative of the roof as a whole. The high level of thermal consistency observed on the first floor ceiling means that there can be some confidence that the mean post-retrofit roof U-value (excluding ceiling joists) 0.15 (± 0.01) W/m²K can be considered representative.

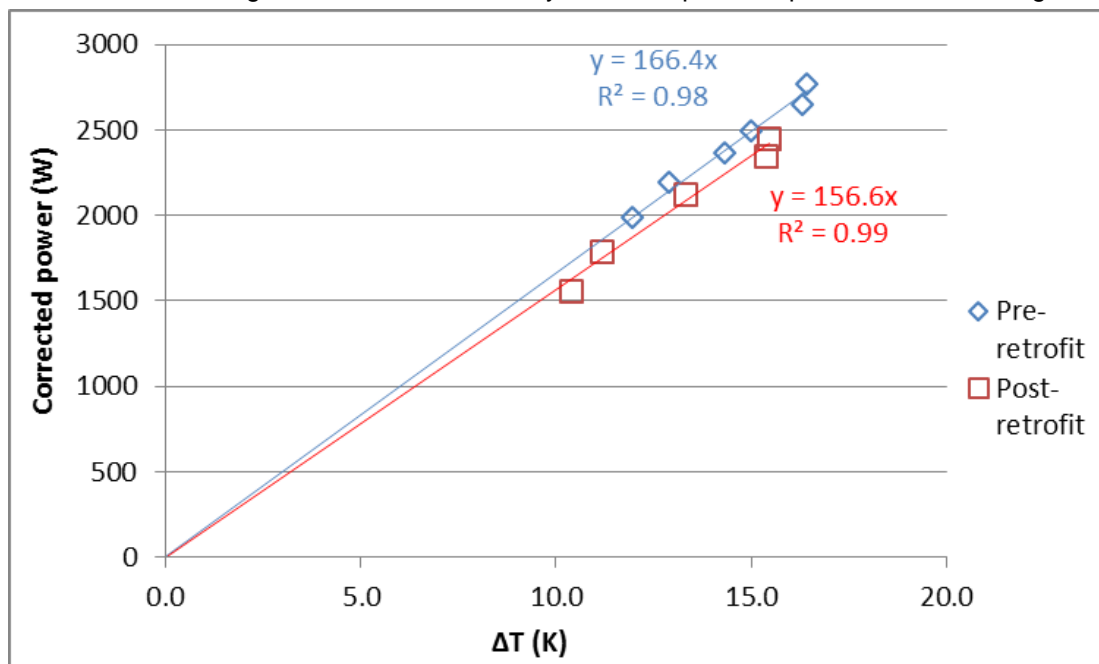
Figure A7: Linear regression HLC estimates for the test house pre- and post-retrofit of the roof. The post-retrofit coheating test measured a HLC of 156.6 (± 8.5) W/K⁶. The coheating test result must be treated with caution. Although there was a high R² correlation for regression neither the solar or wind

All values associated with the post-retrofit coheating test result in Table A2 must be treated with caution due to the high level of uncertainty associated with the test result.

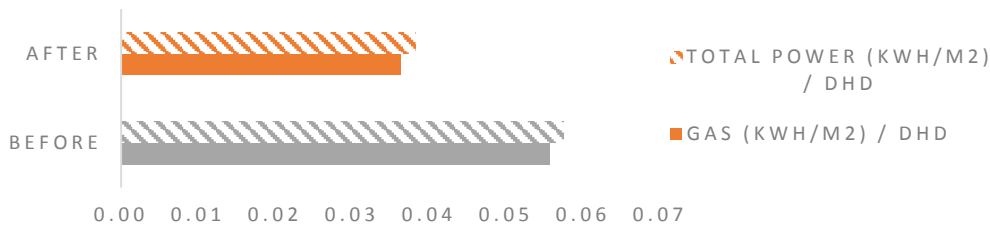
1. **Summary;** Data suggests a 37% energy reduction and £140 annual heating bill saving

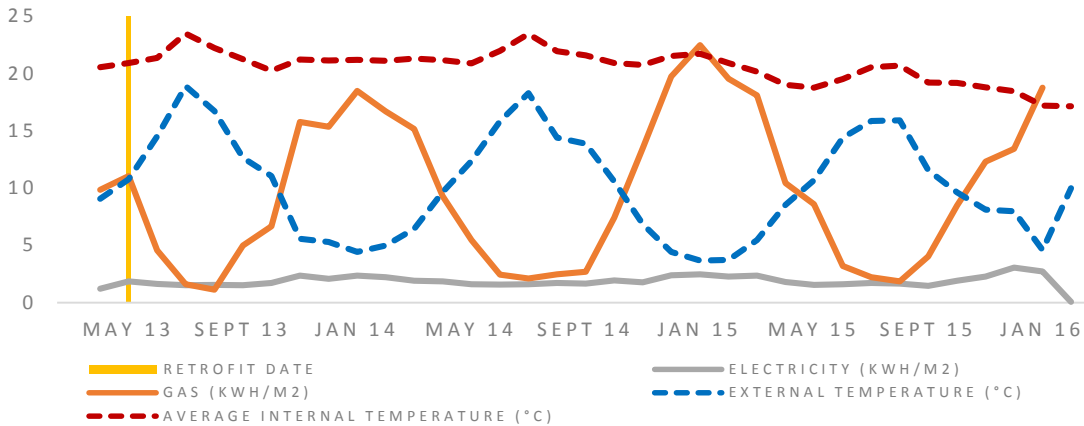
2. **Data quality;** OK, but the *before* period is very small so uncertainty is high

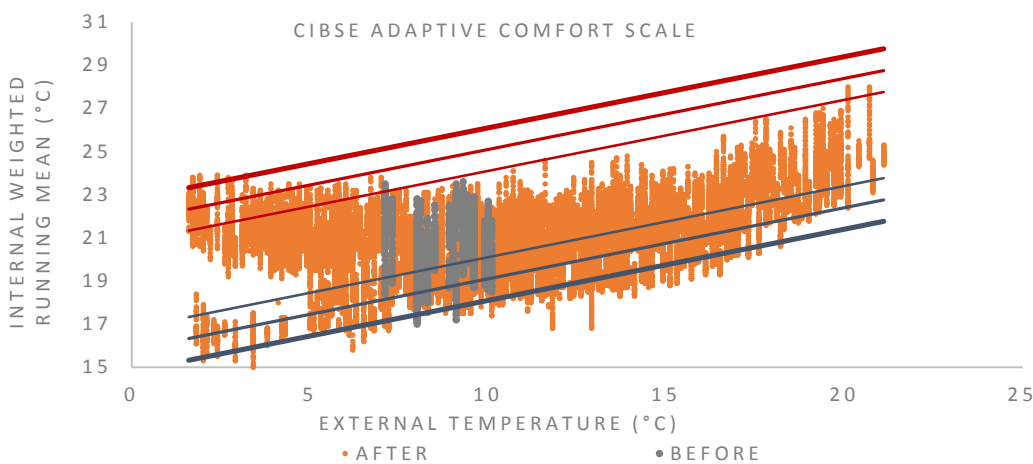
3. **Comfort;** Dwelling appears comfortable, before data is not substantial

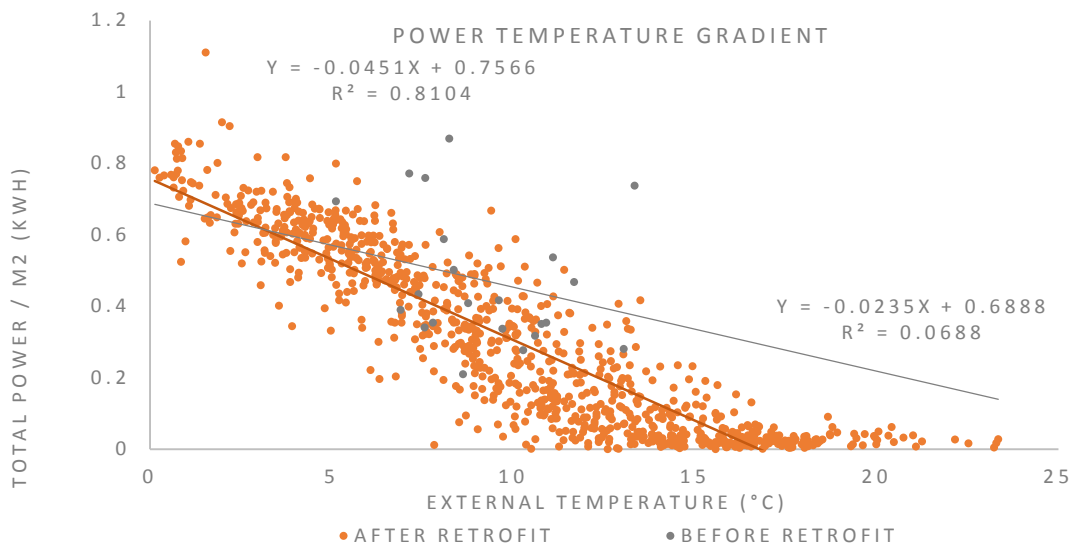
4. **Retrofit performance;** More energy is used when it is cold outside

- thermal bridging at front eaves and ground floor
- insufficient roof insulation
- insulation cut-outs made for services and drains

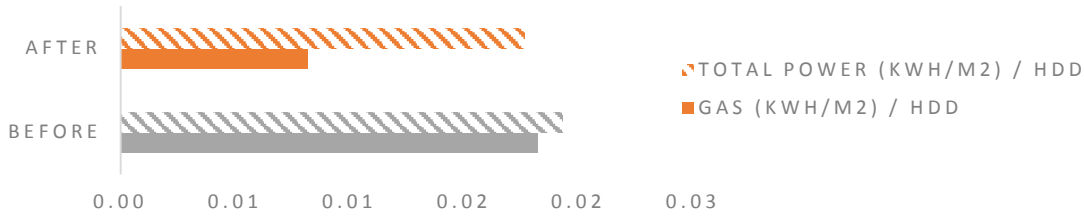
1. **Summary;** Data suggests a 55% heating energy reduction and £69 annual saving

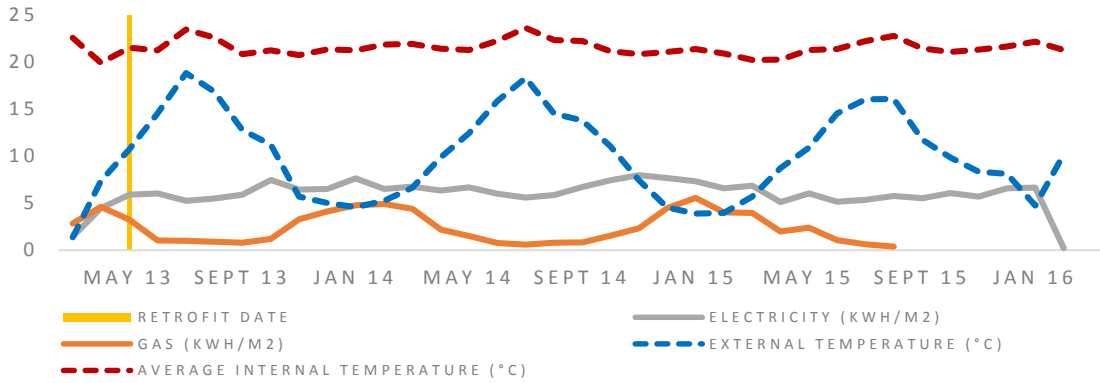
2. **Data quality;** Gas drops out and limited *before* data, leading to high uncertainty

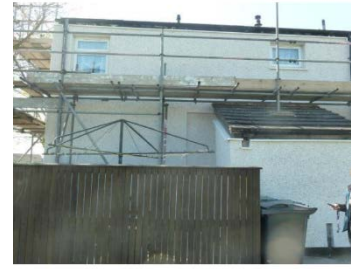
Property E2

Survey observations:

- thermal bridging at front eaves and ground floor
- insufficient roof insulation
- insulation cut-outs for services and drains

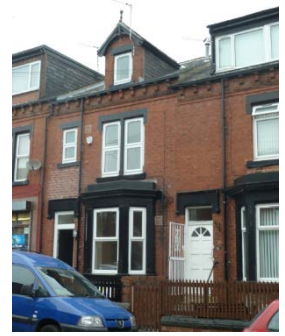
Property E4

Survey observations:

- No insulation at stairs between basement & upper floors
- no insulation at junction of intermediate floor:wall
- party wall returns not insulated

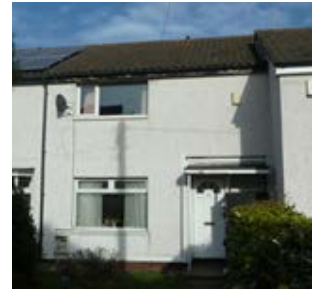
Property E7

Survey observations:

- thermal bridging at front eaves and ground floor
- insufficient roof insulation
- insulation cut-outs for meter-box
- new tenant (May 2015) has condensation

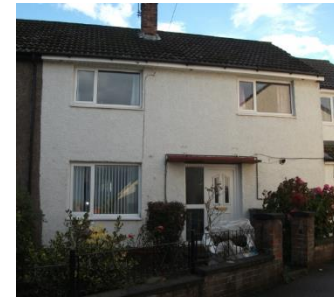
Property E9

Survey observations:

- thermal bridging at eaves and ground floor
- insufficient roof insulation
- no EWI to 2 recent extensions
- thermal bridge shows at junction between EWI treated wall/extension

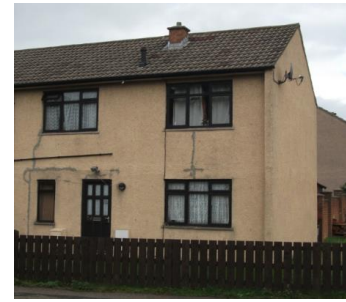
Property E10

- panel construction needs special insulation design to avoid complete thermal bridging
- additionally EWI would require additional roof works and below DPC insulation to avoid thermal bridging at eaves and ground floor

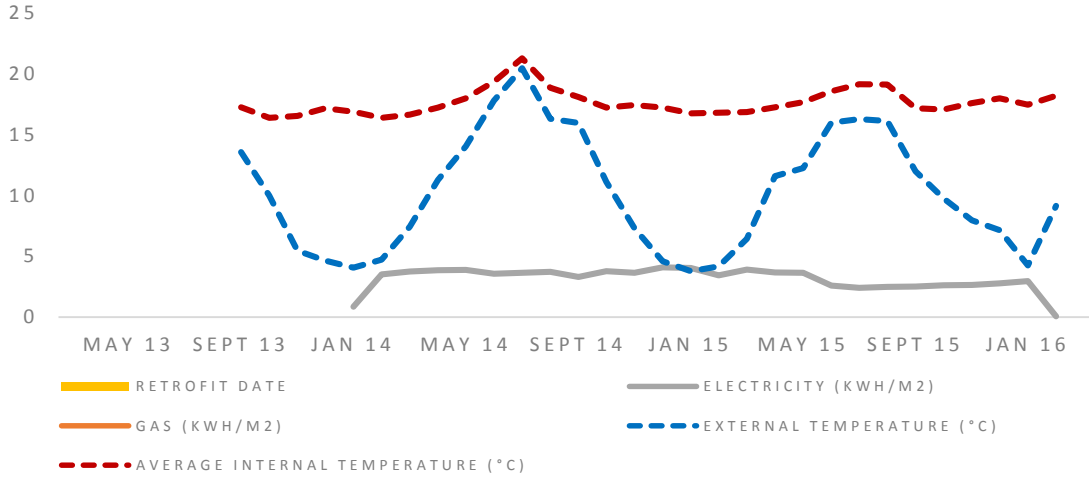
- Summary;** Retrofit did not take place
- Data quality;** No gas data since a smart meter was installed

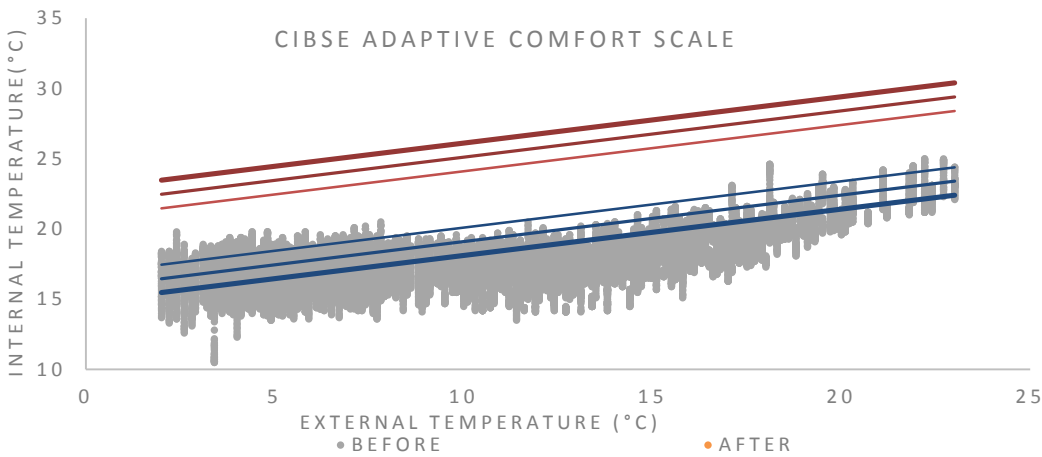
- Comfort;** Dwelling appears cold and under heated, but only one sensor working

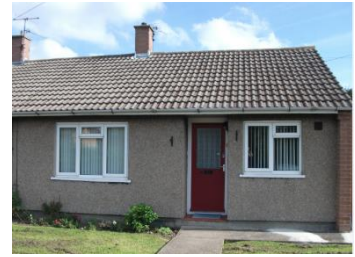
Property E11

- EWI would require additional roof works and below DPC insulation to avoid thermal bridging at eaves and floor
- additional works would be required at windows as minimal cills
- additional works for rear flat roofed extension

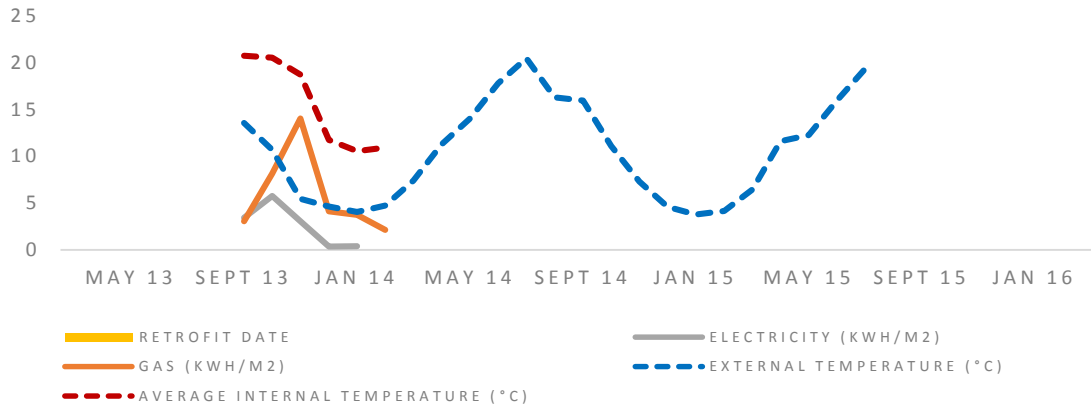
2. **Data quality;** Sensor failure for gas, electricity and internal temperature

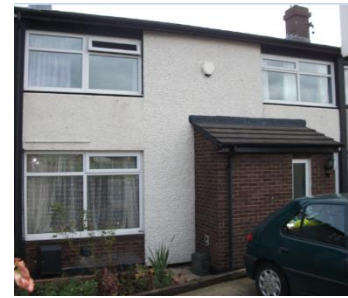
Property E12

- EWI requires additional roof works and below DPC insulation to avoid thermal bridging
- additional works required at windows as returns
- 50mm only loft insulation

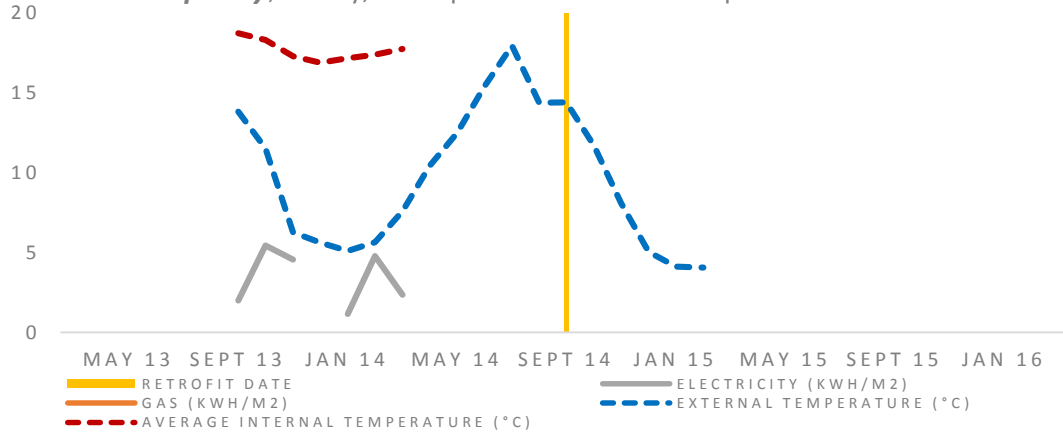
2. **Data quality**; Patchy, incomplete data due to multiple sensor failures.

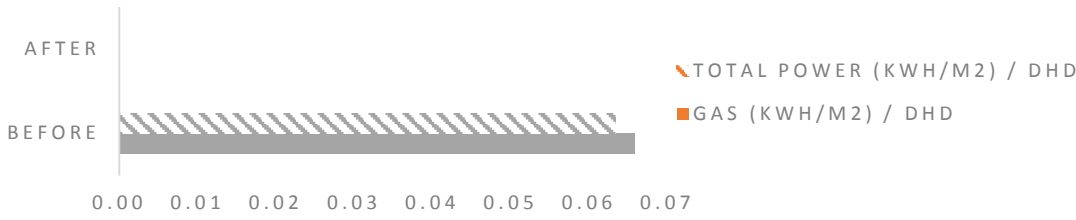
1. Summary; External sensor failure prevented before after comparison

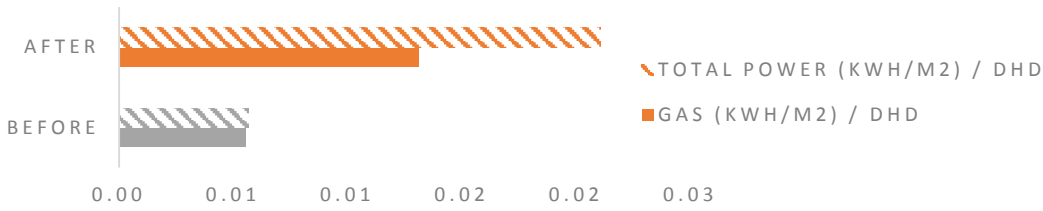
1. **Summary;** Data suggests an increase in energy use to heat the dwelling

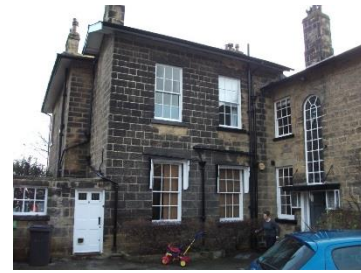
Property E17

- no wall insulation due to listed status
- ventrola system to windows
- damp ingress & gaps between loft insulating slabs increasing thermal loss in attic rooms

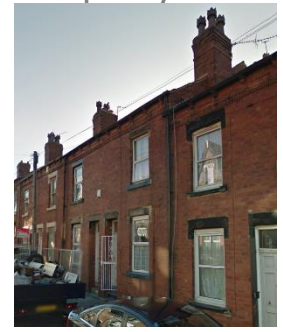
Property E19

- thermal bridging at eaves and ground floor
- large insulation cut-outs at rear for external plumbing, gate, store, service pipe

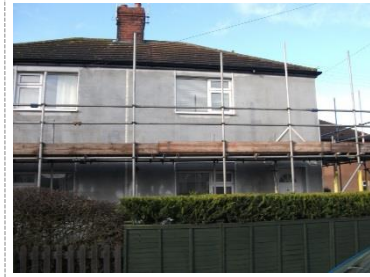
Property E21

- thermal bridging at eaves and ground floor
- excessive condensation each day to windows
- thermal bridging at sloping eaves soffits

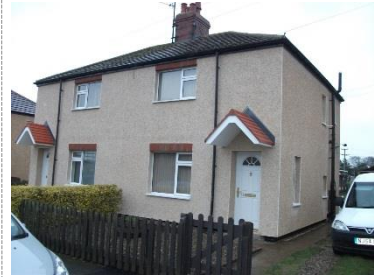
Property E22

- thermal bridging at sloping soffits
- thermal bridging at eaves and ground floor
- EWI close to ground level possibly covering DPC
- cut-outs at services

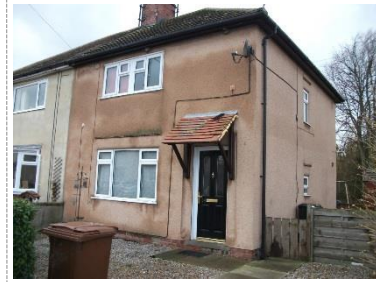
Property E23

- thermal bridging at sloping soffits
- thermal bridging at eaves and ground floor
- cut-outs at services

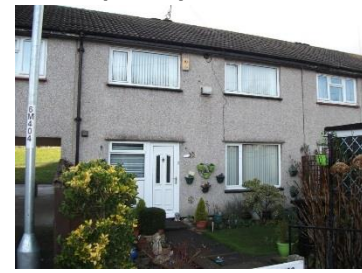
Property E26

- pre-survey only
- EWI would require additional roof works and below DPC insulation to avoid thermal bridging at eaves and ground floor

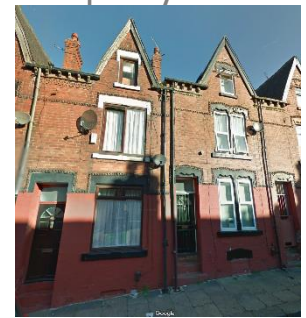
Property E27

- thermal bridging at eaves
- cut-outs for services at rear

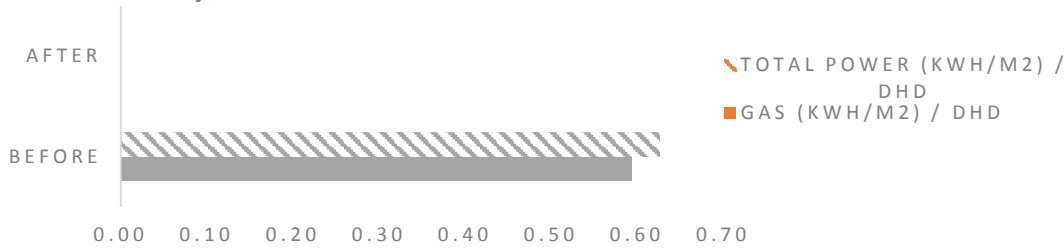
1. Summary; No after retrofit data

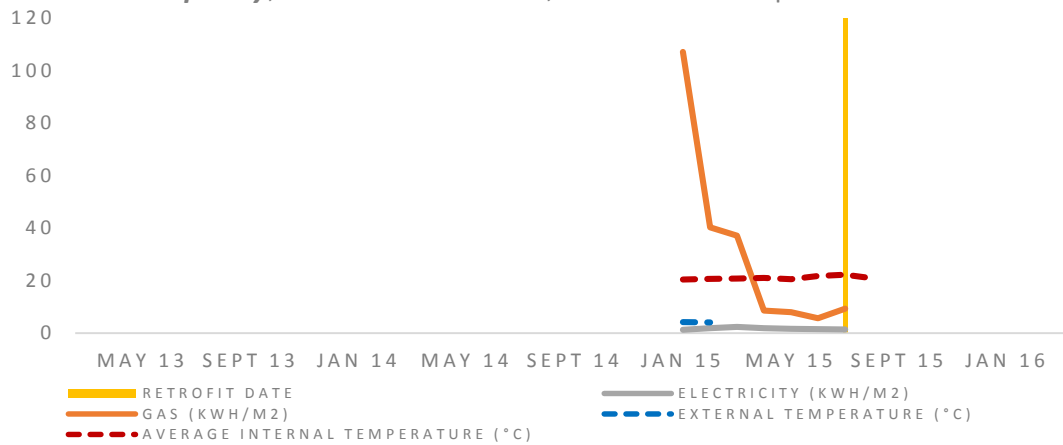
2. Data quality; Data loss after retrofit, little external temperature data.

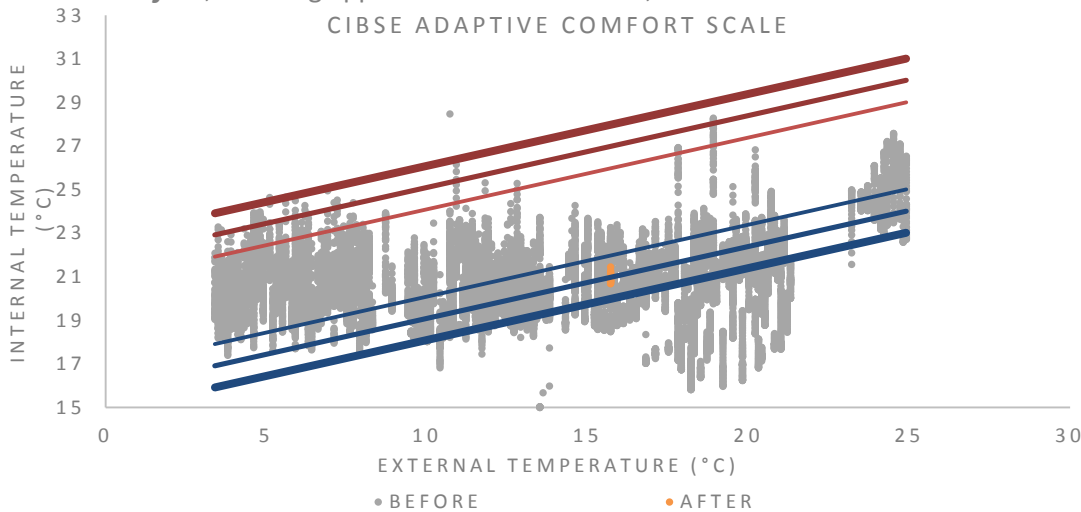
3. Comfort; Dwelling appears difficult to control, under heated

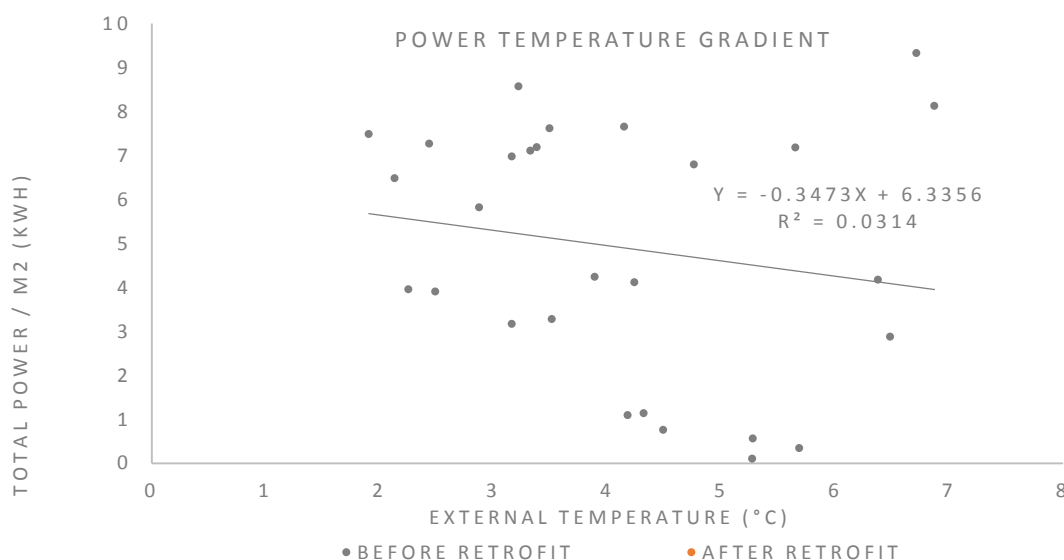
4. Retrofit performance; limited post retrofit data.

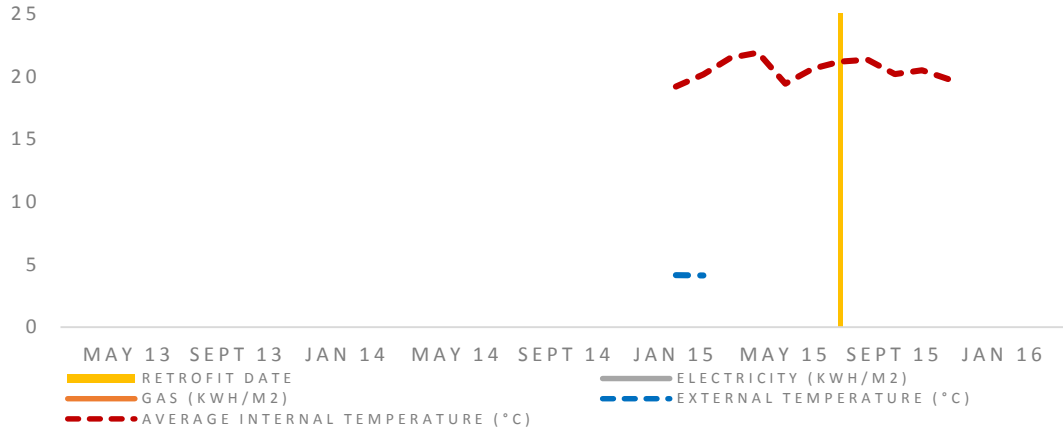
2. **Data quality;** Very limited data, prototype monitoring equipment failure

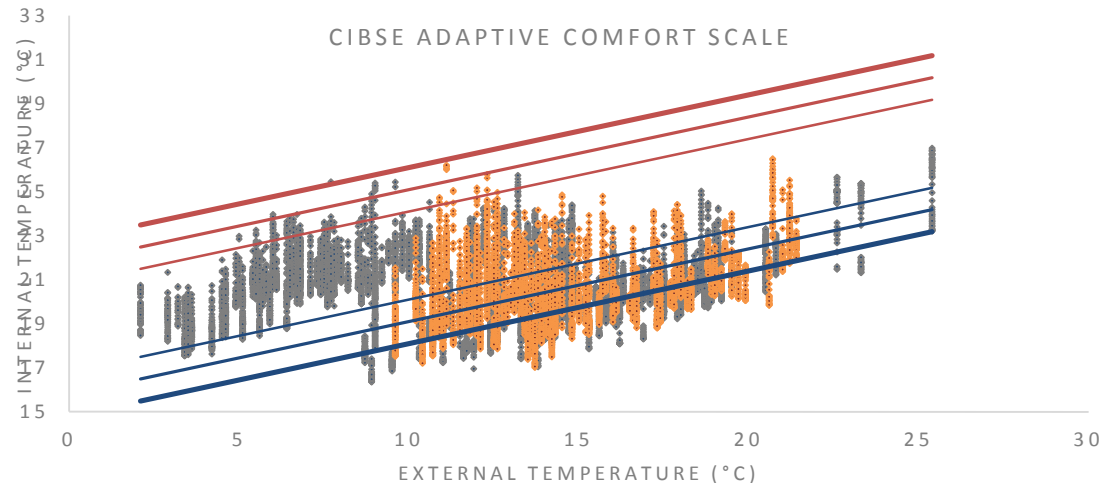
3. **Comfort;** Dwelling appears difficult to control, often under heated.

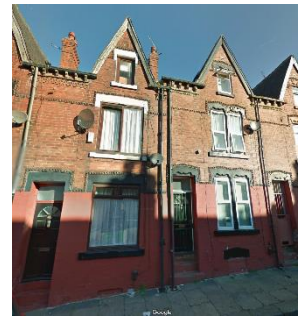
Property E28

- thermal bridging at eaves
- cut-outs for services at rear

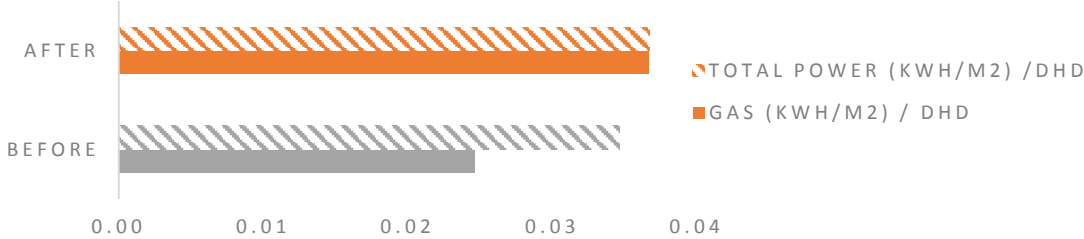
1. Summary; Total energy use increases by 6% after retrofit

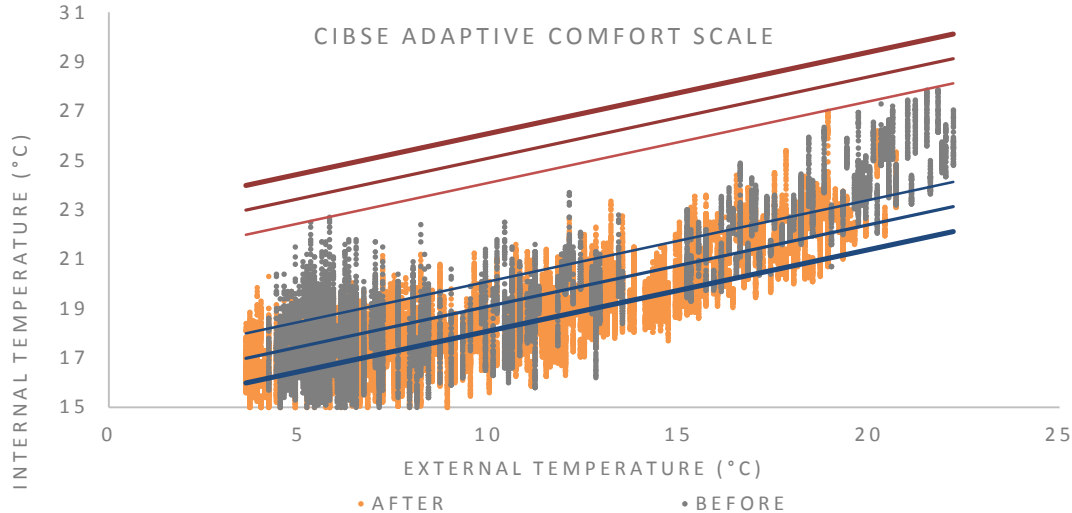
3. Comfort; Dwelling under heated majority of the time, even after retrofit

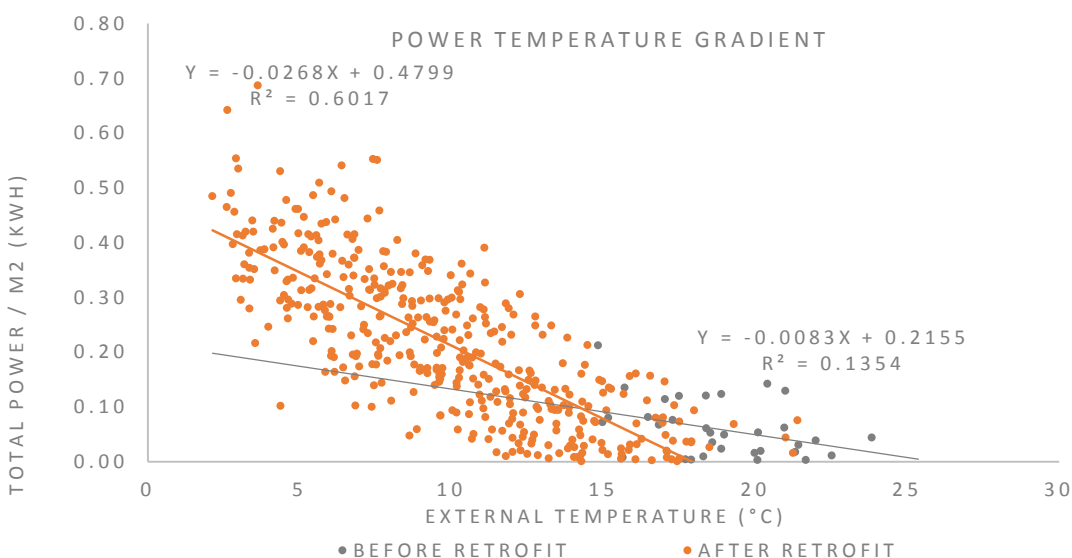
4. Retrofit performance; More energy appears to be used for heating after retrofit

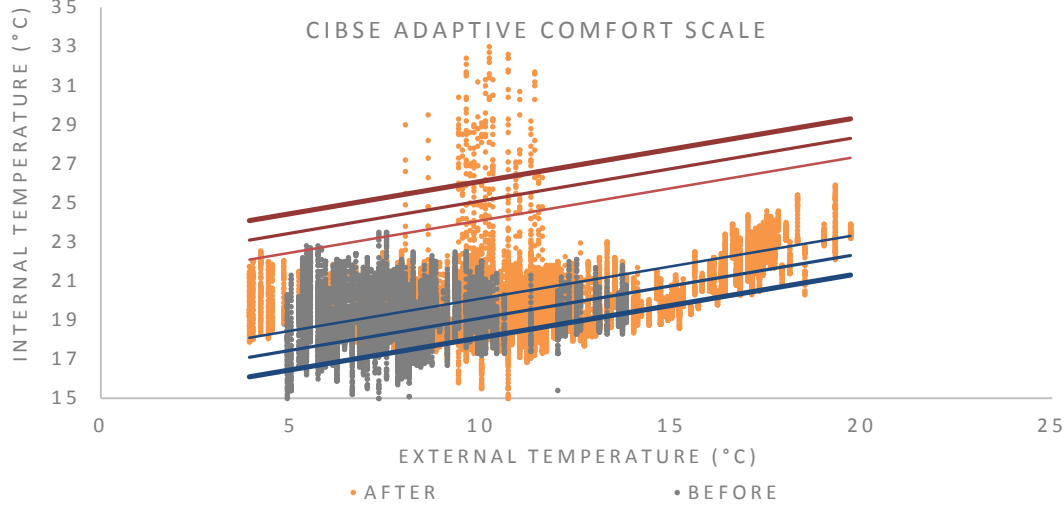
3. Comfort; Dwelling is hard to control and often under heated. Some data anomalies

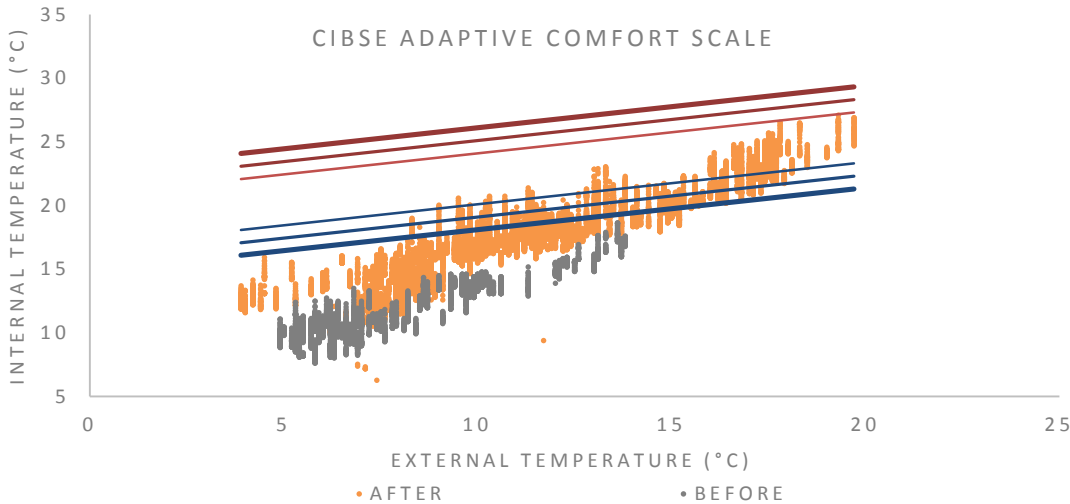
3. **Comfort**; Dwelling is under heated for the majority of the time

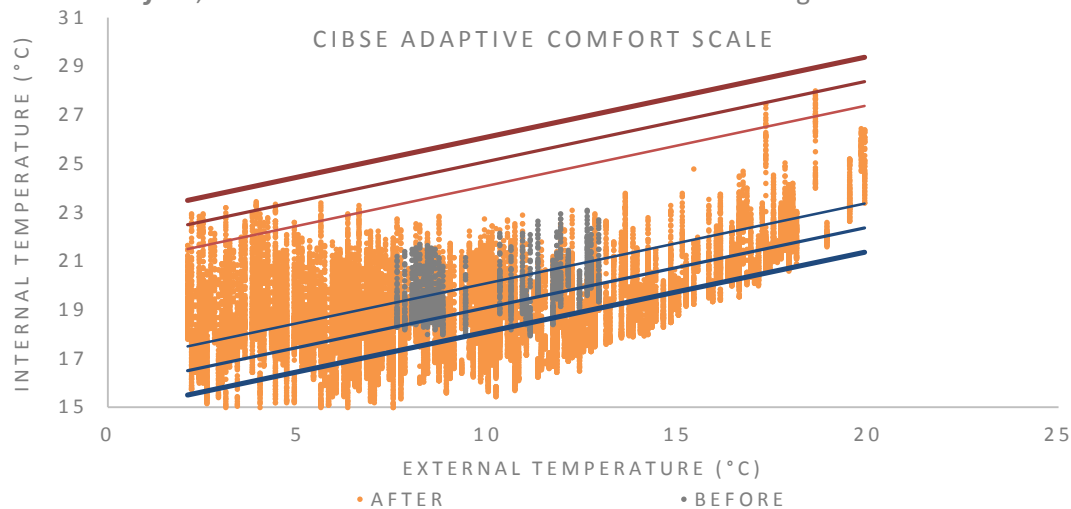
3. **Comfort**; Conditions are difficult to control and the dwelling is often under heated.

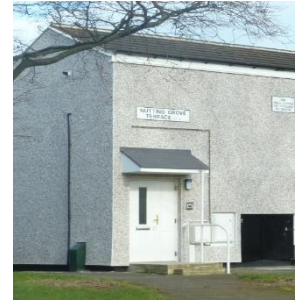
Property E34

- Thermal bridging at eaves
- Poorly laid roof insulation
- No insulation under soffit of stairs
- Insulation cut-out at meter box, etc.
- Well ventilated internally

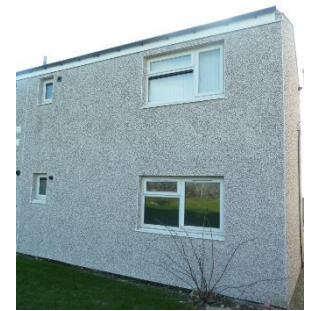
Property E35

- Thermal bridging at eaves
- Poorly laid roof insulation
- No insulation under soffit of stairs
- Insulation cut-out at meter box, etc.

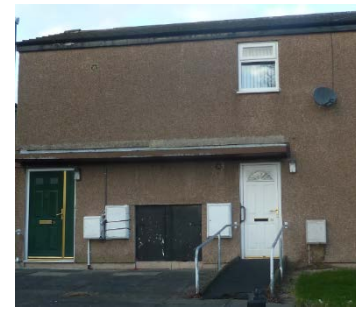
Property E36

- Insulation cut-out at meter box, etc.
- No insulation to store wall forming external wall to bedroom
- Thermal bridge at ground floor level

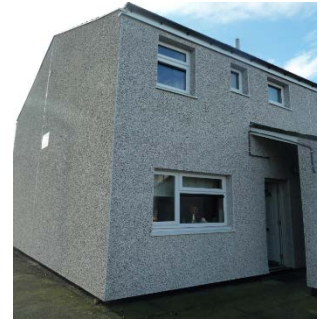
Property E37

- Insulation cut-out at meter box, entrance porch roof, rear garden wall abutting house etc.
- Thermal bridge at eaves & ground floor level

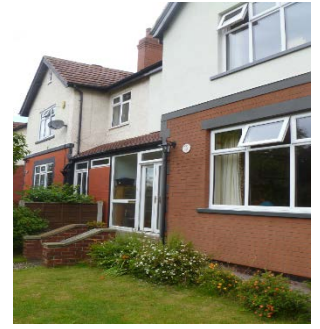
Property E39

- Thermal break between kitchen and conservatory
- Thermal break at uninsulated stairs to basement & basement ceiling
- Thermal bridging at eaves sloping soffits

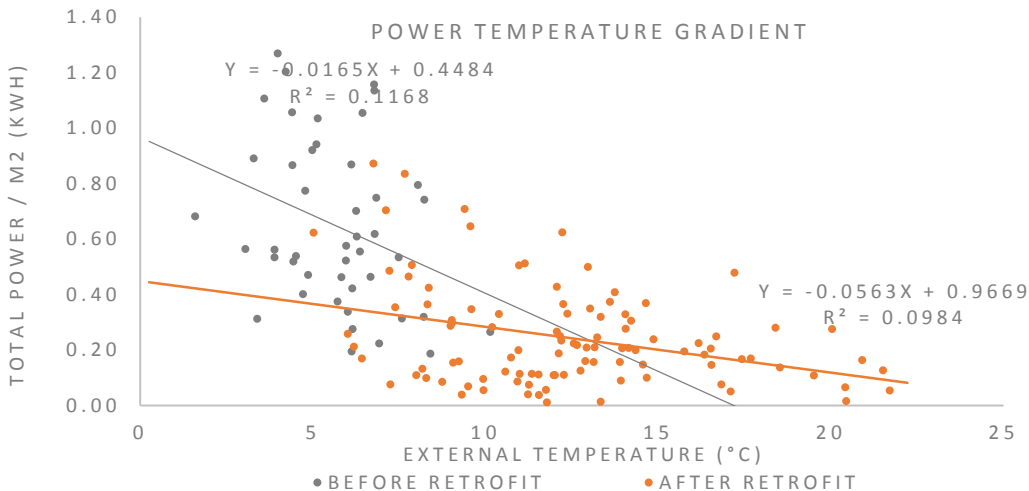
Property E41

4. **Retrofit performance;** Apparent improvement in heating energy consumption

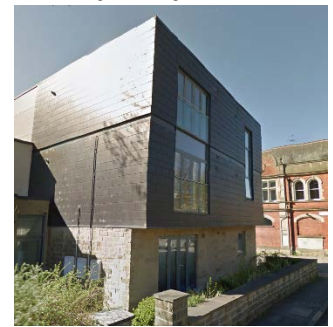
Property E43

- Minimal thermal breaks designed in
- Some reduced insulation sections due to building design

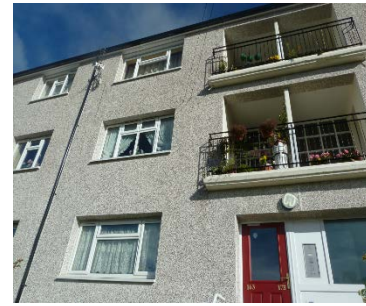
Property E45

- Historic mould from condensation pre-treatment not cleared
- Bathroom/rear balcony wall still damp with mould

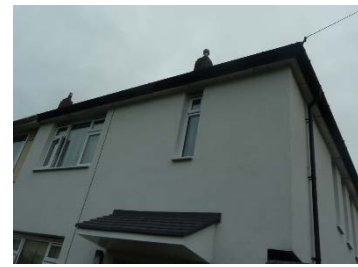
Property E46

- Occupant has low level of heating
- EWI finishes above FFL
- BCIS system dry-lined, possible thermal bypass
- Insulation cut-outs
- Minimal loft & flat roof insulation
