# ***AAIB Bulletin***

***7/2017***

Spitfire IXT	G-LFIX	15-Sep-16	3
--------------	--------	-----------	---

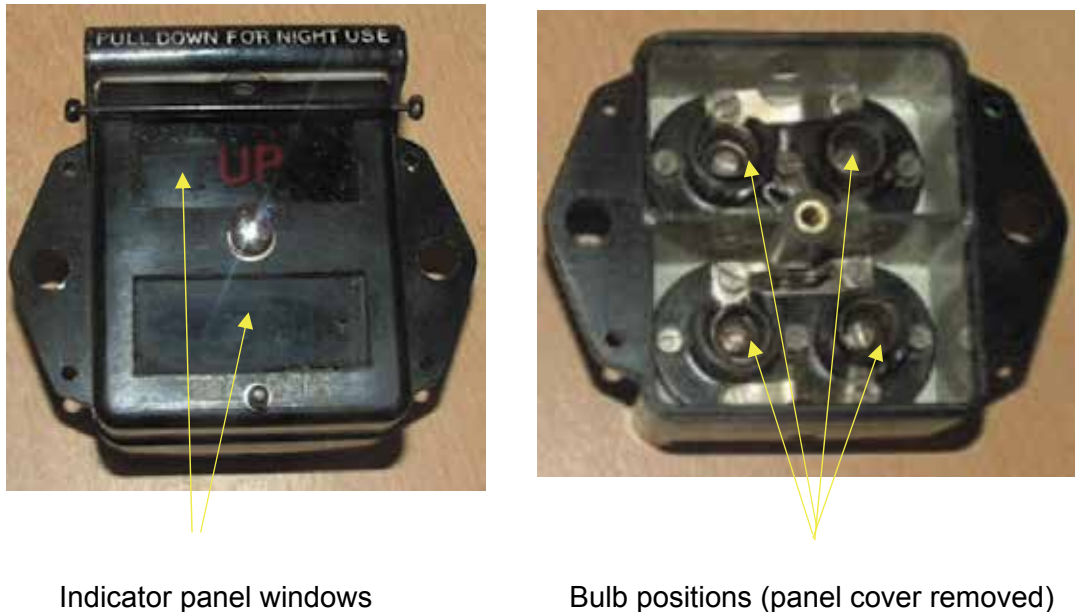
**Figure 2**

The Spitfire Mk IX is fitted with a landing gear position indicator on the left side of the instrument panel. The indicator consists of two black, back-illuminated panels. When the bulbs behind the panels light up the word UP is displayed in the upper panel and the word DOWN in the lower panel (Figure 2).

No defects were found within the landing gear position indication system. The fact that the left landing gear did not achieve a locked position meant that the left light bulb in the landing gear position indicator would not have illuminated. However, tests showed that sufficient light was produced by the right bulb to illuminate the D and O of the DOWN caption.

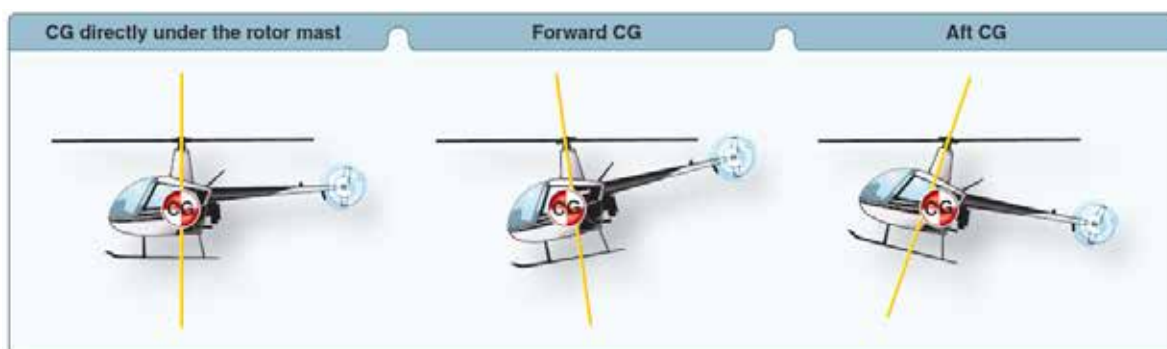
**Figure 2**

*'A forward CG is not as obvious when hovering into a strong wind, since less rearward cyclic displacement is required than when hovering with no wind. When determining whether a critical balance condition exists, it is essential to consider the wind velocity and its relation to the rearward displacement of the cyclic control.'*

Illustration of the effect of CG on helicopter handling<sup>5</sup>

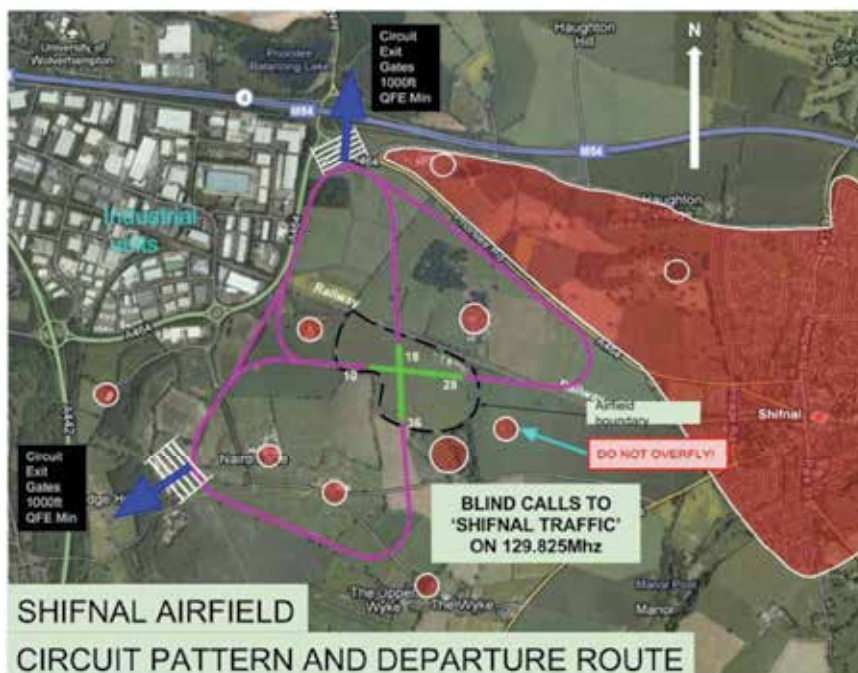
Figure 1

One image on the flying club website shows the airfield, runways, and noise-sensitive areas, together with the circuit patterns and two 'gates' through which aircraft should depart the circuit (Figure 1).

The website image of the circuit and noise-sensitive areas, annotated 'DO NOT OVERFLY!'

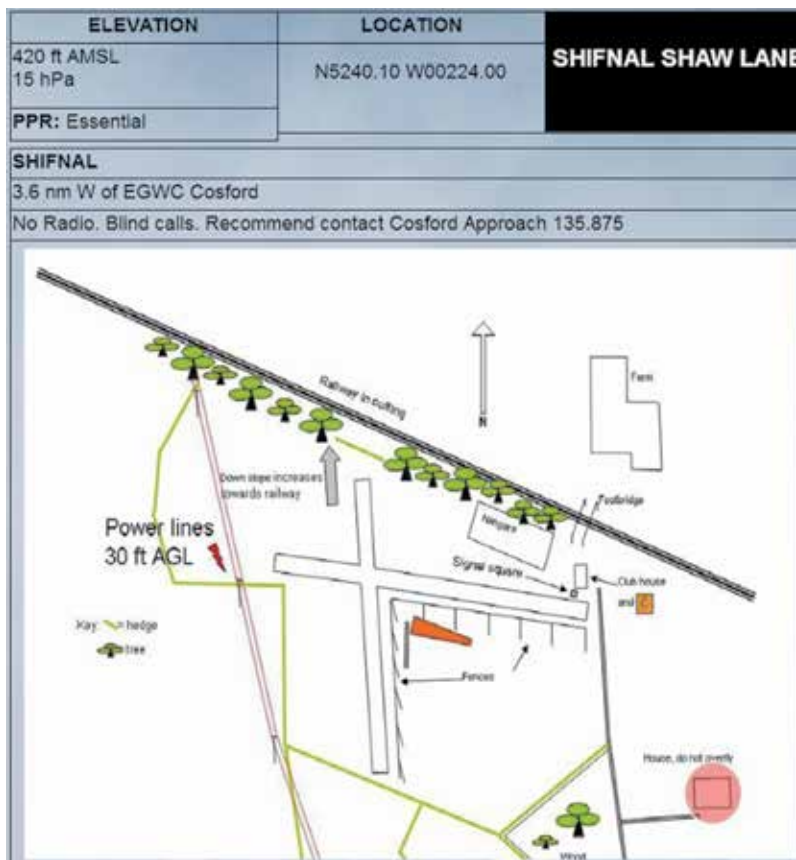
Figure 2

The flying club website also features an image of the airfield layout, with the railway line shown to the north, without the circuit pattern being depicted (Figure 2).

The website depiction of the airfield, showing the railway line to the north

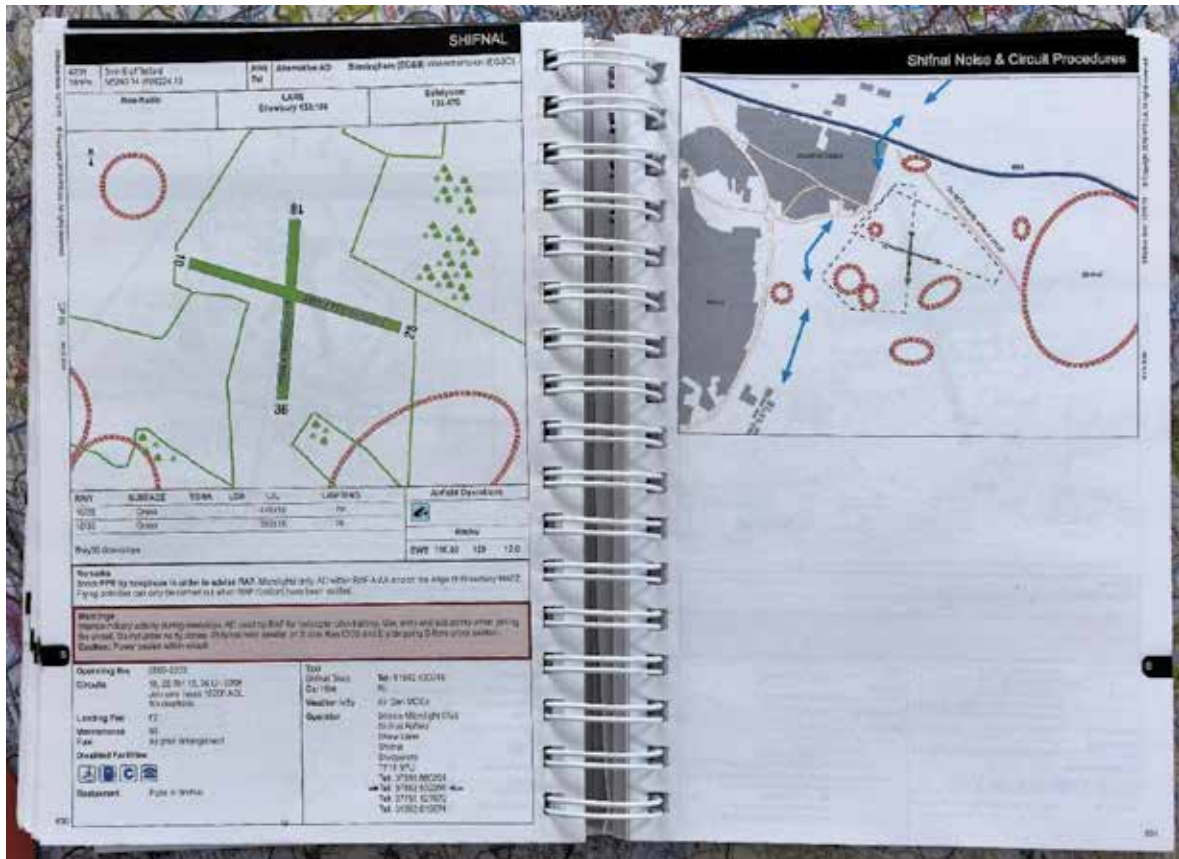
**Figure 3**

Similar information about the airfield was also available in a commercially published airfield guide. When an AAIB investigator visited Longford, the day after the accident, a copy of this guide was on the briefing table in the club caravan, open at the pages for Shifnal (Figure 3).

The information on Shifnal Airfield, and its noise and circuit procedures, in the commercially published airfield guide

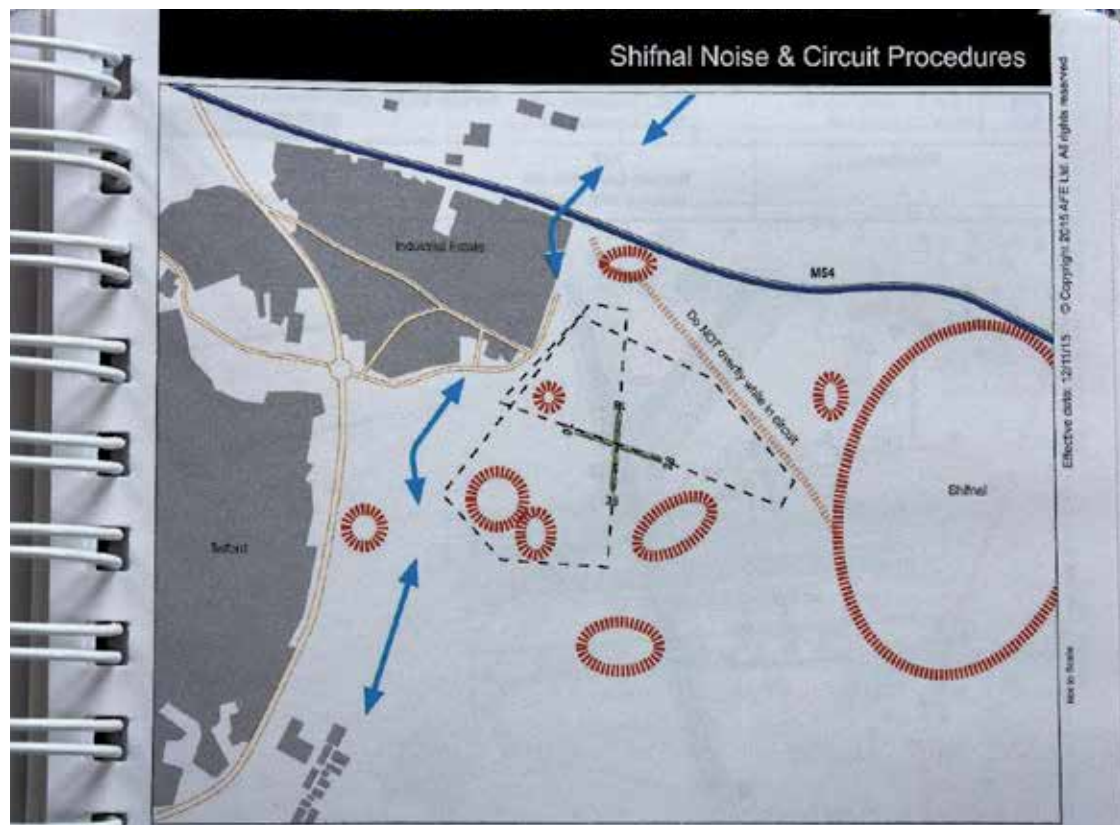
**Figure 4**

The 'Noise and Circuit Procedures' chart (Figure 4) in this guide showed one hachured line north of the airfield, which the circuit parallels, but, although it followed the line of the A464 trunk road, the guide did not indicate whether it was a road, railway, or other line feature.

The Noise and Circuit Procedures chart from the guide

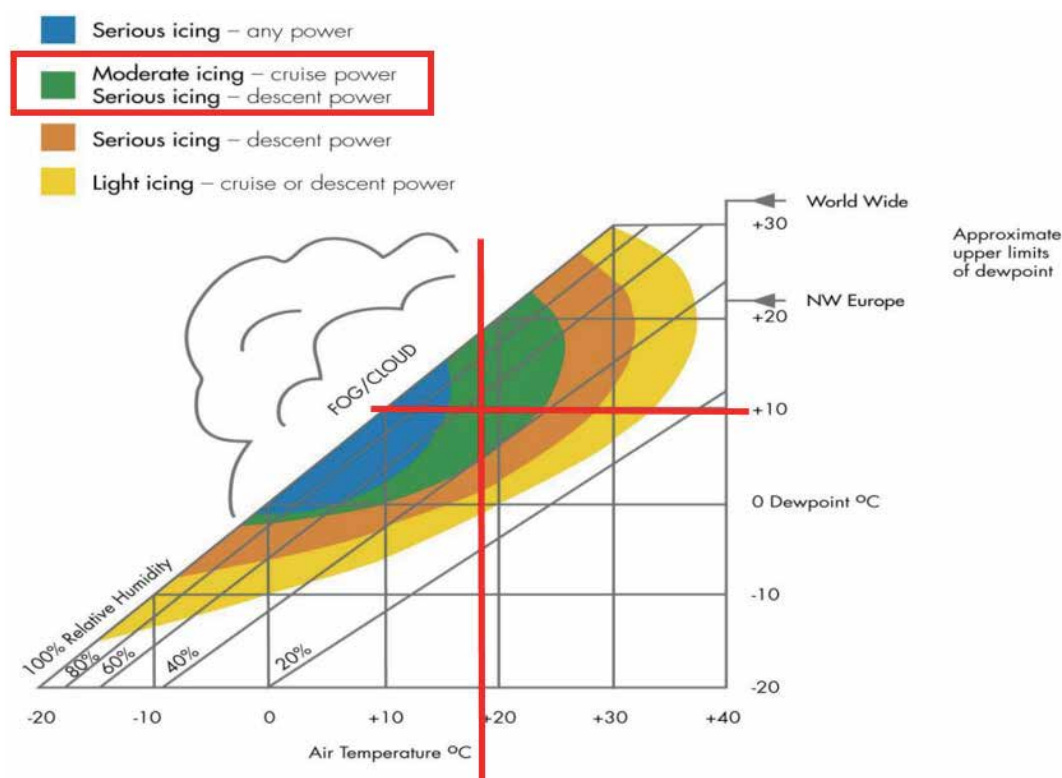
**Figure 8**

The leaflet incorporates a graph of temperature and dew point (Figure 8), depicting the probability of carburettor icing at various power settings. In the reported conditions, the graph shows that moderate icing could be expected at cruise power, and serious icing at descent power.

CAA Chart showing probability of carburettor icing; the red lines show the approximate values of temperature and dew point at the time of the accident

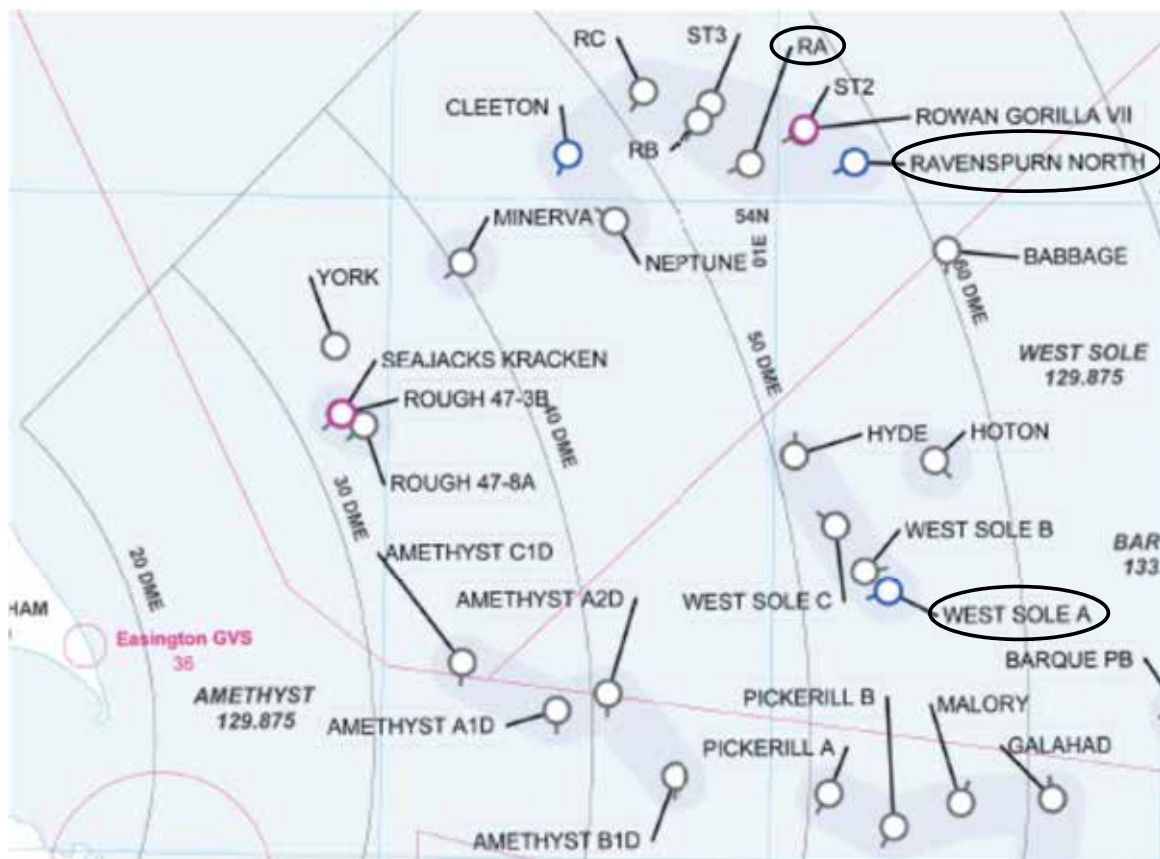
**Figure 1**

On departing the West Sole Alpha platform, the helicopter proceeded to the Ravenspurn field. The co-pilot made a radio call to request helideck availability from the Ravenspurn Field Helicopter Landing Officer (HLO) but only used the word "Ravenspurn" when providing the name of the platform on which the crew intended to land, instead of "Ravenspurn North". The HLO responded: "Ravenspurn Alpha deck is available, standing by on the north side". However, the crew did not pick up on the discrepancy between their intended destination and the clearance and carried out an approach and landing to Ravenspurn North. There was no helideck crew present, as required by the operator, and a radio call alerted the crew to the fact they had landed on Ravenspurn North rather than Ravenspurn Alpha, where they were expected (Figure 1).

Once the crew had the payload information, they realised that they could complete the trip without refuelling offshore. Re-planning involved re-ordering the destinations into one flight plan, rather than the initial two. This involved the co-pilot selecting the destinations using the drop down menu and it was during this process that the destination for sector four was mis-selected as Ravenspurn North (RVN) rather than Ravenspurn Alpha (RA).
